**STS-107 (BI116)  
FLIGHT READINESS REVIEW**

**January 9, 2003**

**Solid Rocket Booster**

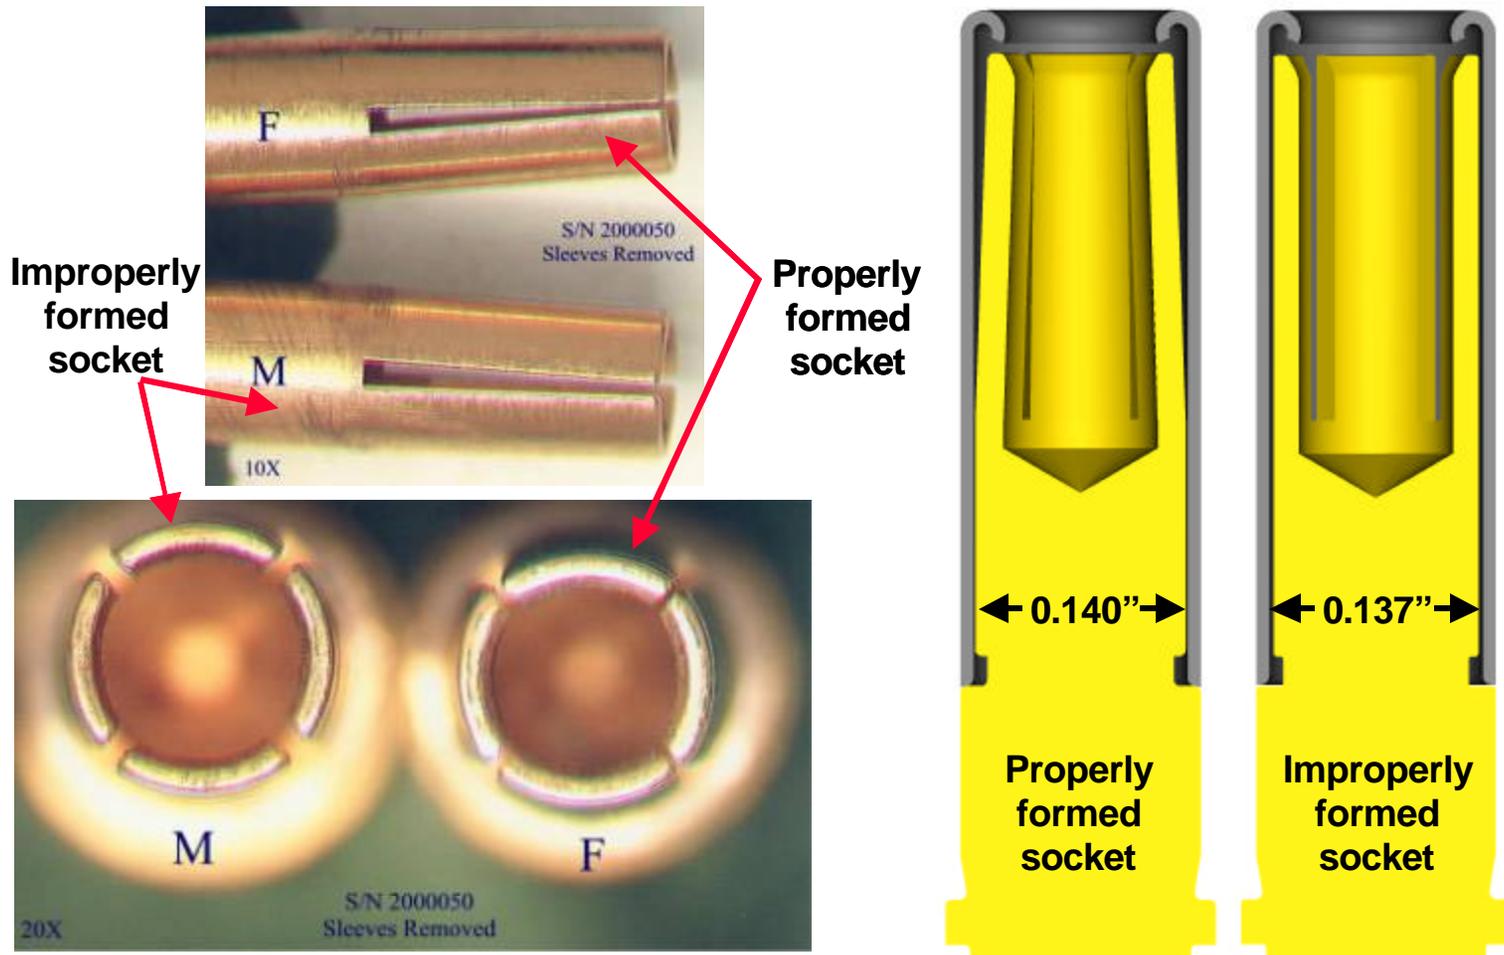
Visual Comparison of Properly and Improperly Formed Sockets

- Formed joint anomaly resolution team
  - Representatives from MSFC, USA and Amphenol
- Identified connector socket manufacturing anomaly
  - Undersized socket barrel outside diameter resulted in improper forming of socket

- Identified improper machining of socket as primary root cause of anomaly
  - Identified quality escapes as secondary root cause
    - In-process checks – six per hour required
    - Burnish and gauge operation – 100% requirement
    - Lot acceptance tests – 1% AQL
- Completed inspection and pin retention test of all available hardware
  - No discrepancies found on STS-107, inspected 12-18-02
  - Replaced two cables on STS-114, inspected 12-16-02
  - STS-115 aft boosters still to be inspected and tested
  - Identified one unused contact on STS-116 as discrepant on 12-11-02

- STS-107 NAS6CR connectors successfully passed inspection and pin retention test
- All other uses of NAS6CR connectors on future missions will be inspected and non-conformances corrected
- Investigation data supports isolated quality escapes limited to NAS6CR connector sockets
- Inspection of NAJ-12-16 sockets indicates no similar concern
  - NAJ-12-16 sockets only used in Criticality 3 applications
- All SRB system's functionality and redundancy verified before and after vehicle assembly
- Critical systems verified during pre-flight testing
- STS-107 and subsequent safe to fly

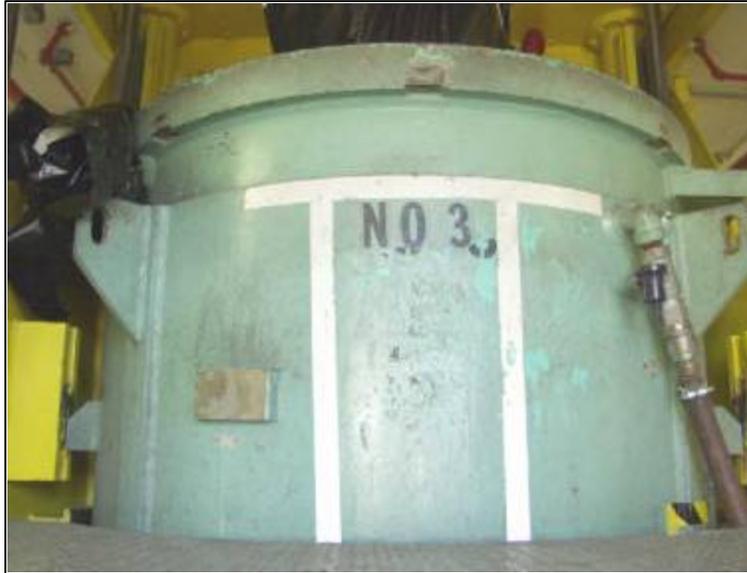
- Five small paint chips detected in propellant premix for SRB BSM propellant batch at vendor
  - Identified prior to mix operation
  - Chips loosened from painted lip of 400 gallon mix bowl when chemical addition cover removed

**400 Gallon Mix Bowl**

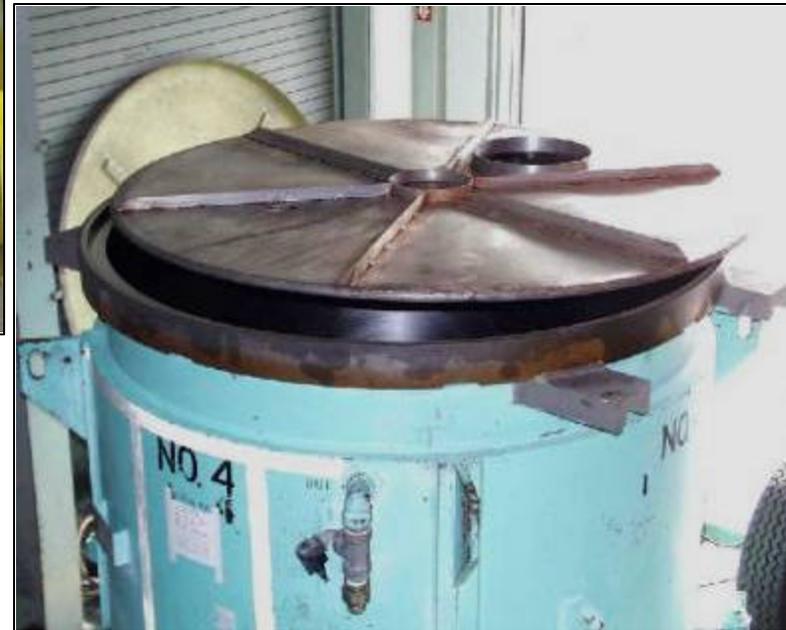
**Chemical Addition Cover  
(paint removed from rim of bowl)**

- Anomaly resolution team formed
  - USA, NASA, Boeing and Pratt & Whitney Space Propulsion
  - Independent USA Chief Engineer's team formed for oversight
- All BSMs in inventory suspect
- Inspection of mix bowl showed areas of missing paint
  - Materials analysis positively identified FOD as paint from mix bowl
- Analysis reveals no affect on BSM performance
  - Structural, thermal and ignition interval
- Debris transport analysis determined BSM ejecta with similar properties as virgin paint chips would be flight concern for Orbiter windows
- Analysis alone unable to show sufficient paint consumption during BSM burn
  - Test program required

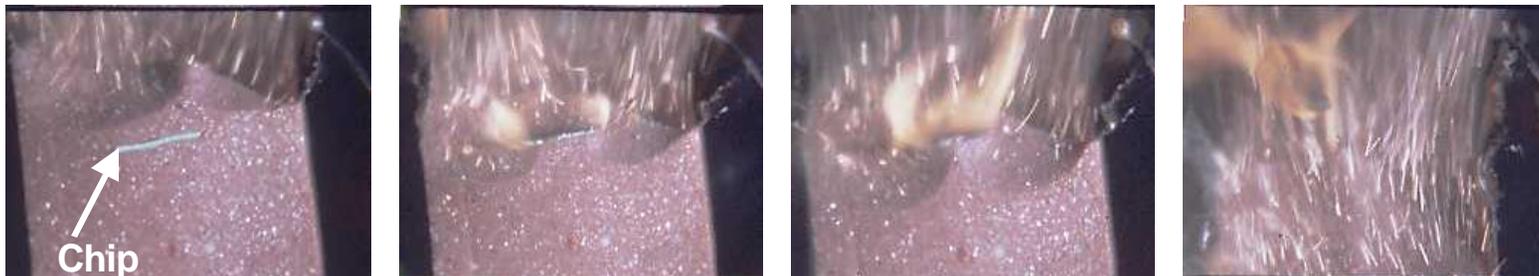
- Test program initiated to determine thermal effects of BSM propellant burn on imbedded paint
  - Seven successful window bomb tests performed on propellant samples
    - Window bomb testing allows high speed photography of propellant during burn
    - Propellant cast into  $\frac{1}{4}$  by  $\frac{1}{4}$  by  $\frac{1}{2}$  inch samples with paint chips inserted prior to cure
    - Paint chips inserted both horizontally and vertically to flame front
- Photographic review shows paint burning with red glow of a heated carbonized structure when released into flow stream

**Window Bomb Test for Paint Chip Planar with Flame Front**

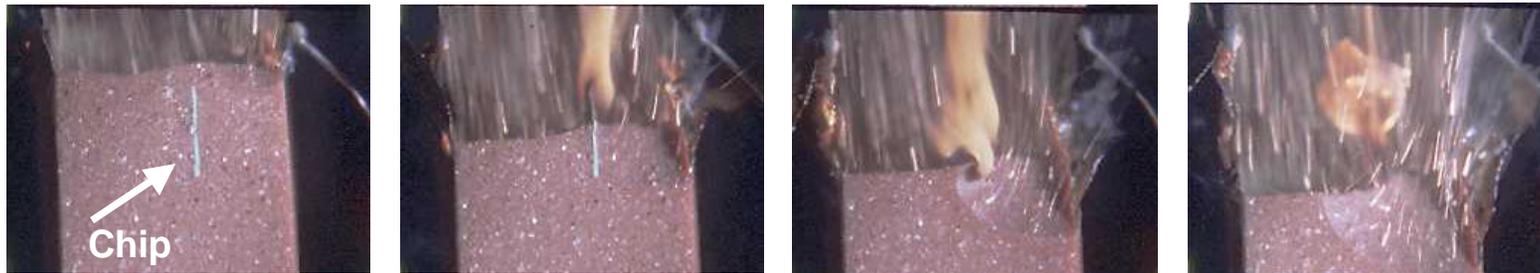
**Window Bomb Test for Paint Chip Perpendicular to Flame Front**

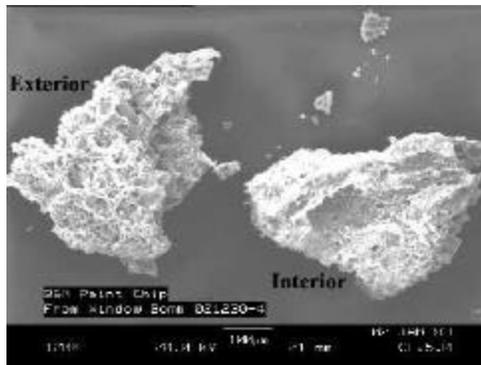
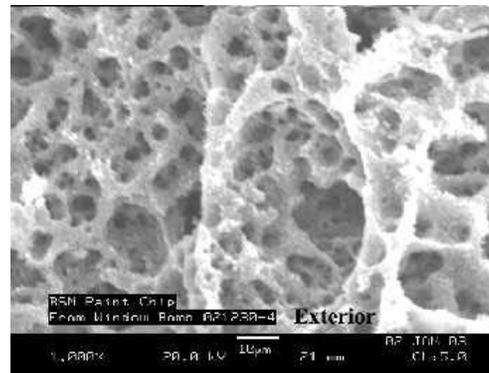
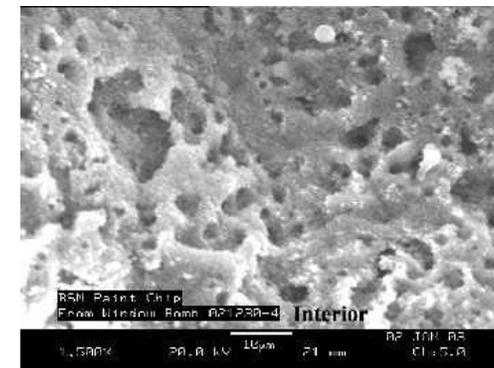
- Five of seven tests resulted in released material captured on 250 micron filter screen
  - Released material on other two tests passed through filter
  - Captured residue examined by scanning electron microscope and determined to be highly porous, fragile, carbonized structure
    - Energy Dispersive X-Ray confirms paint tint material (titanium oxide) is captured in carbonized particles
- Analysis determined that released material would not withstand forces imparted during BSM nozzle entry
  - Results in rendering particles to dust, or ash, like configuration similar to nominal BSM exhaust from combustion of propellant

**SEM Results for Captured Residue  
(hollow, carbonized structure)**

- BSM performance not affected by presence of paint FOD
- All Orbiter/ET debris impact concerns cleared by testing and analysis
- No increased risk to flight safety or mission success for identified paint FOD
- STS-107 and subsequent safe to fly
