STS-107 POST LAUNCH FILM REVIEW
KSC Photo/Video Analysis Team
18 January 2003

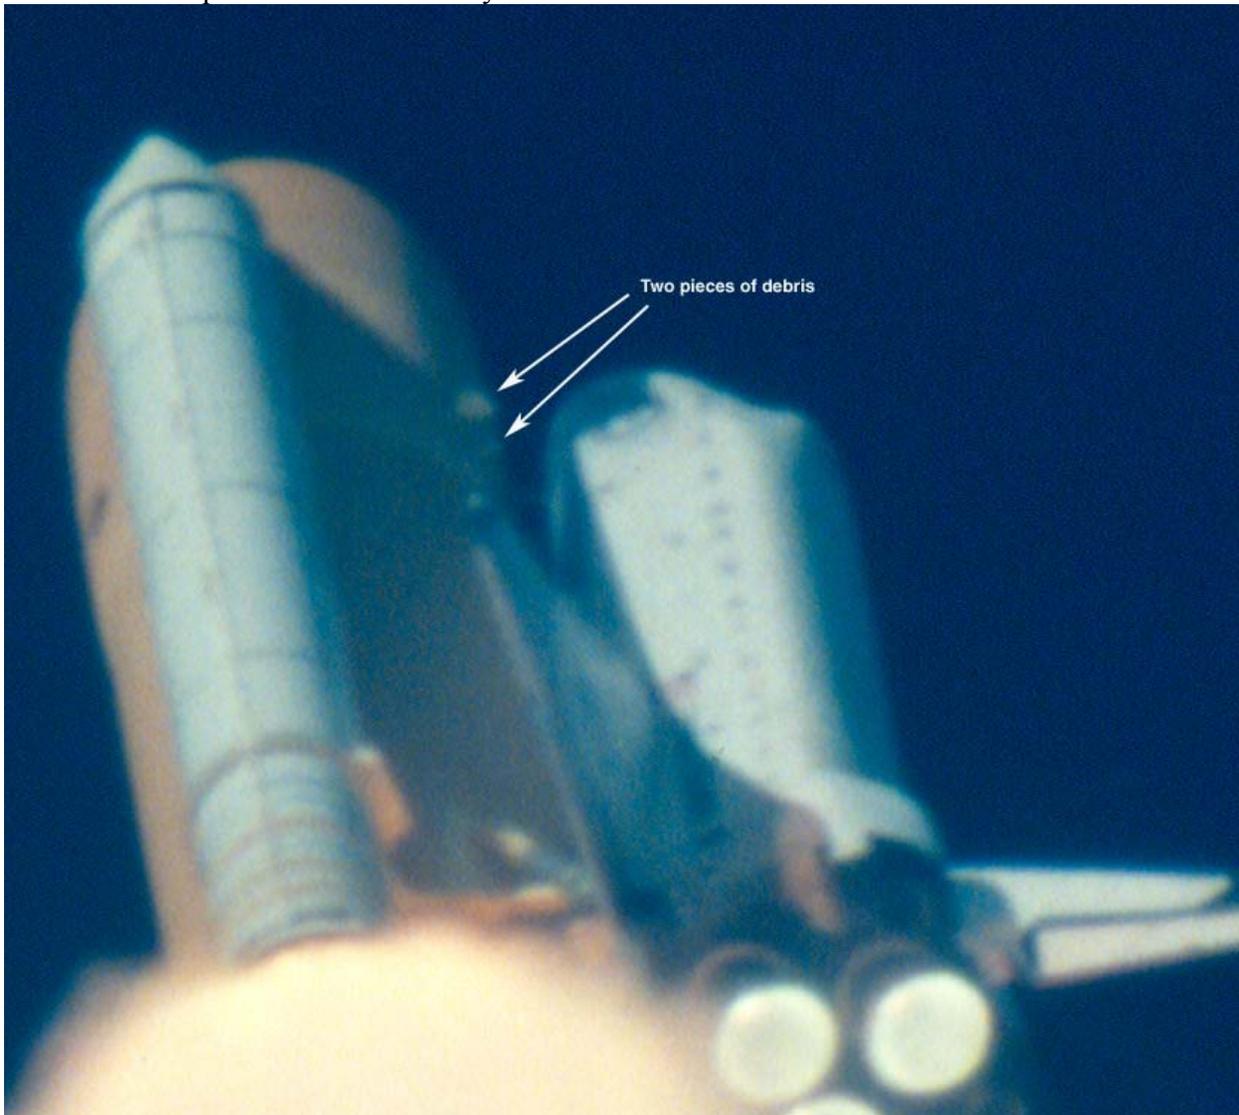
Photo 1. Film E-212

1. At approximately 81-82 seconds after T-0, debris originating from the area near the ET -Y bipod strut attach point is observed striking the underside of the LH wing of the Orbiter. The impact site appears to be near the leading edge of the wing. Two distinct pieces of debris can be seen on Film item E-212 before impact with the wing (see Photo 1.) The best view of the event is on tracking video ET-208 (attached with report). Damage assessment on the Orbiter is difficult due to poor resolution. Analysis will continue on this event.

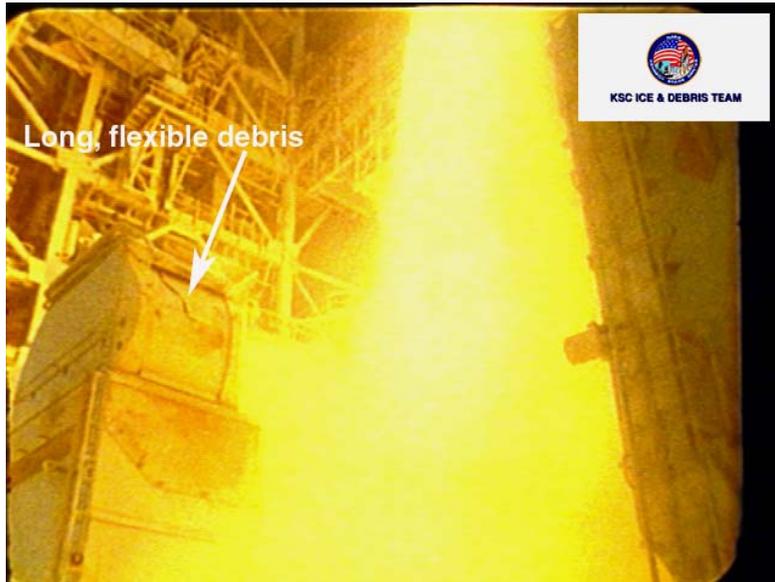
Long, flexible debris comes out of LH2 TSM after door closes. (E-19)

Photo 2. Film E-19. Debris from LH2 TSM.
