PR ET-093-TS-0014

PD 2.0 and 3.0 mold installation

PD 1.0 mold installation

OPERATION 30 Summary Closure

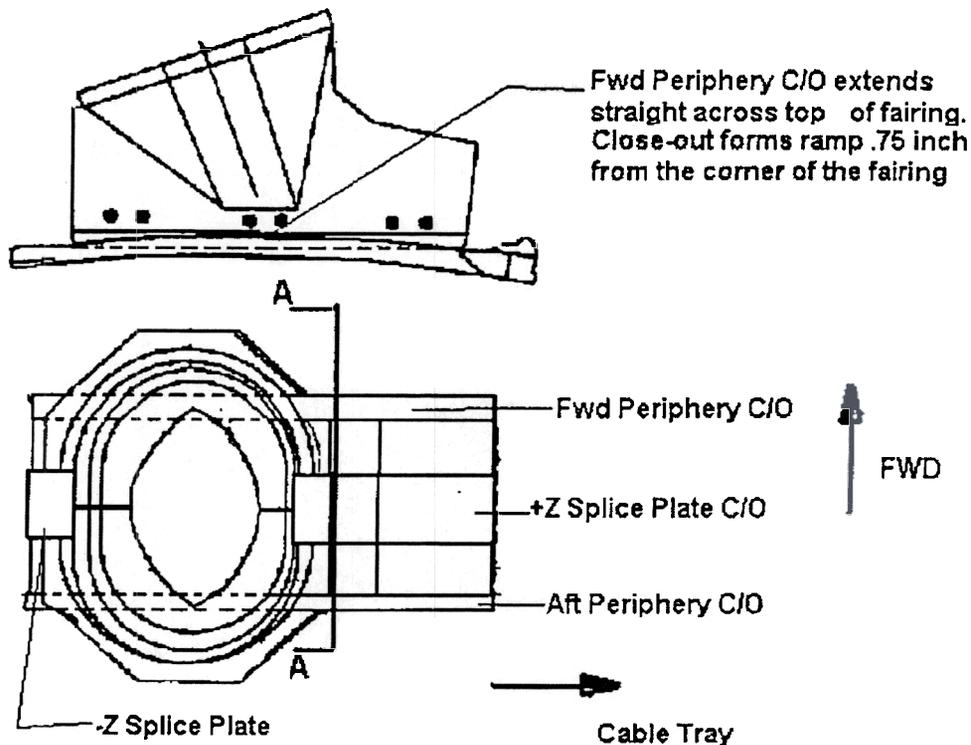
Figure: Foam Close-Out
 (For Reference Only)
 -Y Side Shown (+Y side similar)

The forward periphery close-out is straight across the fairing tangential to the tank surface.

Foam flush with adjacent except as noted on Fwd and aft periphery

Reference PD item 1.0, the forward periphery of the -Y aft fairing closeout had numerous voids on both the +Z and -Z ends. The closeout was removed and re-foamed per an MRB. The repair was successful.

Cause for PD item 1.0: (2) Design Deficiency.

Fabricate mold forward periphery (ref Figure: Foam Close-Out) as follows:

20-8 Install mold on forward periphery (ref Figure: Foam Close-Out) as follows:

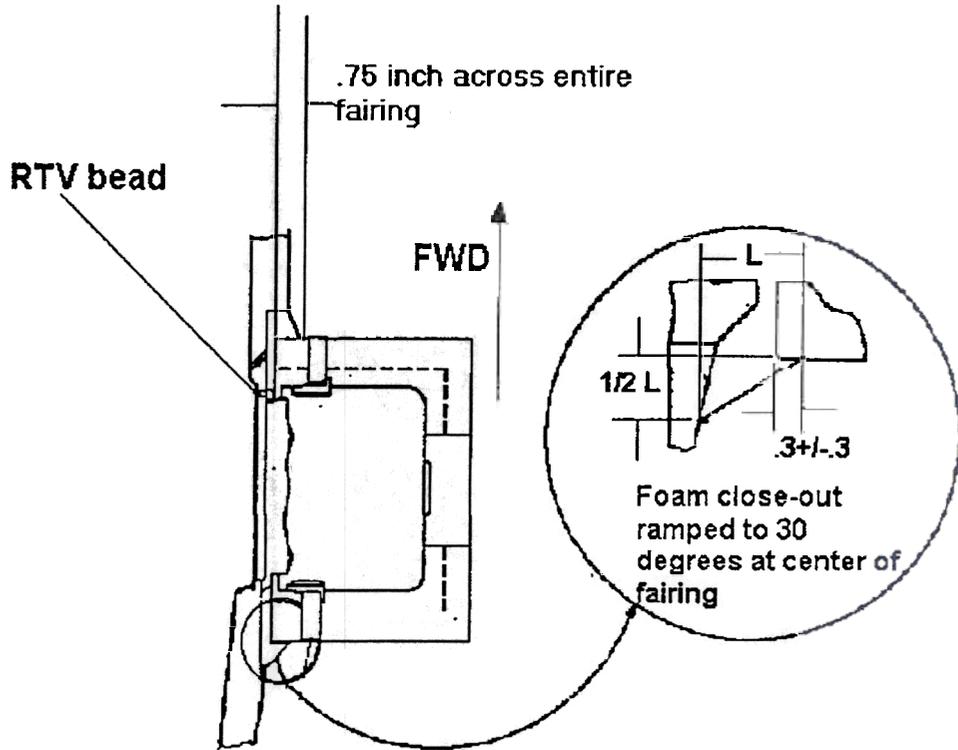
View A-A
Figure: Foam Close-Out
(For Reference Only)

See View A-A for aft Periphery C/O Configuration
