TITLE: SUSPECTED AREAS (1 EACH +Y AND -Y) OF LOW FOAM AFT OF THE ET/SRB FITTI

SPACE SHUTTLE	1. Report Number	PAGE 1 OF 16
		<input type="checkbox"/> INTERIM PROBLEM REPORT <input checked="" type="checkbox"/> PROBLEM REPORT <input type="checkbox"/> DISCREPANCY REPORT

PR ET-093-TS-0008

## **LOW FOAM ON AFT DOME**

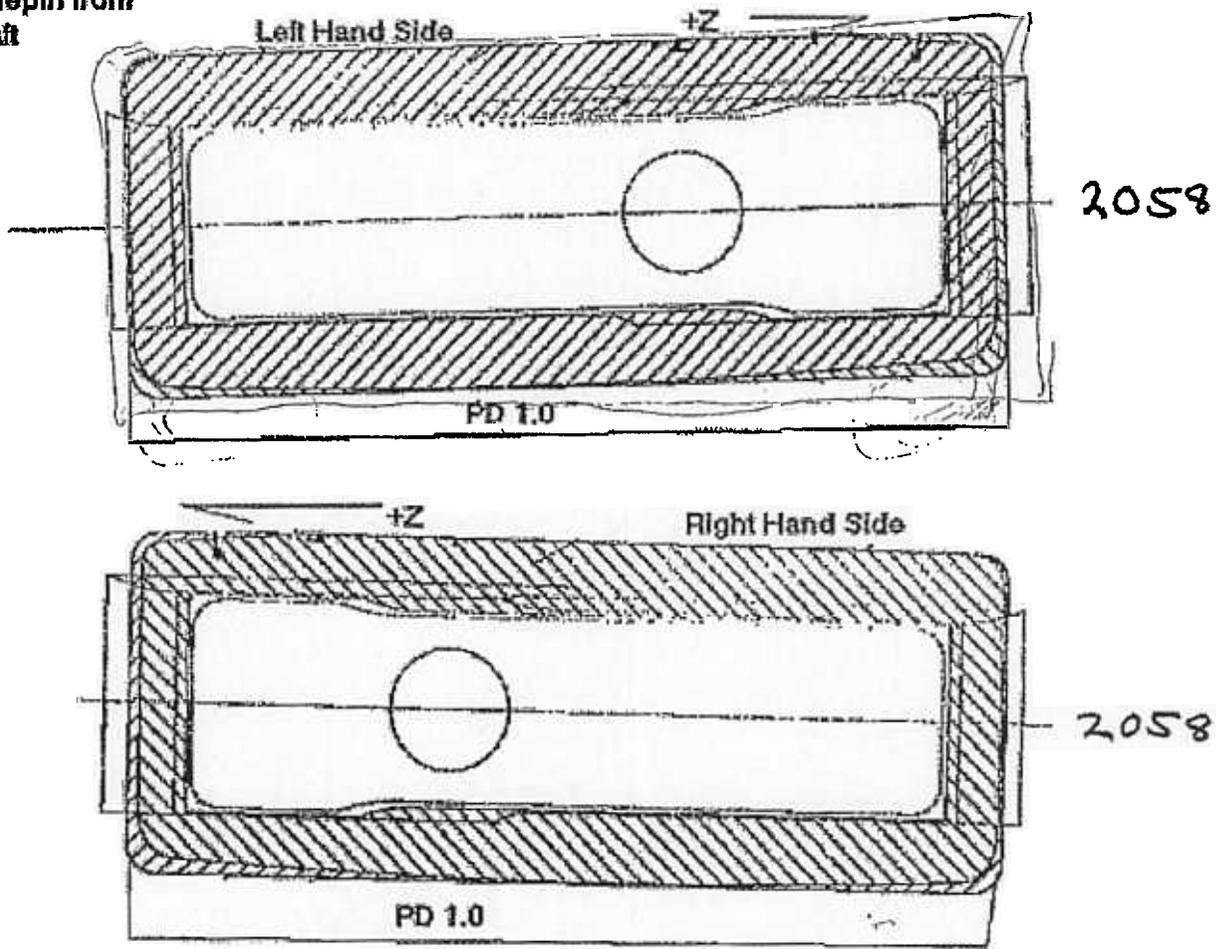
Figure 10-1

12. Item 1	13. Problem Description Suspected areas (1 each +Y and -Y) of low foam aft of the ET/SRB fitting closeout. Areas are approximately 1 inch wide by 26 inches long.
---------------	--

10-1 ① Ref PD 1. and Dwg 80971018423, Sht 9, + 809740789  
Map foam "trough" below the EB fitting by recording Width, Depth, and adjacent (using a Kamati calibrated per T3503.041) every 2 inches along the area from the +Z end. <sup>-500</sup> <sup>foam thickness</sup> <sup>is about 1/2" out</sup> <sup>(measured from get dome)</sup>

The NCFI on the aft dome was trimmed beyond the drawing allowances. This was evaluated and was found to exceed the 80901019010 allowances for repair of an area adjacent to a scheduled close-out (.75 inch beyond boundary by 4 inches long).

Cause: Though this was an unfamiliar task which has only been performed a handful of times in the life of the program, due caution was not exercised when performing the clean-up of the remaining PDL. This was workmanship.

Close-out application performed per the following details (OMI T1297.002) shall encapsulate the PD 1.0 low areas providing additional thermal protection.

- Construct molds per standard procedures (reference OMI T1297.002)
- Vent molds at the center.
- Inject 50cc of foam at the -Z end and at the +Z end.
- Allow excess foam to vent out the center.

Foam was applied to the scheduled periphery at either end of the close-out (where the cut-outs were the deepest) instead of in the center to provide for the most foam where needed. This afforded the greatest protection over the low foam areas.
