APPENDIX B. MSFC PHOTOGRAPHIC ANALYSIS SUMMARY

Space Shuttle Mission STS-101

Engineering Photographic Analysis Summary Report Marshall Space Flight Center

Prepared: June 21, 2000

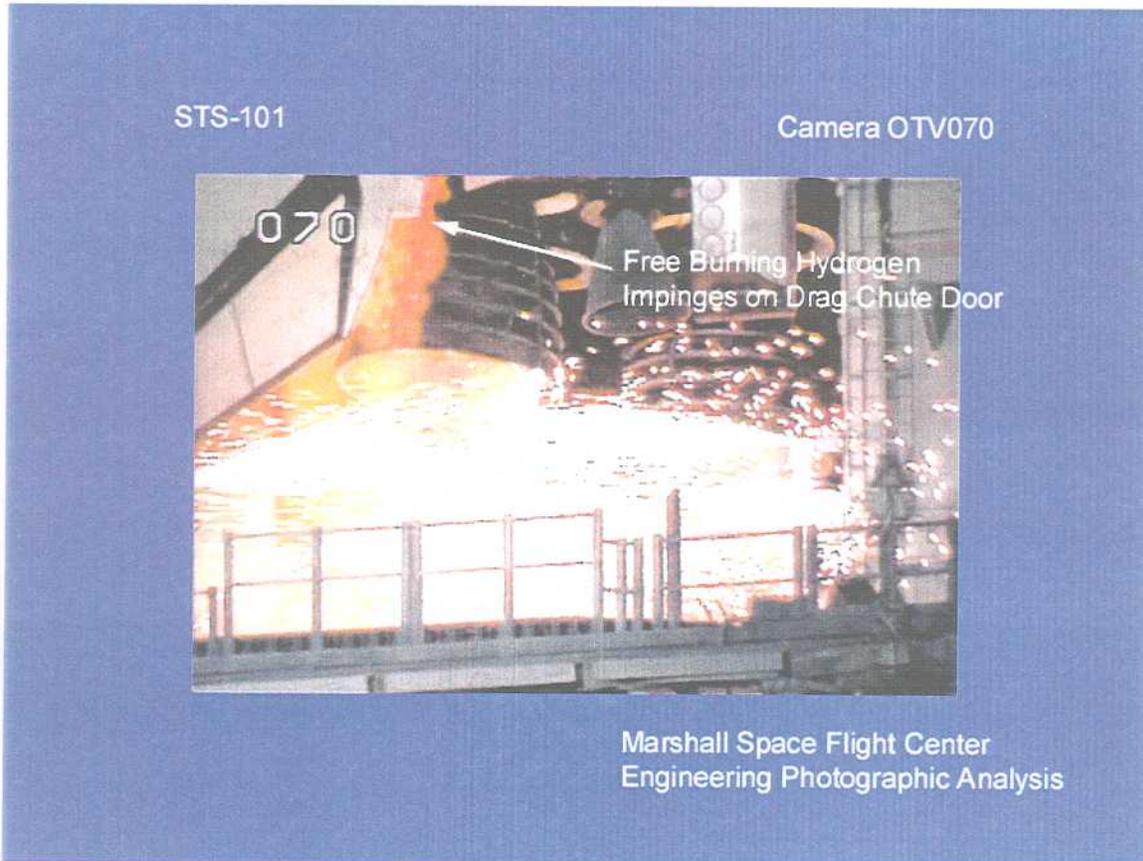
Figure 1. Free Burning Hydrogen at SSME Start-Up

Free burning Hydrogen was observed, as a glowing reddish-orange gas, at engine start-up. This is a typical occurrence at start-up. The free burning Hydrogen was noted in this instance to impinge on the drag chute door as shown in the figure below.

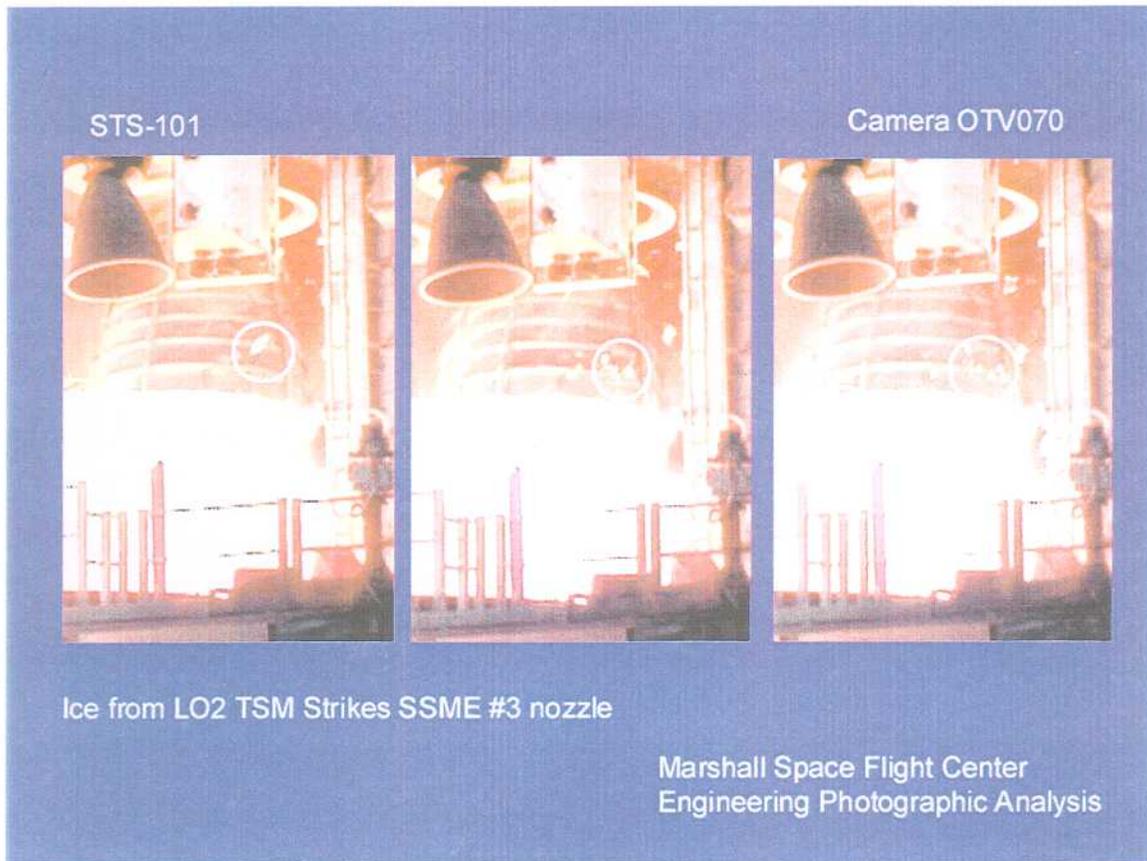
Figure 2. Ice Strikes SSME#3 Nozzle

Two pieces of ice debris from the LO2 TSM impacted SSME#3 nozzle near the eighth hatband. Images below show one of the ice masses impacting SSME#3 nozzle and breaking apart. No damage to the nozzle was observed from either ice impact.

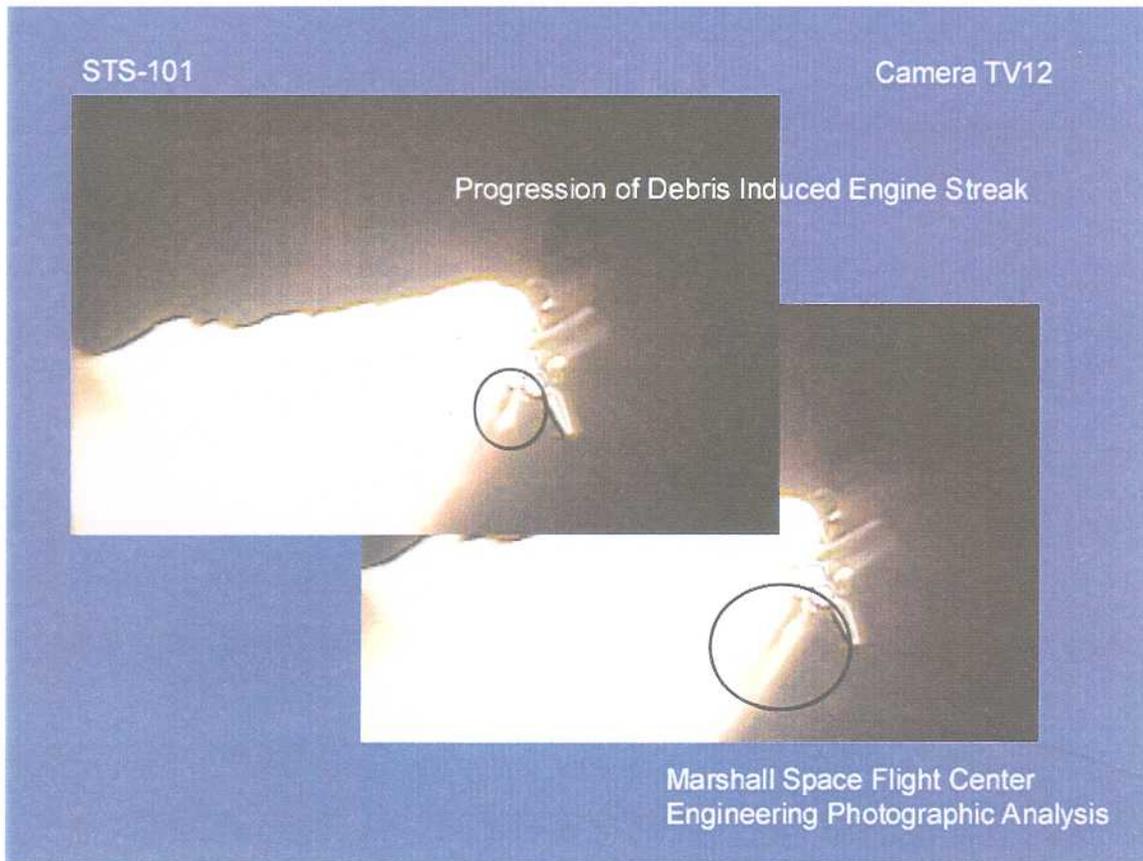
Figure 3. Debris Induced Streak Observed by Video Camera TV-12

A view from video camera TV12 of the debris induced streak in the SSME plumes. These debris induced streaks are typically the result of butcher paper or purge barrier material falling into a plume.

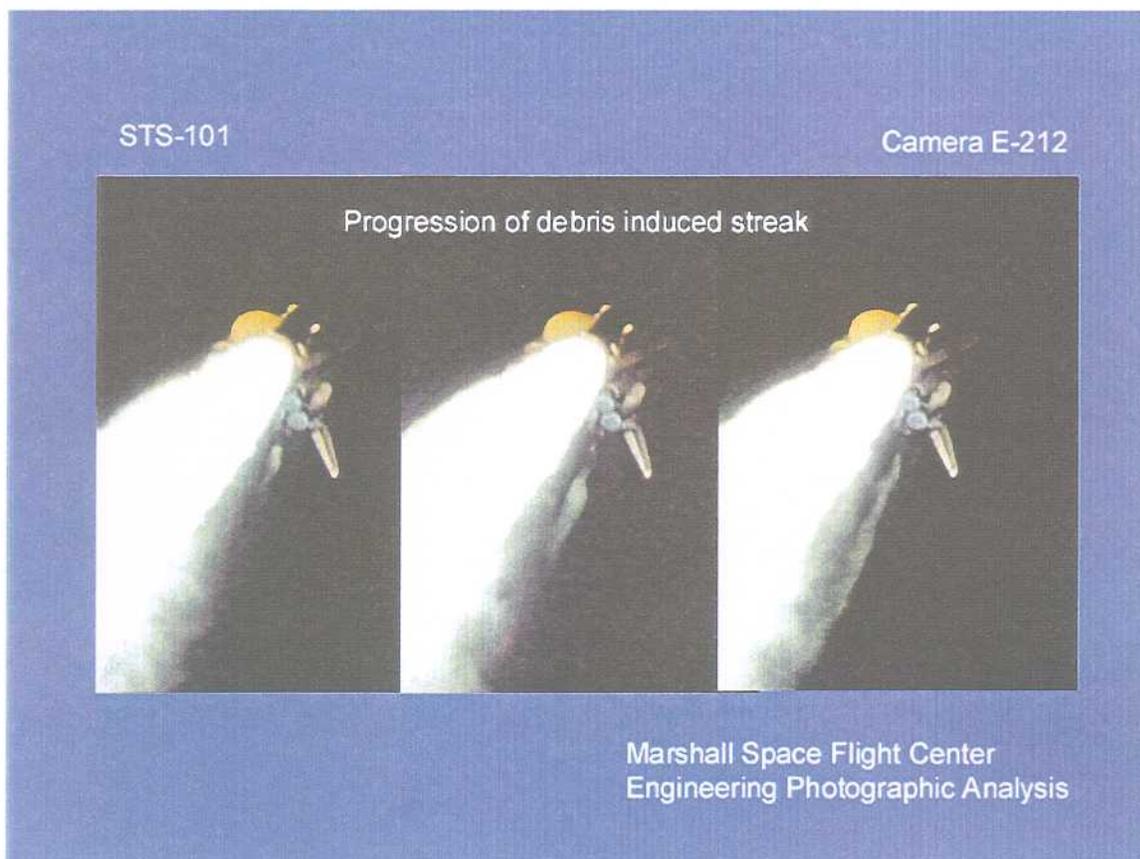
Figure 4. Debris Induced Streak Observed by Film Camera E212

A sequence of frames from the 35mm Film Camera E212 showing the debris induced streak originating in the SSME plumes. This is the same streak as shown in figure 3. The film cameras typically give better resolution of events. In the sequence of frames below, the streak can be seen originating in the plume at a distance from the nozzle. This separation from the nozzle exit plane is an indicator that a streak is caused by debris falling into the plume.

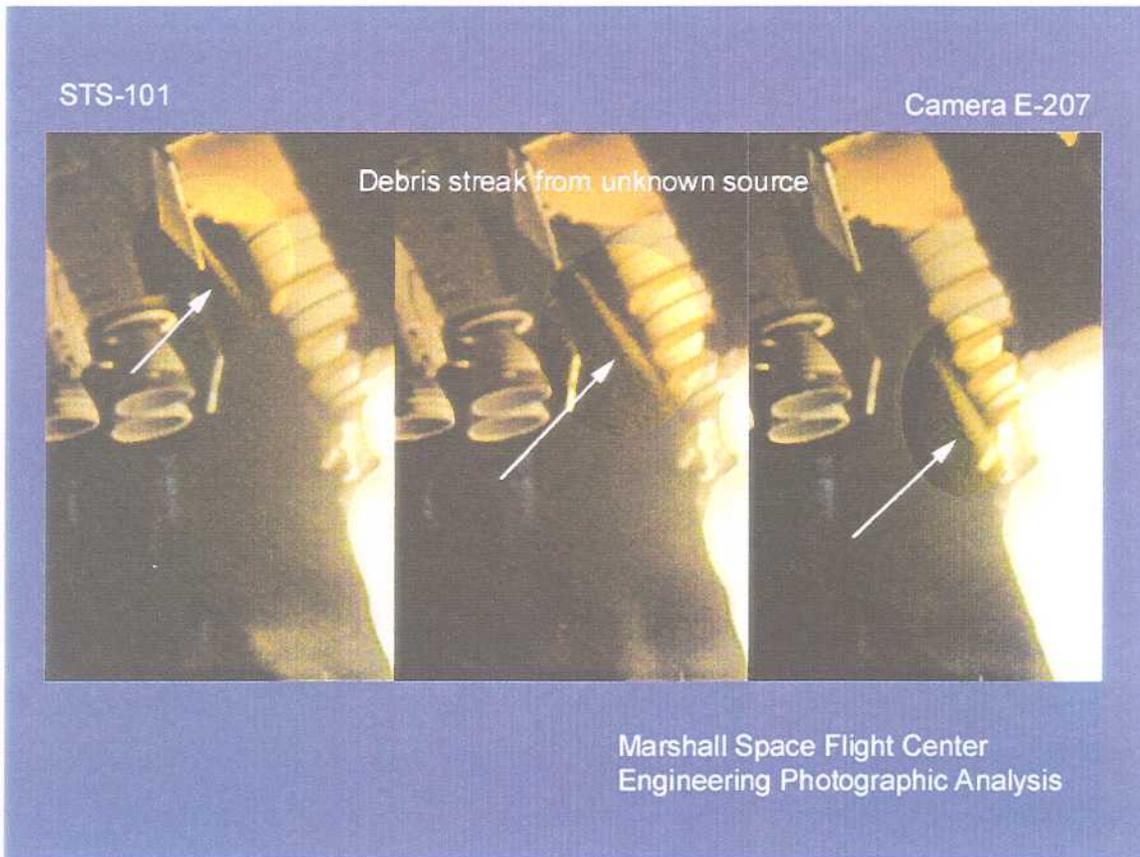
Figure 5. Debris Streak Observed by Film Camera E207

A sequence of images from the 35mm Film Camera E207 that shows debris of unknown origin that caused a streak, not associated with plume streaking, which appears to be located near orbiter between inboard orbiter elevon and right SRB. This event was timed at 140:10:11:44.148 UTC. A similar event occurred on STS-26. The STS-26 event was identified as debris from tiles. Inspection of tiles after landing revealed a damage site which is suspected as the cause of this streak.

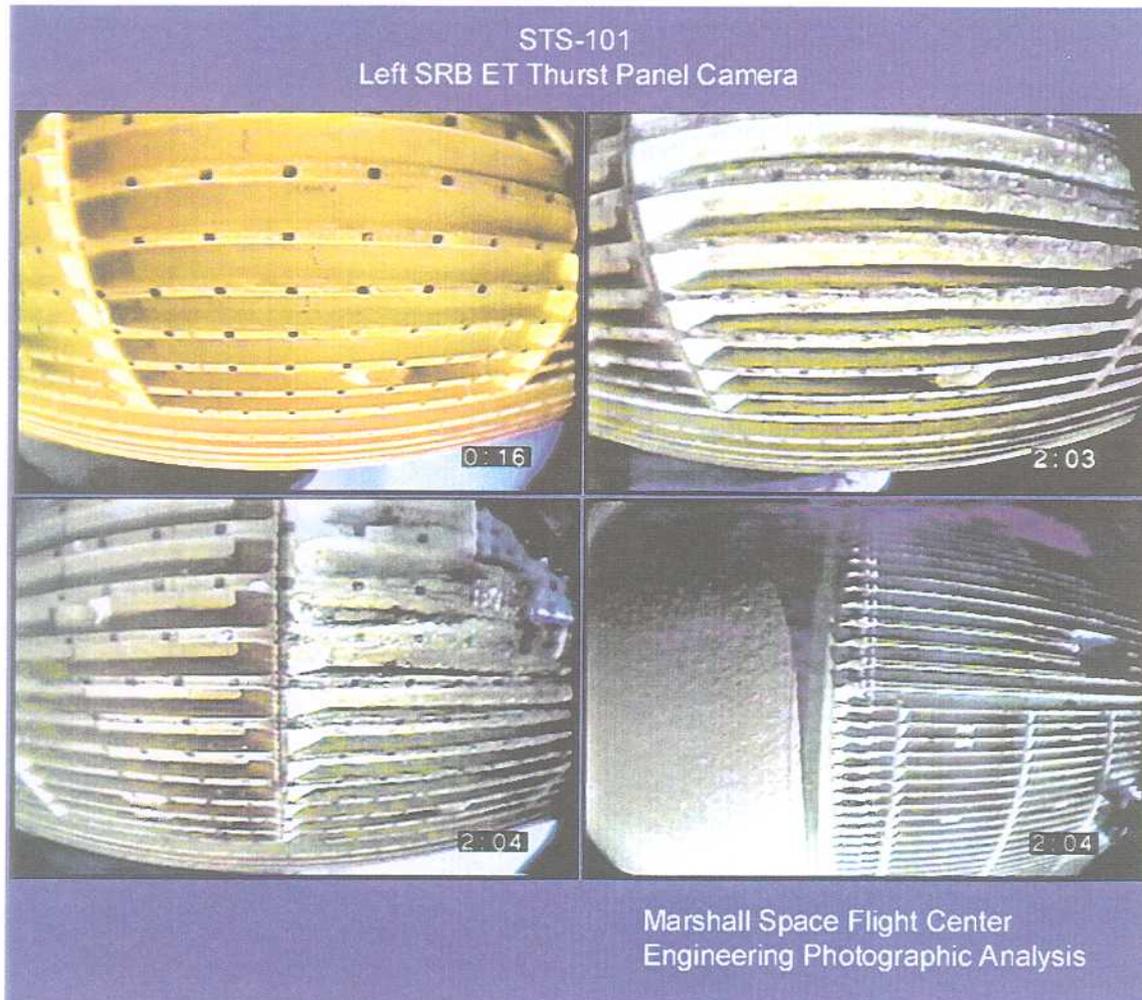
Figure 6. Left SRB Video Camera

Views of the External Tank from the left Solid Rocket Booster Video Camera early (0:16), just before (2:03) and just after (2:04) separation from vehicle, showing a progression of the condition of the Thermal Protective Surface on the -Y Thrust Panel.

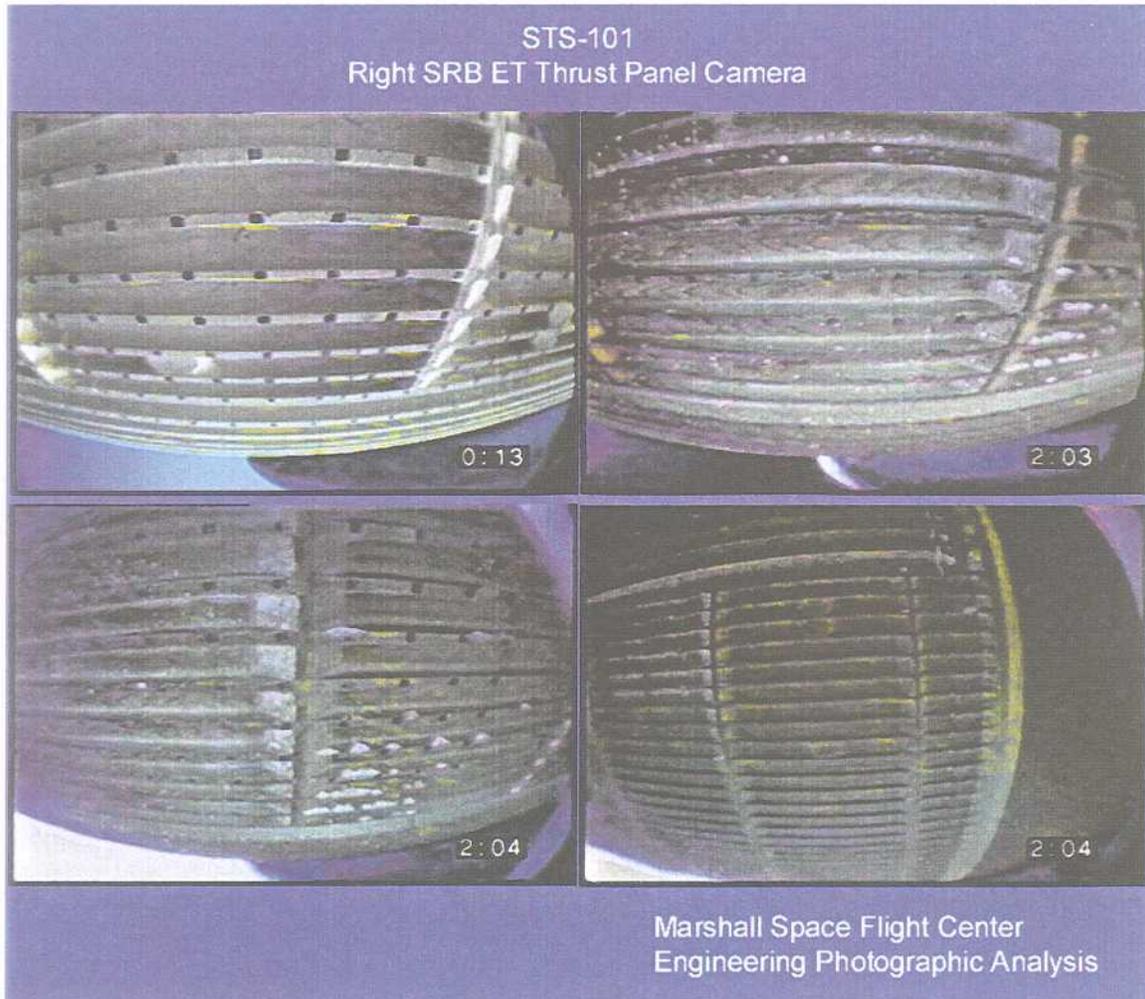
Figure 7. Right SRB Video Camera

Views of the External Tank from the right Solid Rocket Booster Video Camera early (0:13), just before (2:03) and just after (2:04) separation from vehicle, showing a progression of the condition of the Thermal Protective Surface (TPS) on the +Y Thrust Panel.

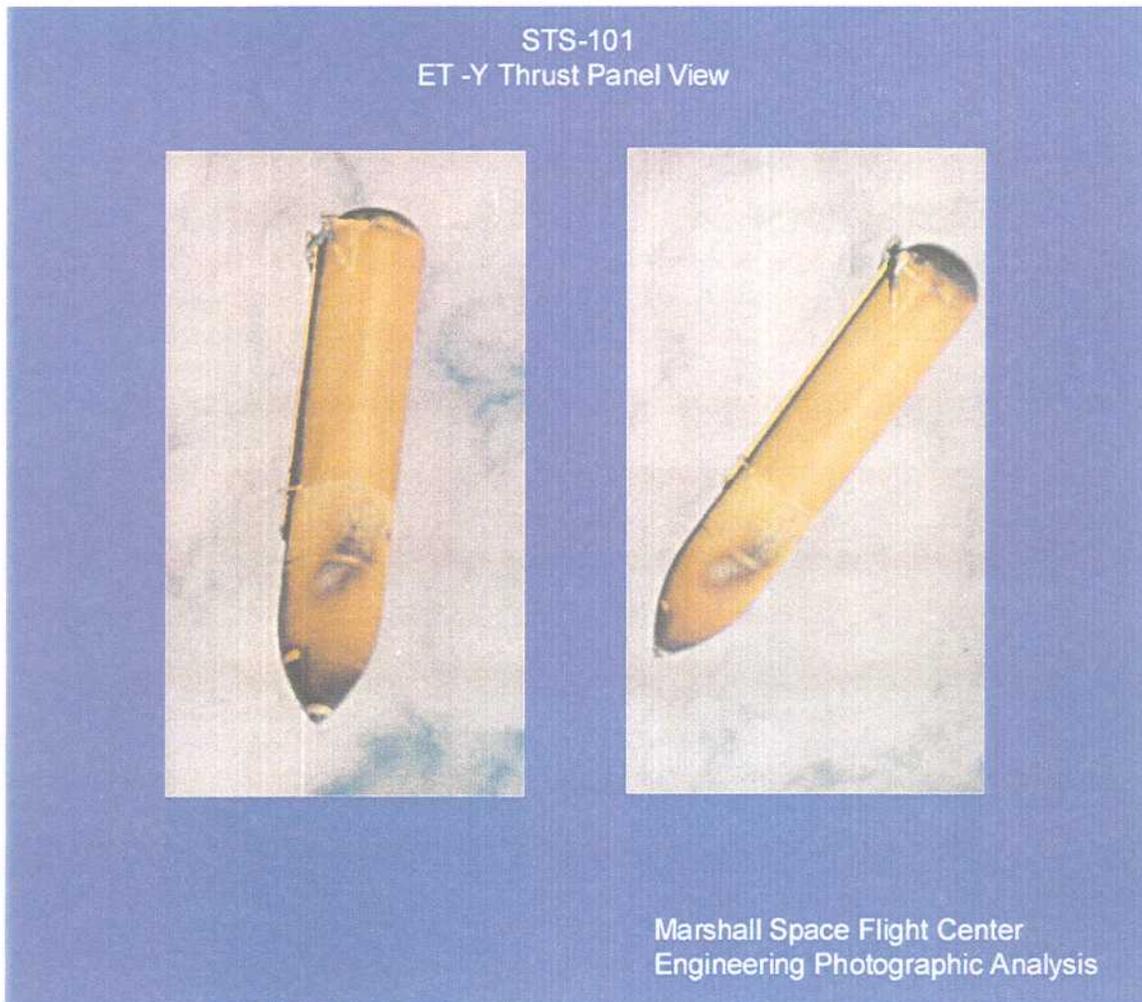
Figure 8. View of -Y side of the ET from On-board 35mm Hand-held Camera

Views of the -Y side of External Tank (ET) after separation from vehicle, showing the condition of the Thermal Protective Surface (TPS). No obvious or large scale TPS divoting is observed, scarring of TPS from BSM motor firing appears normal.

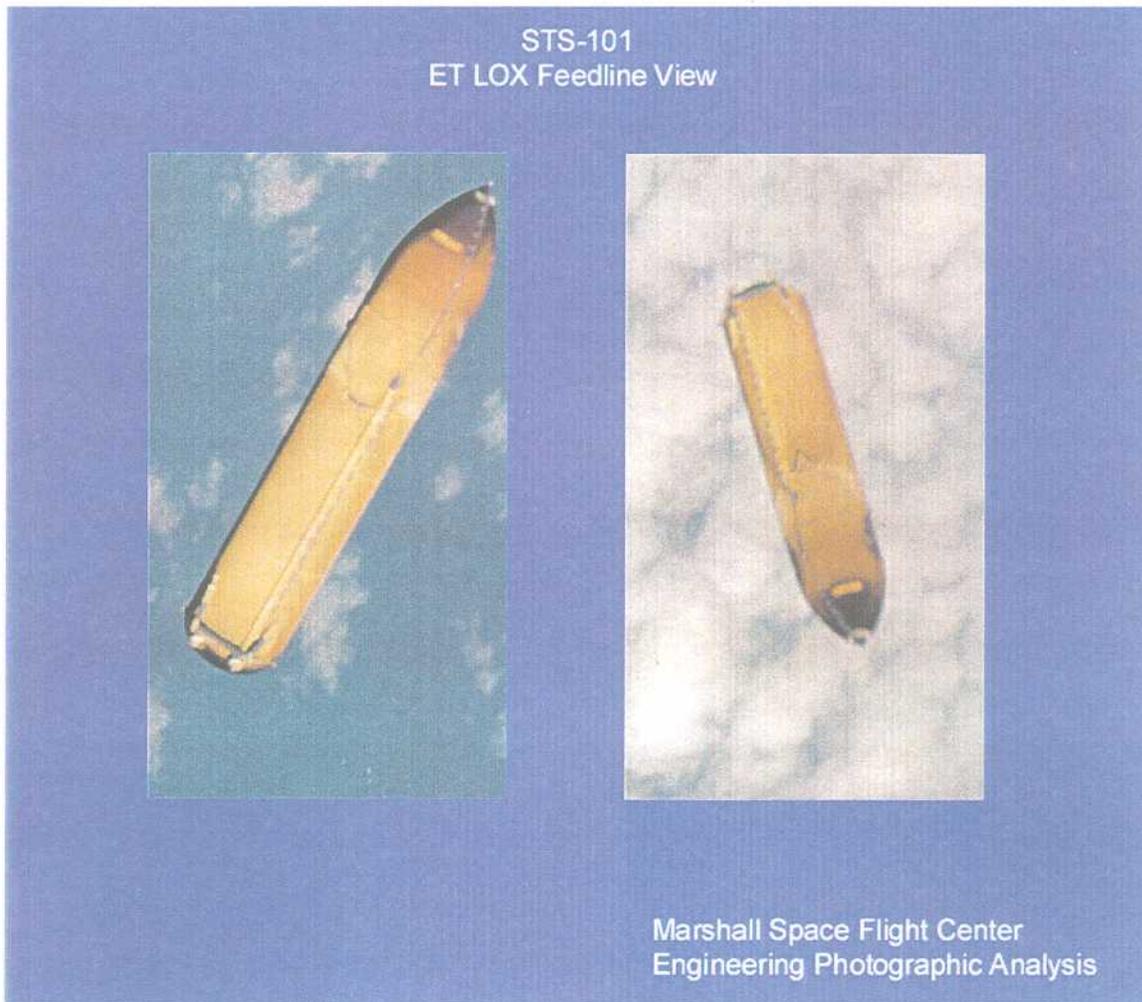
Figure 9. View of Top Side of the ET from On-board 35mm Hand-held Camera

Views of the top side of External Tank (ET) after separation from vehicle, showing the LO2 Feedline and the condition of the Thermal Protective Surface (TPS). No obvious or large scale TPS divoting is observed, scarring of TPS from BSM motor firing appears normal.

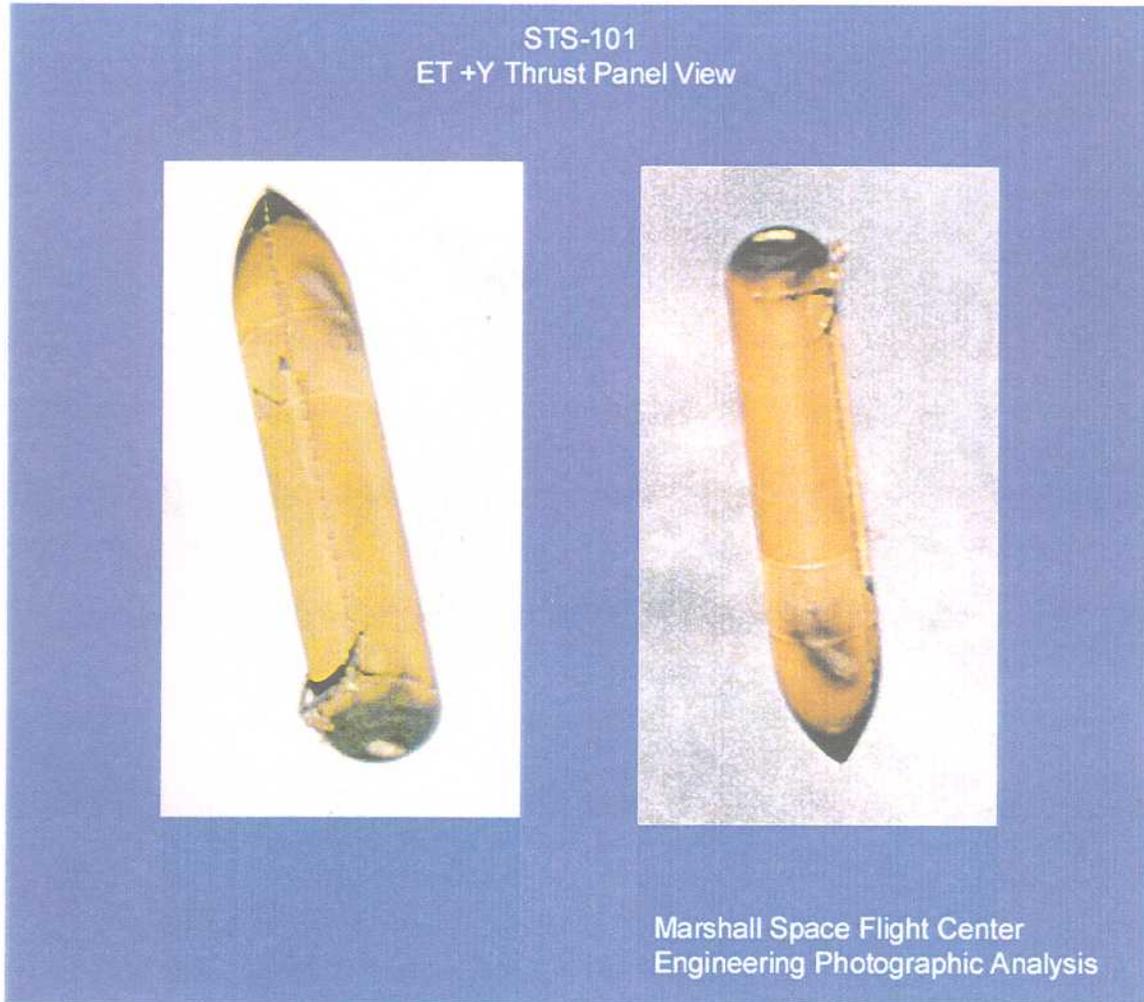
Figure 10. View of -Y side of the ET from On-board 35mm Hand-held Camera

Views of the +Y side of External Tank (ET) after separation from vehicle, showing the condition of the Thermal Protective Surface (TPS). No obvious or large scale TPS divoting is observed, scarring of TPS from BSM motor firing appears normal. Charring of the TPS on the aft dome of the LOX tank appears normal.

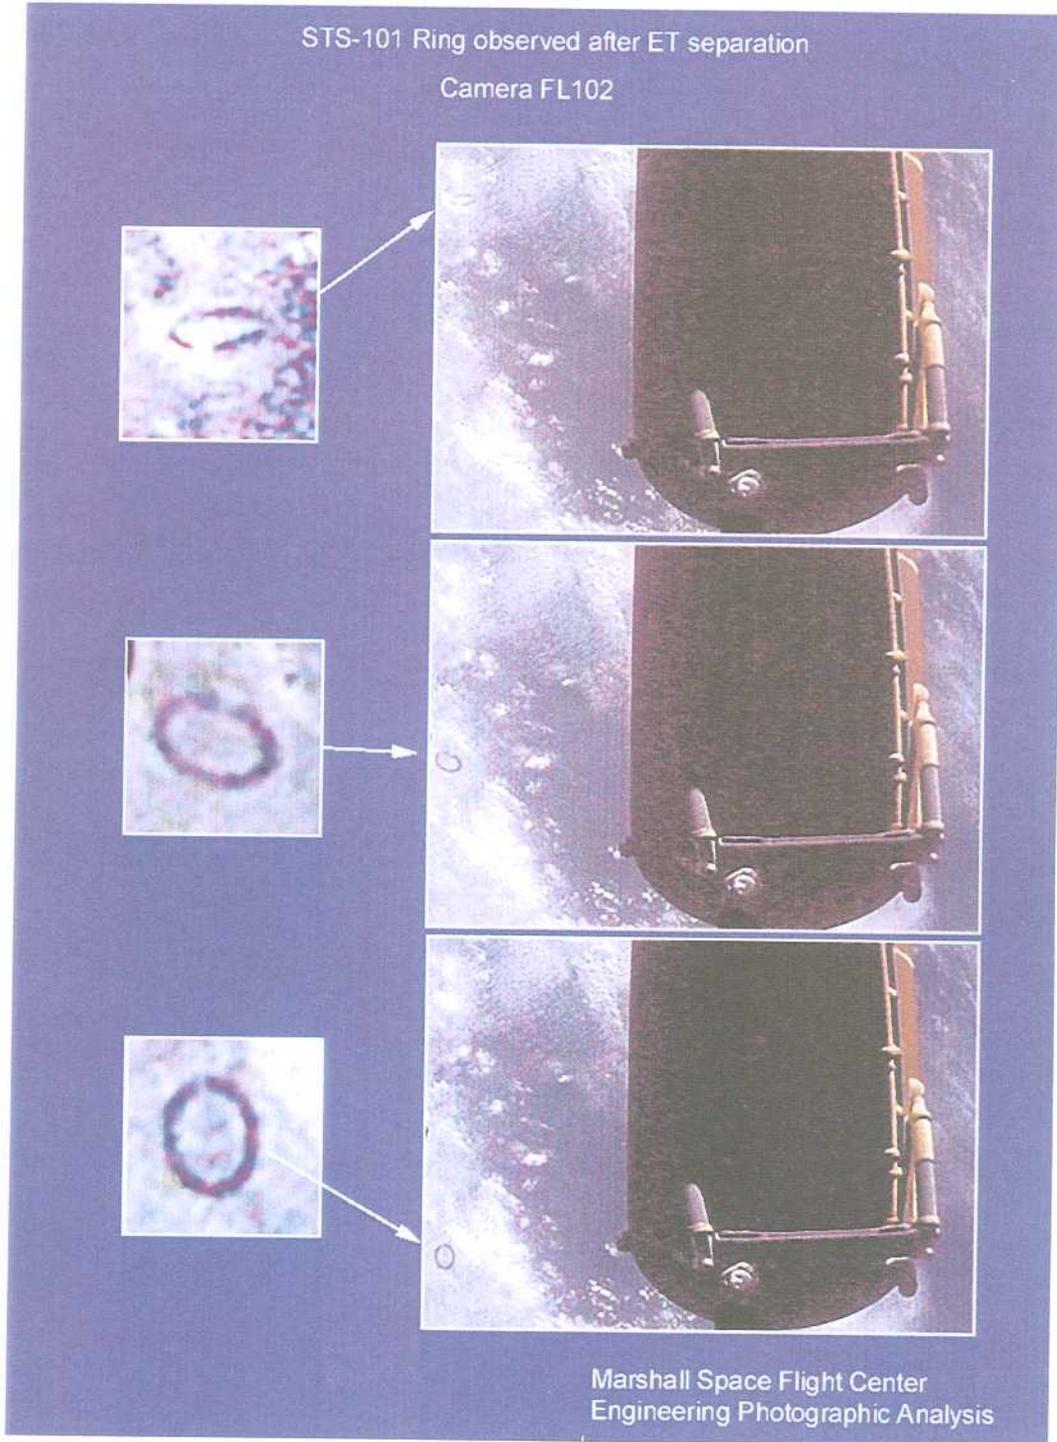
Figure 11. Ring shaped Debris Object Observed After SRB Separation

A ring-shaped debris object was noted moving from top to bottom of the field of view after SRB separation. The object was out of focus, indicating that it was near the camera, rather than the ET. It is suspected that the object is an O-ring from one of the 17" disconnects.

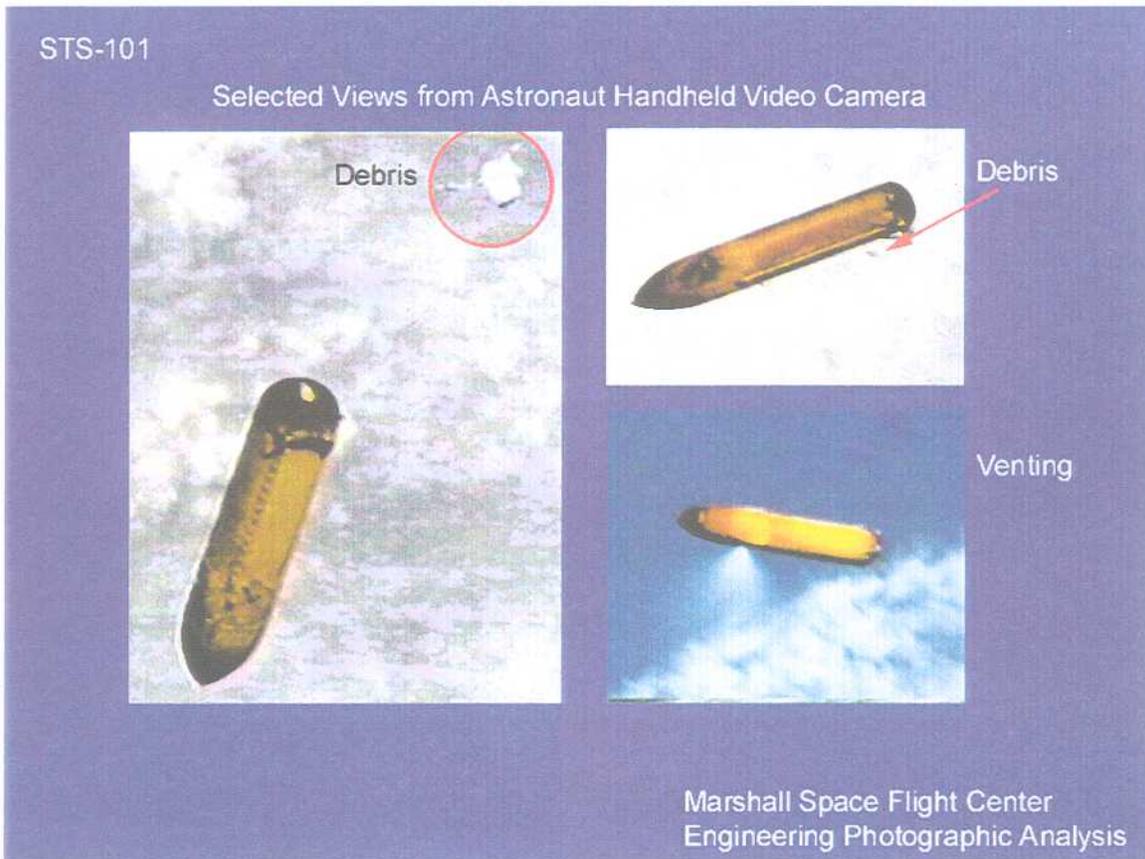
Figure 12. Selected Views from the Astronaut Hand Held Video

Two conspicuous debris objects were observed from the astronaut hand held video. One was an odd shaped debris item, noted in the upper right corner of the left hand frame below and appears to be ice. The other debris object is most likely ice floating between the camera and the ET. Typical GUCP venting was also observed.

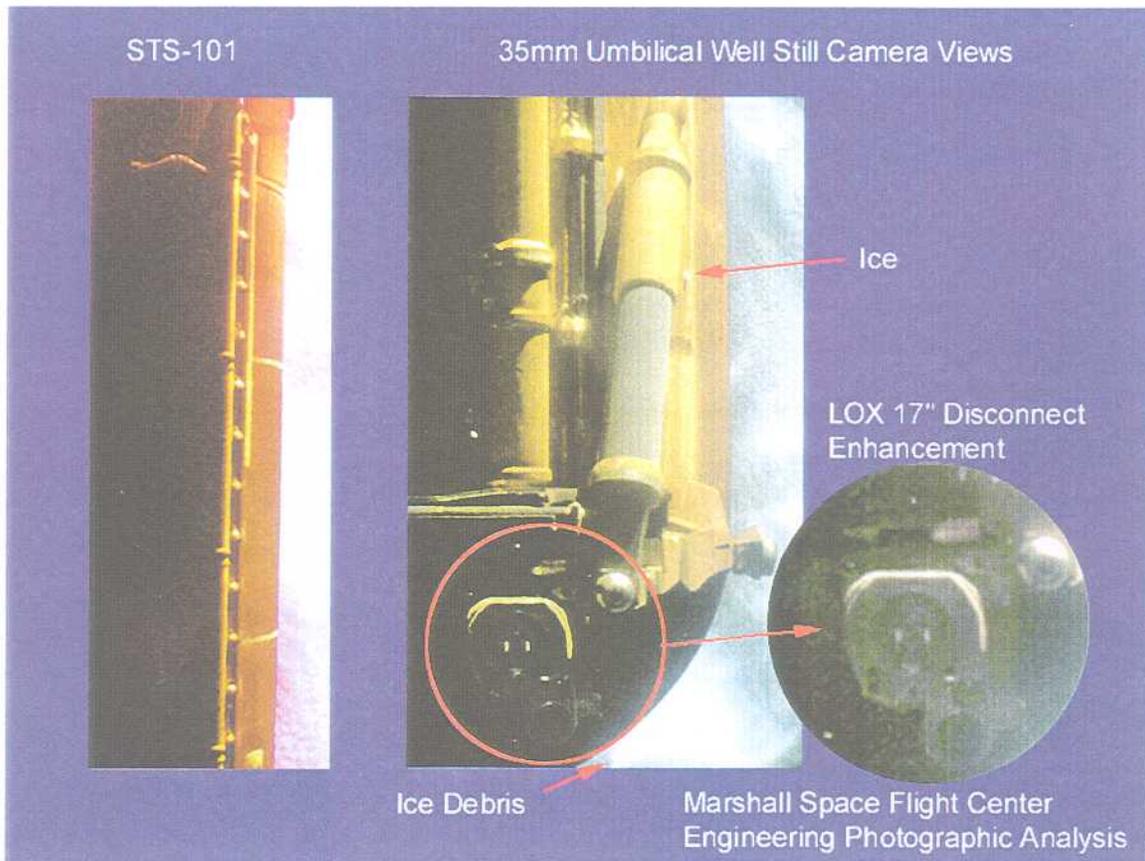
Figure 13 Umbilical Well 35mm Still Camera

Ice was observed on the ET after separation, as noted in the frame below. Because of a late +X translation, the forward portion of the ET was not imaged by the still camera. Image fog degraded several of the last exposures on the 35mm film roll, creating a reddened cast to the images.

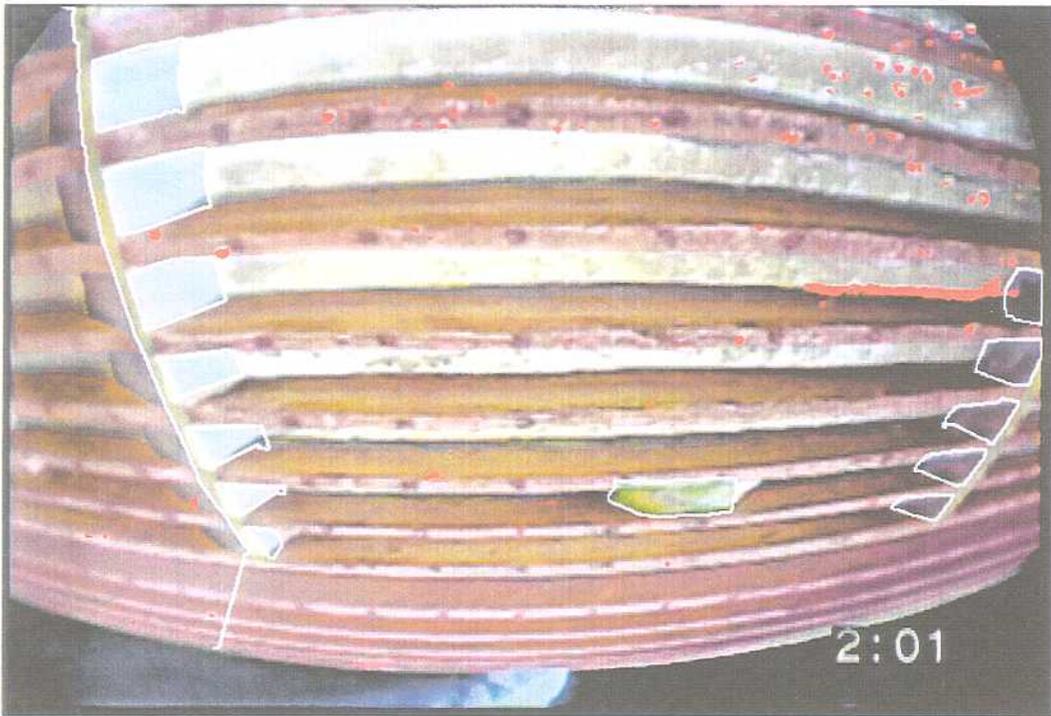
Figure 14. STS-101 -Y Thrust Panel

Figure 14 illustrates all tabulated foam loss events on the -Y Thrust Panel of the ET for flight STS-101. White lines in the figure enclose vented areas. There were 100 total foam loss events recorded. The number of events recorded during each 0.5 second time interval and the total number of events from approximately T+90.0 seconds are shown in Figure 15. Using a fourth order polynomial approximation to trend the count data, the maximum foam loss activity appears to peak just after T+ 110.0 seconds. The maximum number of events recorded during any 0.5 second time interval was seven. Figure 16 and Table 3 compare vented and non-vented areas.

Category	Count
Vented	95
Non-Vented	5
Total	100

Category	Count
Valley	42
Stringer	4
Longitudinal Rib	53
Circumferential Rib	0
Hi-Lock	0
Ramp	1
Total	100

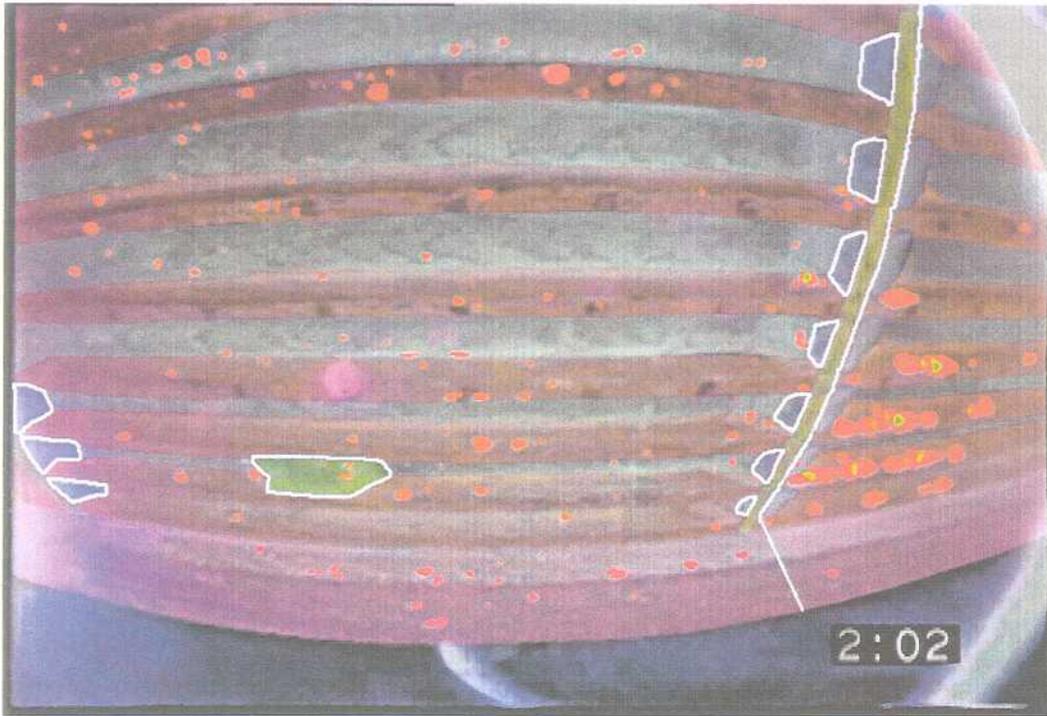
Figure 18. STS-101 +Y Thrust Panel

Figure 18 illustrates all tabulated foam loss events on the +Y Thrust Panel of the ET for flight STS-101. White lines in the figure enclose vented areas. There were 258 total foam loss events recorded. The number of events recorded during each 0.5 second time interval and the total number of events from approximately T+90.0 seconds are shown in Figure 19. Using a third order polynomial approximation to trend the count data, the maximum foam loss activity appears to peak at approximately T+ 110.0 seconds. The maximum number of events recorded during any 0.5 second time interval was 23. Table 5 and Figure 20 compare vented and non-vented areas.

Category	Count
Vented	206
Non-Vented	52
Total	258

Category	Count
Valley	77
Stringer	35
Longitudinal Rib	132
Circumferential Rib	2
Hi-Lock	10
Ramp	2
Total	258

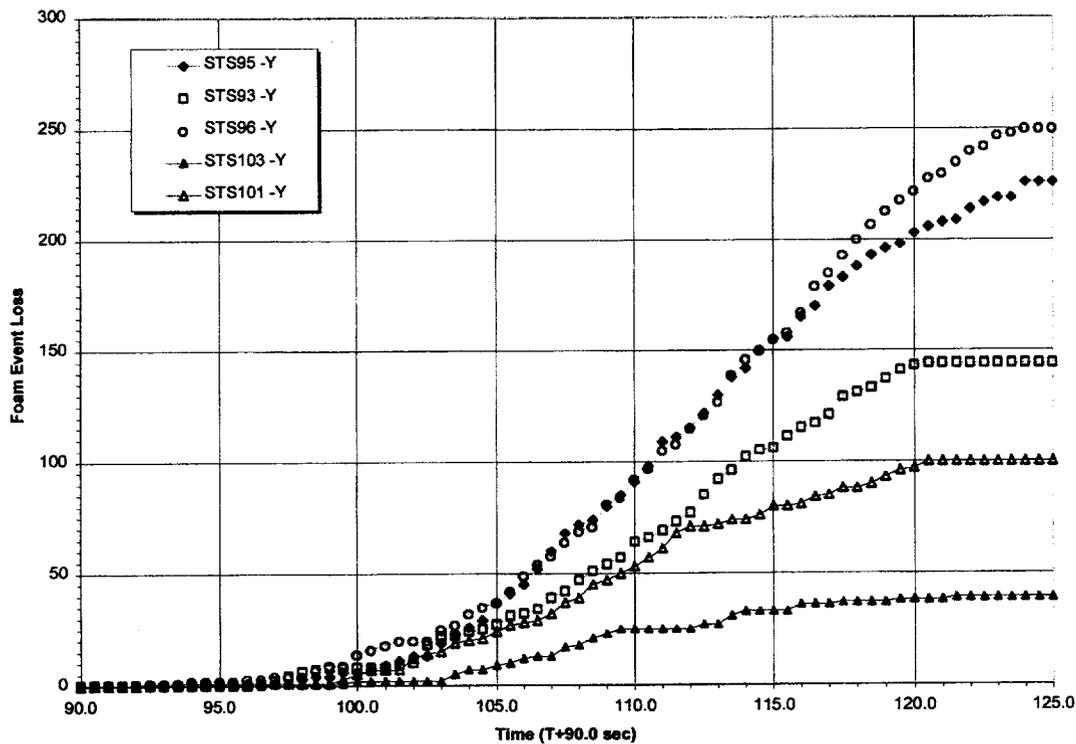
Figure 22. Foam Loss Comparison for -Y Thrust Panels

The foam loss events from the -Y thrust panels are bounded by a maximum of approximately 250 total events. The foam loss events from the +Y thrust panels are bounded by a maximum of approximately 650 total events. This maximum was achieved on mission STS-96 where a majority of the foam loss events recorded by the right SRB camera were noted to be in areas of the +Y thrust panel that were not vented.

No venting of the ET foam was performed for mission STS-95 and partial venting for STS-96 and STS-93. More extensive venting was done for Missions STS-103 and STS-101. The noticeable reduction in foam loss events in STS-103 and STS-101 is most probably attributable to the venting of more extensive areas of the thrust panels.

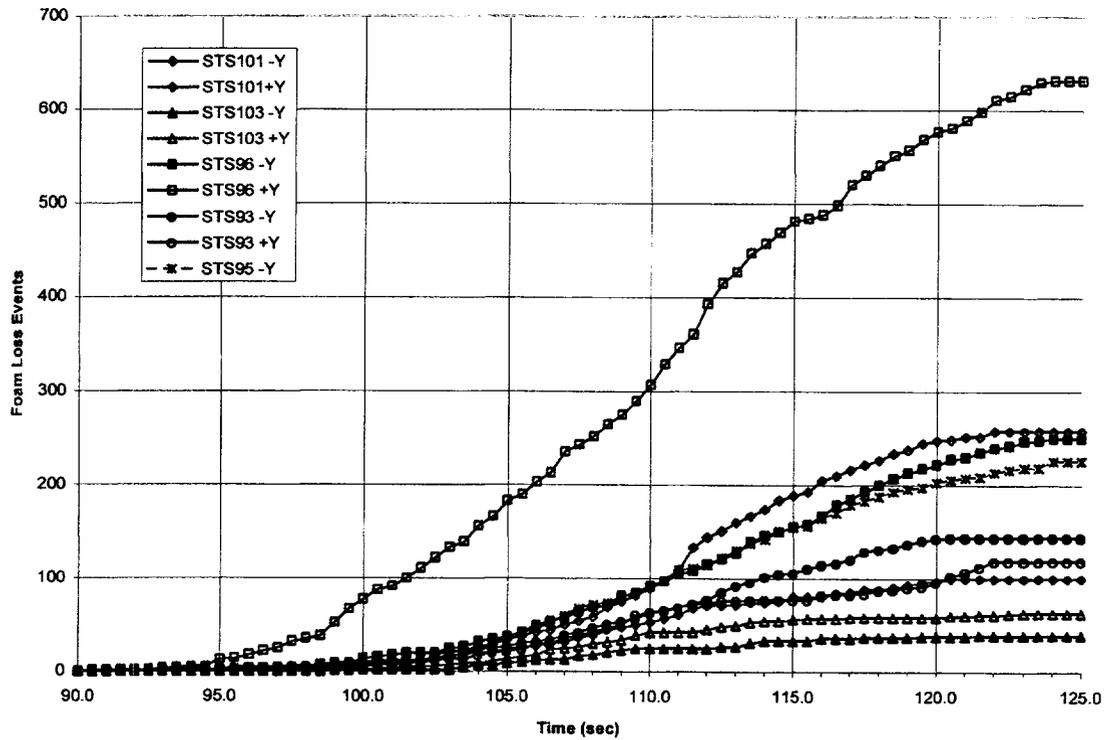
Figure 24. Comparison of Foam Loss Events from all SRB Cameras

Figure 24 compares the number of foam loss events recorded by each camera for each flight. Most event timelines fall in the lower cluster, again, with only the STS-96 Right SRB camera recording the anomalous timeline.
