6.0 FILM REVIEW

6.1 LAUNCH FILM AND VIDEO SUMMARY

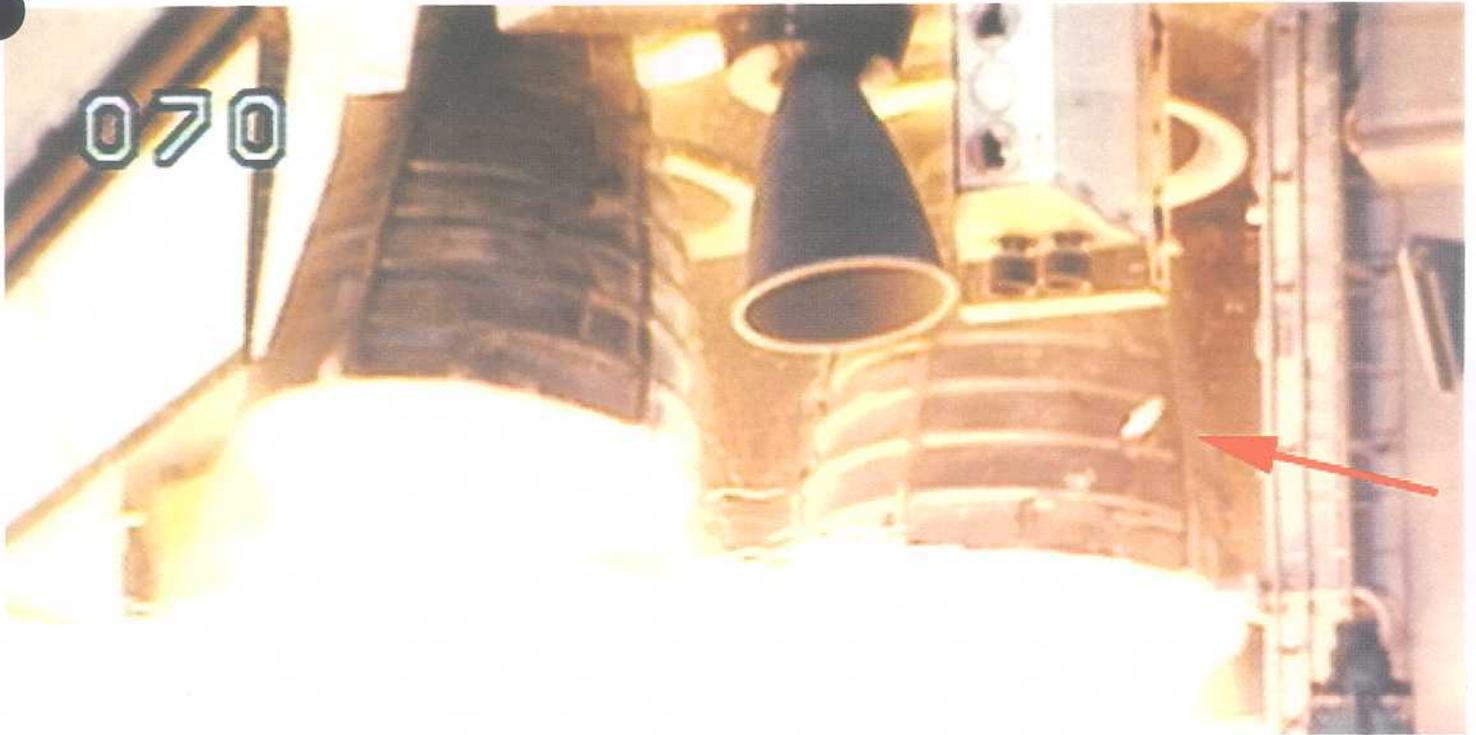
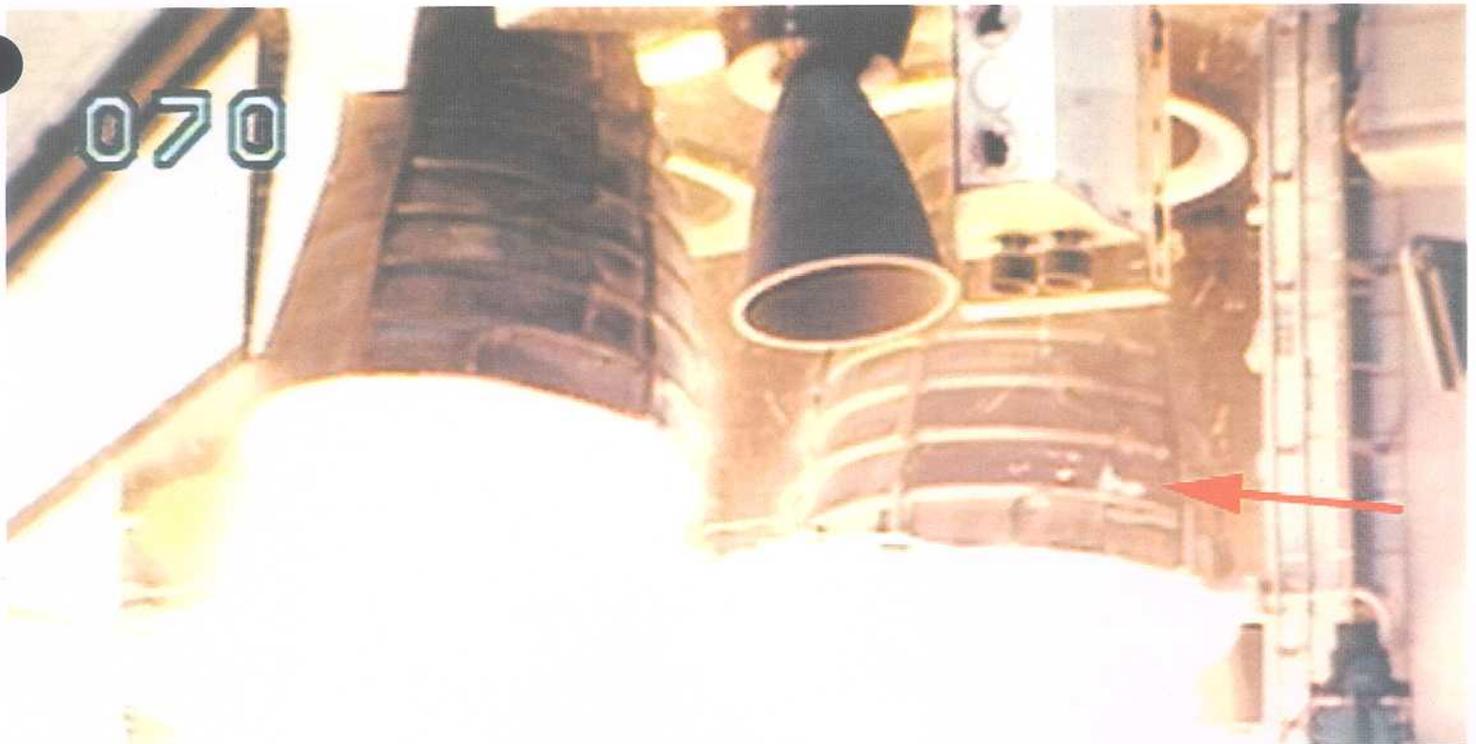
Photo 13: Ice Contacting SSME #3 Nozzle

Retraction of the LO2 Orbiter T-0 carrier plate caused pieces of ice to shake loose and fall aft impacting the SSME #3 nozzle near the #8 hatband. No damage occurred (OTV 070).

Retraction of the LO2 Orbiter T-0 carrier plate caused pieces of ice to shake loose and fall aft impacting the SSME #3 nozzle near the #8 hatband. No damage occurred.

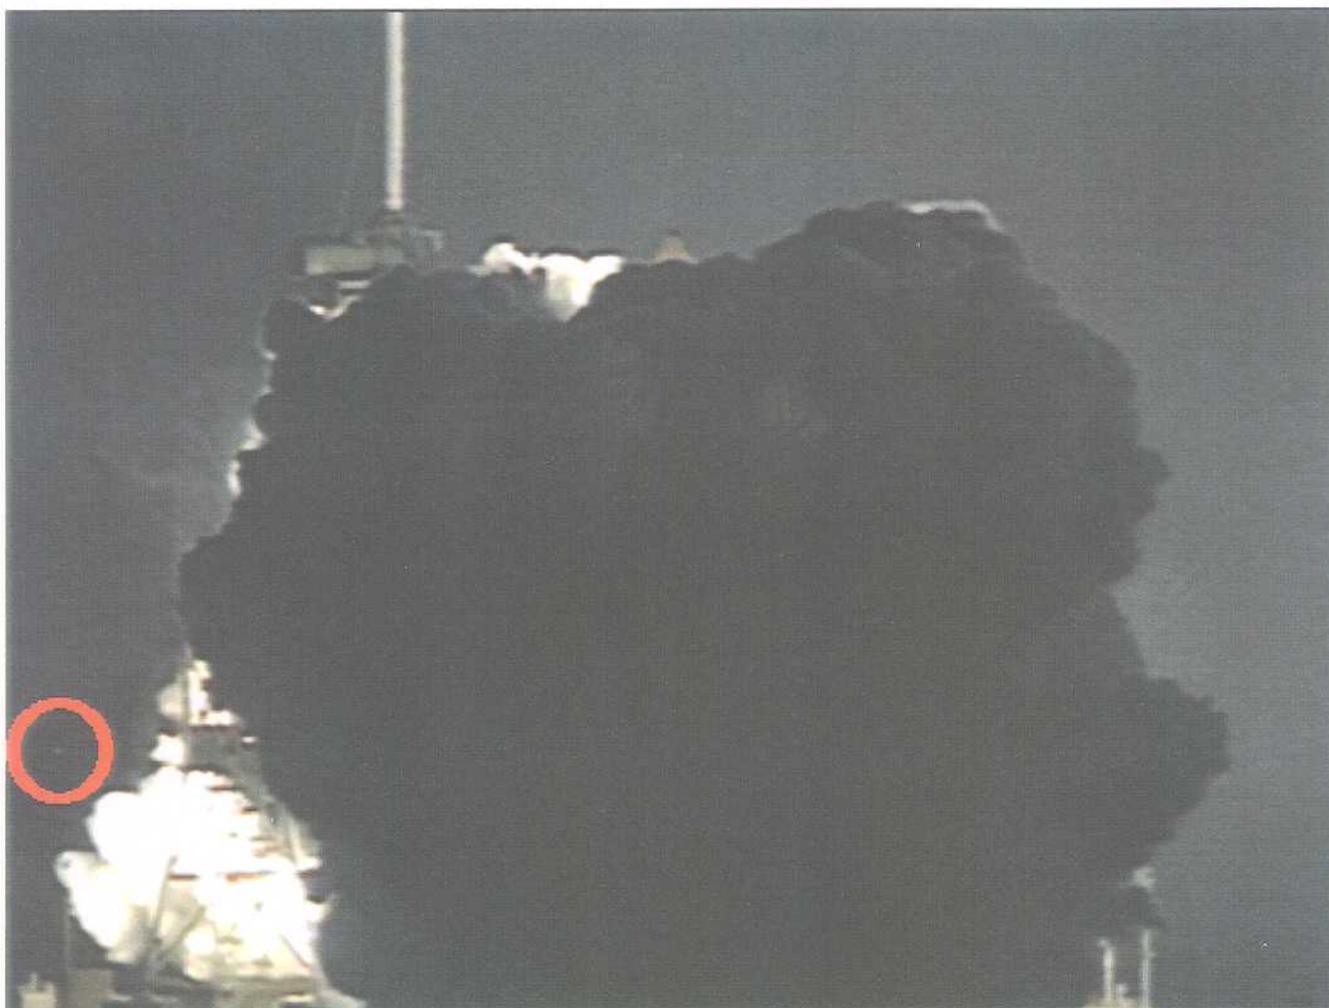
Photo 14: Debris from RSS/FSS

TV-21 showed an object believed to be a cable tray cover from the FSS or a PCR panel from the RSS moving westward away from the SSV shortly after T-0. The object appeared to originate from the 135 or 155 foot level of those structures.

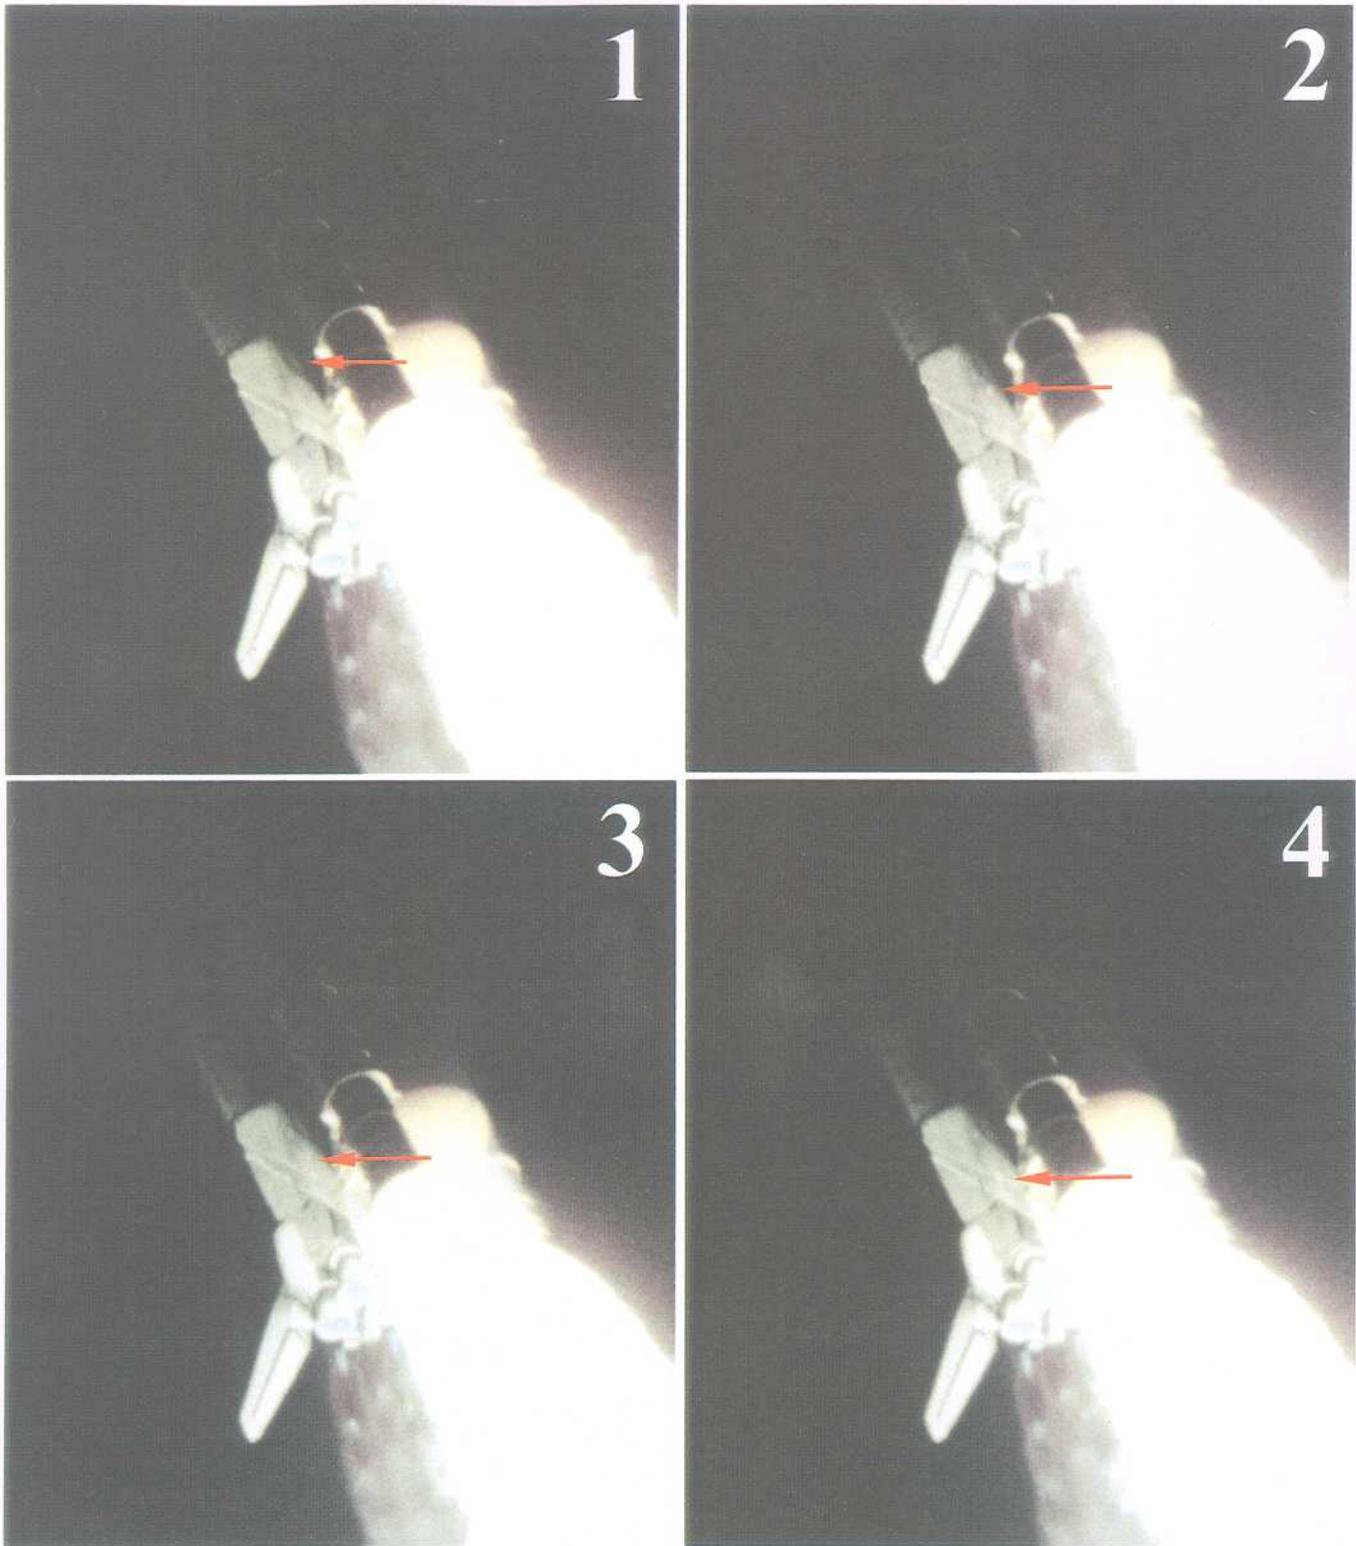
Photo 15: Ice Impacting Orbiter Right Wing

An impact occurred at 10:11:44.109 GMT (approx. T+34 seconds MET) on the Orbiter lower surface at a point that appeared to be about 8 feet forward of the right inboard elevon hinge, perhaps centered with respect to the elevon or just a little more outboard (E-224).

The debris object was white, or light-colored, perhaps 6 inches in length, and disintegrated upon impact thereby comprising most of the material in the "streak", though there may also have been some tile material as well from the damage site.

After the impact, no damage site could be discerned. However, the film was grainy and individual tiles could be resolved. Therefore, the damage site was not extremely large, which would have been visible to some degree.

The debris object appeared to originate from the mid-body area of the vehicle, though that could not be precisely determined due to the grainy nature of the image as well as that portion of the vehicle being in deep shadow.

Since the debris object disintegrated upon impact with no large particles visible in the "streak", the object most likely was a piece of ET foam or crusty ice from the ET LO2 feedline bellows or support brackets. It is unlikely the object was a piece of SRB insulation since no significant material was found to be missing during the post flight inspection at Hangar AF. Likewise, the object could not be a white tile since the trajectory would take it aft over the wing with no mechanism to carry a white tile along the lower surface.

A debris object, believed to be a piece of ice from the ET LO2 feedline upper bellows, impacted the Orbiter lower surface at 10:11:44.109 GMT (T+34 seconds MET). The ice passed the main landing gear door area (1), continued a trajectory aft (2), impacted and disintegrated at a point that appeared to be about 8 feet forward of the right inboard elevon hinge (3), and created a cloud of ice particles/tile material (4).

Shuttle Program management elected not to use the RMS for a tile survey due to lighting problems and poor resolution on such previous surveys. However, it was prudent to take some precautions anyway, so the Orbiter performed a thermal conditioning maneuver prior to re-entry to cold bias the right wing and elevon structure. This increased the temperature margin and, therefore, reduced the potential for structural damage. The detection of the debris impact and resulting damage site was not considered a Safety of Flight issue, but more of an R&R effort after landing.

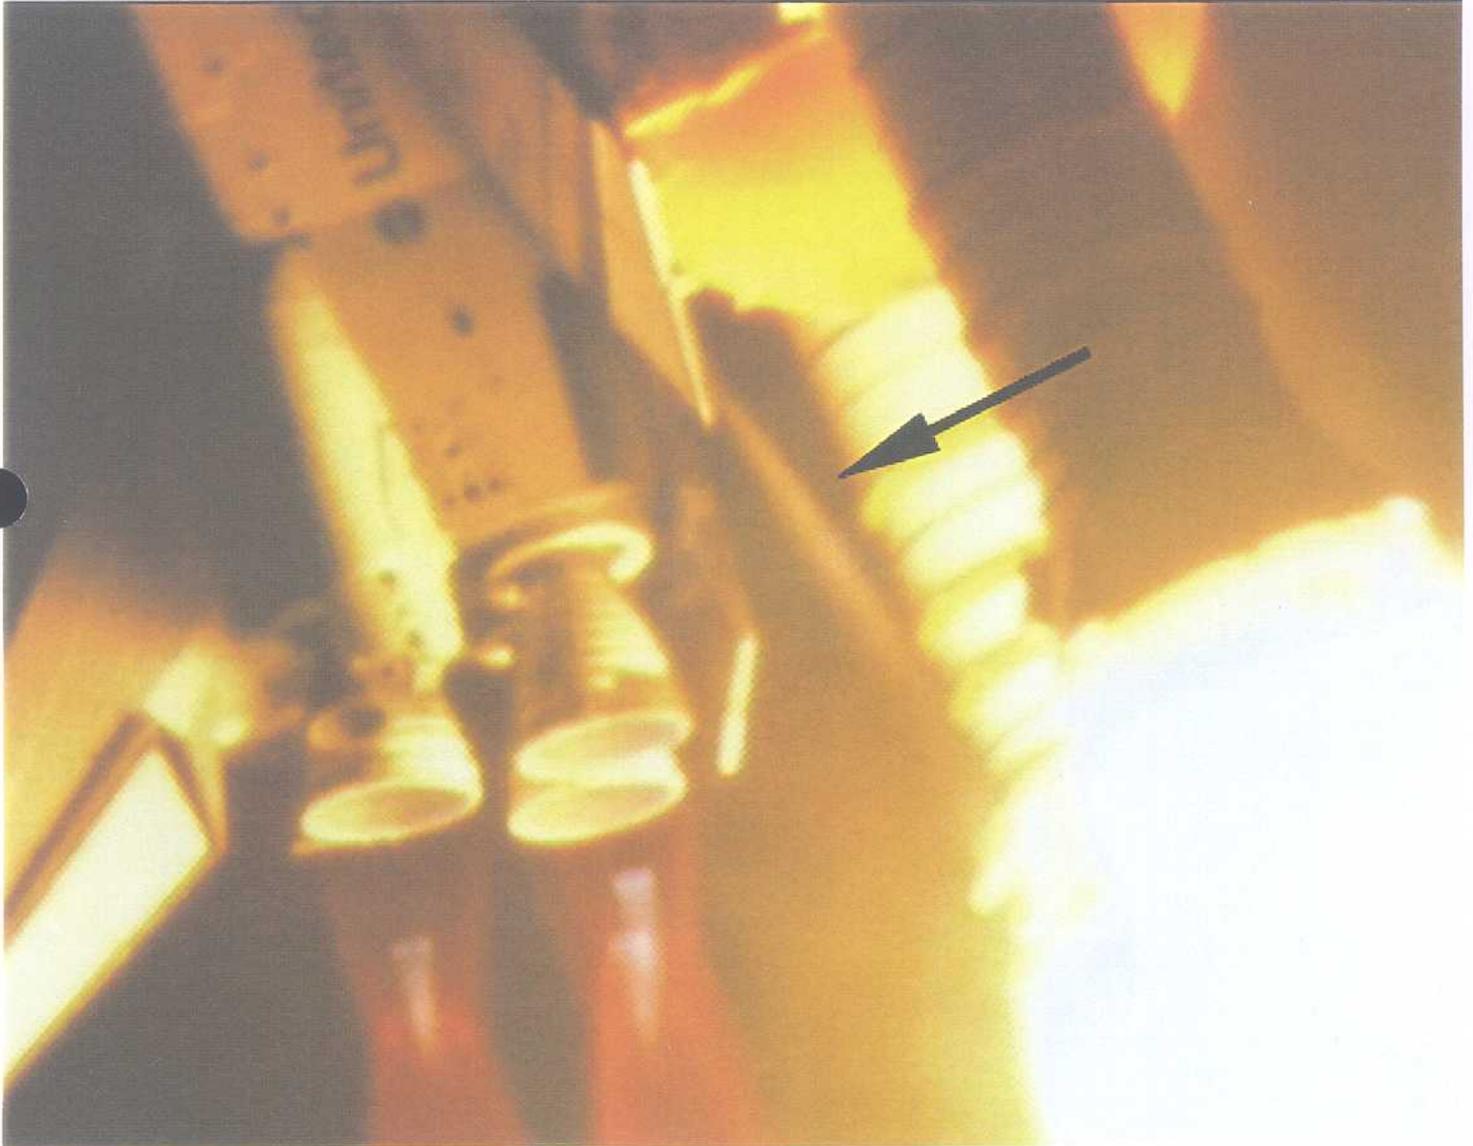
Photo 16: Vaporous Streak from Right Wing

This event in turn caused a light-colored, "vaporous" streak to pass the trailing edge of the right inboard elevon at T+34 seconds MET.

A second, very nebulous streak occurred approximately 7 second later (11:51.5 GMT). That may indicate either another piece of foam or ice came loose and followed the same trajectory, or the tile damage site continued to erode.

This streak was compared to a somewhat similar streak detected on STS-26R, which was the result of a debris impact that caused a tile damage site 18 inches long by 8 inches wide by 1.5 inches deep. However, the STS-101 streak was considerably less "dense" indicating a much smaller damage site.

The ice impact caused a light-colored, "vaporous" streak to pass the trailing edge of the right inboard elevon. The ice, perhaps 6 inches in length originally, disintegrated upon impact thereby comprising most of the material in the "streak", though there may also have been some tile material as well from the damage site.

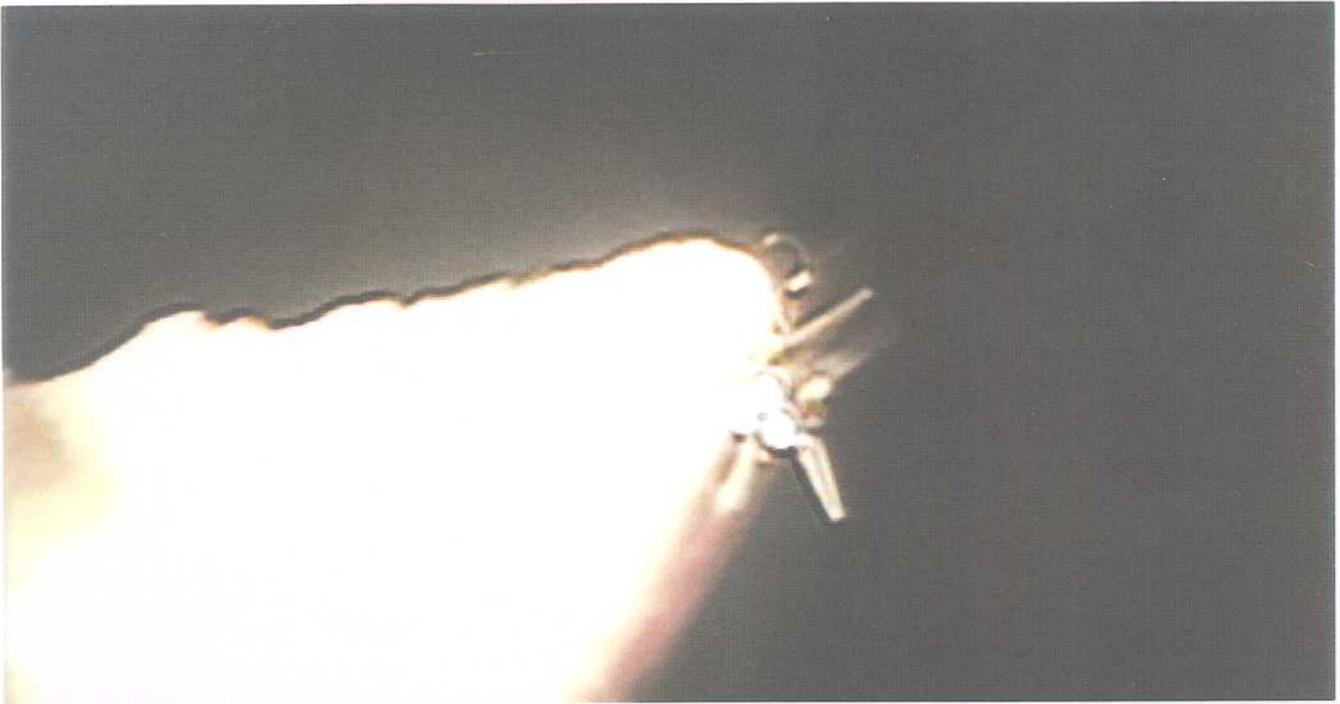
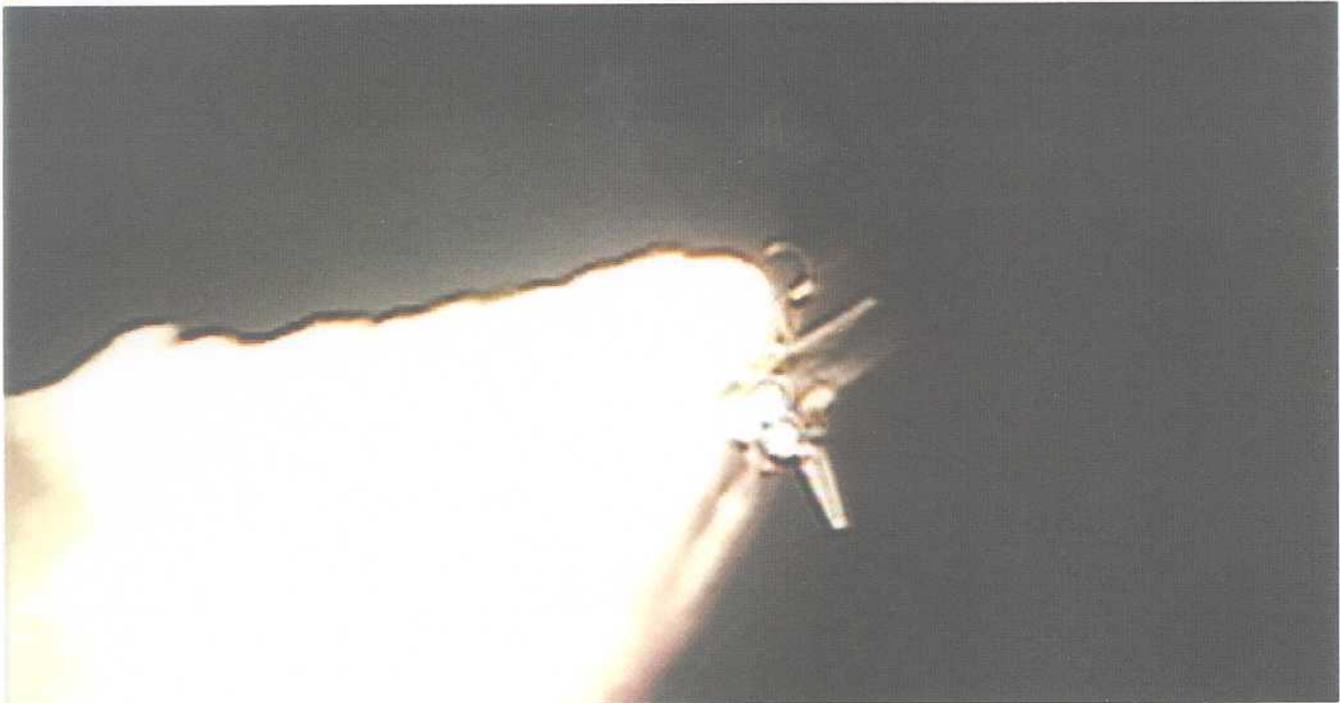
Photo 17: Large Flash in SSME Plume

TV-4A recorded pieces of forward RCS thruster paper covers falling aft of the vehicle at 16.5 and 27 seconds MET. A large flare occurred in the SSME #1 exhaust plume at 53 seconds MET for 0.17 seconds duration in this field of view. This type of flare is usually caused by debris, such as a particle of SRB aft skirt aft ring instafoam, passing through the exhaust plume. The large flare in the SSME #1 exhaust plume at 10:12:03.279 GMT was also visible in E-207 frame 2804, E-220 frame 5803, E-222, -223, and -224.

A large flare occurred in the SSME #1 exhaust plume at 53 seconds MET for 0.17 seconds duration. This type of flare is usually caused by debris, such as a particle of SRB aft skirt aft ring instafoam, passing through the exhaust plume.

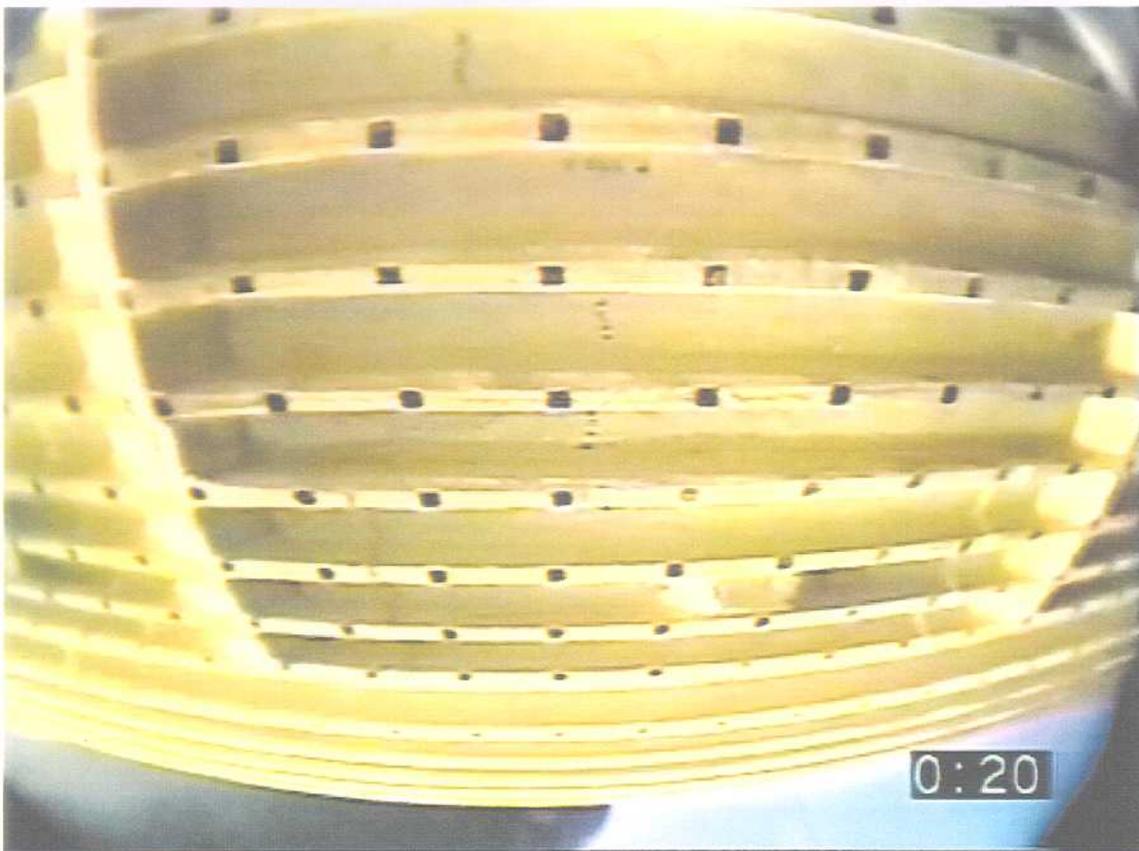
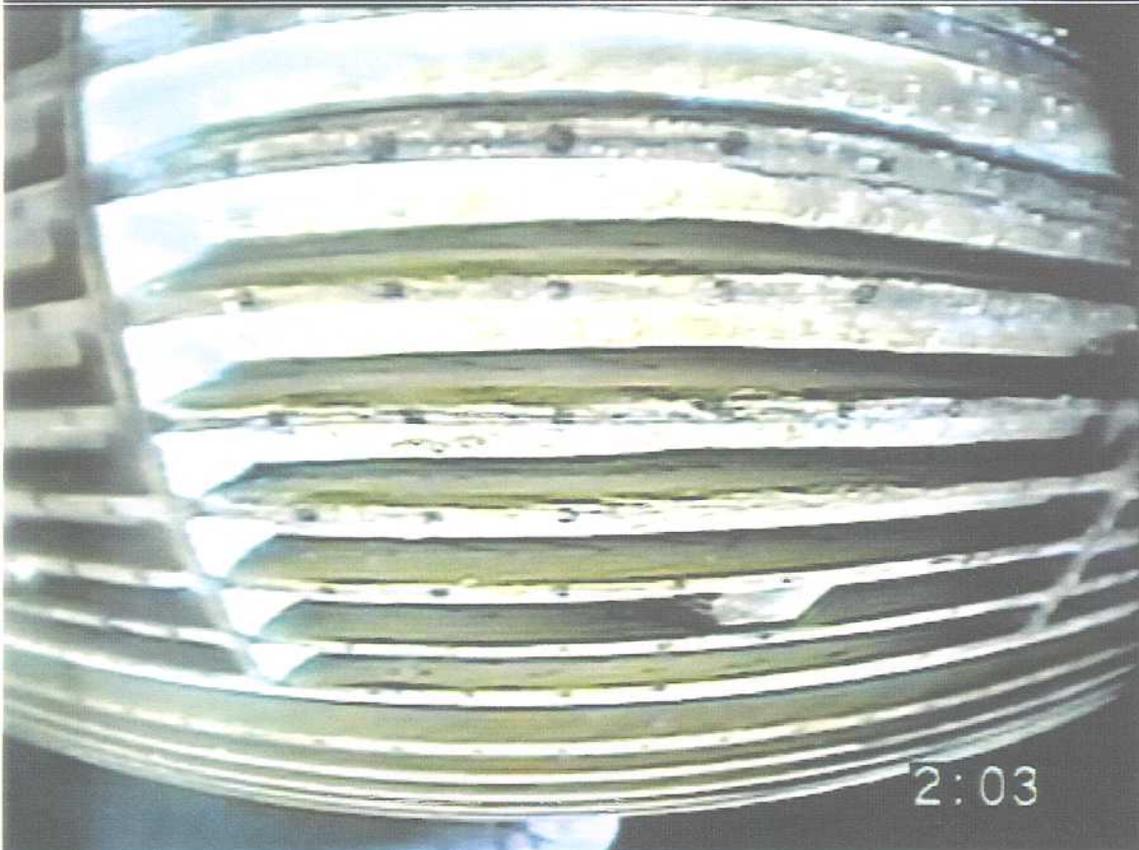
Photo 18: ET -Y Thrust Panel

100 seconds MET	One small divot appeared in vented rib #18 just aft of Xt-963
100-110 sec MET	10 total divots on ribs (none greater than 1-inch in size)
110-120 sec MET	38 total divots (with 1 greater than 1-inch in size on rib #23)
120-124 sec MET	58 total divots (no additional divots greater than 1-inch)
After separation	3-inch divot at rib #15 adjacent to LH2 acreage flange closeout

Views of the ET -Y thrust panel at 20 and 123 seconds MET. As expected, divots were smaller in size and fewer in number in the vented areas when compared to the unvented areas. Some very small areas of exposed "new" foam were caused by normal ascent recession/erosion and not included in the total divot count. Divots were very shallow with no primed substrate visible. Most divots were small and less than 0.5 inches in diameter.

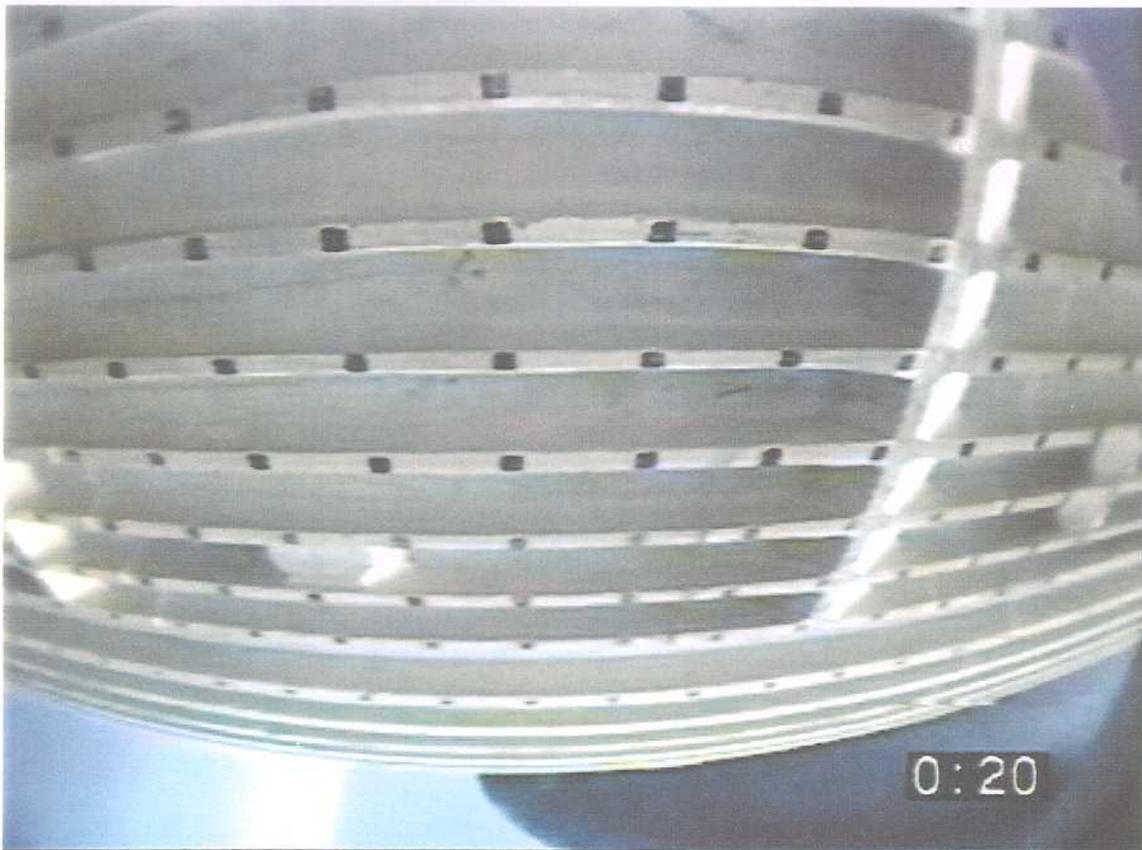
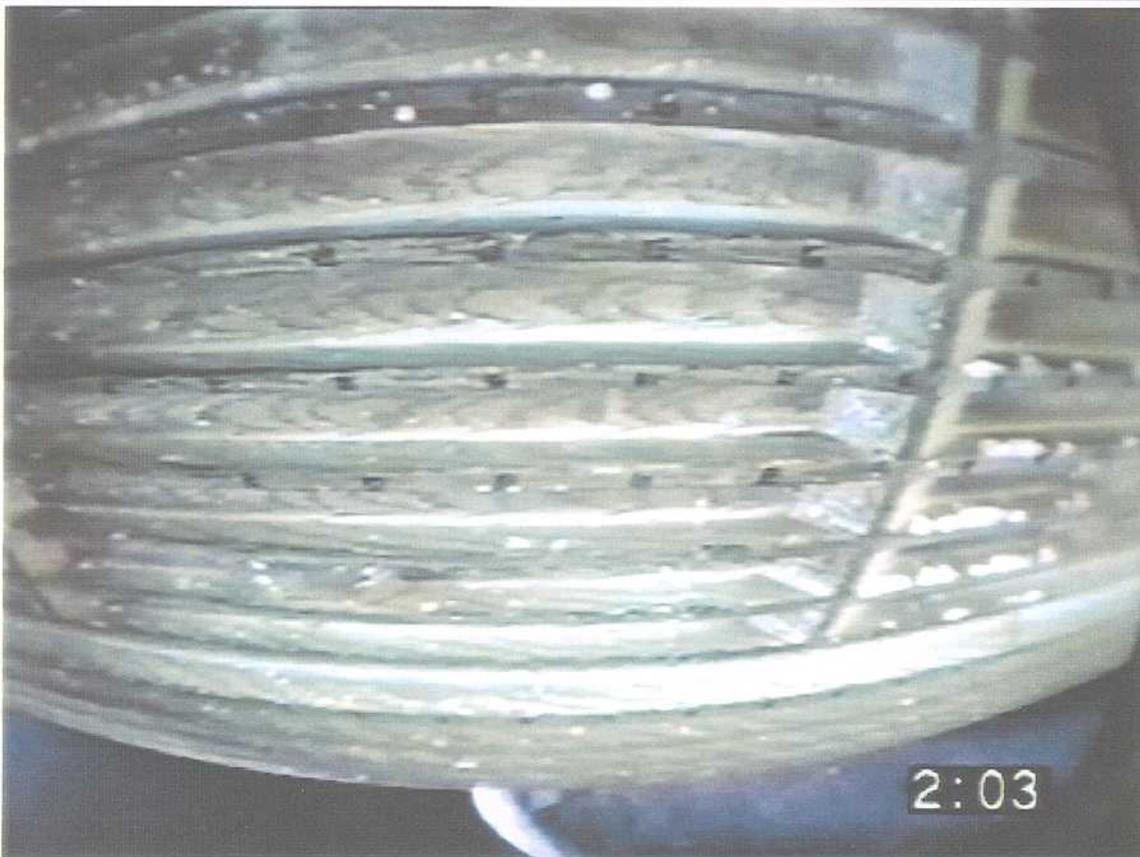
Photo 19: ET +Y Thrust Panel

There was a greater number of divots visible in the right field of view (+Y side) compared to the left (-Y) side.

99 seconds MET	First divot appeared on the circumferential rib ramp at Xt-963 between ribs #5 and #6
99-109 sec MET	23 divots in the vented area (zero greater than 1-inch in size) 14 divots in unvented area aft of station Xt-1013 (with four greater than 1-inch)
109-119 sec MET	78 divots in the vented area (one greater than 1-inch rib #7) 50 divots in unvented area aft of station Xt-1013 (with 16 greater than 1-inch aft of Xt-1013 at ribs #2, #3, and #4)
119-124 sec MET	92 divots in the vented area (one greater than 1-inch rib #7) 78 divots in unvented area aft of station Xt-1013 (with 21 greater than 1-inch aft of Xt-1013 at ribs #2, #3, and #4)
After separation	Numerous large divots visible in the unvented area aft of Station Xt-1013 with the largest estimated 3-4 inches long 6 divots were noted in adjacent valley ramps of ribs #1-7 at circumferential rib station Xt-1058

Views of the ET +Y thrust panel at 20 and 123 seconds MET. As expected, divots were smaller in size and fewer in number in the vented areas when compared to the unvented areas (note larger divots in the right side of the frame). Generally, divots in vented areas were less than 0.5 inches in diameter and shallow in depth.

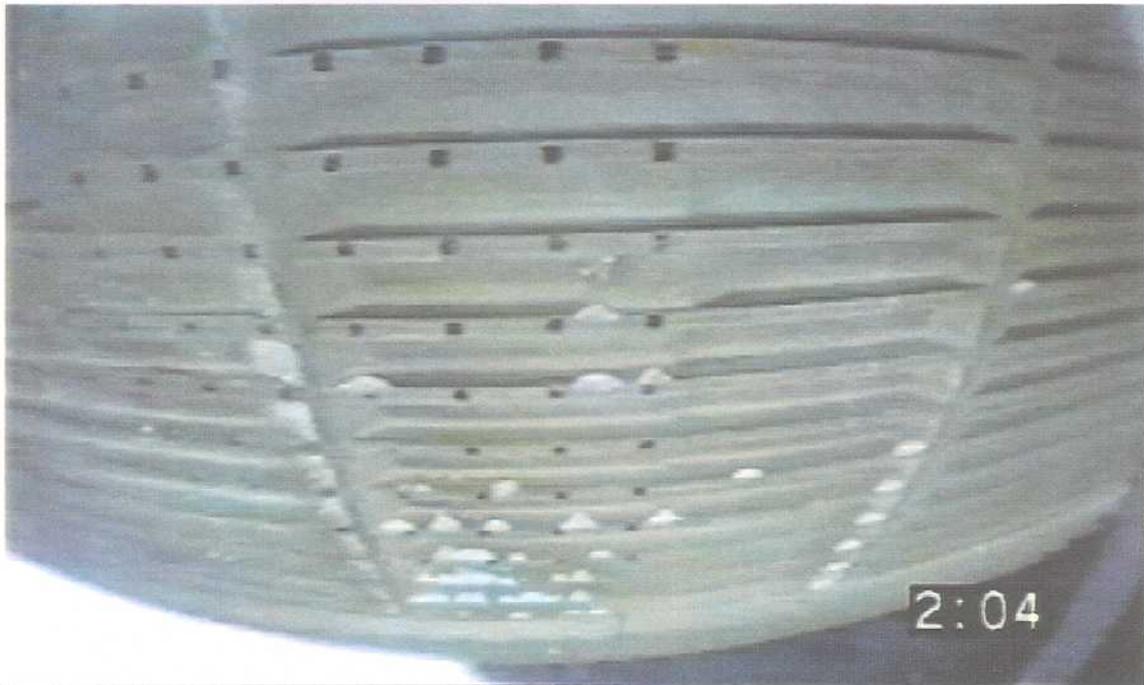
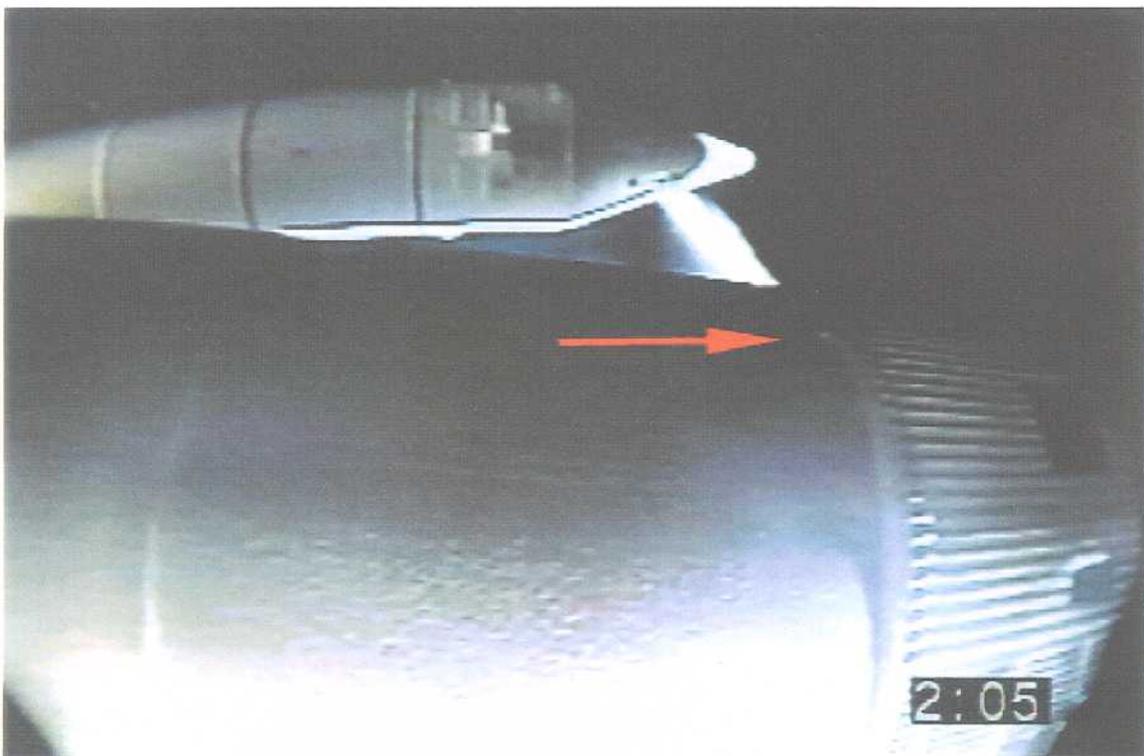
Photo 20: Divot on -Z Side

A divot approximately 9-inches in diameter was present on the ET -Z side at the intertank-to-LH2 tank interface.

At the start of SRB separation from the External Tank, the camera had a more direct view of the larger divots located in intertank stringers where the TPS was not vented. Bottom photo shows a divot approximately 9-inches in diameter on the ET -Z side acreage just aft of the intertank-to-LH2 tank splice.

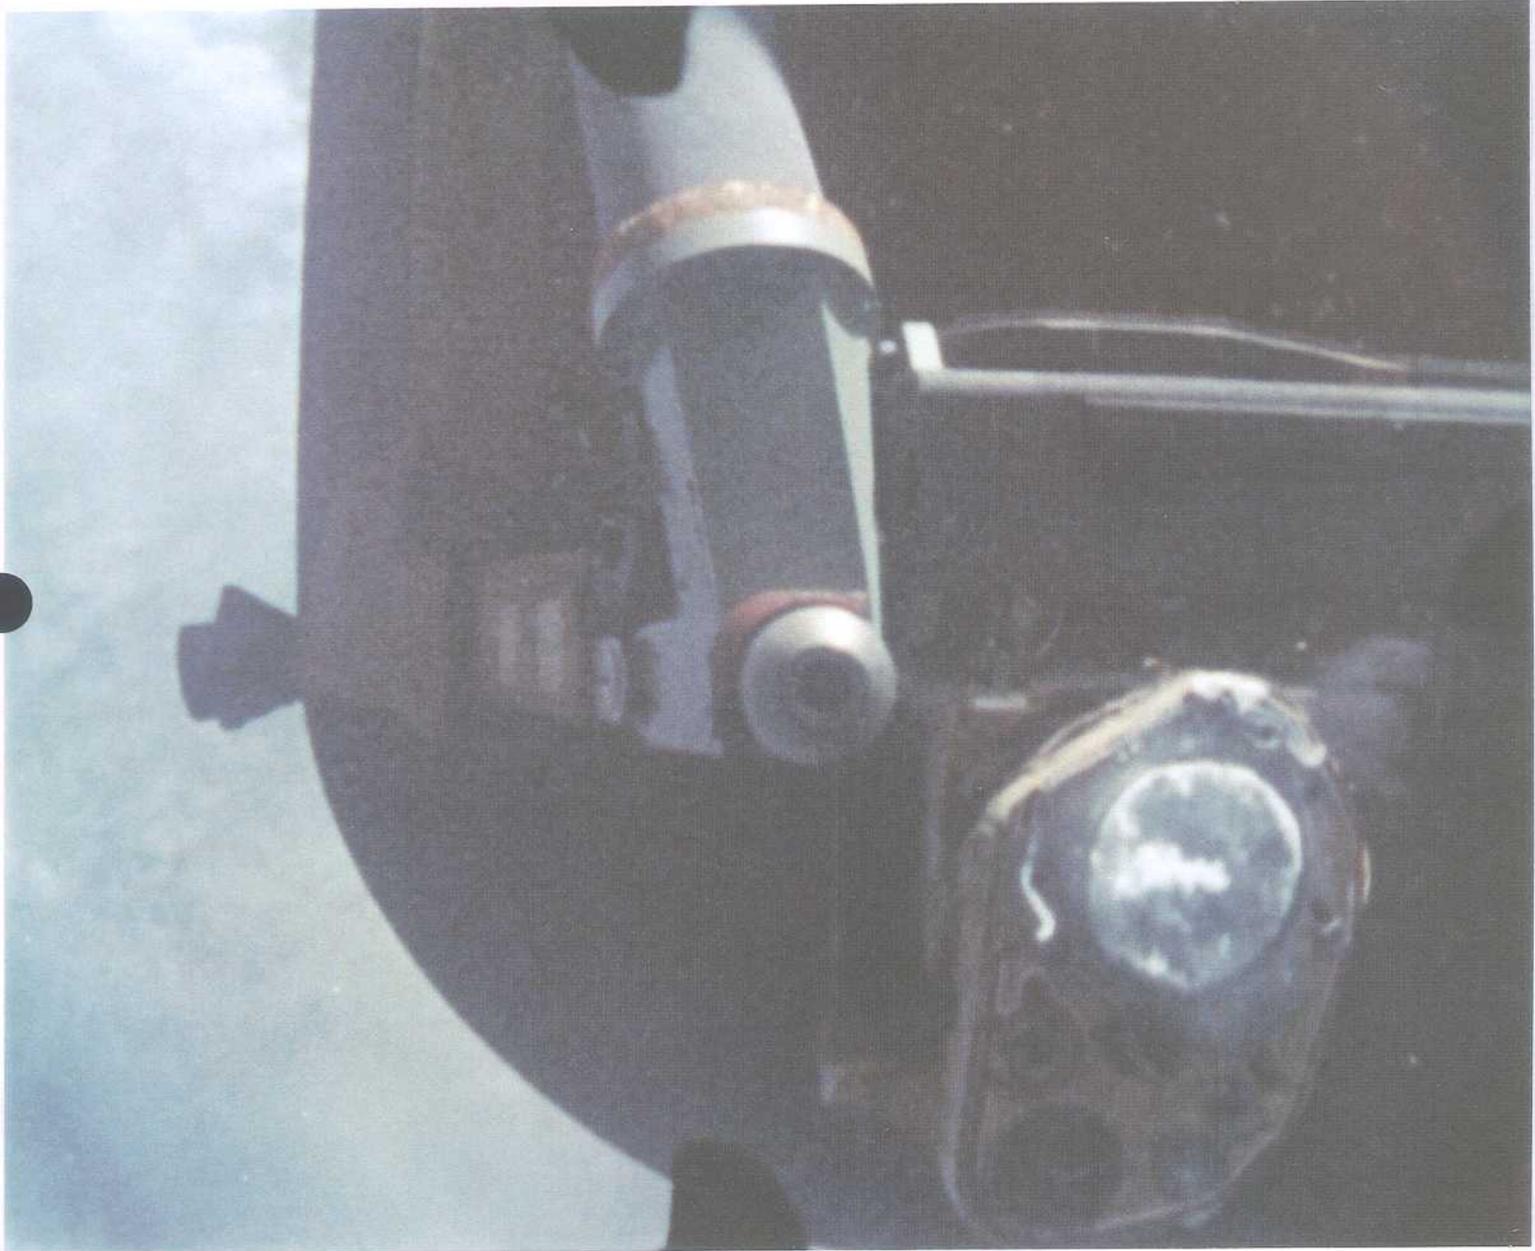
Photo 21: Protruding Purge Seal

During ET separation, no damage was noted on the LH2 ET/ORB umbilical with one exception. The forward outboard portion (10 o'clock position) of the purge seal had pulled loose and protruded in the +Z direction.

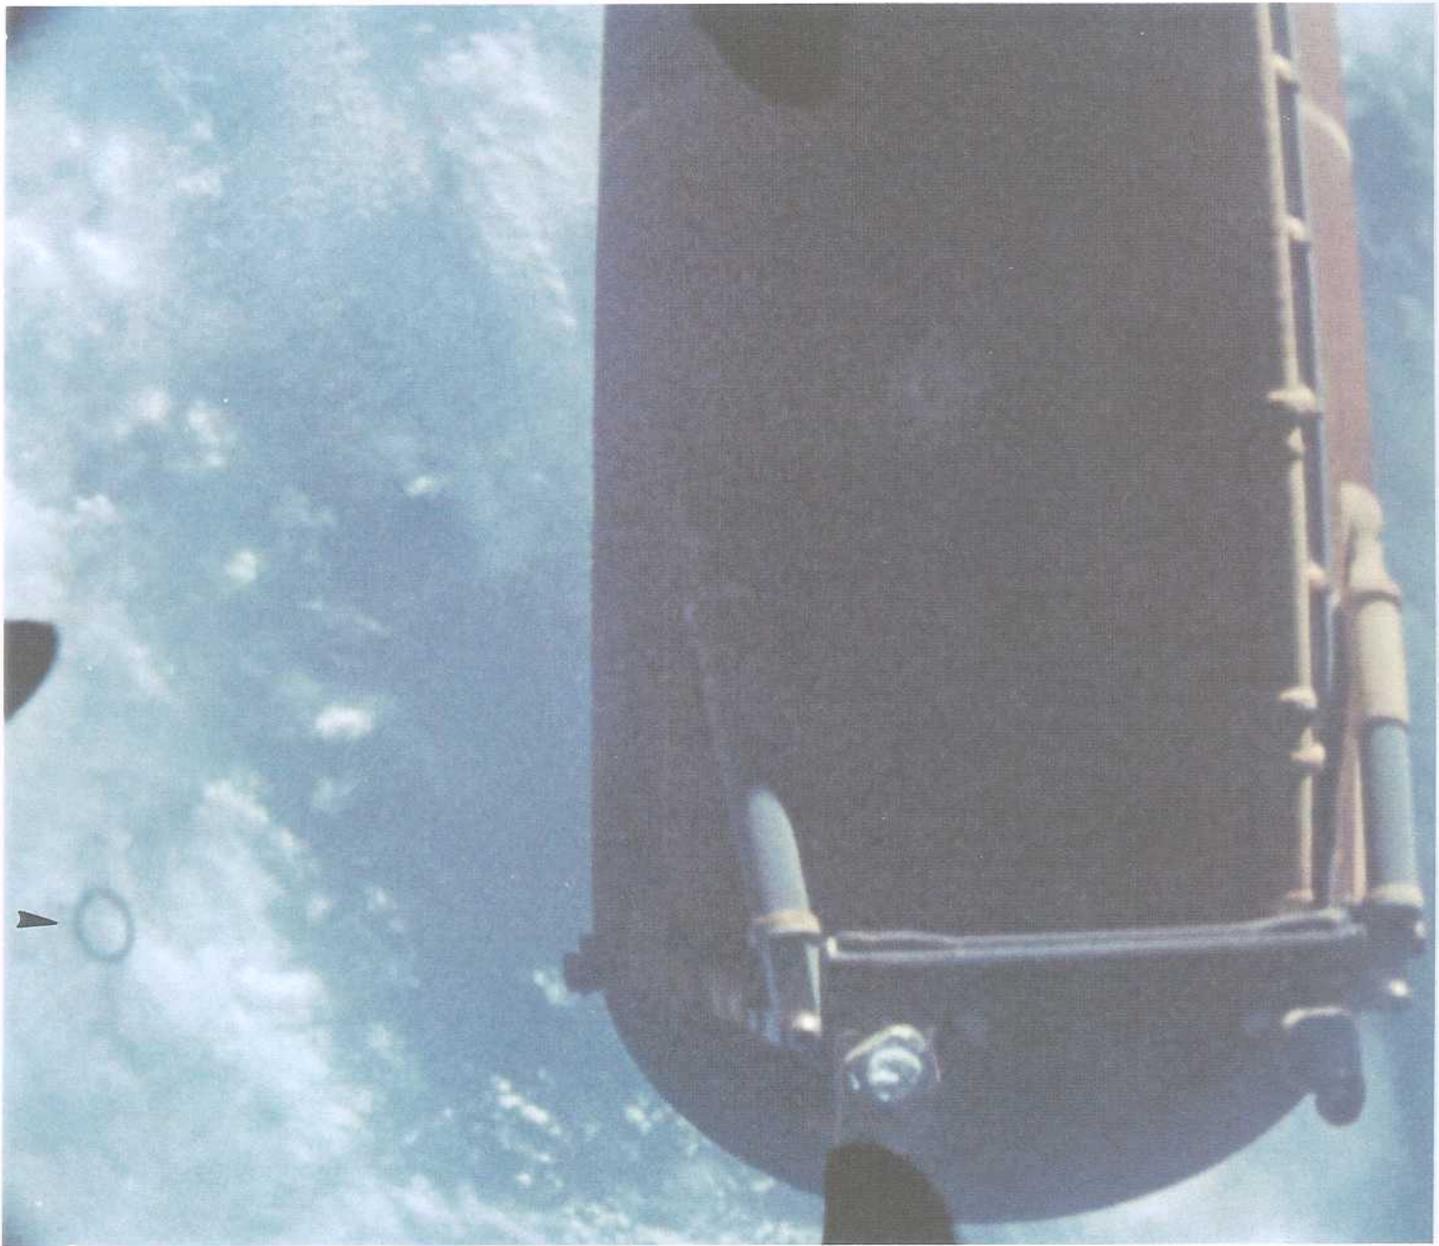
Photo 22: Loose O-Ring

A debris object passed close to the camera lens in a fore to aft direction as the distance between separated ET and Orbiter increased (frame 7830). Since the object was silhouetted, no detail such as color or surface finish could be discerned. However, due to the large inner diameter, the object was believed to be an O-ring of some type rather than a washer. The origin was not determined.

A debris object passed close to the camera lens in a fore to aft direction as the distance between separated ET and Orbiter increased. Since the object was silhouetted, no detail such as color or surface finish could be discerned. However, due to the large inner diameter, the object was believed to be an O-ring of some type rather than a washer. The origin was not determined.

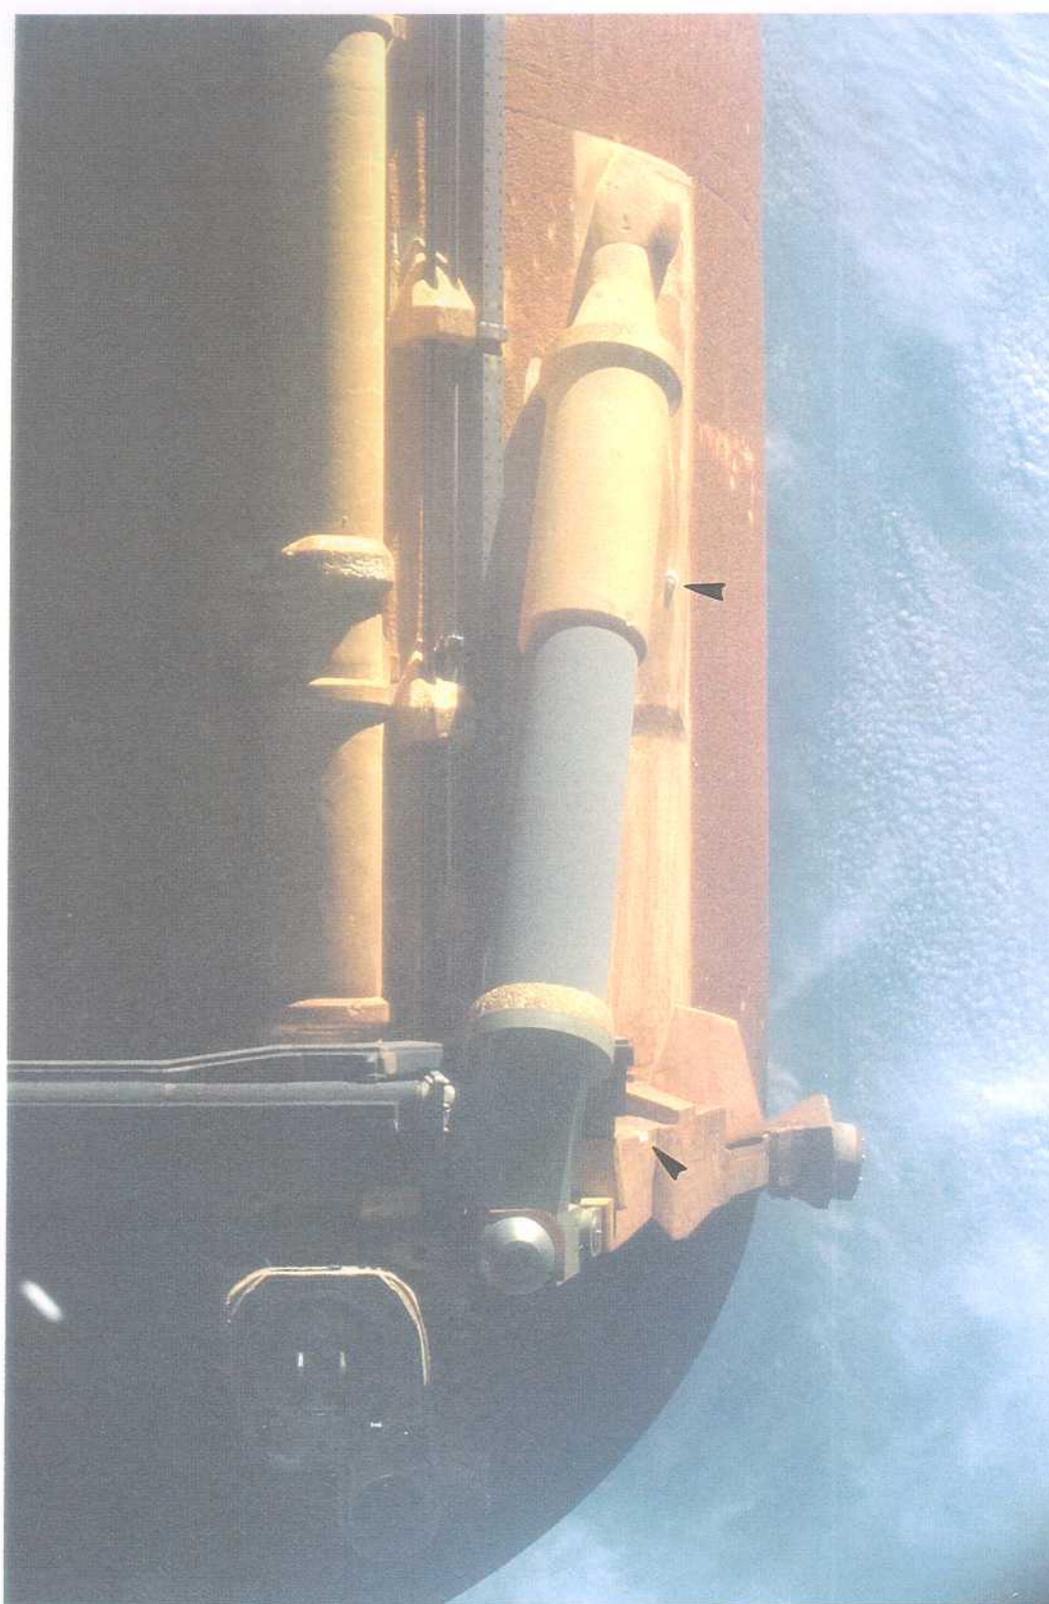
Photo 23: ET After Separation

A white object, which appeared to be an ice/frost formation approximately 3 inches in diameter, adhered to the +Y longeron TPS closeout in the area where a vertical crack was detected during cryoloading prior to launch. The object protruded far enough to cast a noticeable shadow and may have been a lifted piece of the closeout foam itself, but more likely was condensate/water vapor inside the crack venting at altitude as the atmospheric pressure decreased. Ascent aeroheating probably had decreased enough to permit this moisture to freeze in place.

A divot in the forward surface outboard edge of the +Y vertical strut cable tray closeout was estimated to be 4 inches long by 2 inches wide.

A white object, which appeared to be an ice/frost formation approximately 3 inches in diameter, adhered to the +Y longeron TPS closeout in the area where a vertical crack was detected during cryoloading prior to launch (arrow). The object protruded far enough to cast a noticeable shadow and may have been a lifted piece of the closeout foam itself, but more likely was condensate/water vapor inside the crack venting at altitude as the atmospheric pressure decreased. Ascent aeroheating probably had decreased enough to permit this moisture to freeze in place. A divot in the forward surface outboard edge of the +Y vertical strut cable tray closeout was estimated to be 4 inches long by 2 inches wide (arrow).
