6.0 FILM REVIEW

6.1 LAUNCH FILM AND VIDEO SUMMARY

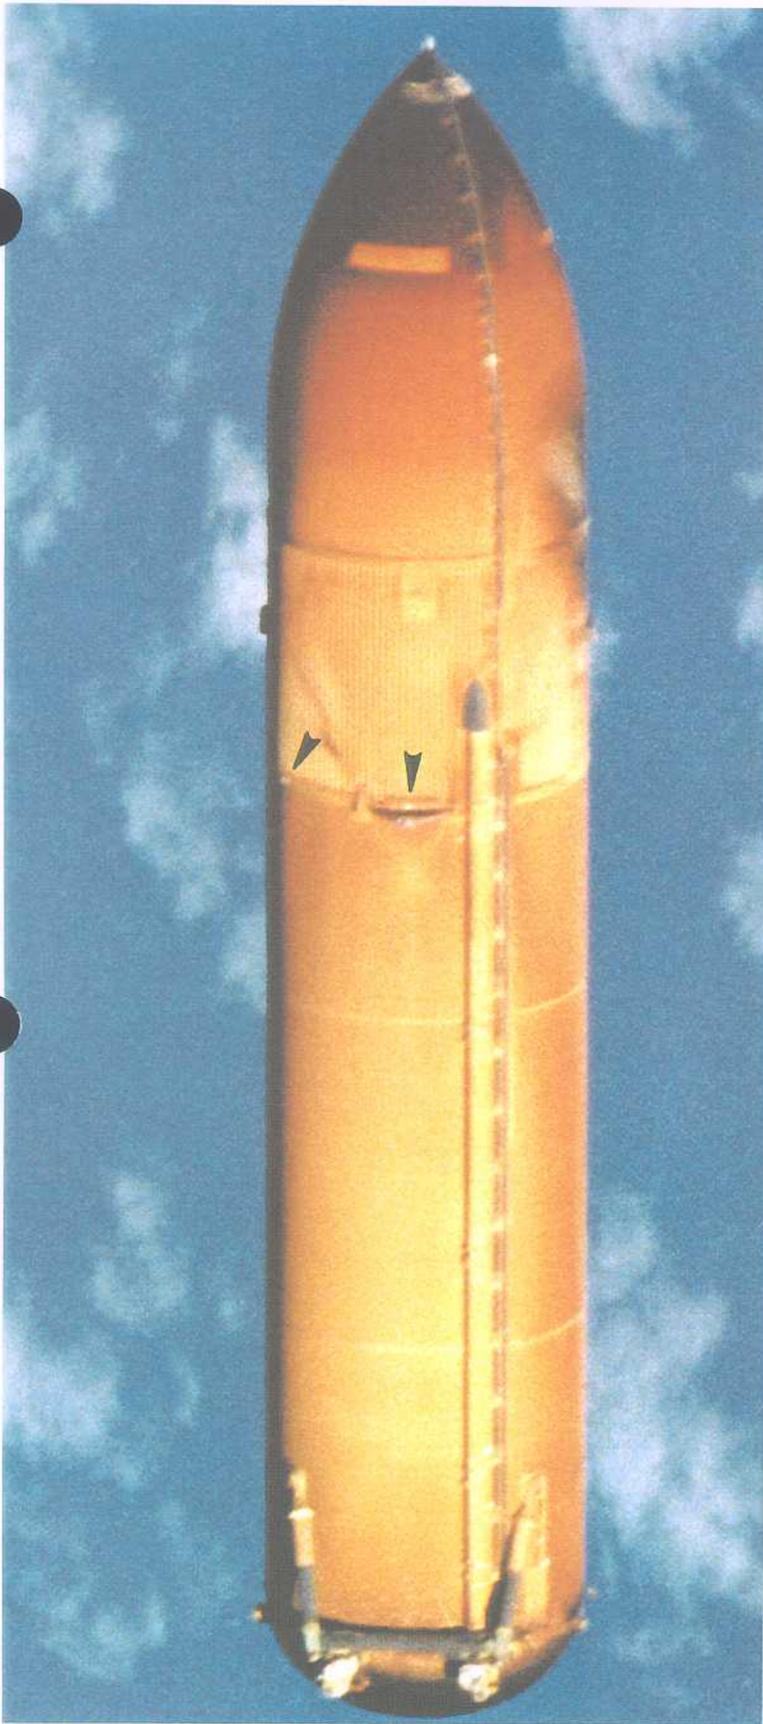
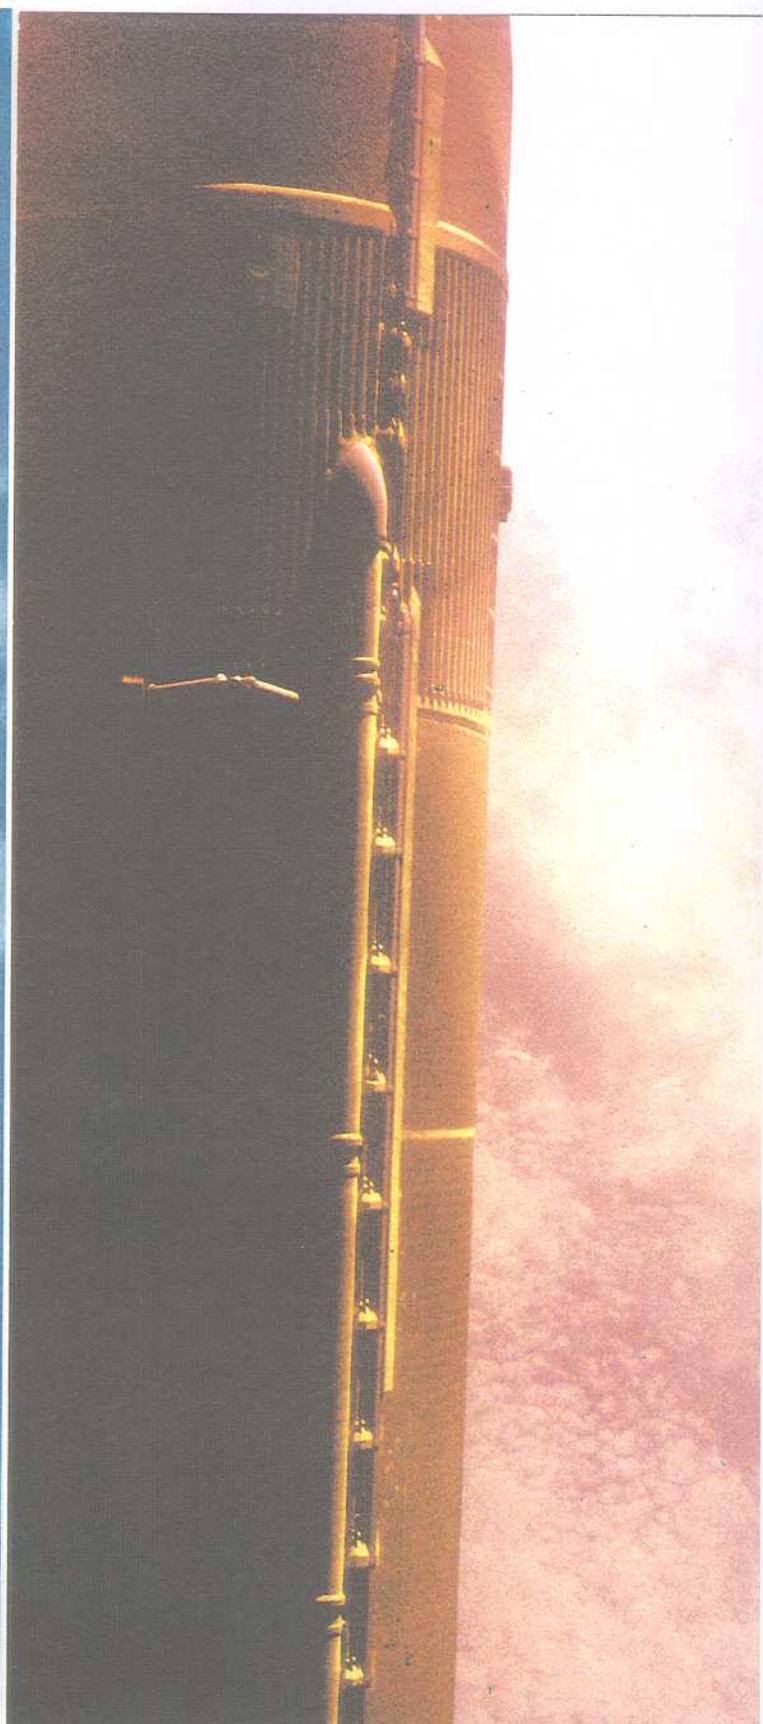
Photo 24: ET Intertank Area

A light spot in the LH2 tank-to-intertank flange closeout on centerline between the bipods and a light spot in the LH2 tank-to-intertank flange closeout near the $-Y$ thrust panel may be divots, but could not be confirmed in the other films.

Crew hand held image shows possible divots in the LH2 tank-to-intertank splice between the bipods and near the -Y thrust panel (arrows, left photo). However, view from the 35mm camera in the ET/ORB LO2 umbilical could not confirm the presence of the divots due to shifted field of view and deep shadow (right photo).

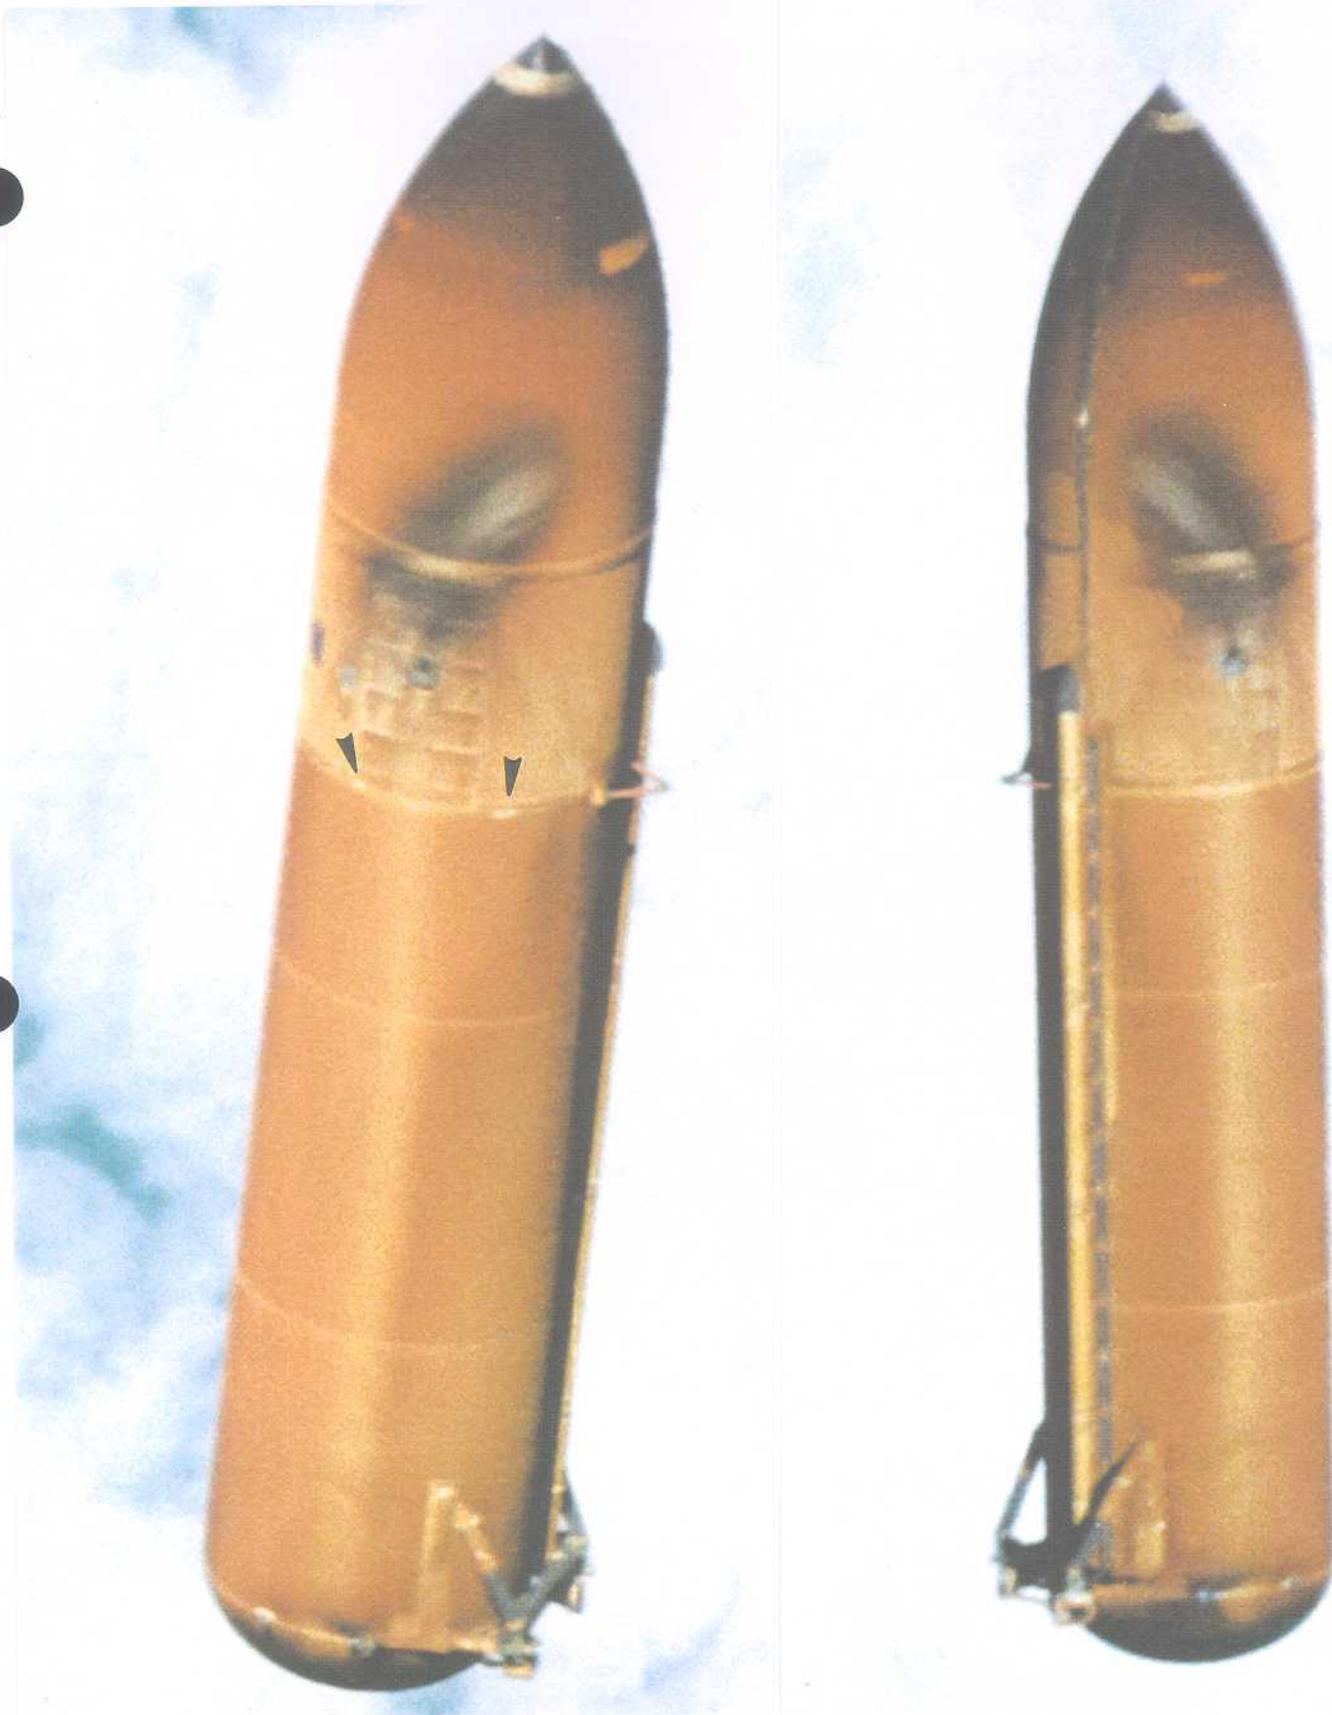
Photo 25: ET Thrust Panels

Both $+Y$ and $-Y$ intertank thrust panels, including areas not visible in the two SRB video cameras, exhibited no large divots (5-inches in diameter or greater). Smaller divots could not be discerned due to the subject distance and resolution.

Crew hand held images show no large divots in either thrust panel - that would be discernible with the given image resolution and subject distance. Yet three 9-inch diameter divots are readily visible in the LH2 tank-to-intertank splice (arrows).
