2.0 PRE-LAUNCH SSV/PAD DEBRIS INSPECTION

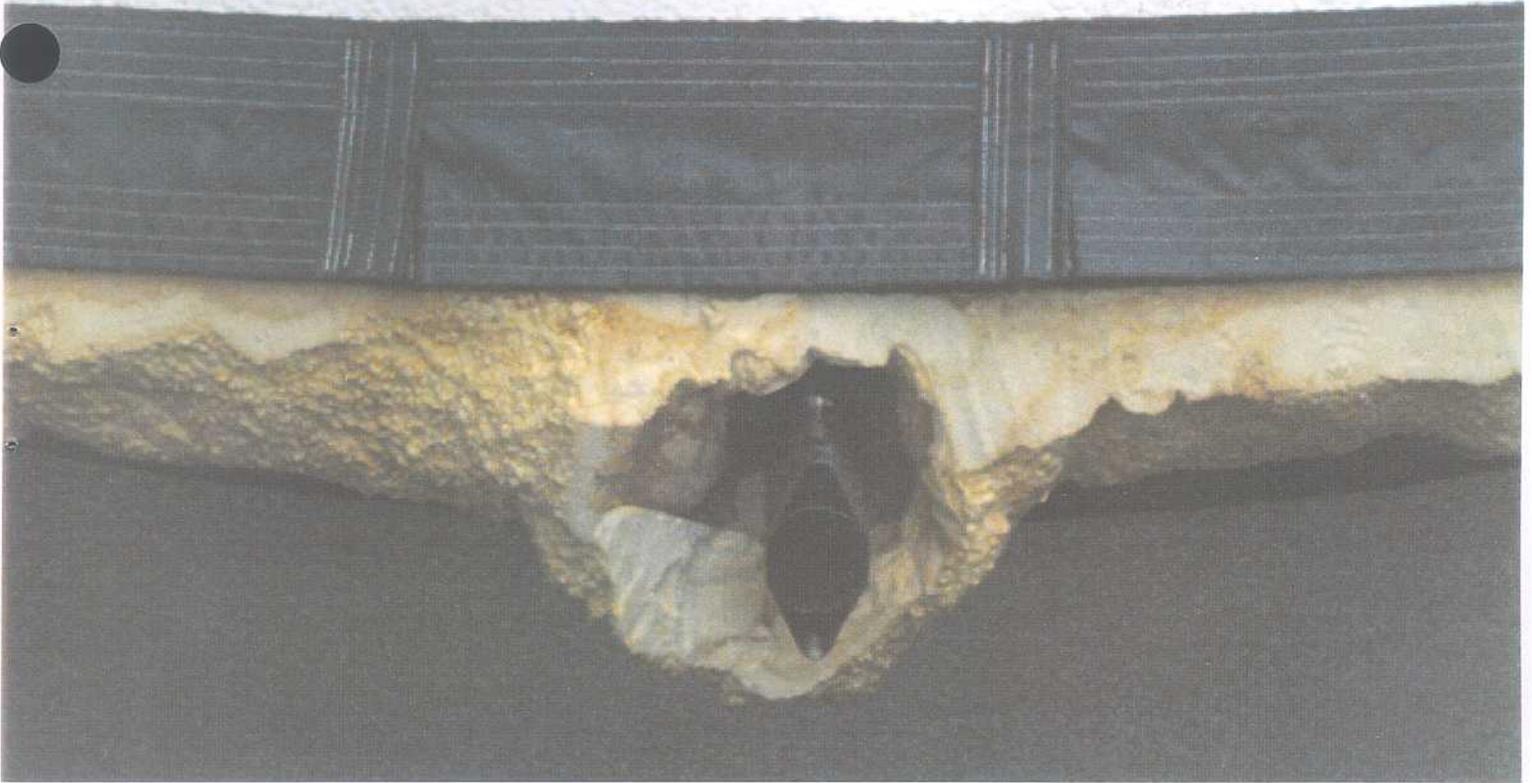
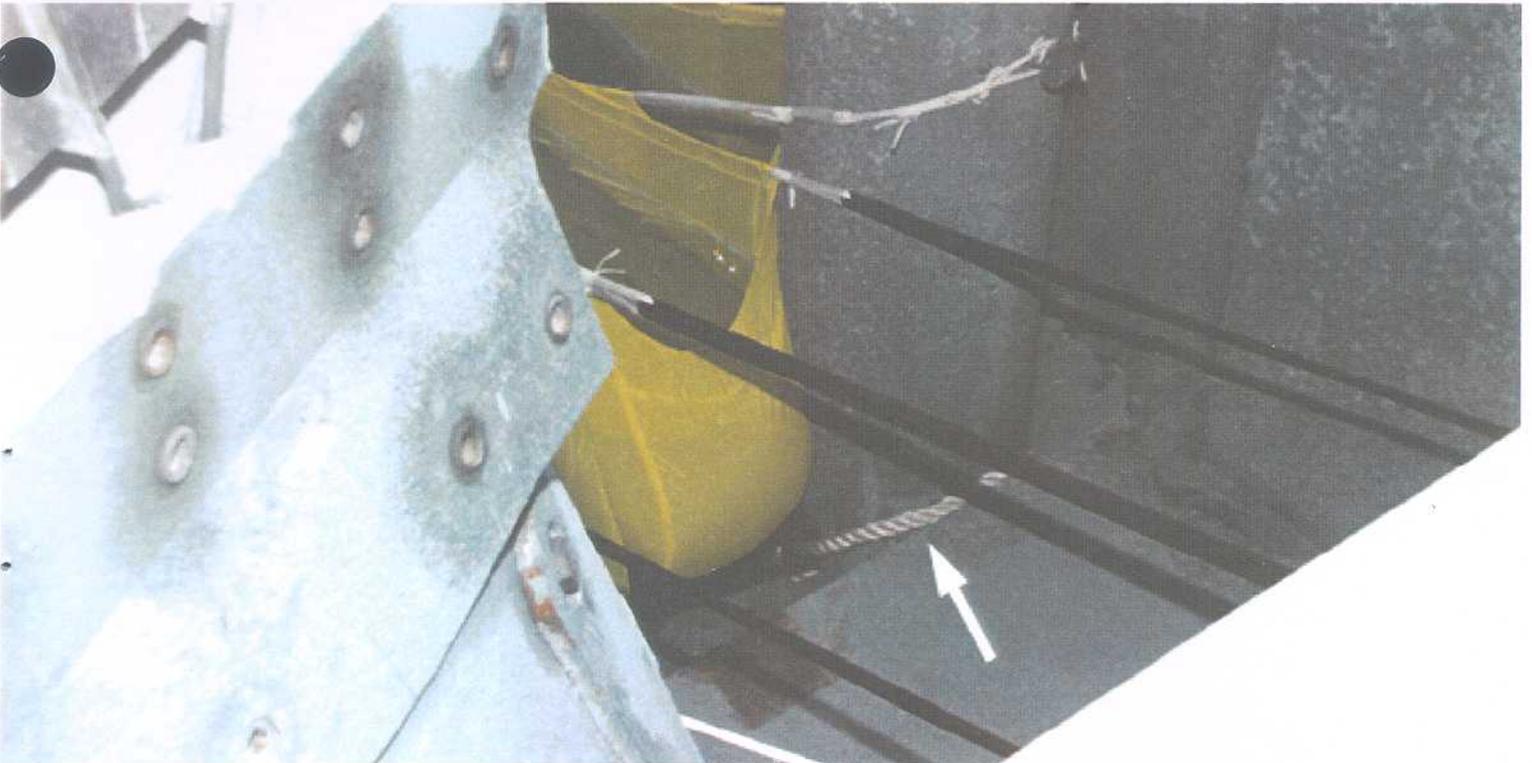
Photo 2: Pre-Launch Debris Inspection

Loose foam pieces in RH SRB APU exhaust pipe cut-outs and a rope with a metal thimble wrapped around the water pipe in the HDP #2 haunch area were removed prior to tanking
