From: Freeland, Donna M [FreelaDM@usasrb.ksc.nasa.gov] Sent: Friday, January 24, 2003 4:38 PM
To: 'Armando.Oliu-1@nasa.gov'
Cc: Bao. Nguyen-1 (E-mail); Williams, Tina M
Subject: FW: STS-107 SRB Post Flight Retrieval Assessment

STS-I07 SRB POST FLIGHT/RETRIEVAL ASSESSMENT
KSC Debris Team
20 January 2003

The BI-116 Solid Rocket Boosters were inspected for debris damage and debris sources at CCAFS Hangar AF on 20 January 2003. Overall, both boosters were in excellent condition.

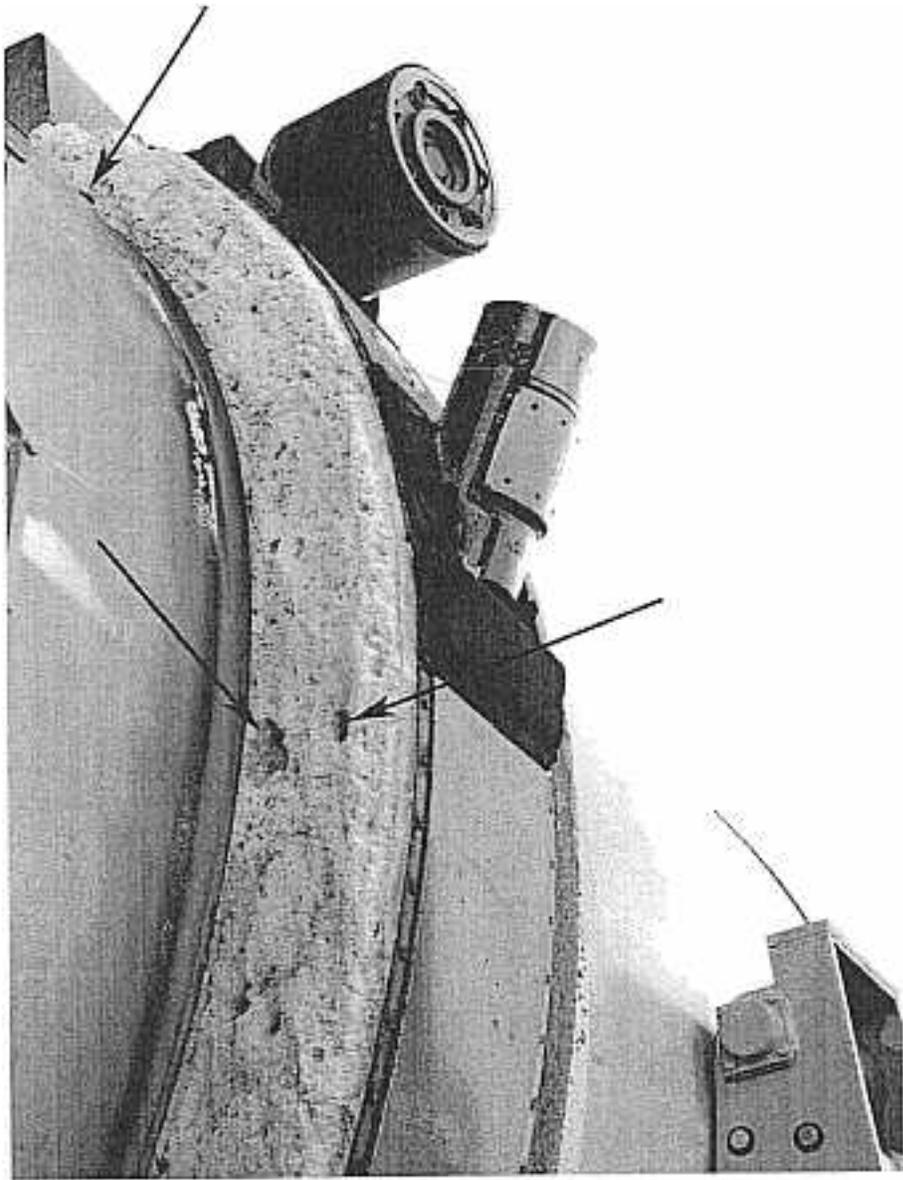
Photo 1. **LH SRB**

The LH ETA ring instafoam closeout exhibited missing foam on the aft side. The areas of missing foam were sooted, indicating they came off in flight and not as the result of water impact. The largest area was approximately 3 inches in diameter by 2-1/2 inches deep. This appears to correlate with the debris seen coming from this area on the tracking films (E-220, E-222, E-223, E-224). See photo.

Missing instafoam, with sooting, from the aft side of the l.H ETA ring.
