STS-108 Run 3

# PROCESSING OPERATIONS CONTROL OMI PLANNING SHEET

Title: SSV ICE AND DEBRIS ASSESSMENT	Sub Element/Zone 30
-----------------------------------------	------------------------

**STS-108 ORBITER POST LANDING INSPECTION**  
DEBRIS ASSESSMENT  
18 December 2001

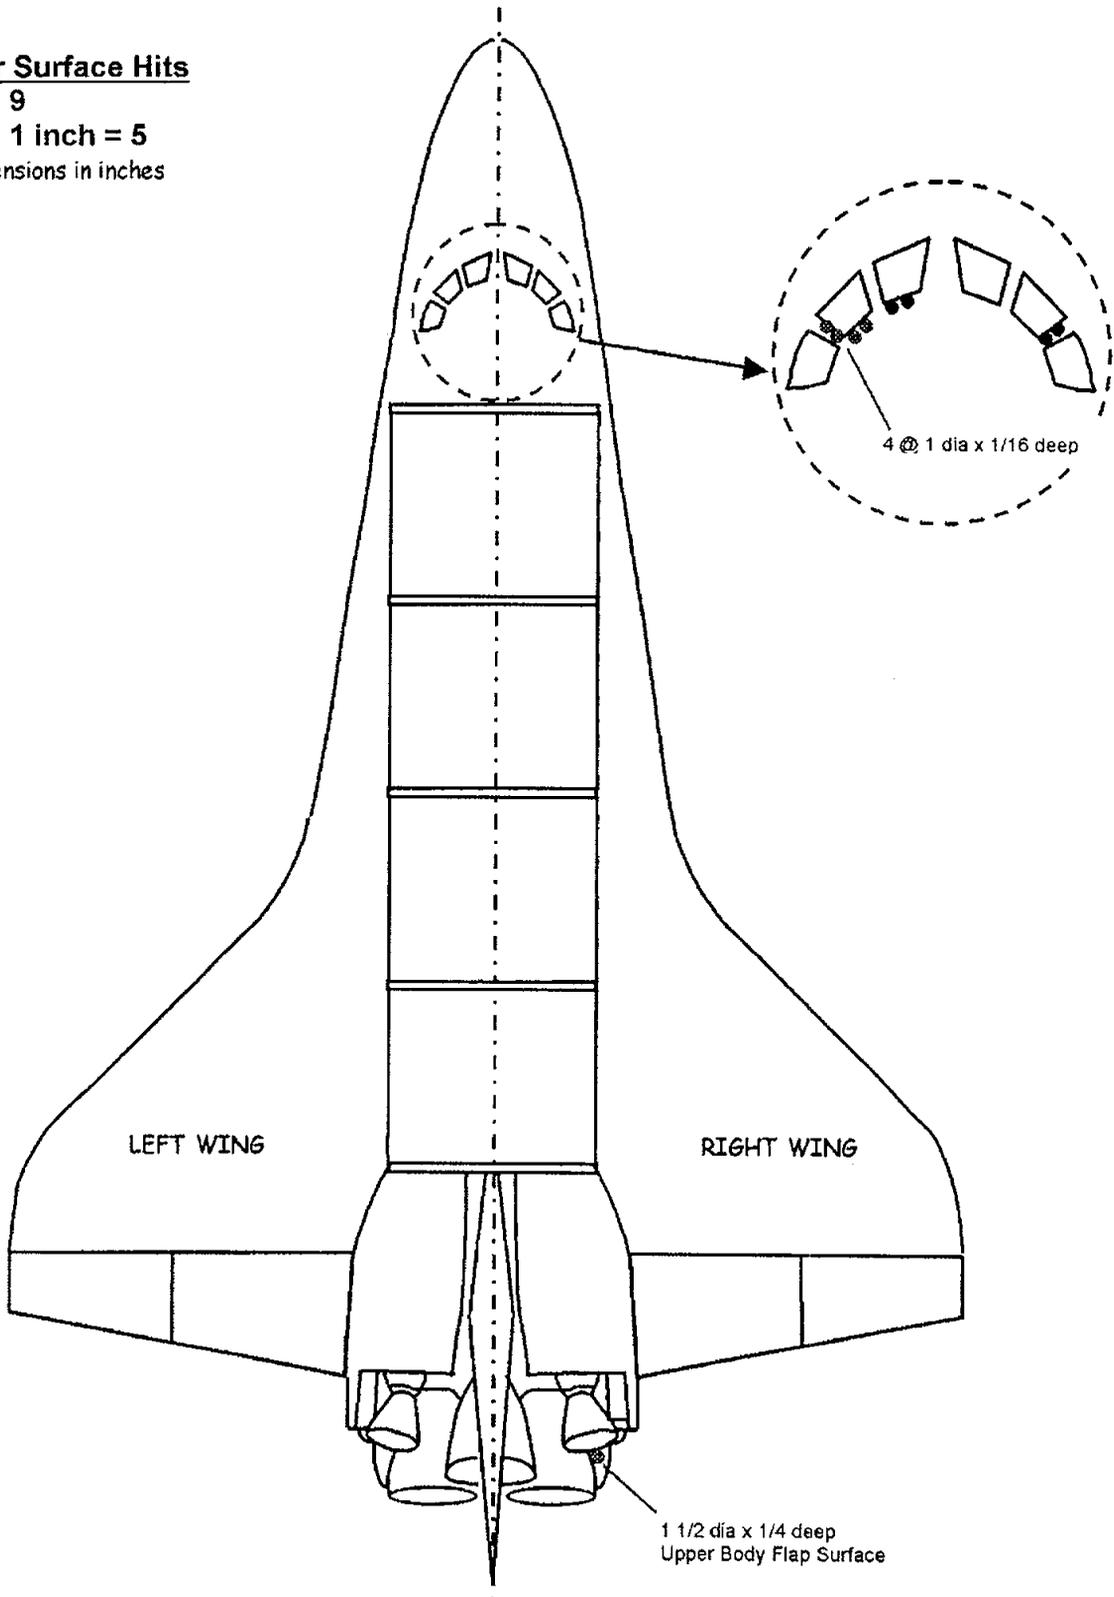
# DEBRIS DAMAGE LOCATIONS

Hits > 1 inch = 5

All dimensions in inches

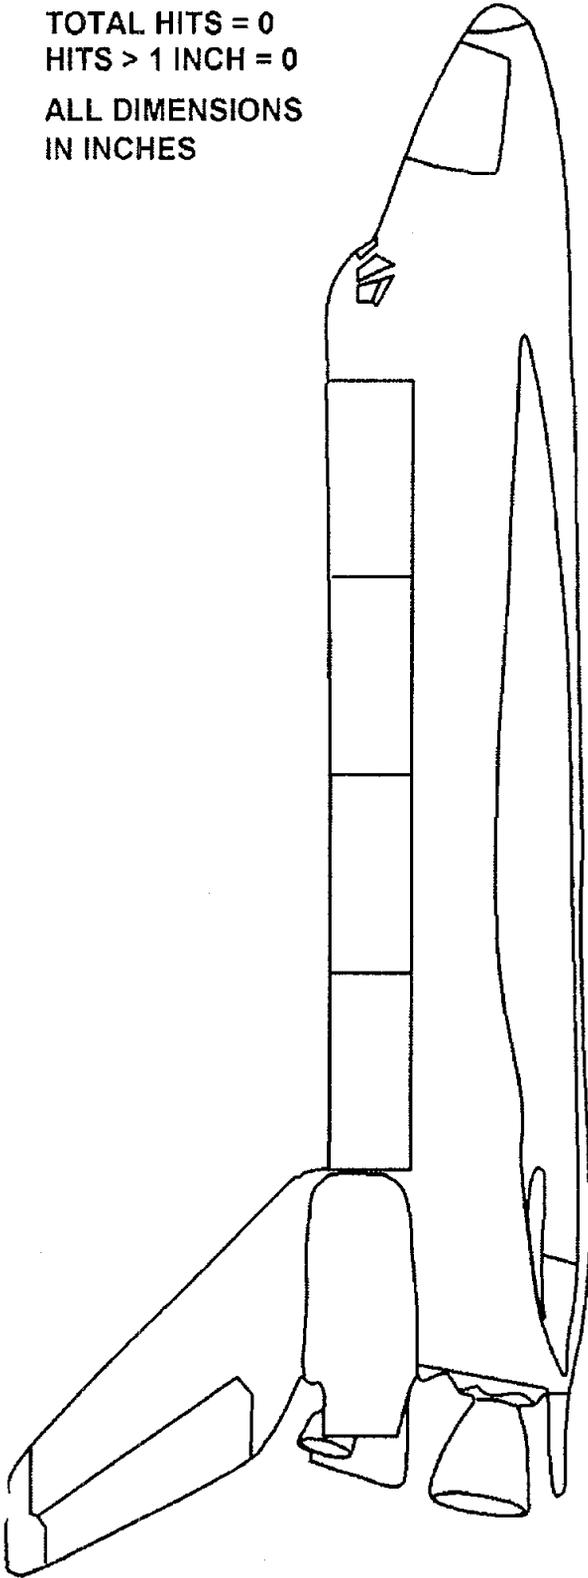
# DEBRIS DAMAGE LOCATIONS

RHS  
TOTAL HITS = 0  
HITS > 1 INCH = 0  
ALL DIMENSIONS  
IN INCHES

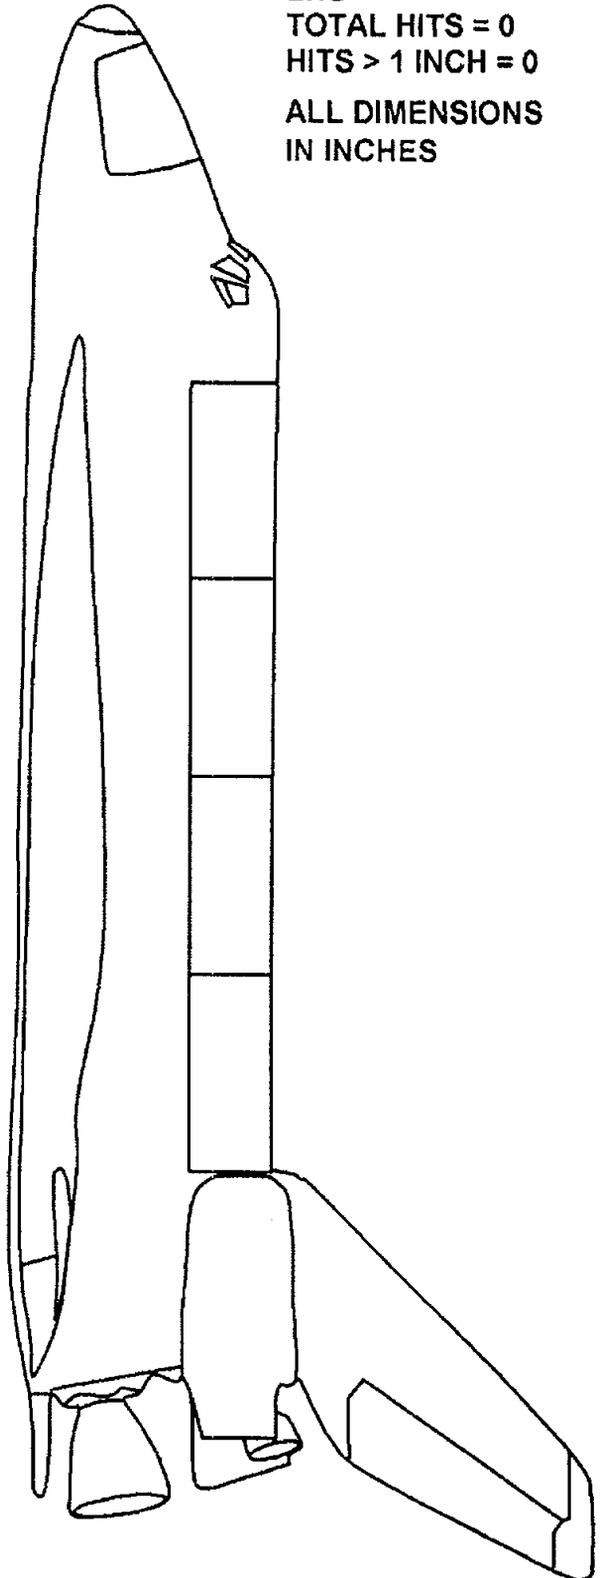
LHS  
TOTAL HITS = 0  
HITS > 1 INCH = 0  
ALL DIMENSIONS  
IN INCHES
