Mission STS-109  
OV-102 Flight 27  
Thermal Protection System  
Post-Flight Assessment

Mission STS-109

OV-102 Flight 27

Thermal Protection System Post-Flight Assessment

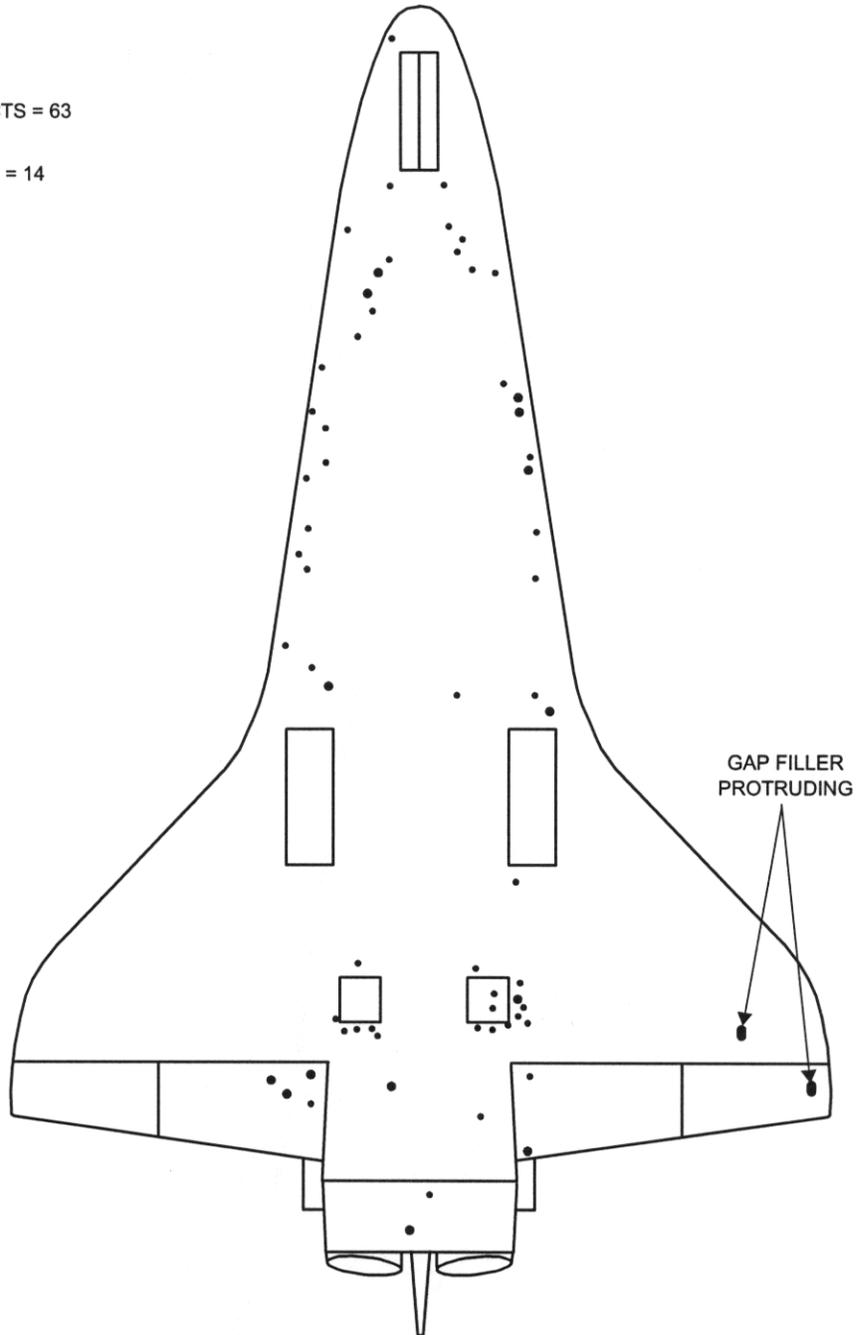
Figure 1. Lower Surface Debris Damage

TOTAL IMPACTS = 63

IMPACTS > 1" = 14

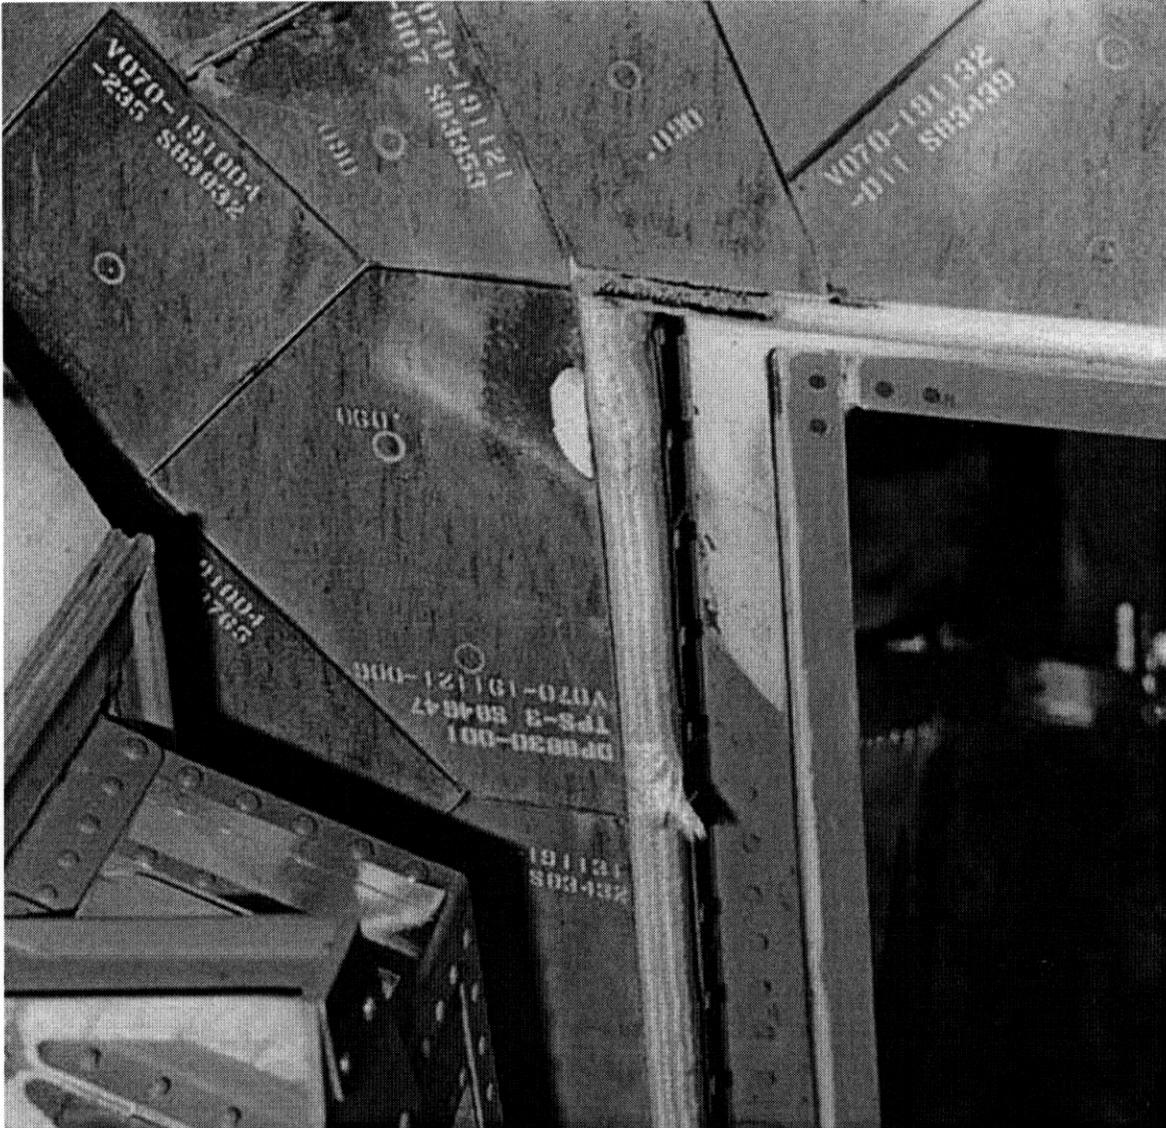
Post-flight evaluation of the MLGD areas concluded that the TPS performed nominally and no major damage of RSI components was evident. The V070-191121-006 tile sustained a shallow edge damage at the interface to the adjacent thermal barrier. The damaged area did not result in any subsurface flow or overtemperature between the tile and the thermal barrier. This tile is located at the forward/outboard corner (structure side) of the right-hand MLGD. Damage at this location is consistent with damages seen on the other vehicles (refer to photo 13).

*Photo 13. V070-191121-006 Tile Damage and Torn Thermal Barrier At Forward/Outboard Corner of Right-Hand MLGD*

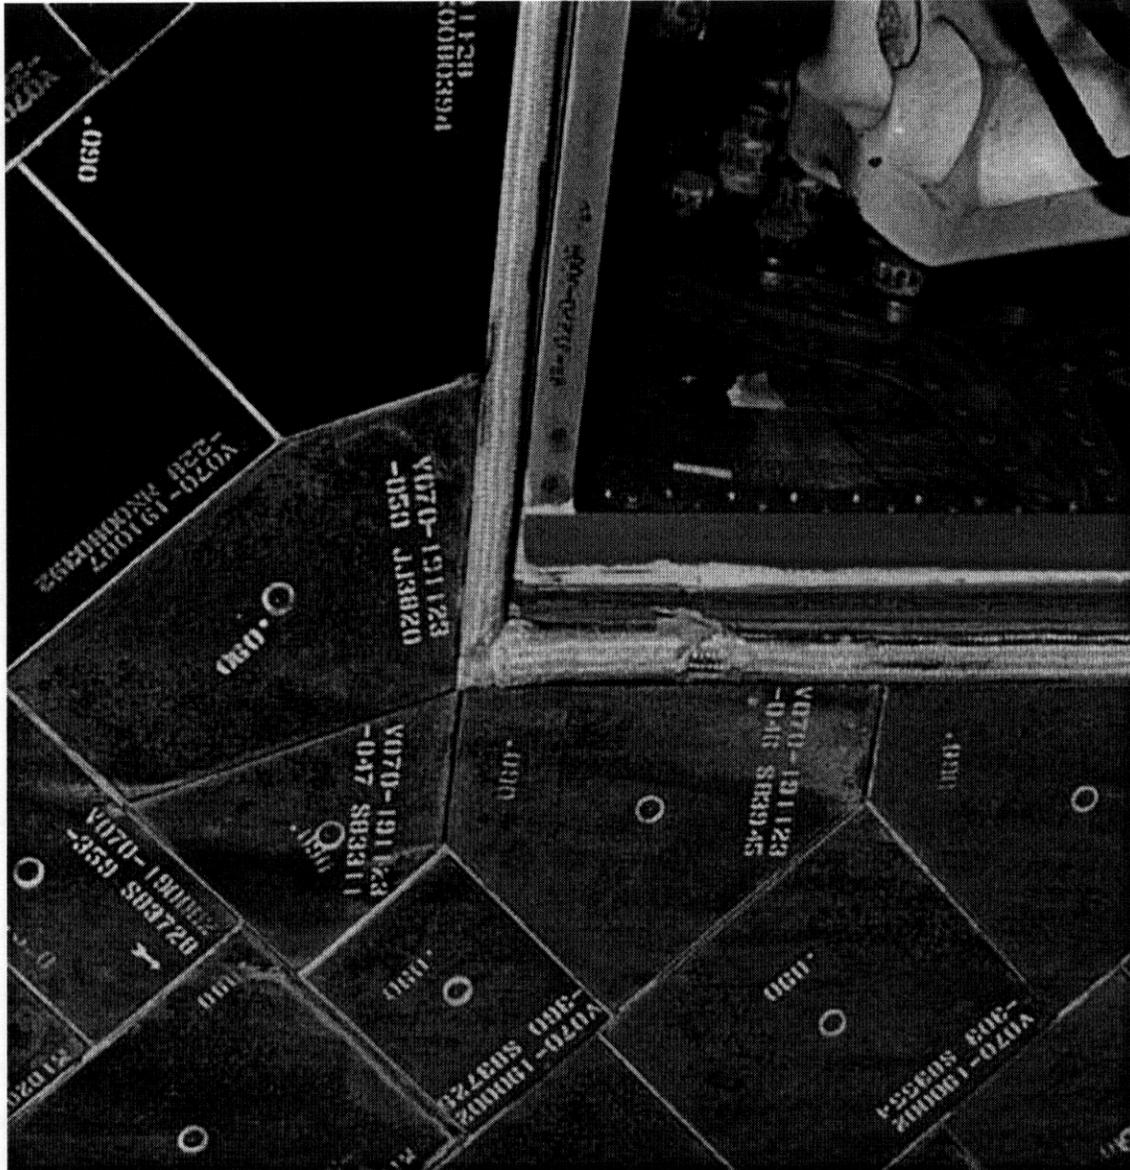
Several breached thermal barriers were found around the periphery of the right-hand MLGD cavity. Three thermal barriers on the left-hand MLGD and eight thermal barriers on the right-hand MLGD door were removed and replaced due to flight damage (refer to photo 13 and photo 14). Refer to table 11 for MLGD thermal barrier replacement history and locations.

Photo 14. Damaged Thermal Barrier At Aft/Inboard Corner of Right-Hand MLGD

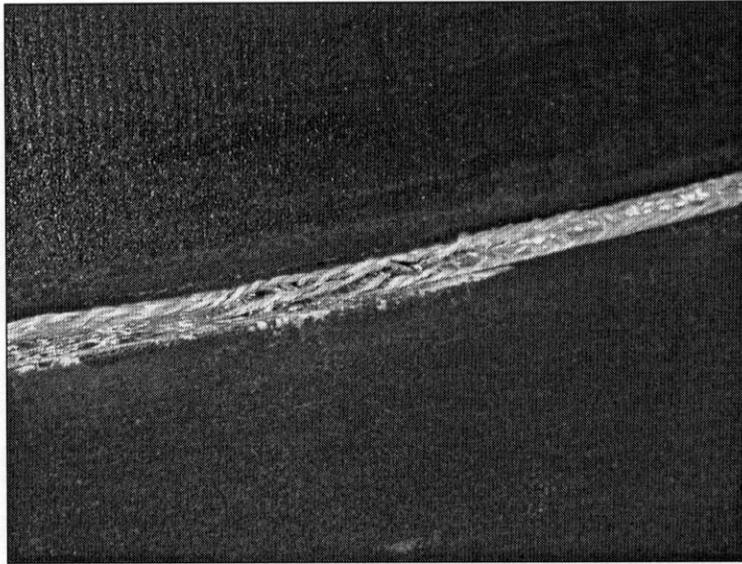
The V070-399441 gap filler was breached in two locations. One location was approximately 2.5 inches in length and was located on left side 6 to 8 inches from the outboard edge of the chin panel and the other location was approximately 0.5 inch in length and was located just left of the centerline (refer to [photo 15](#)). The inner fabric was exposed on the larger damage toward the outboard left portion of the gap filler. Aside from the damages, the outer fabric of this gap filler appeared to be separated by adhering to both the nose cap expansion seal and the chin panel gap seal. In addition to the damages to the V070-399441 gap filler, there were significant damages to the V070-399412-053, V070-399412-082, V070-399442-009, and V070-399442-010 gap fillers that warranted replacement.

*Photo 15. V070-399441 Gap Filler Adherence to Adjacent RCC*

The result of these softgood damages warranted the removal of the chin panel; however, there was also a concern with the aerothermal roughness of the installation. The preflight concerns with the installation step and gap conditions were addressed by the evaluation of the internal components. Since there was no internal thermal damage to the softgoods and that the reinstallation step and gap measurements did not exceed those accepted before the STS-109 mission, there was no requirement for chin panel reshimming to improve the marginal step condition between the nose and chin panel.

During the chin panel rework, the reported adherence of the fabric to the adjacent RCC was addressed by wet sanding the RCC to remove the glass fibers embedded on the glass sealant. Prior to this repair, a 0.23 inch by 0.05 inch by 0.028 inch silicon carbide chip in the right-hand outboard corner of the MC621-0007-8557 chin panel angle seal was discovered and was repaired per ML0601-9026 procedure TPS-365 method A after the wet sanding.

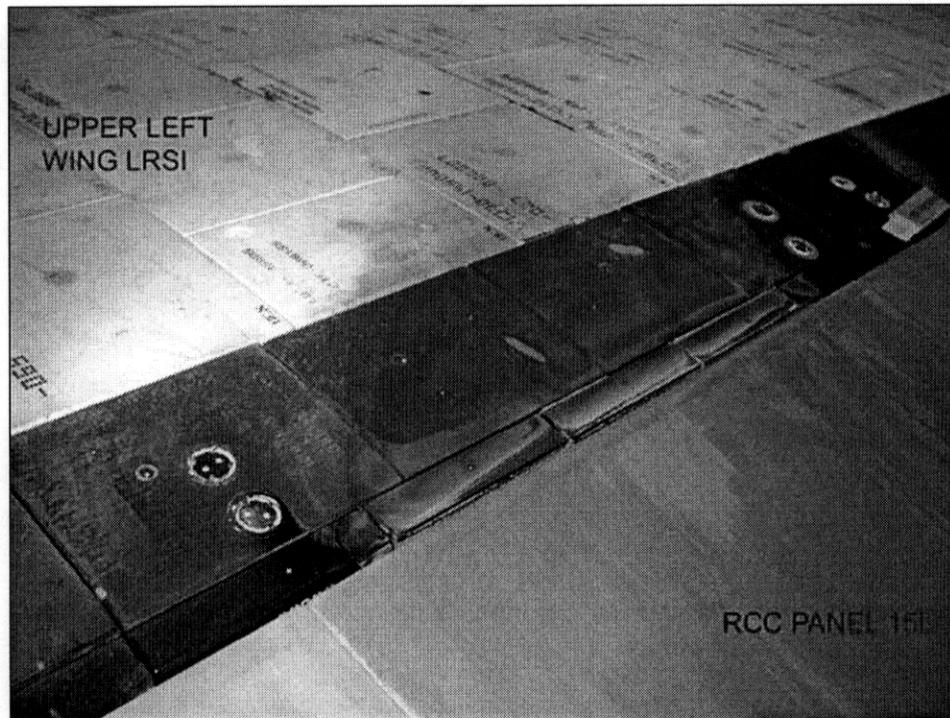
There was an unusual discovery on the left wing leading edge. USA QC inspectors discovered the condition during V6028 inspections of the wing leading edge and upper wing. There is a discolored area on the upper wing that emanates from the number 15 upper access panel gap (refer to photo 16). This gap is intended to vent the RCC cavity and from the appearance of the upper wing, these vented gases included some condensable material that collected on the upper wing HRSI/LRSI tiles. This condition was sampled and analyzed for elemental identification. The contaminant was a curious lead-rich inorganic residue.

*Photo 16. Upper Wing Discoloration*

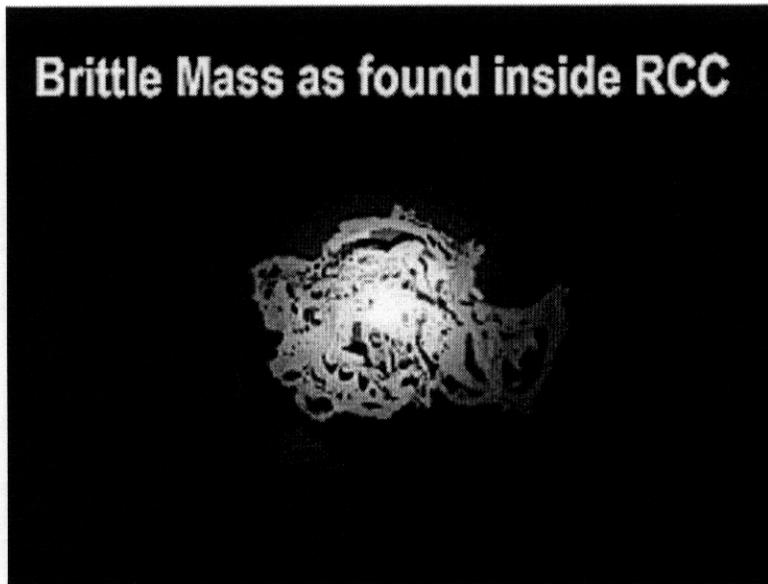
There was no sign of localized overtemperature (e.g., slumped tile edges/corners, embrittled fabric, etc.) in the area. Given the results of the inspection, it does not appear as though there was any appreciable flow ingestion to call the discrepancy a “flowpath”. The upper and lower access panels were removed for further inspection. Upon internal inspection, a white mass of material was discovered in the left-hand WLE panel number 15 cavity as shown in photo 17. The chemical identification of this debris indicated that it was primarily made of an amorphous titanium oxide mass. Although it was widely accepted that this contaminant was benign to the LESS components, the source/cause of this FOD was investigated.

*Photo 17. WLE RCC Internal Contaminate*

The findings of the LESS PRT investigation identified that the most likely source was a mass of white masking tape that was soiled with a lead-containing paint. Investigation indicated that less than half of a roll of 3M #850 tape would have been able to produce the quantity of material found in the RCC cavity. This used tape ball was believed to have fallen into the RCC cavity during OMM activity in Palmdale. The foreign material was removed from the cavity by vacuuming. The upper wing discoloration was removed using Scotchbrite pad and DI water and no further action was required for internal WLE surfaces. The entire rework was accepted with unrestricted material review board approval.

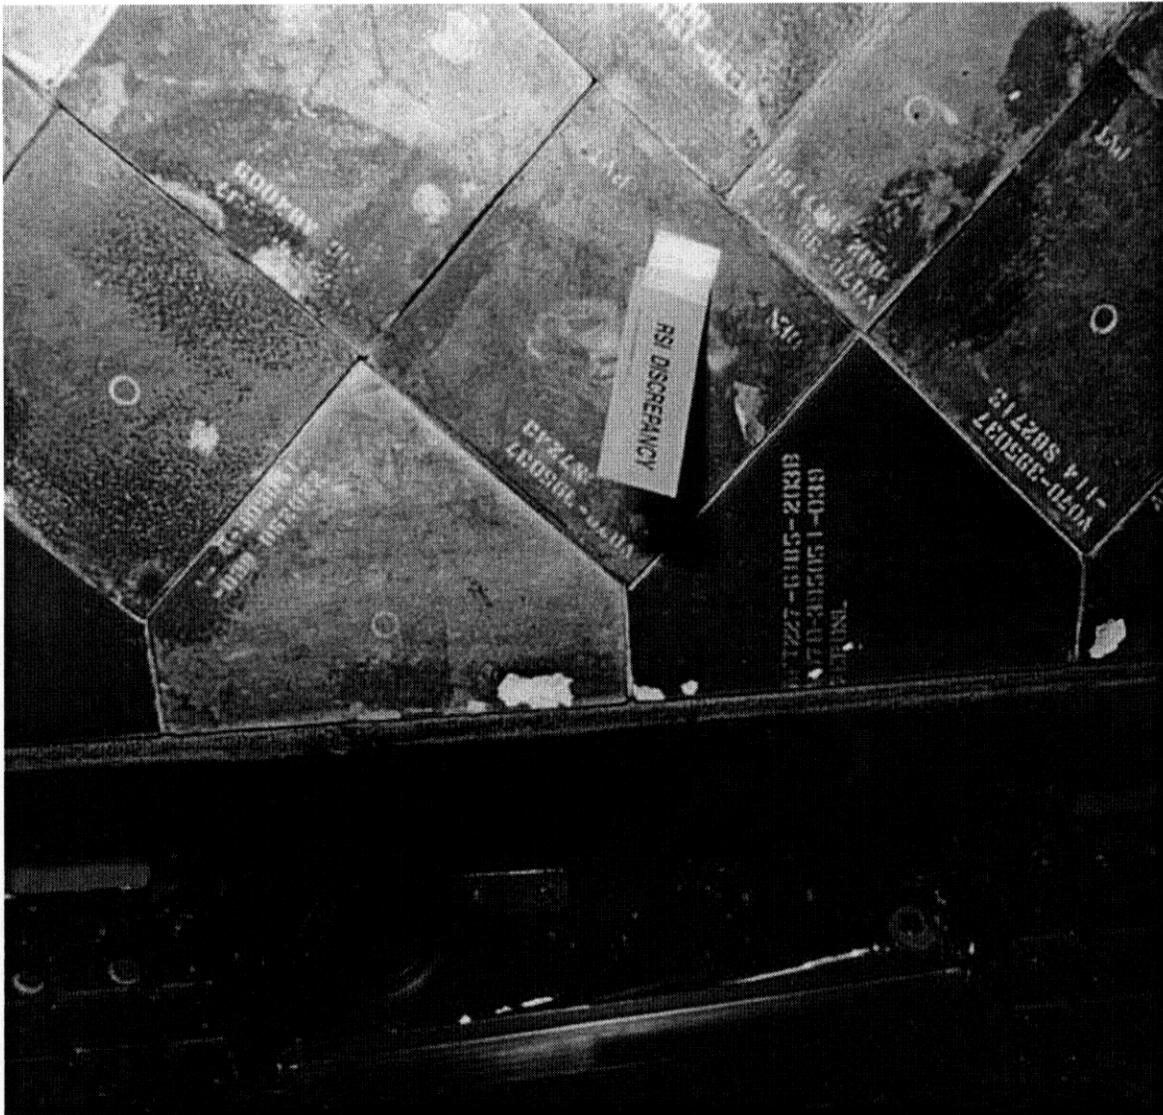
All of the perimeter thermal barriers for both ET doors were removed and replaced during J3 OMM prior to flight 27. Post-flight 27 inspection of the external tank door thermal barriers concluded that three barriers on the right-hand door and two barriers on the left-hand door required replacement due to flight damage or degradation. The forward and aft outboard thermal barriers on the left-hand door were replaced due to outer fabric damage. The forward and aft (small) hinge cover thermal barriers were replaced on the left-hand door due to splits in the outer fabric caused by apparent pinching from the door hinges. Evaluation of the ET doors and door cavity found various minor damages to tile surfaces. All other RSI components were found to be in nominal condition. Refer to table 13 for ET door thermal barrier replacement history and locations, and photo 18 for left-hand ET door tile damages.

*Photo 18. Tile Damages at Left-Hand ET Door Perimeter Structure*

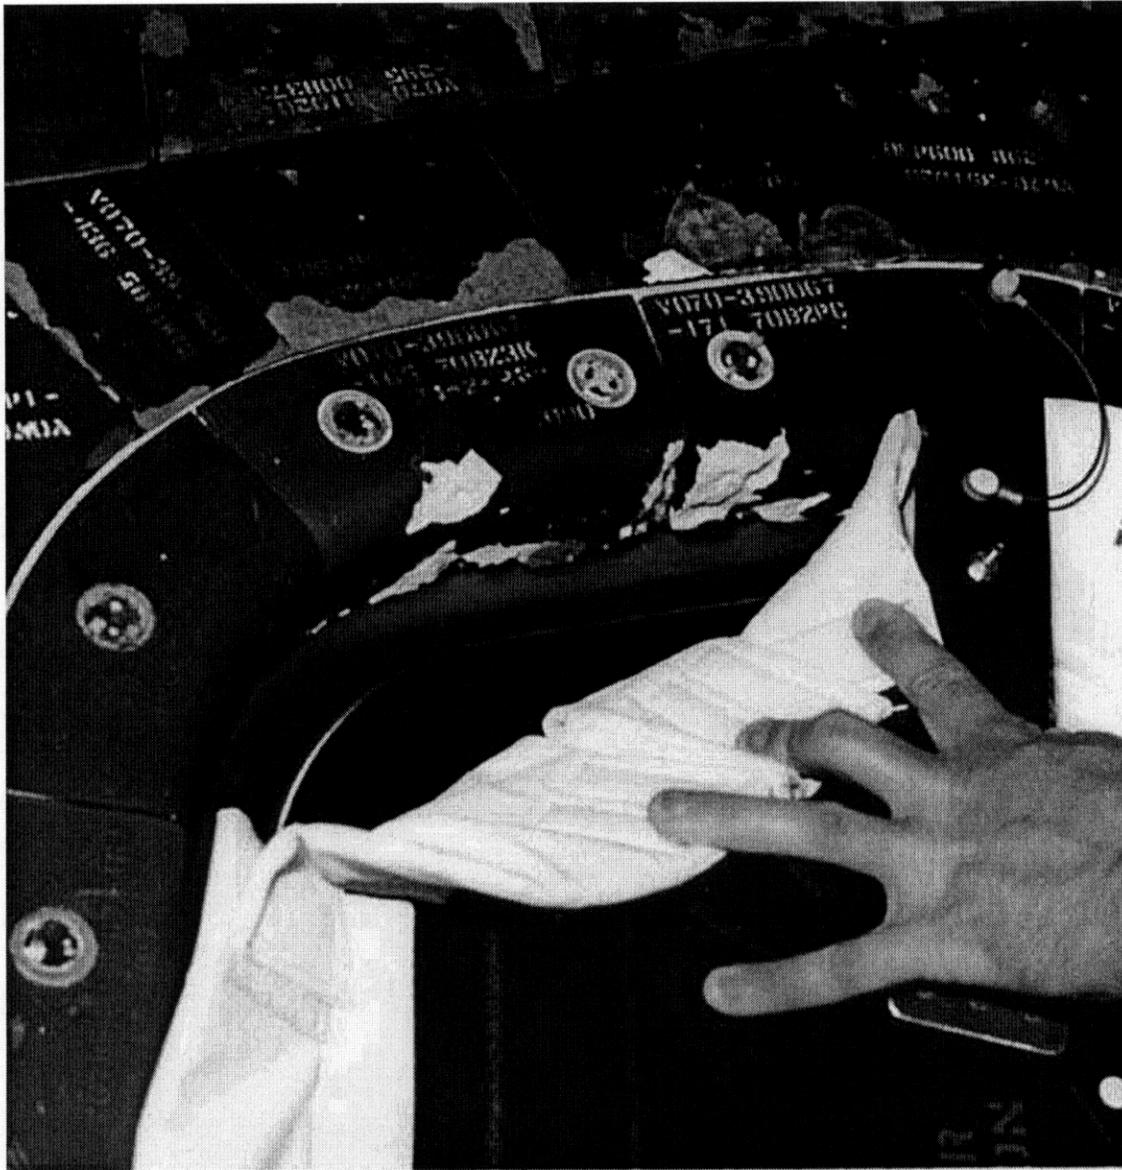
Photo 21. Tile Damages On Window Number 3 Periphery Carrier Panels

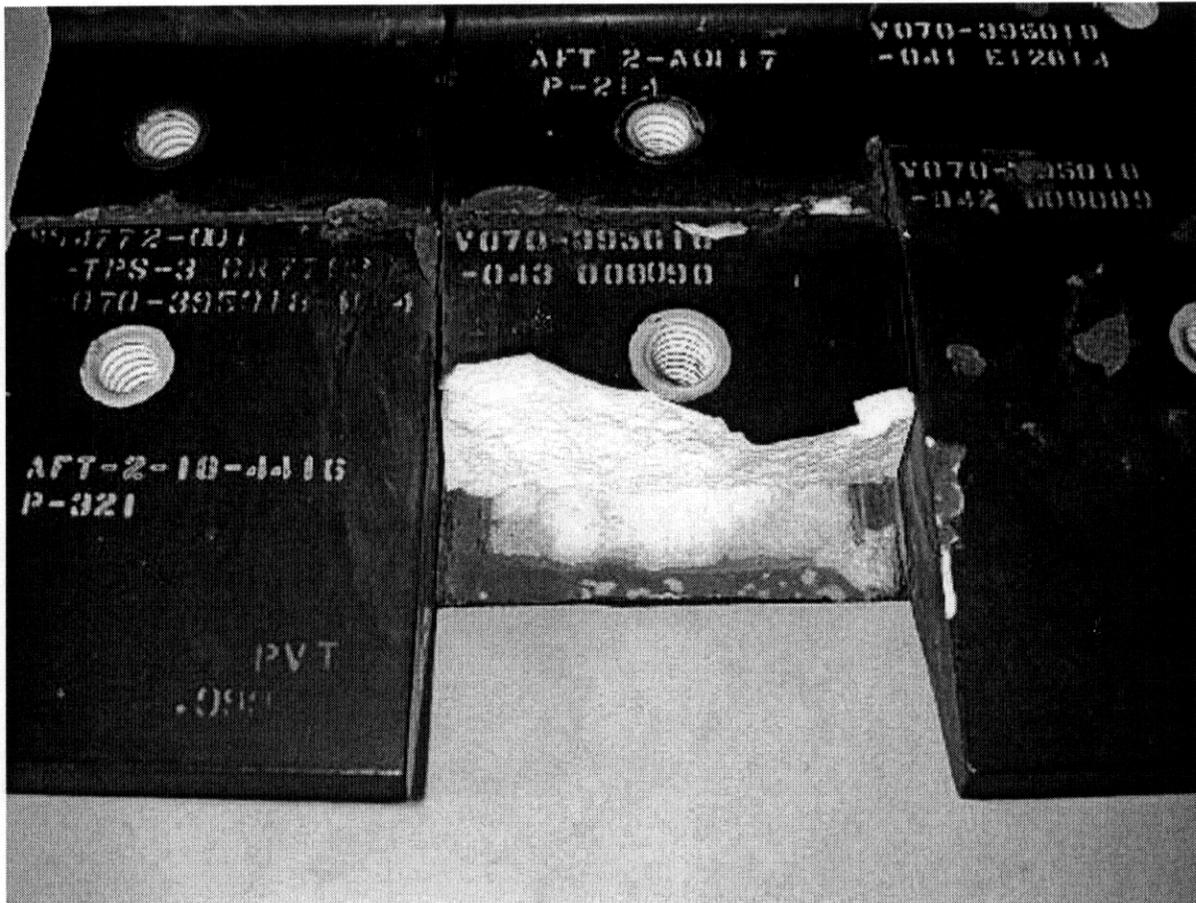
*Photo 23. Tile Damages On Body Flap/Fuselage Stub Carrier Panels*
