NASA-DoD Lead-Free Electronics Project

Automated X-Ray of Circuit Card Assemblies

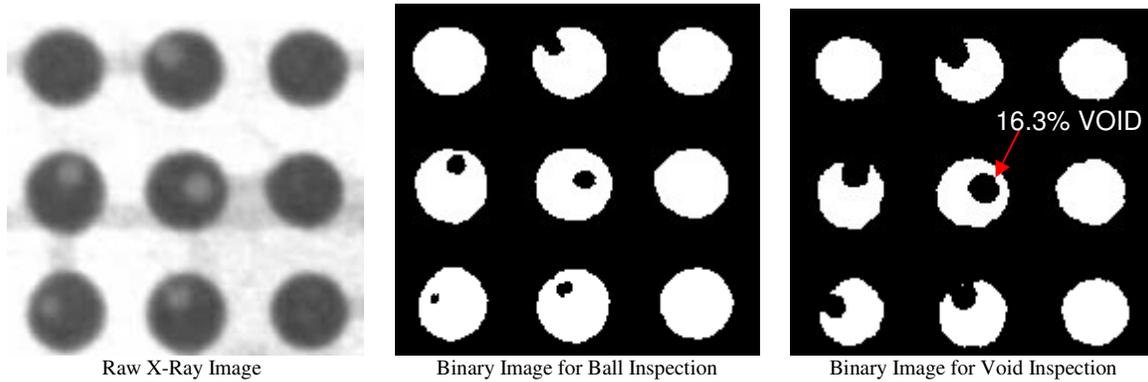
The first image above is the raw x-ray image of part of a BGA. Voids within the solder ball are clearly visible as lighter spots within the joints. The second image is the binary image used to determine the presence, size, and shape of the solder balls. A threshold value has been set (based on the contrast between solder and surrounding areas) for this image such that the resulting shapes in the binary image match the size of the solder balls in the raw x-ray image. The third image is the binary image used to evaluate the presence and size of voids. Because the contrast between the voids and the surrounding solder is different from the contrast between the solder ball and the surrounding area, the threshold level is different, and a different image is created. This threshold value is set such that the resulting voids in the binary image match the size of the voids in the raw x-ray image

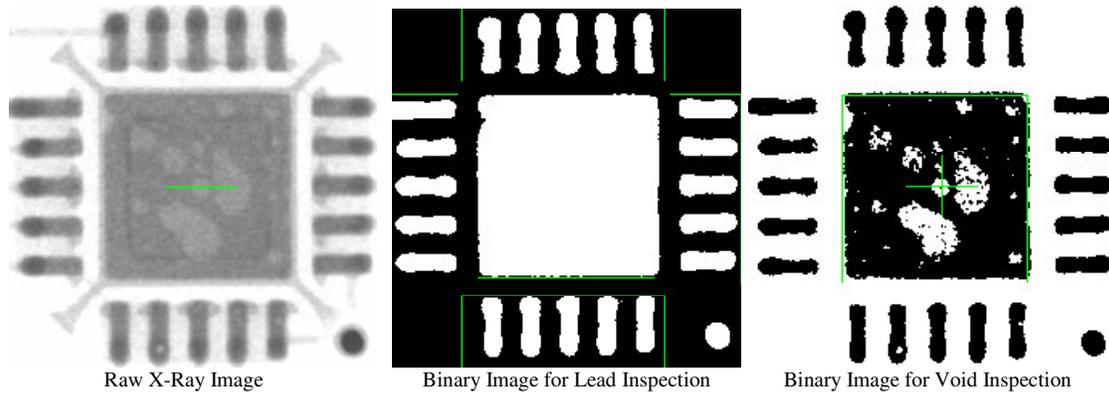
Similar to the BGA inspection, the images below of for QFN x-ray inspection. The first image is the raw x-ray image, the second is the binary image for lead bank inspection, and the third is the binary image for void detection. The combined area of the voids shown in this example was calculated at 16%.

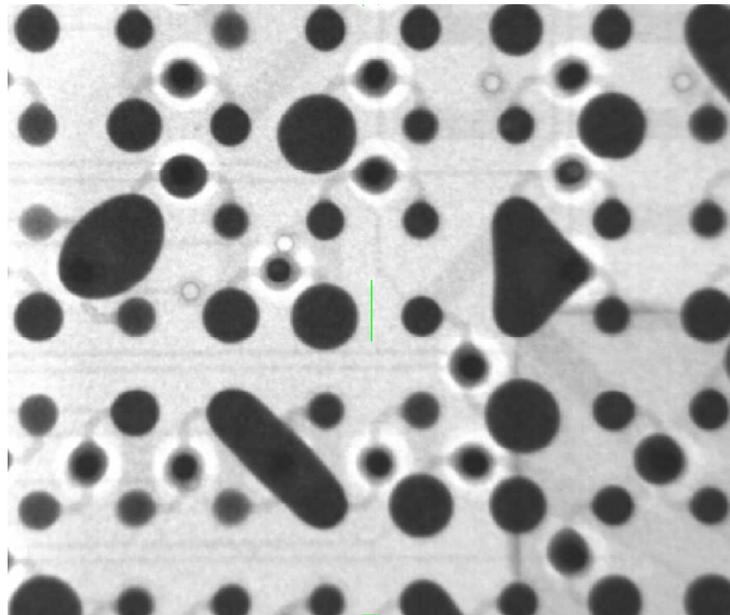
U44 SN 191

Bridging: The only obvious voids identified were on U44 of SN191, where something apparently went wrong:

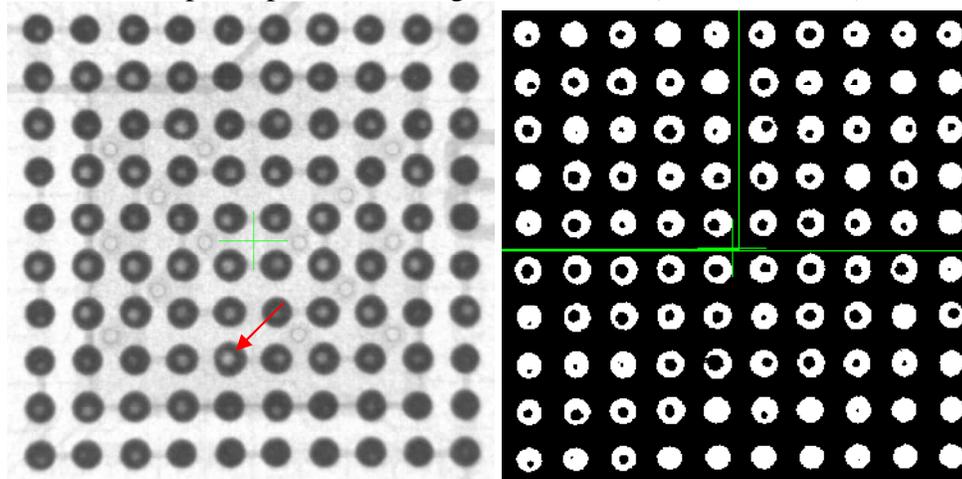
Example of prolific voiding: U63 SN 190 (one void >25%)

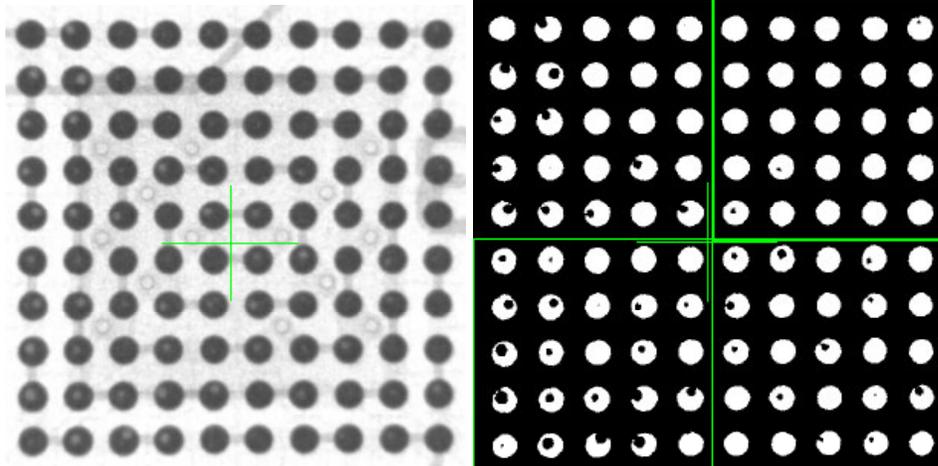
SN 138 exhibits the most voiding (none >25%):

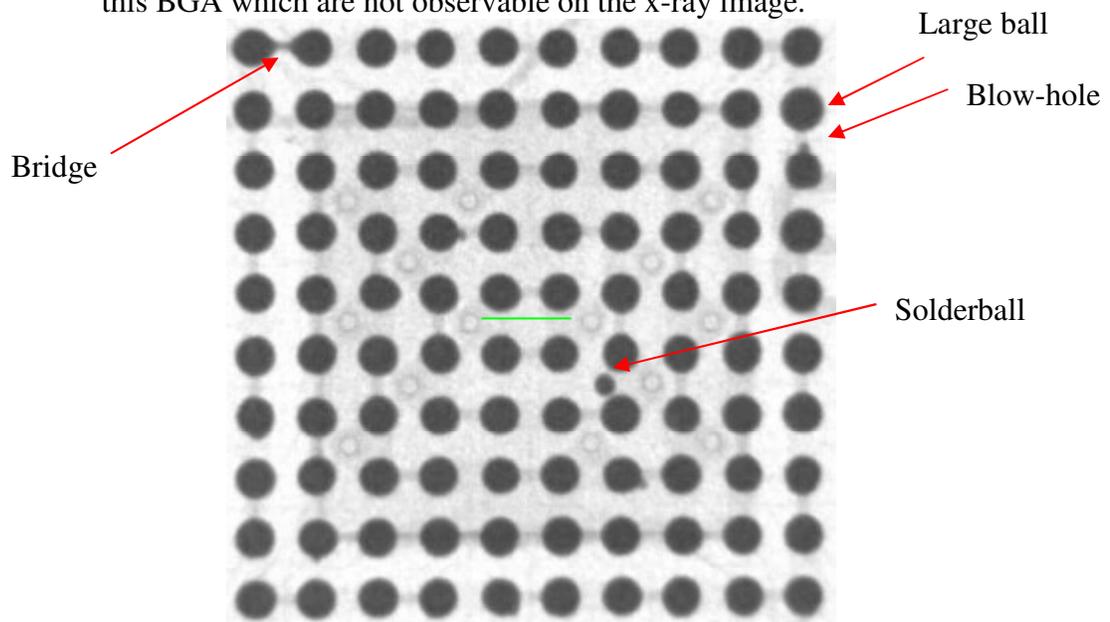
Other: SN 1, U63 has a solder ball (extra) violating minimum electrical clearance(?), a solder ball larger than normal (not excessive), a blow-hole on a ball, and a bridge. There were also several small solderballs under this BGA which are not observable on the x-ray image.

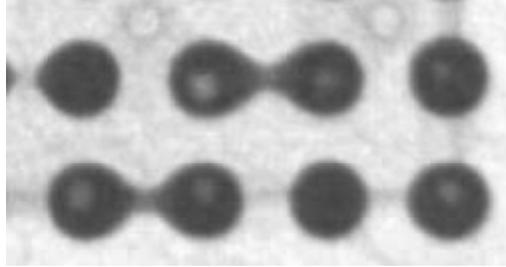
Bridging: One board had bridging on one component (bridges appear to be along the metallization of the component)
