ENVIRONMENTAL EXPOSURE OF JG-PP/JCAA TEST PWAS

Prepared On: January 31, 2005

By: American Competitiveness Institute
One International Plaza; Suite 600
Philadelphia, Pennsylvania 19113

Environmental Exposure of JG-PP/JCAA Test PWAs

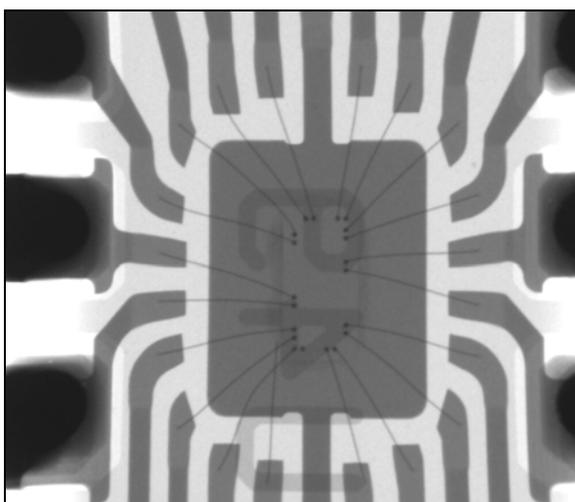
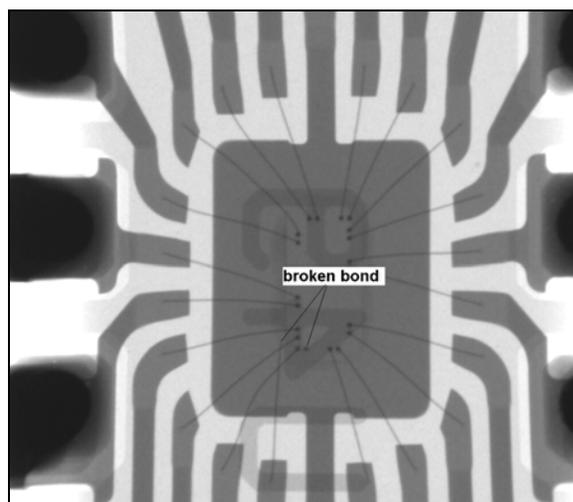
Board 38: Component U49

- There was an open found between the ninth and tenth pins on the component. Those two pins were supposed to be shorted within the component.
- The open circuit was caused by a broken bond within the chip. This can be seen in the X-ray images (Figures 3 and 4).

ACI does not believe that this failure was caused by the humidity test. It is a packaging failure.

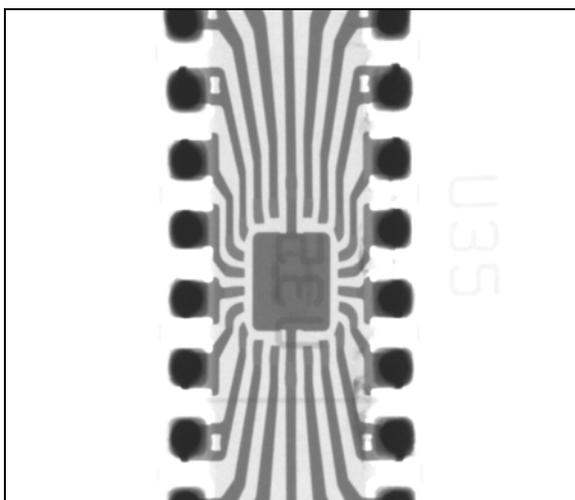
Figure 5.

- Component U35 showed open circuits where the component leads were supposed to be in series (daisy chained). X-ray analysis of this component revealed die with no internal wire bonds to the lead frame. Figure 5 is an X-ray image of the component showing no internal wire bonds. Figure 6 is the same component on board number 105 showing wire bonds properly attached to the die.

The missing leads are attributed to a packaging failure.

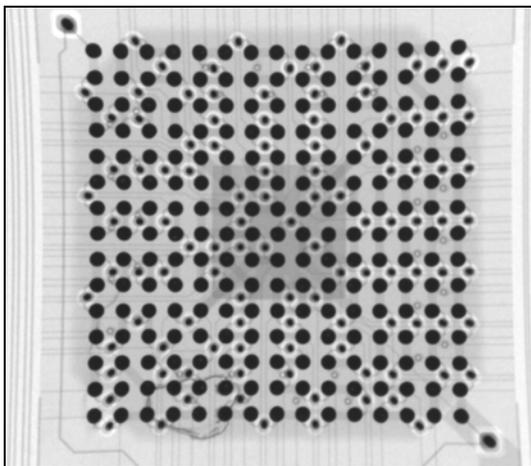
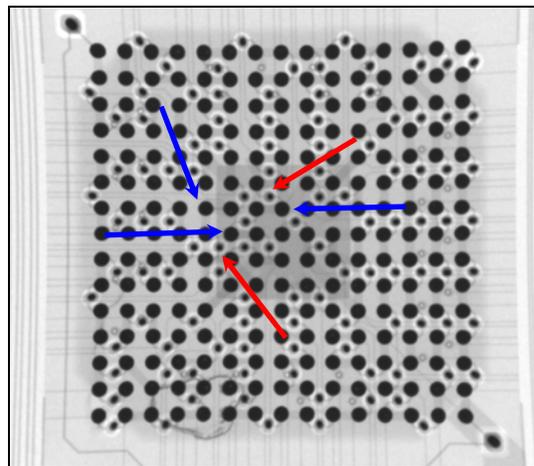
Board 104: Component U56

- Continuity testing prior to and after the salt atmosphere exposure showed that there was an open circuit within the component (Figure 7). The location of the open circuit was identified between the two via locations marked with red arrows on Figure 8. The two should be electrically connected through the 3 BGA balls marked with blue arrows in Figure 8. Figure 9 is an image of the questionable area of component U56. ACI observed solder joint voiding, which may contribute to the open circuit. Figure 10 is an image of U55, a properly working component of the same model on the same board. Voiding was within specification, per IPC-A-610C, Section 12.2.12. There are significantly less voids in the solder in this component than on U56. Solder voids are a function of the reflow soldering manufacturing process and not a result from the salt atmosphere testing.

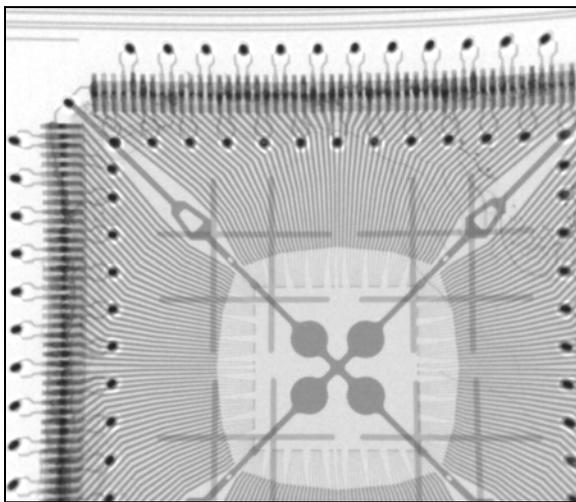
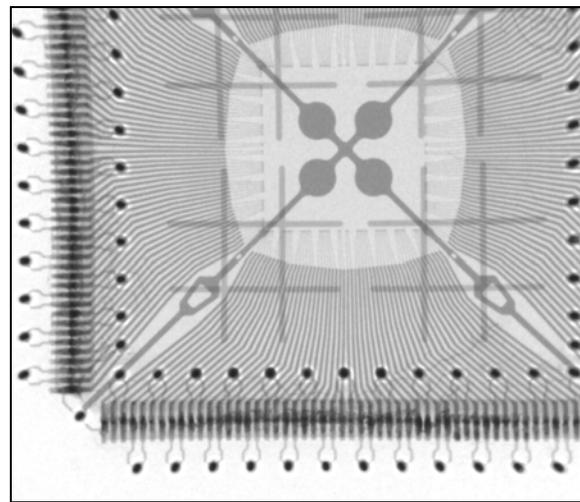
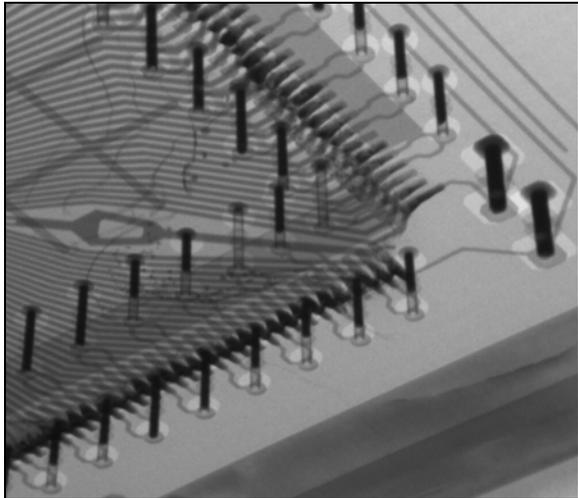
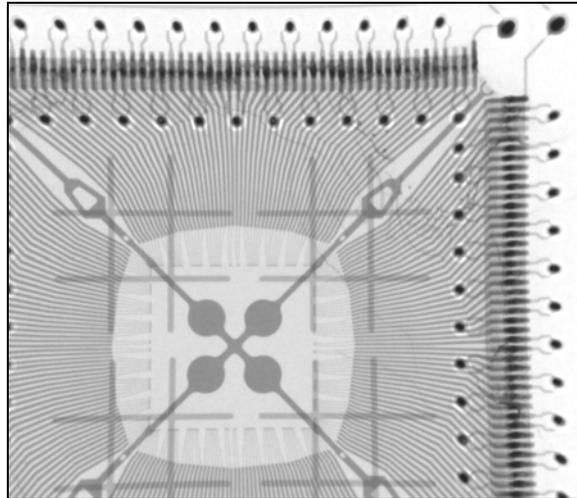
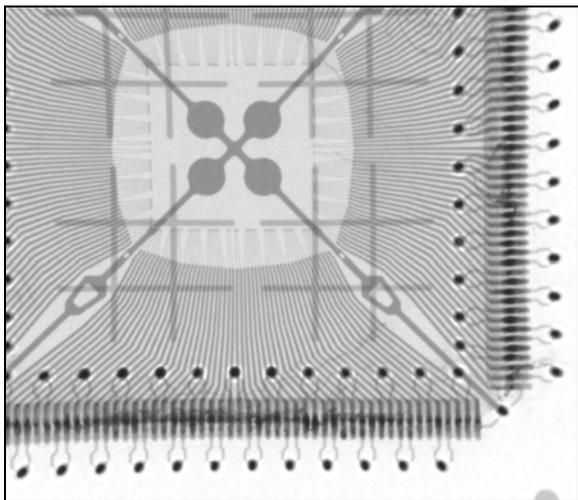
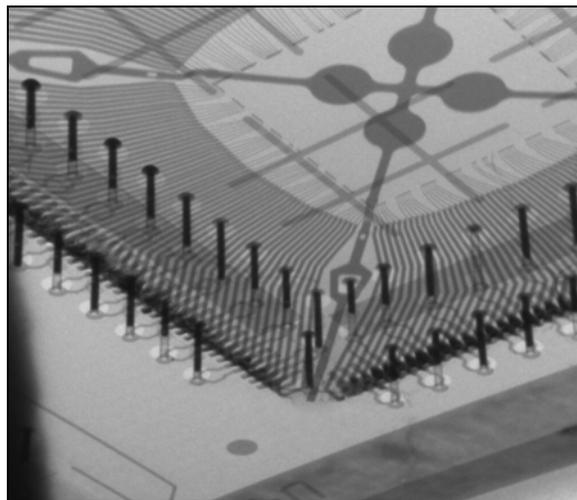
Board 105: Component U3

- There was a resistance reading of 70.6 Ohms across the terminals of the component indicating an improperly wired component.
- The X-ray images show what could be solder thickness issues of the legs on the board as they seem to change throughout the whole part.
 - Figure 11: (60kV 50 μ A) Board 105 debris U3 bottom left corner top down
 - Figure 12: (60kV 50 μ A) Board 105 debris U3 bottom right corner top down
 - Figure 13: (60kV 50 μ A 45° + rotation 55° Oblique) Board 105 debris U3 pin 1
 - Figure 14: (60kV 50 μ A) Board 105 debris U3 pin 1
 - Figure 15: (60kV 50 μ A) Board 105 debris U3 upper right corner top down
 - Figure 16: (60kV 50 μ A 45° + rotation 55° Oblique) Board 105 debris U3 upper right corner
 - Figure 17: (60kV 50 μ A 45° + rotation 55° Oblique) Board 105 debris U3

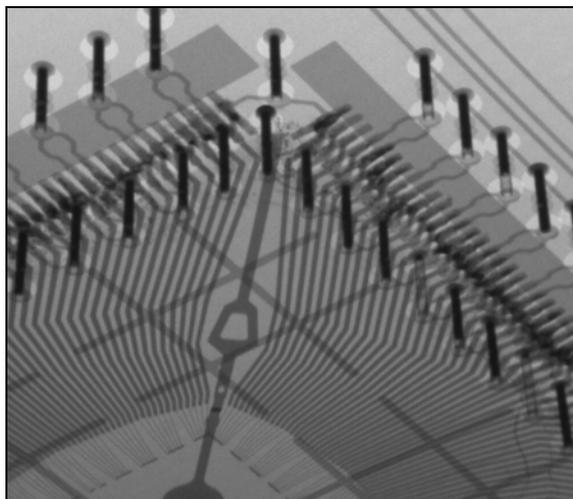
Figure 17. Board 105 debris U3

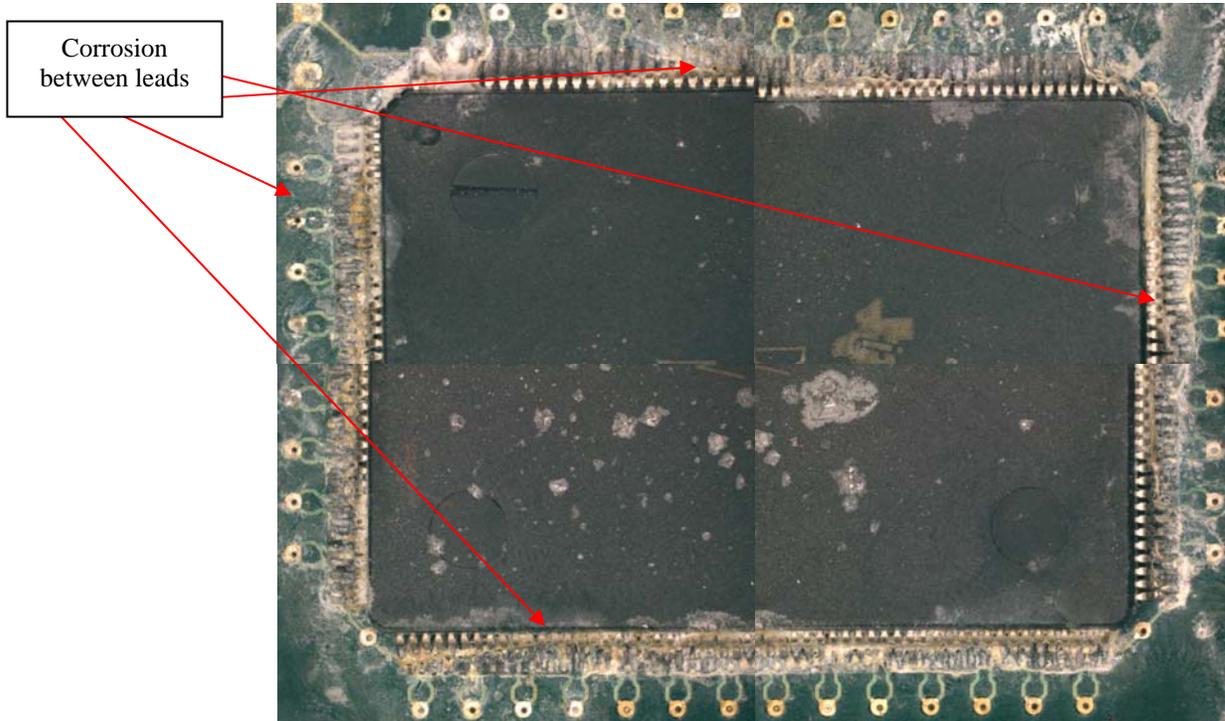
Figure 18. Optical image of QFP U3 from board 105 at 7X.

Corrosion of nearby traces or underlying balls

Visual inspection of failed salt atmosphere components exhibited corrosion between the leads. This level of corrosion was consistent between all boards and components.

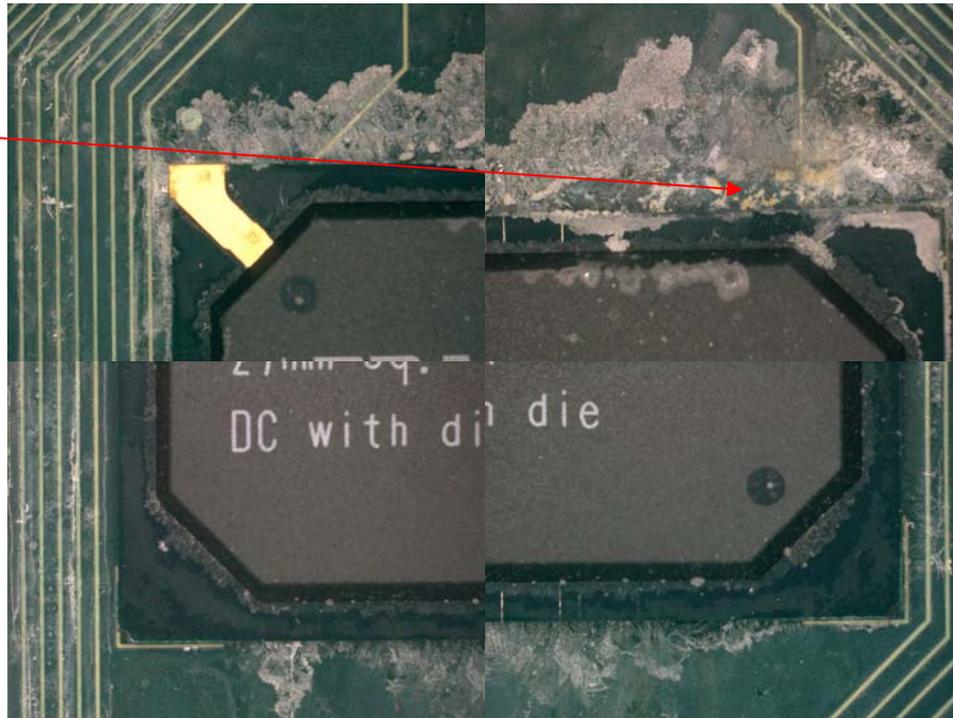
Figure 19 Optical image of BGA U56 from board 104 at 7X.

Corrosion between leads

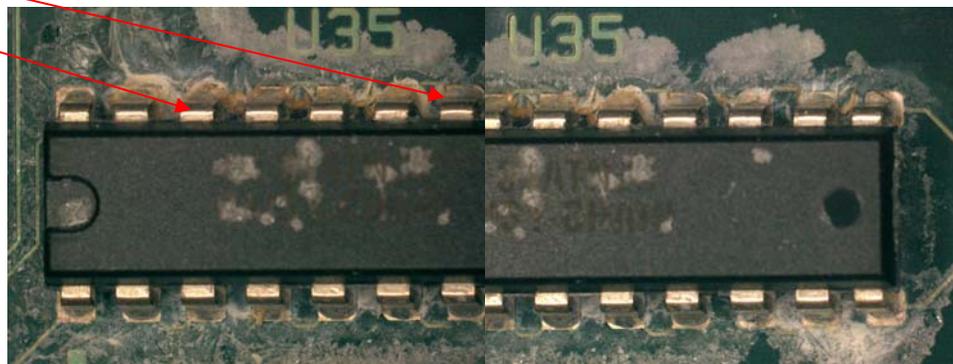
Figure 20 Optical image of SOIC U35 from board 104 at 7X.

The goal of this test is to determine if hardware can survive in a corrosive salt atmosphere, simulating exposure effects from a seacoast environment. Corrosion will appear on all unprotected surfaces. As indicated, all salt atmosphere failures were attributed to electronic packaging failures or wiring defects. None were attributed to exposure to a corrosive environment.

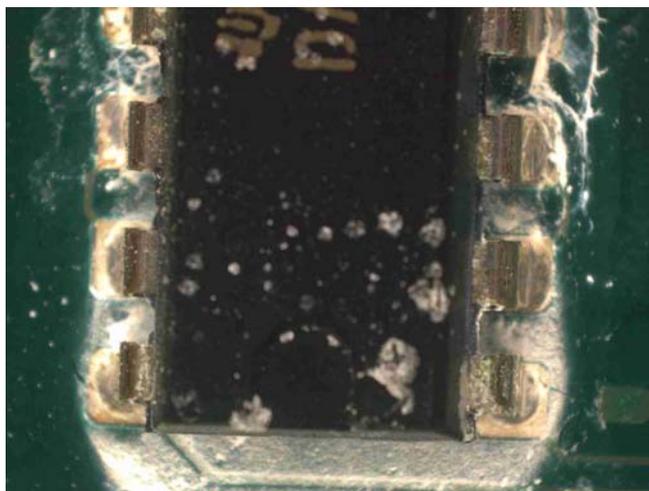
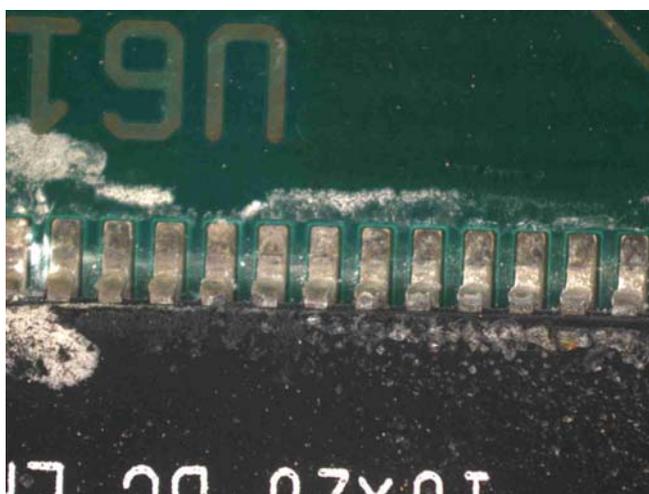
In performing a visual inspection, there was no difference between the Tin Lead (SnPb) solder joints and the Tin Silver Copper (SnAgCu), Tin Silver Copper Bismuth (SnAgCuBi), and the Tin Copper (SnCu) Lead Free solder joints. This corresponds to the continuity test results which indicated that all failures were attributed to electronic packaging failures and not the Salt Atmosphere tests.
