**Network Centric Systems  
Raytheon Company  
McKinney, TX 75071**

**EER-2006-34171-002  
Engineering Evaluation Report**

# **JCAA/JG-PP LEAD-FREE SOLDER PROJECT: FAILURE ANALYSIS OF TEST VEHICLES SUBJECTED TO COMBINED ENVIRONMENTS TEST**

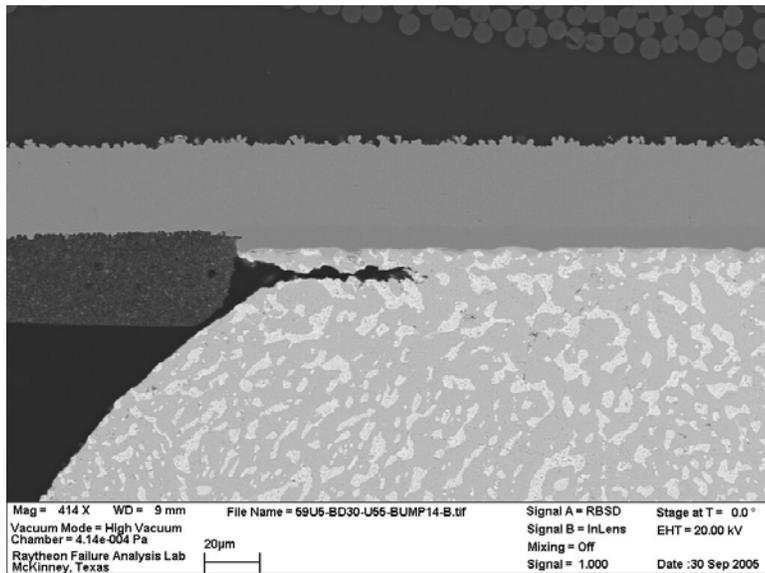
**Figure 6** SEM Micrograph of SnPb Soldered SnPb BGA-225 on Manufactured Test Vehicle (SN 30, U55, Bump 14) Minor cracking is present in the solder. There is again some evidence of work hardening in the solder. The cracks identified in the BGA samples do not extend all the way through the solder.

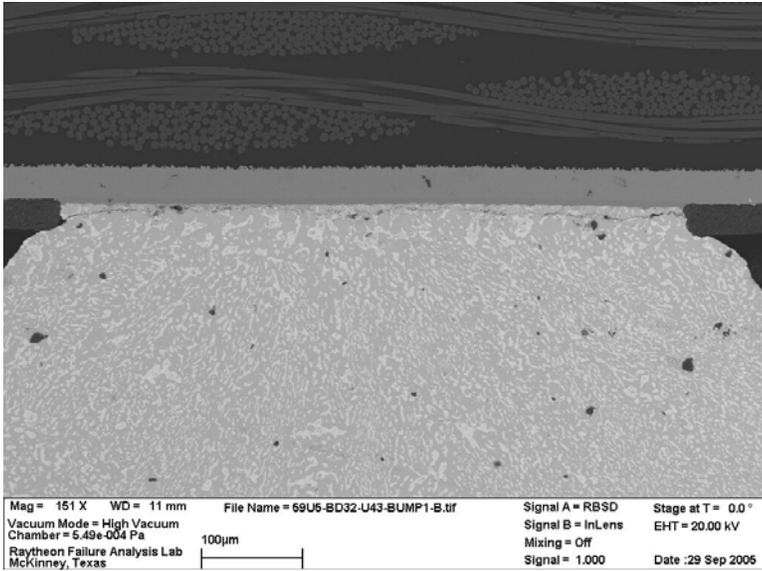
**Figure 7** SEM Micrograph of SnPb Soldered SnPb BGA-225 on Manufactured Test Vehicle (SN 32 U43, Bump 1) Crack through the solder near the component interface.

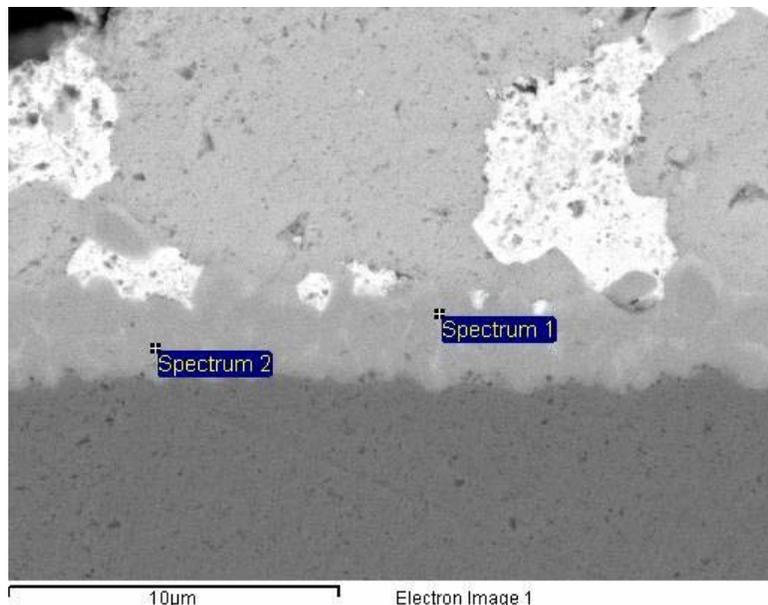
**Figure 11** SEM Micrograph of SnPb Soldered SnPb CLCC-20 on Manufactured Test Vehicle (SN 31, U22, Lead 1) Solder to board interface, the IMC is CuSn, however some phases of AuSn are also present.

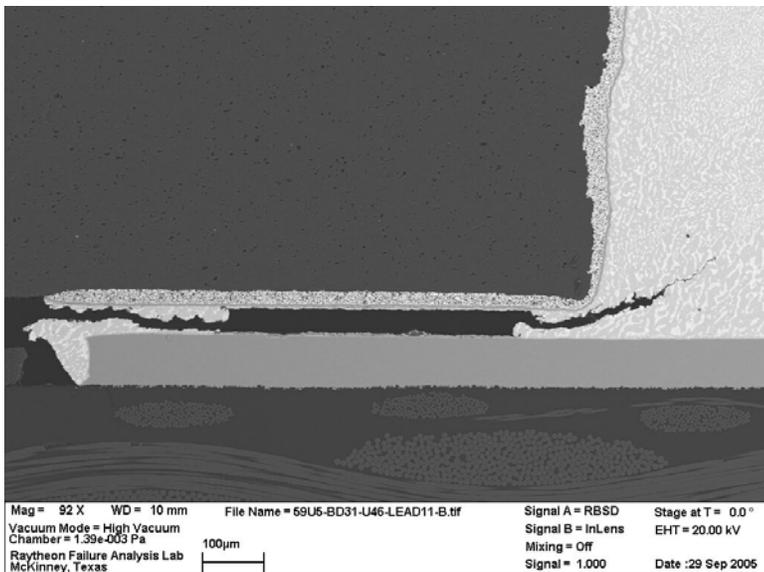
**Figure 15** SEM Micrograph of SnPb Soldered SnPb CLCC-20 on Manufactured Test Vehicle (SN 31, U46, Lead 11) Crack does not extend through the solder joint. There appears to be some voiding in the solder below the component.

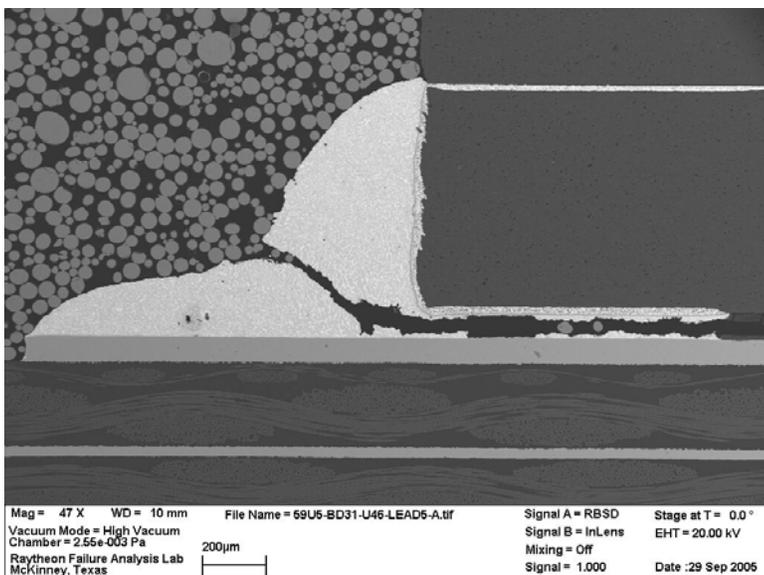
**Figure 16** SEM Micrograph of SnPb Soldered SnPb CLCC-20 on Manufactured Test Vehicle (SN 31, U46, Lead 5) Cracks propagate through entire joint.

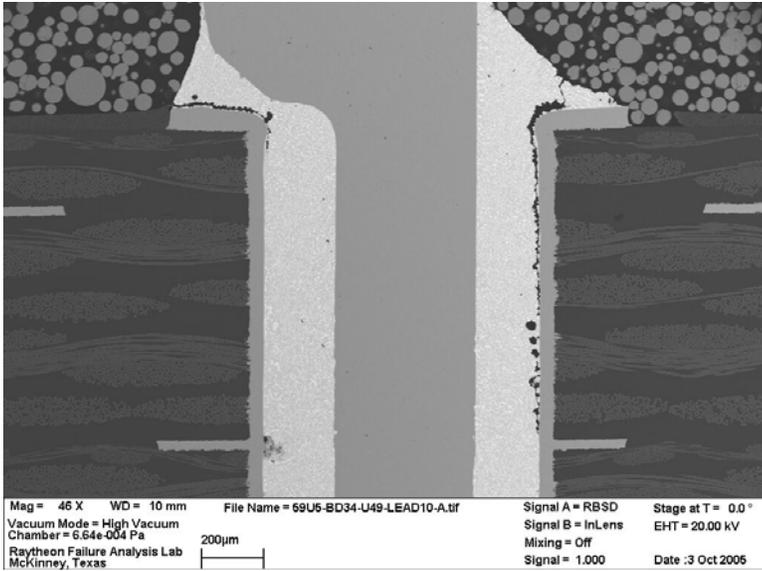
**Figure 20** SEM Micrograph of SnPb Soldered Sn PDIP-20 on Manufactured Test Vehicle (SN 34, U49, Lead 10) The cracks in the solder are near the board feedthrough interface.

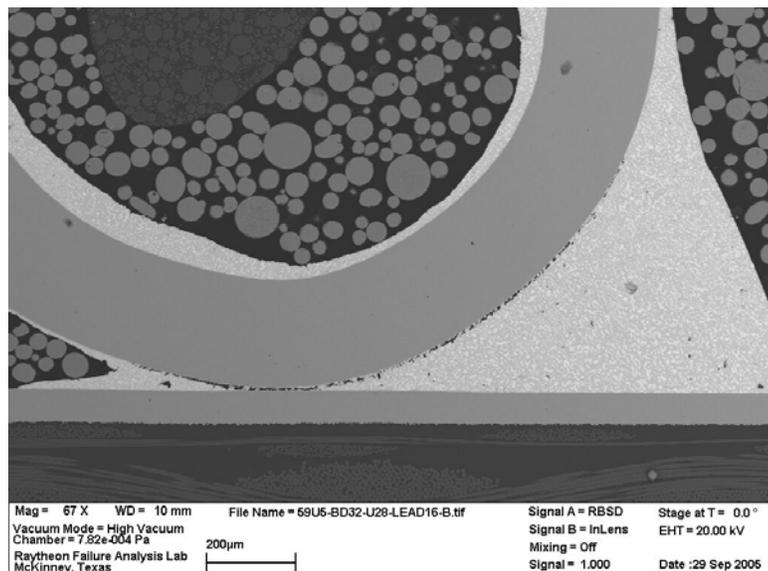
**Figure 22** SEM Micrograph of SnPb Soldered Sn PLCC-20 on Manufactured Test Vehicle (SN 32, U28, Lead 16) Crack in solder near the lead interface extends about  $\frac{3}{4}$  of the way through the joint, also a small crack near outer edge of fillet.

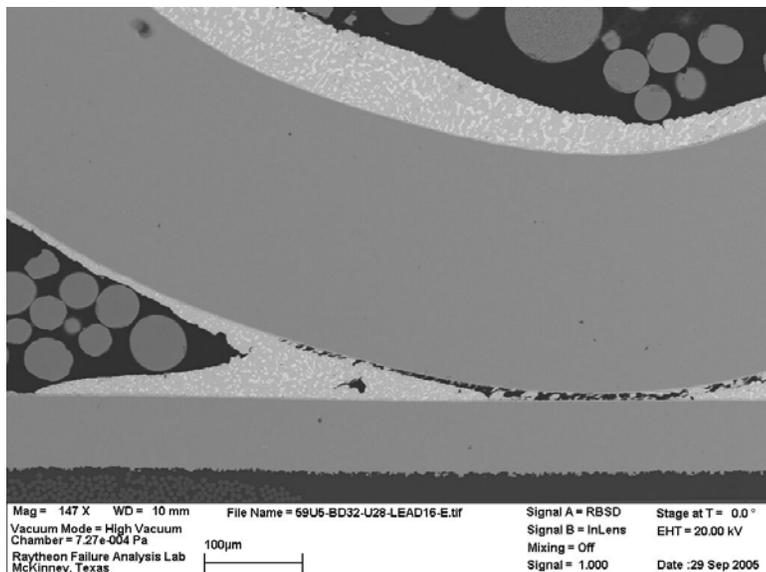
**Figure 23** SEM Micrograph of SnPb Soldered Sn PLCC-20 on Manufactured Test Vehicle (SN 32, U28, Lead 16) Closer view of crack near the lead interface.

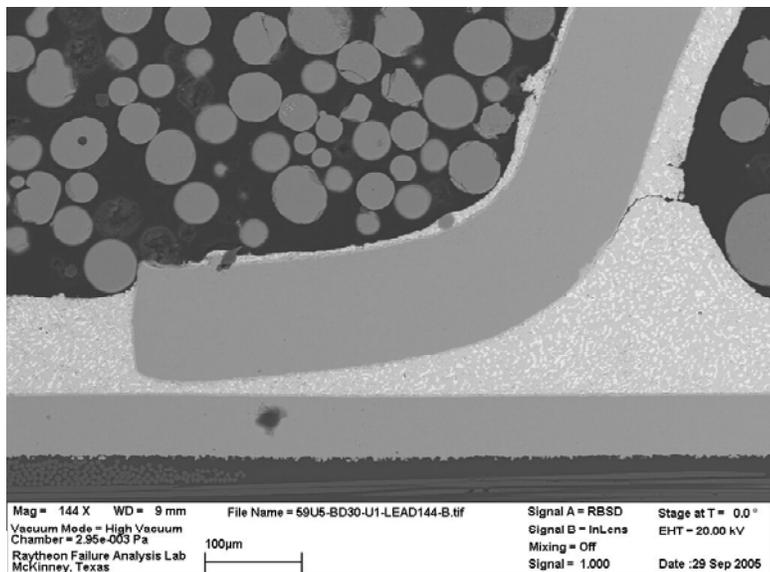
**Figure 24** SEM Micrograph of SnPb Soldered Sn TQFP-144 on Manufactured Test Vehicle (SN 30, U1, Lead 144) Cracking is present in the solder joint. The joint is not cracked all the way through the solder. See the EDS data in Figure 28 and Figure 29 providing elemental analysis information on this solder joint metallurgy.

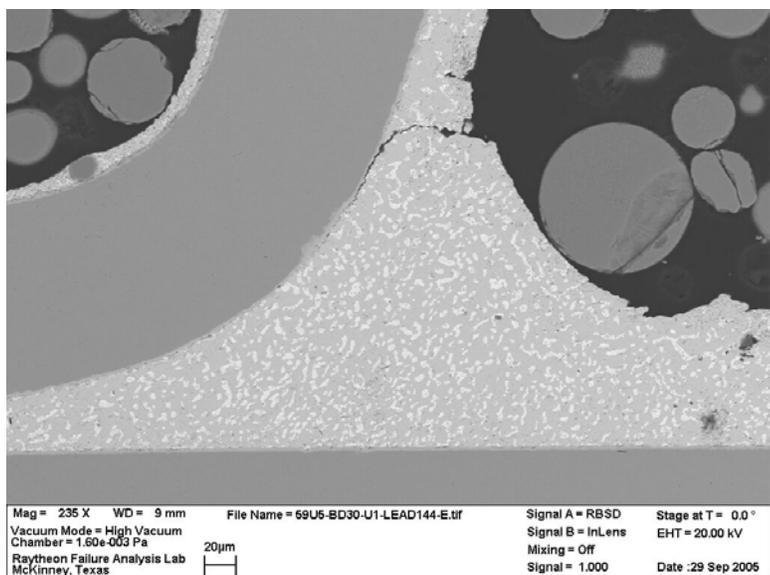
**Figure 25** SEM Micrograph of SnPb Soldered Sn TQFP-144 on Manufactured Test Vehicle (SN 30, U1, Lead 144) Heel region showing the partial solder crack.

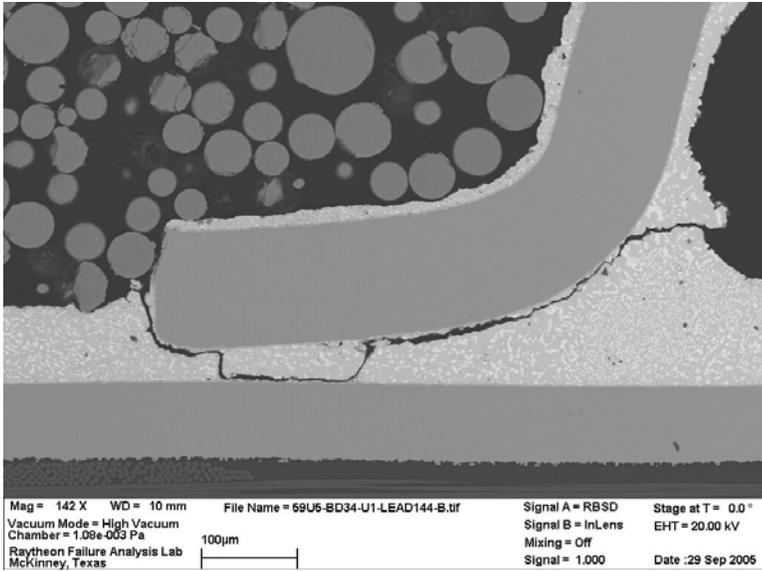
**Figure 26** SEM Micrograph of SnPb Soldered Sn TQFP-144 on Manufactured Test Vehicle (SN 34, U1, Lead 144) The solder joint is cracked through the solder.

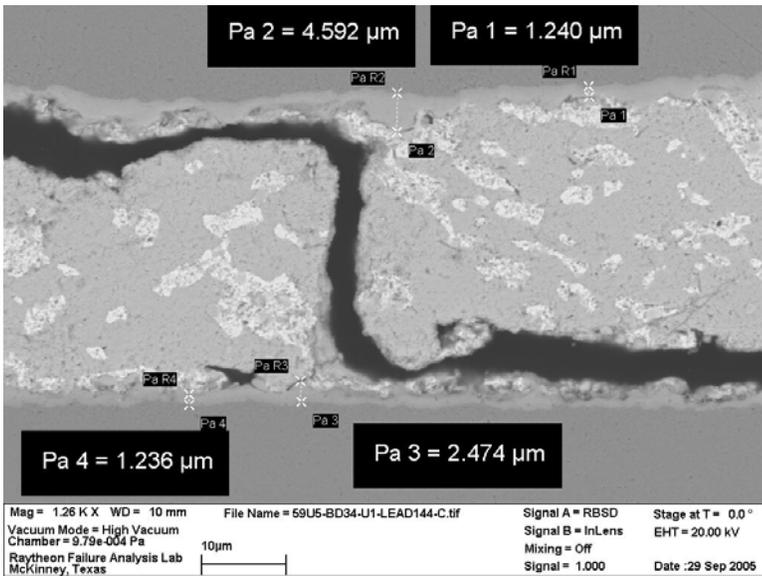
**Figure 27** SEM Micrograph of SnPb Soldered Sn TQFP-144 on Manufactured Test Vehicle (SN 34, U1, Lead 144) Intermetallic measurements at the component lead and board pad interfaces. The crack is through the solder not the intermetallic layer.

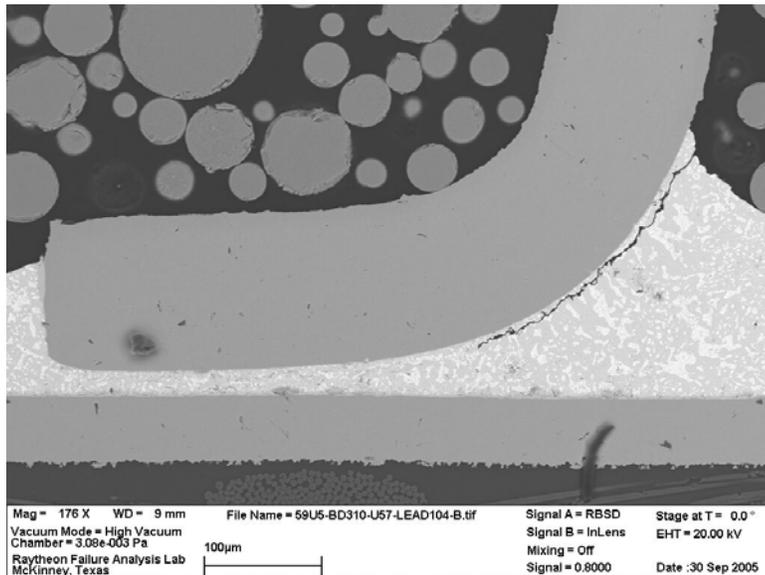
**Figure 30** SEM Micrograph of SnPb Soldered AuPdNi TQFP-208 on Manufactured Test Vehicle (SN 30, U57, Lead 104) A crack extends about one third of the way across the solder joint. Lead 157 is similar in appearance.

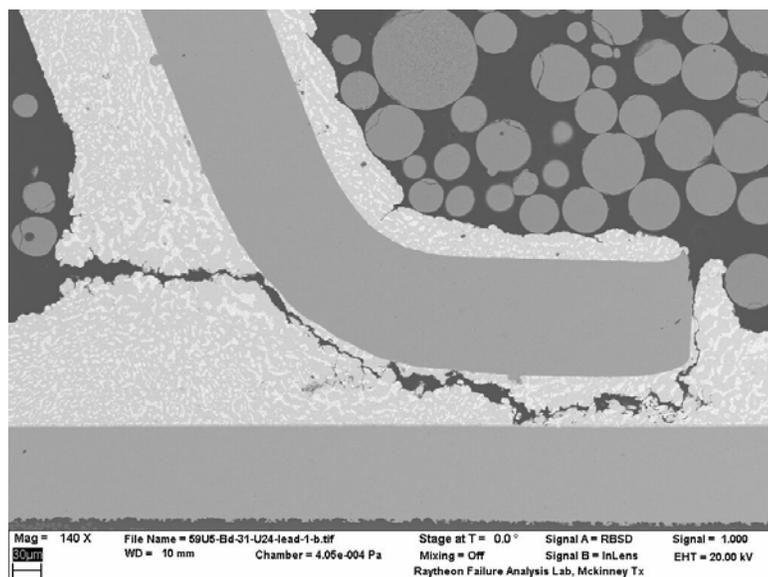
**Figure 31** SEM Micrograph of SnPb Soldered SnPb TSOP-50 on Manufactured Test Vehicle (SN 31, U24, Lead 1) Crack propagates all the way through the joint.

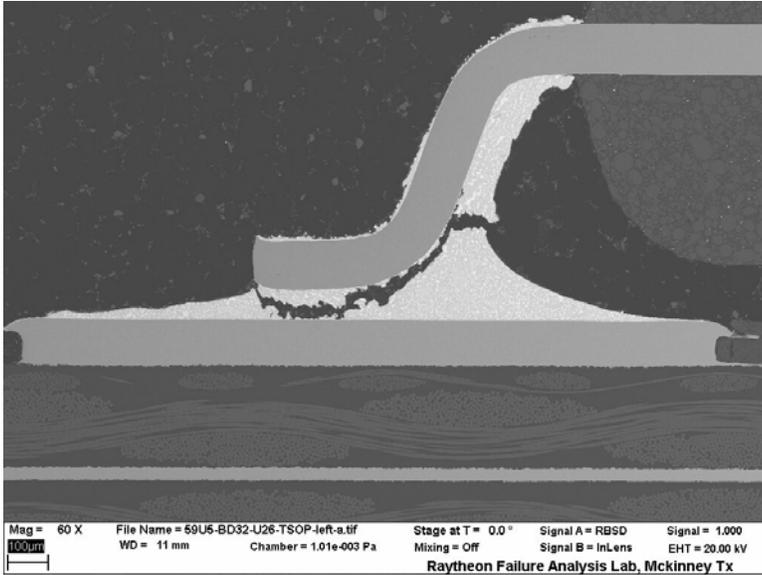
**Figure 32** SEM Micrograph of SnPb Soldered SnPb TSOP-50 on Manufactured Test Vehicle (SN 32 U26, left side) Solder is fractured all the way through.

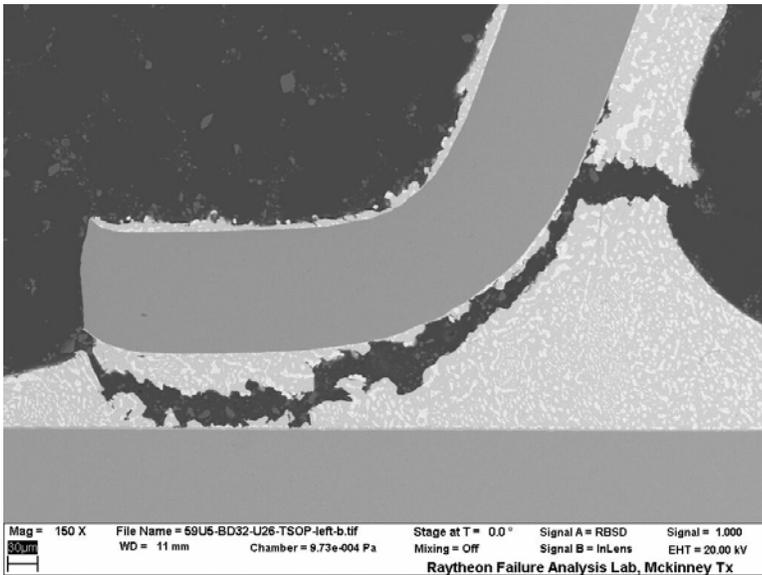
**Figure 33** SEM Micrograph of SnPb Soldered SnPb TSOP-50 on Manufactured Test Vehicle (SN 32 U26, left side) Solder is fractured all the way through.

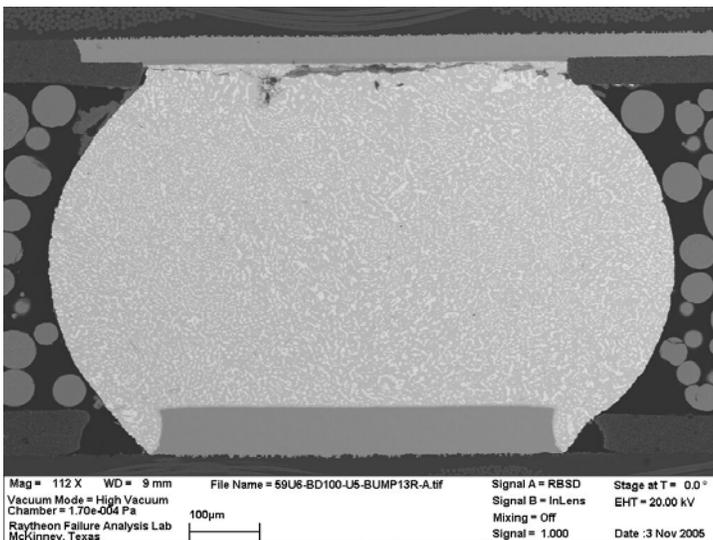
**Figure 36** SEM Micrograph of SnAgCu Soldered SnPb BGA-225 on Manufactured Test Vehicle (SN 100, U5, Bump 15R) Crack extends all the way through the solder joint at the component side of the joint.

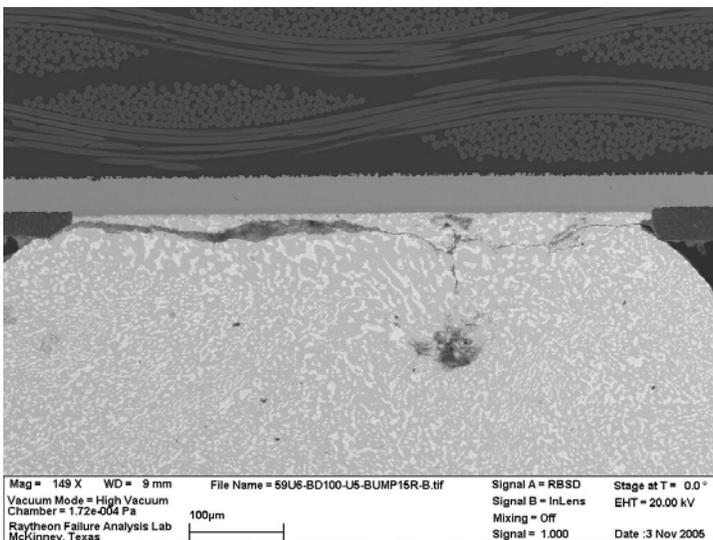
**Figure 37** SEM Micrograph of SnAgCu Soldered SnPb BGA-225 on Manufactured Test Vehicle (SN 100, U5, Bump 15R) Closer view of the crack through the solder joint at the component side of the joint.

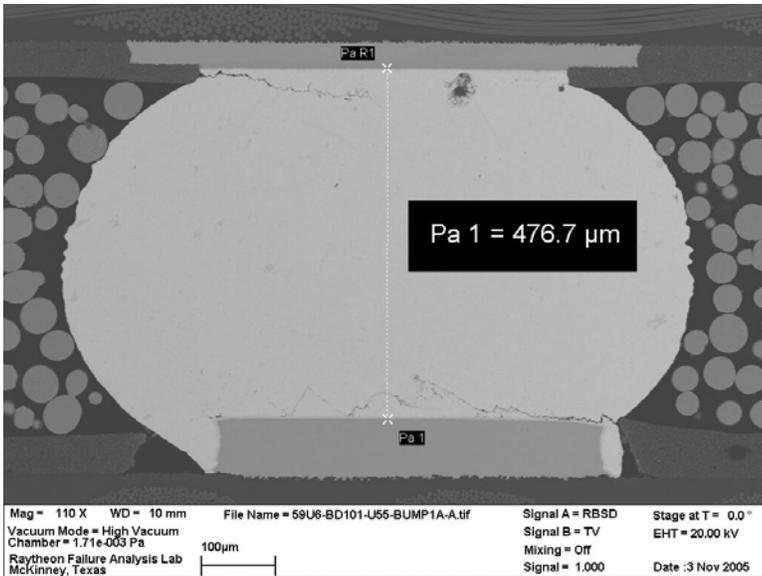
**Figure 38** SEM Micrograph of SnAgCu Soldered SnAgCu BGA-225 on Manufactured Test Vehicle (SN 101, U55, Bump 1A) Crack at component interface extends about ½ way through joint. Crack at PWB interface almost completely through.

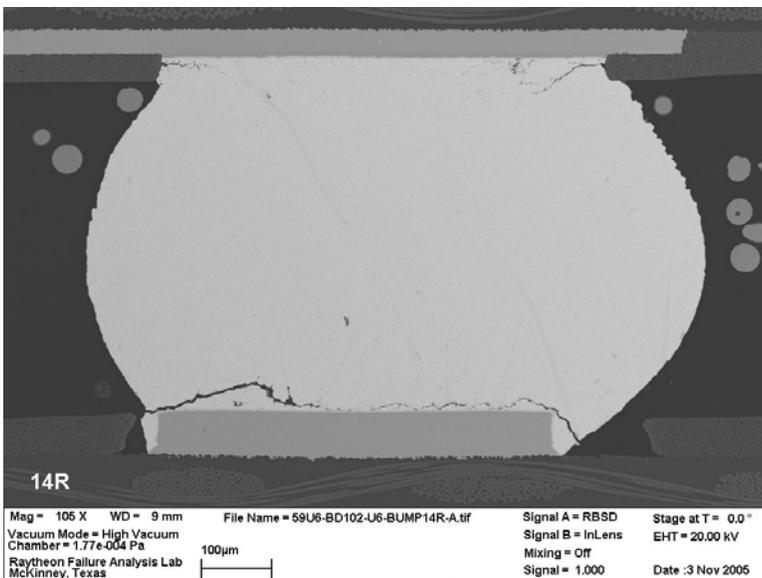
**Figure 39** SEM Micrograph of SnAgCu Soldered SnAgCu BGA-225 on Manufactured Test Vehicle (SN Board 102, U6, Bump 14R) Solder bump is cracked all the way through the solder at the board side interface. Partial cracks are present at the component side interface.

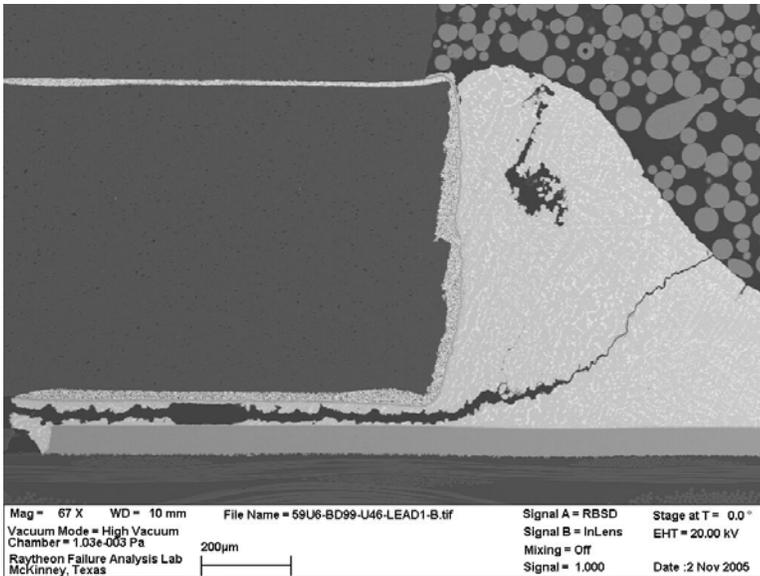
**Figure 41** SEM Micrograph of SnAgCu Soldered SnPb CLCC-20 on Manufactured Test Vehicle (SN 99, U46, Lead 1) Crack extends completely through joint. Voids are present below component and in bulk solder.

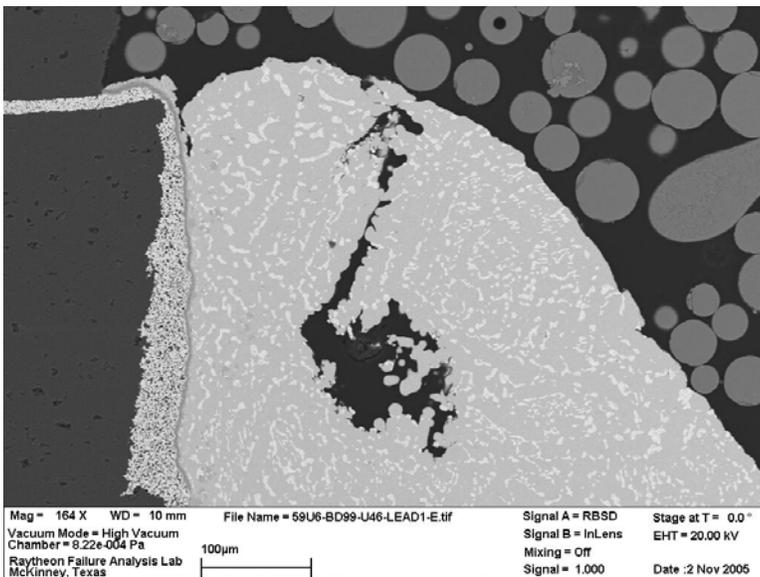
**Figure 42** SEM Micrograph of SnAgCu Soldered SnPb CLCC-20 on Manufactured Test Vehicle (SN 99, U46, Lead 1) The CLCC-20 device U46 on board SN 99 should have a tin-lead finish and tin-silver-copper solder joint. In this high magnification view, the appearance of the solder resembles tin-lead solder. The image was taken in backscatter mode, which indicates atomic number information. The bright phases are lead-rich phases and the medium gray phases are the tin-rich phases. This could indicate a good mix between the tin-silver-copper solder and the tin-lead finish on the component. However, there appears to be a lot of lead present to be solely from the tinned finish.

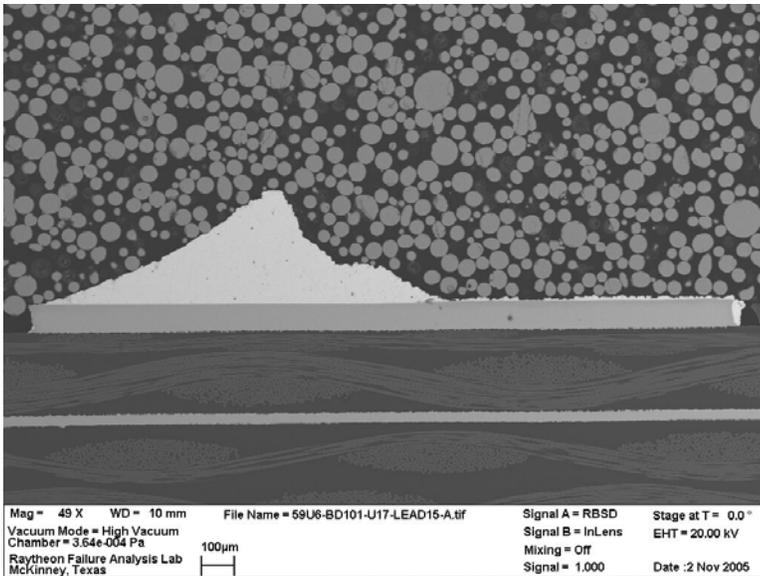
**Figure 43** SEM Micrograph of SnAgCu Soldered SnAgCu CLCC-20 on Manufactured Test Vehicle (SN 101, U17, Lead 15) Component missing as a result of the fractured solder joint.

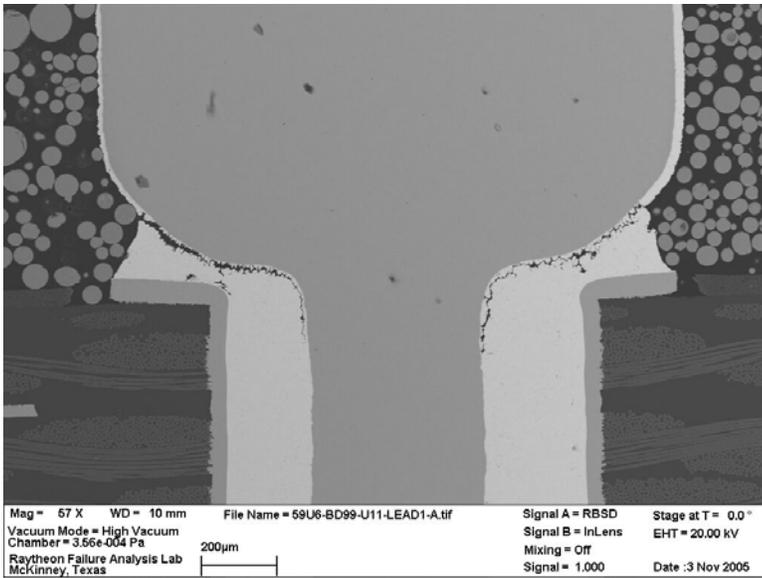
**Figure 44** SEM Micrograph of SnAgCu Soldered Sn PDIP-20 on Manufactured Test Vehicle (SN 99, U11, Lead 1) Cracks in solder on both sides of lead near lead interface. EDS data in Figure 46 and Figure 47 provide the metallurgical solder joint data.

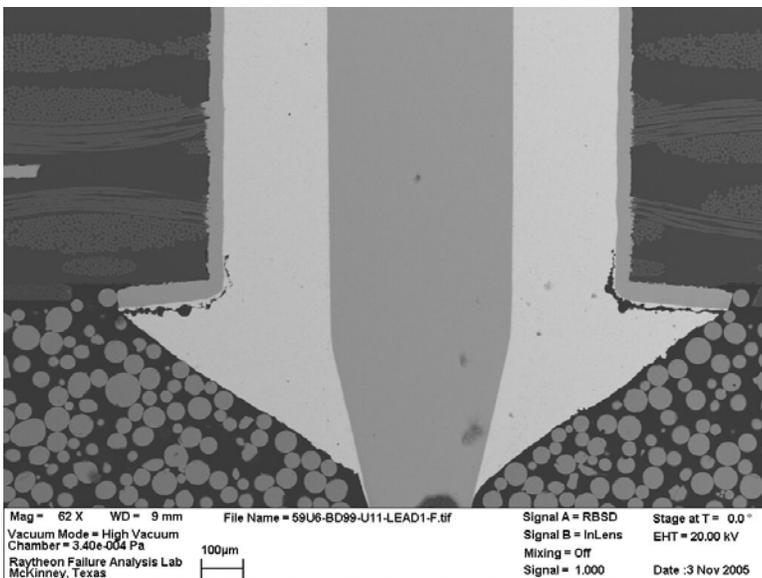
**Figure 45** SEM Micrograph of SnAgCu Soldered Sn PDIP-20 on Manufactured Test Vehicle (SN 99, U11, Lead 1) Cracks also present on opposite side of board near PWB interface.

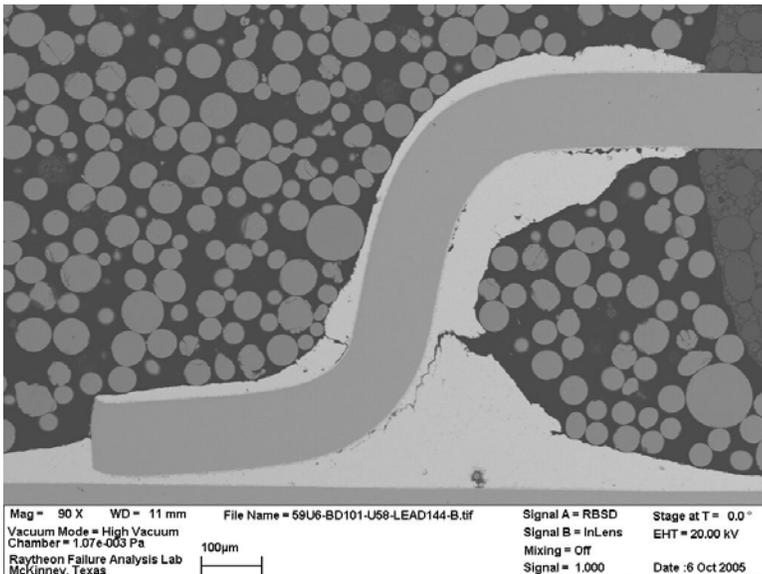
**Figure 54** SEM Micrograph of SnAgCu Soldered Sn TQFP-144 on Manufactured Test Vehicle (SN 101, U58, Lead 144) Crack extends ¼ of way into joint. Initiates on inside of joint near lead interface.

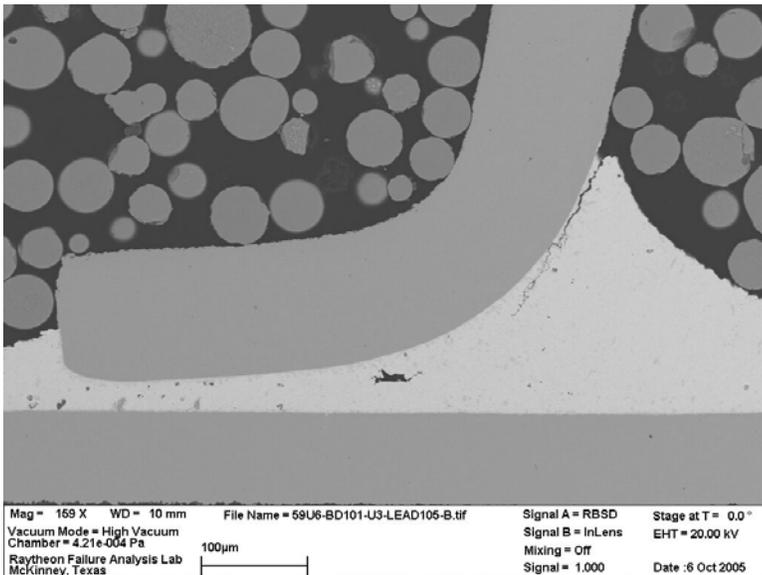
**Figure 55** SEM Micrograph of SnAgCu Soldered AuPdNi TQFP-208 on Manufactured Test Vehicle (SN 101, U3, Lead 105) Crack extends about ¼ of the way into the joint at the lead interface. The crack is initiating on the inside portion of the joint. A small void is present in the joint. EDS data for the joint metallurgy for this device can be observed in Figure 57, Figure 58, Figure 59, and Figure 60.

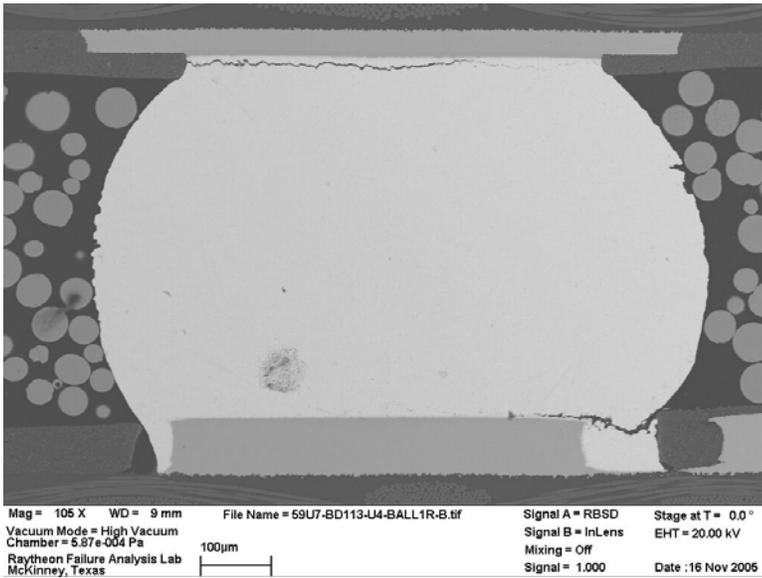
**Figure 64** SEM Micrograph of SnAgCuBi Soldered SnAgCu BGA-225 on Manufactured Test Vehicle (SN 113, U4, Bump 1R) Solder cracked at both interfaces, crack extends completely through the solder joint at the component side interface.

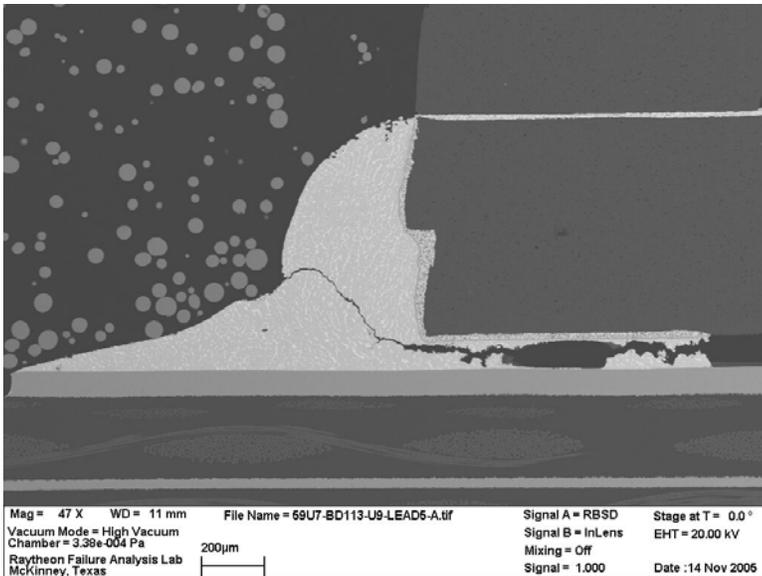
**Figure 71** SEM Micrograph of SnAgCuBi Soldered SnPb CLCC-20 on Manufactured Test Vehicle (SN 113, U9, Lead 5) Crack extends through the solder joint, it appears the solder was voided below the component.

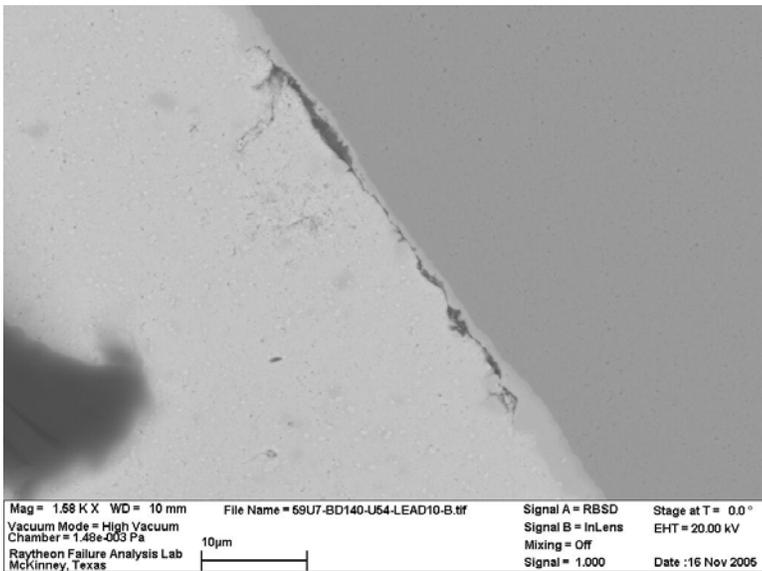
**Figure 76** SEM Micrograph of SnAgCuBi Soldered Sn PLCC-20 on Manufactured Test Vehicle (SN 140, U54, Lead 10) Small crack near lead intermetallic interface. EDS data of solder joint indicates metallurgy in Figure 77 and Figure 78.

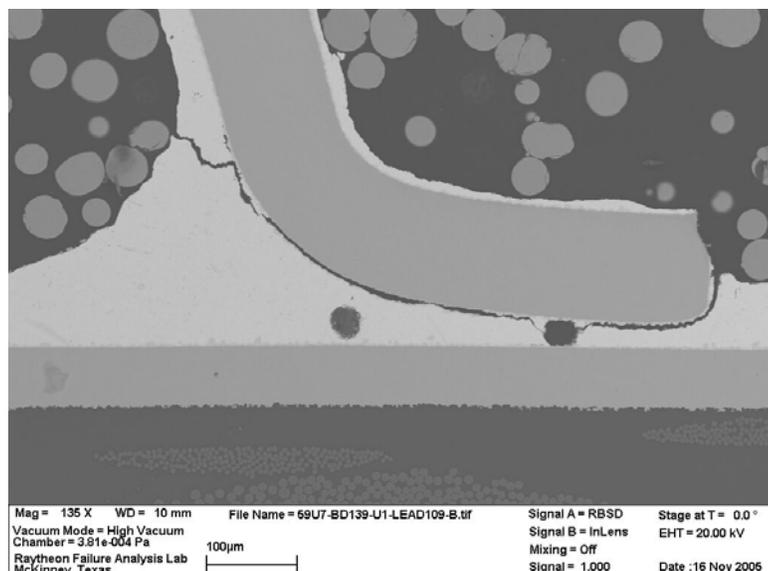
**Figure 79** SEM Micrograph of SnAgCuBi Soldered Sn TQFP-144 on Manufactured Test Vehicle (SN 139, U1, Lead 109) Crack extends through the solder, along the lead interface after the crack gets through the heel solder fillet.

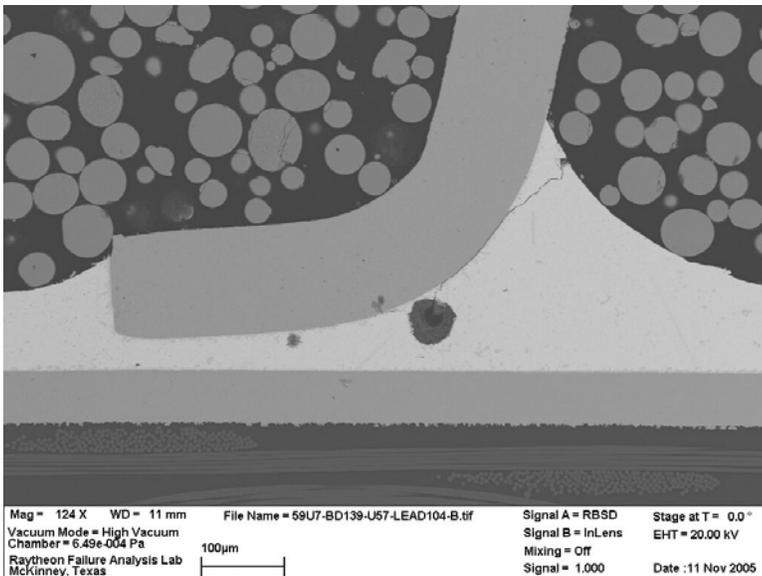
**Figure 80** SEM Micrograph of SnAgCuBi Soldered AuPdNi TQFP-208 on Manufactured Test Vehicle (SN 139, U57, Lead 104) Partial crack through the solder at the lead to IMC interface.

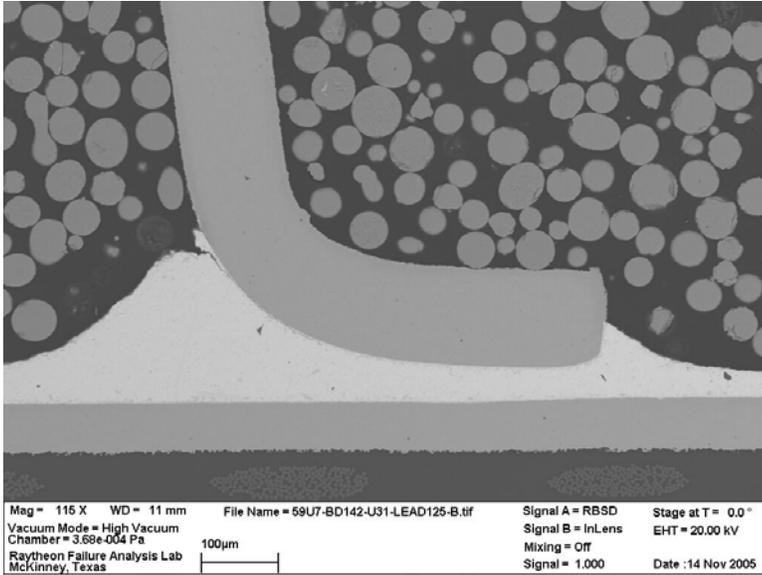
**Figure 81** SEM Micrograph of SnAgCuBi Soldered AuPdNi TQFP-208 on Manufactured Test Vehicle (SN 142, U31, Lead 125) Crack approximately 1/2 through the solder along the lead IMC to solder interface.

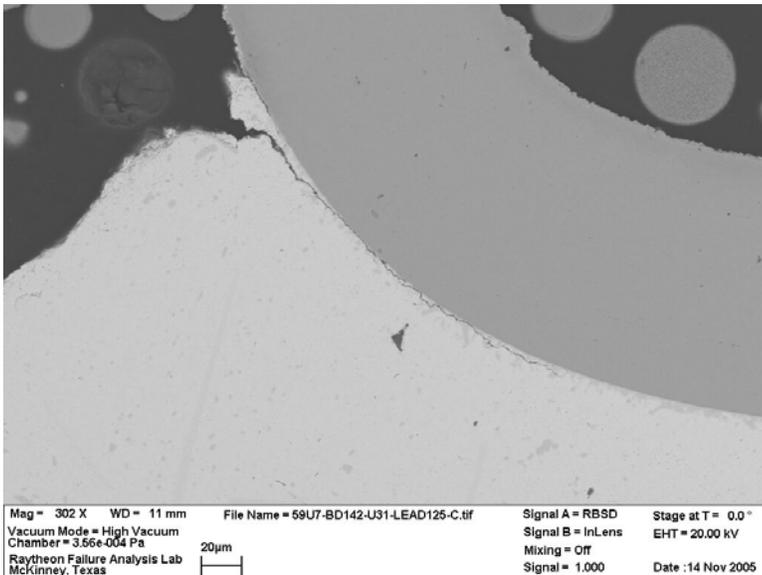
**Figure 82** SEM Micrograph of SnAgCuBi Soldered AuPdNi TQFP-208 on Manufactured Test Vehicle (SN 142, U31, Lead 125) Crack approximately 1/2 through the solder along the lead IMC to solder interface.

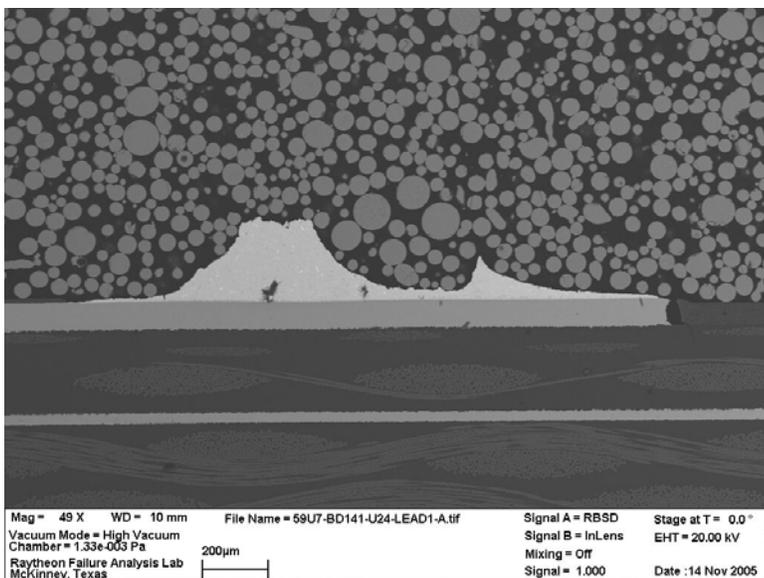
**Figure 84** SEM Micrograph of SnAgCuBi Soldered SnPb TSOP-50 on Manufactured Test Vehicle (SN 141, U24, Lead 1) Component missing, came off during testing.

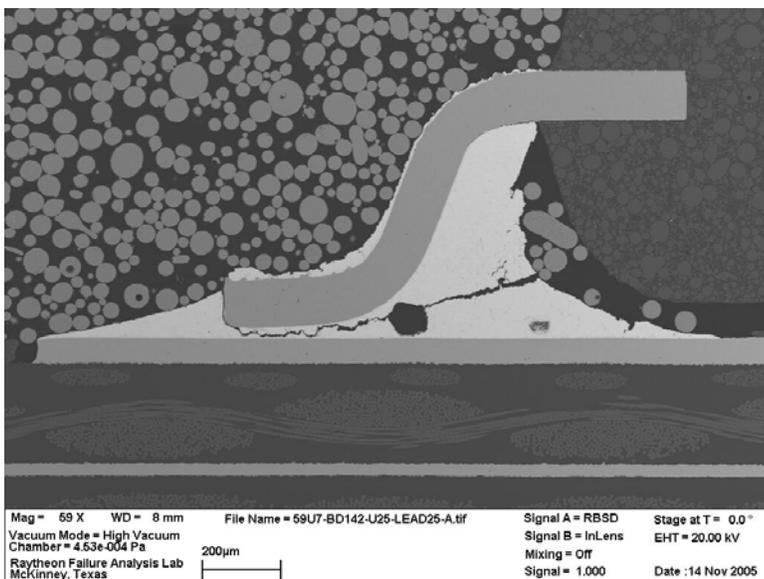
**Figure 85** SEM Micrograph of SnAgCuBi Soldered SnCu TSOP-50 on Manufactured Test Vehicle (SN 142, U25, Lead 25) Crack through the solder, also a void in the solder. EDS data of joint present in Figure 86 and Figure 87.

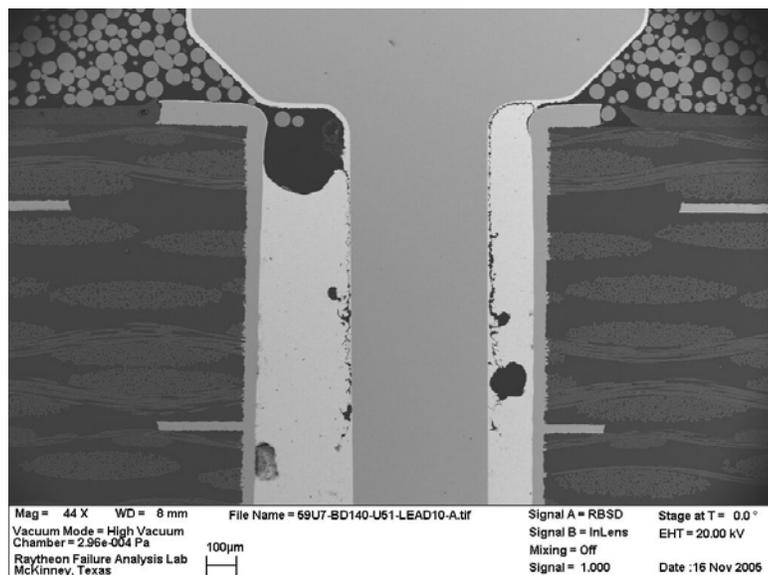
**Figure 88** SEM Micrograph of SnCu Soldered Sn PDIP-20 on Manufactured Test Vehicle (SN 140, U51, Lead 10) Cracks in solder on both side of the lead. The metallurgy was examined by EDS in Figure 91, Figure 92, Figure 93 and Figure 94.

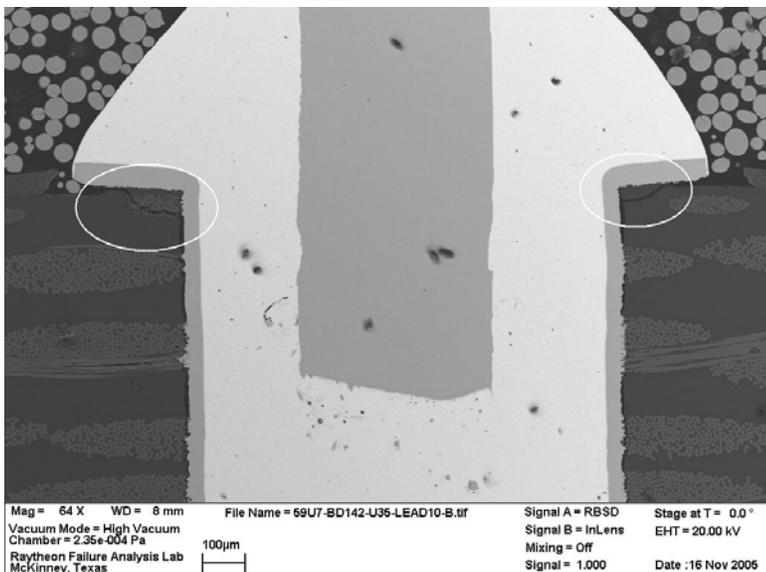
**Figure 89** SEM Micrograph of SnCu Soldered AuPdNi PDIP-20 on Manufactured Test Vehicle (SN 142, U35, Lead 10) Cracks in the PWB, top corners and extending into the PWB along the Cu plating interface.

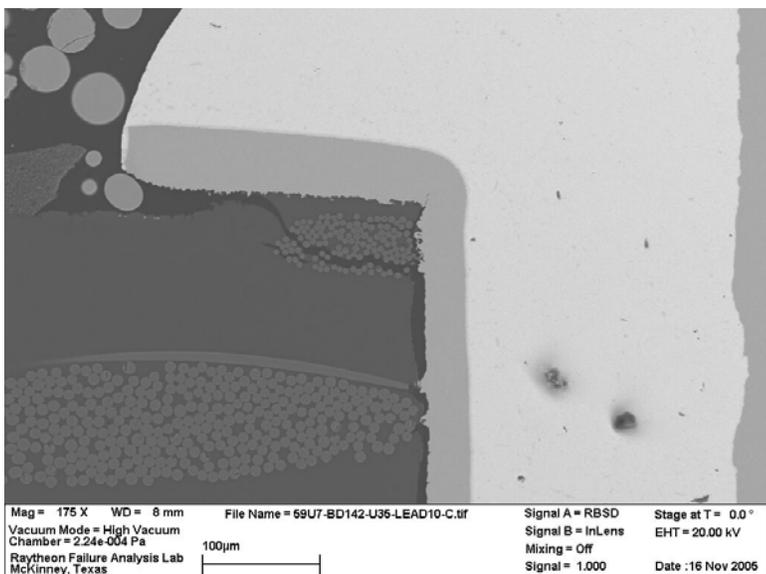
**Figure 90** SEM Micrograph of SnCu Soldered AuPdNi PDIP-20 on Manufactured Test Vehicle (SN 142, U35, Lead 10) Crack in the PWB.

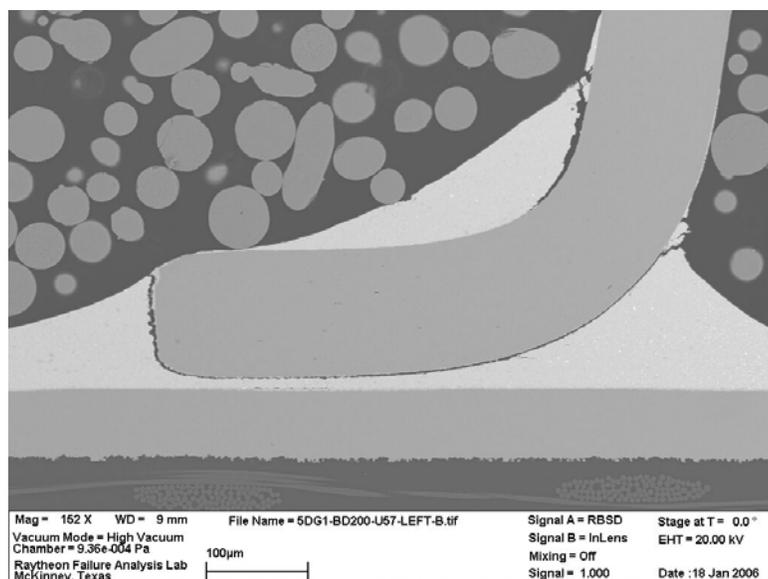
The U57 TQFP-208 devices soldered with SnAgCuBi on rework test vehicles had separation between the lead intermetallics and solder. The U3 TQFP-208 devices soldered with SnAgCuBi on rework test vehicles were missing due to the fracture of the joints. Microvoids were identified in the solder at the pad interface. The U3 devices failed very early in comparison to the U57 devices. This was most likely the result of poor wetting of the solder at the time of rework.

**Figure 95** SEM Micrograph of Reworked AuPdNi TQFP-208 Soldered with Tin-Silver-Copper-Bismuth Solder Alloy on Rework Test Vehicles (SN 200, U57, Lead Left) Separation present between lead and solder extending

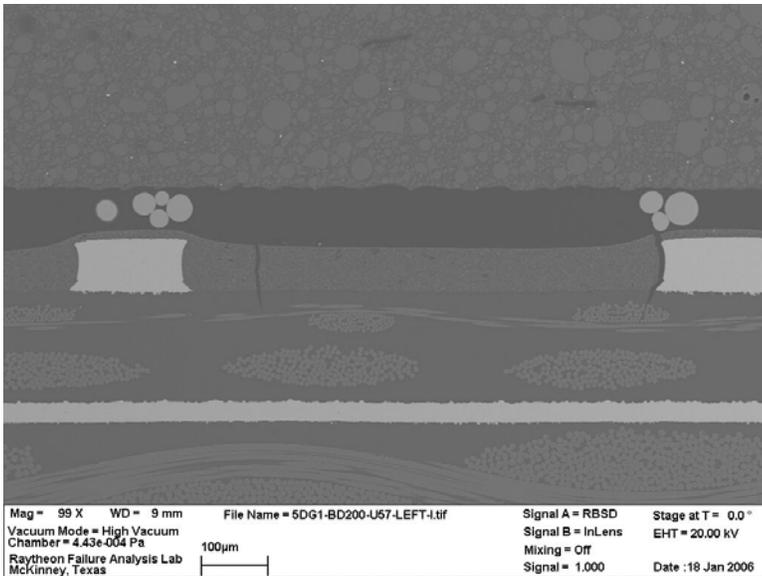
**Figure 98** SEM Micrograph of Reworked AuPdNi TQFP-208 Soldered with Tin-Silver-Copper-Bismuth Solder Alloy on Rework Test Vehicles (SN 200, U57, Lead Left) Cracks present in solder mask and board below component.

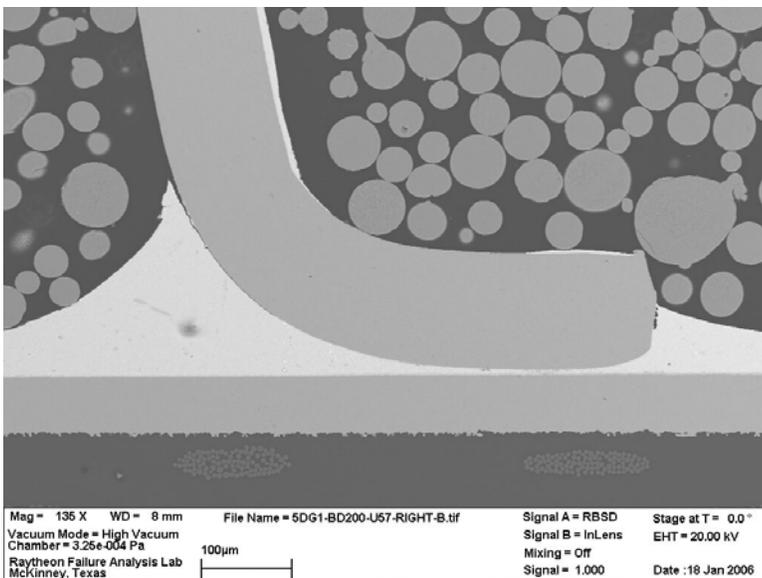
**Figure 99** SEM Micrograph of Reworked AuPdNi TQFP-208 Soldered with Tin-Silver-Copper-Bismuth Solder Alloy on Rework Test Vehicles (SN 200, U57, Lead Right) Separation occurring between lead intermetallic layer and solder extending about 1/4 of the way into joint.

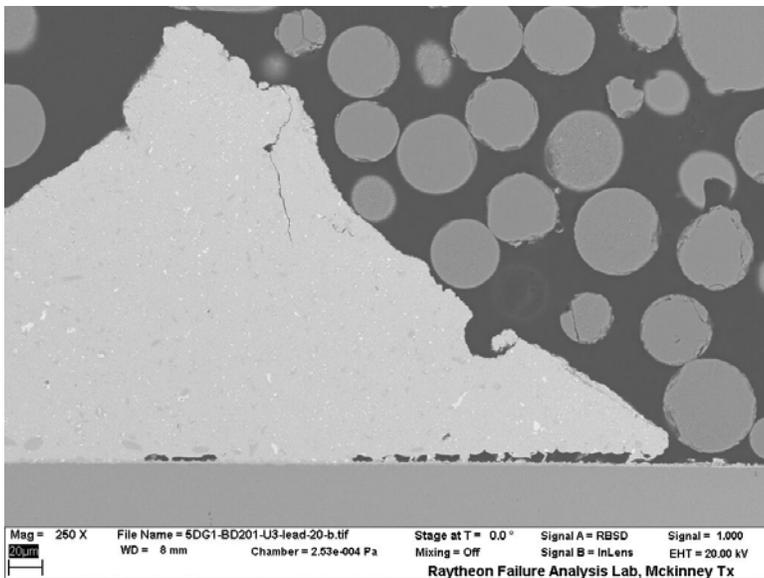
**Figure 106** SEM Micrograph of Reworked AuPdNi TQFP-208 Soldered with Tin-Silver-Copper-Bismuth Solder Alloy on Rework Test Vehicles (SN 201, U57, Lead 20) Microcracks present in the solder. Voiding at the solder to IMC interface. It appears the solder did not wet well to the board pad at the time of rework.
