Debris/Ice/TPS Assessment and Integrated Photographic Analysis of Shuttle Mission STS-87

Technical Memorandum-1998 - 206642

February 1998

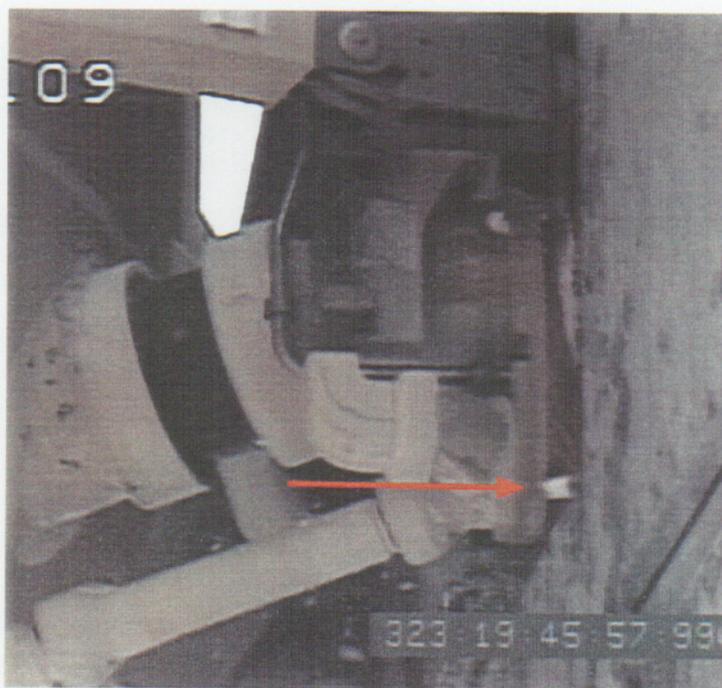
Figure 2.1 (A) Umbilical Ice Striking LH2 Umbilical Door Sill

Multiple pieces of ice debris were seen falling from the ET/Orbiter umbilicals during SSME ignition. An ice/frost finger from a LH2 umbilical purge vent fell aft and contacted the LH2 press line (~19:45:56.6 UTC) and then struck the LH2 umbilical door sill. Three other pieces of umbilical ice debris were seen to strike the ET/Orbiter LH2 umbilical door sill (~19:45:56.4 through 19:45:58.0 UTC). A single piece of umbilical ice debris was seen to strike the LH2 four-inch recirculation line at ~19:45:56.65 UTC. No damage to the press line, the door sill, or the four-inch recirculation line was visible. (Cameras OTV109, OTV163, E31)

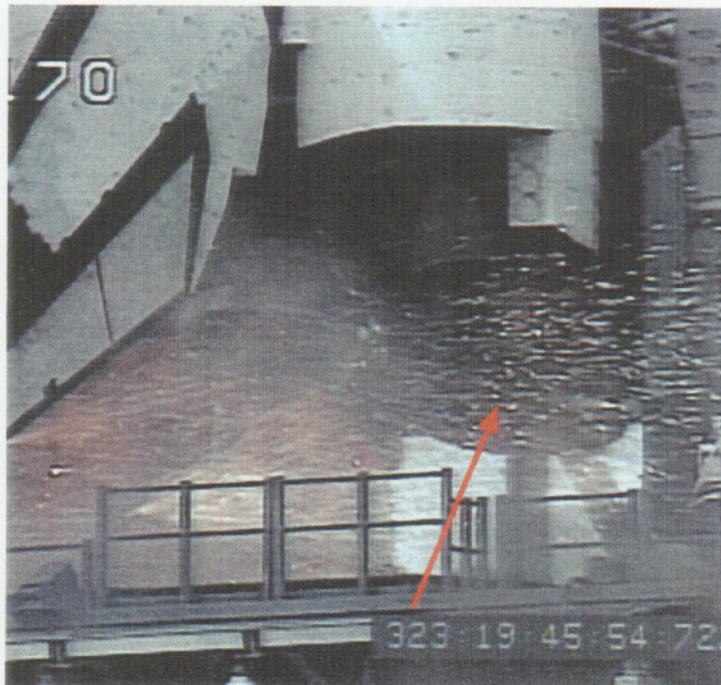
Figure 2.3 (A) Orange Vapor During SSME Ignition

Orange vapor, probably free burning hydrogen, was seen forward of the SSME rims and near the base heat shield during SSME ignition (~19:45:54.7 UTC). Orange vapors have been seen on previous missions. (E2, E5, E17, E19, E20, OTV170)

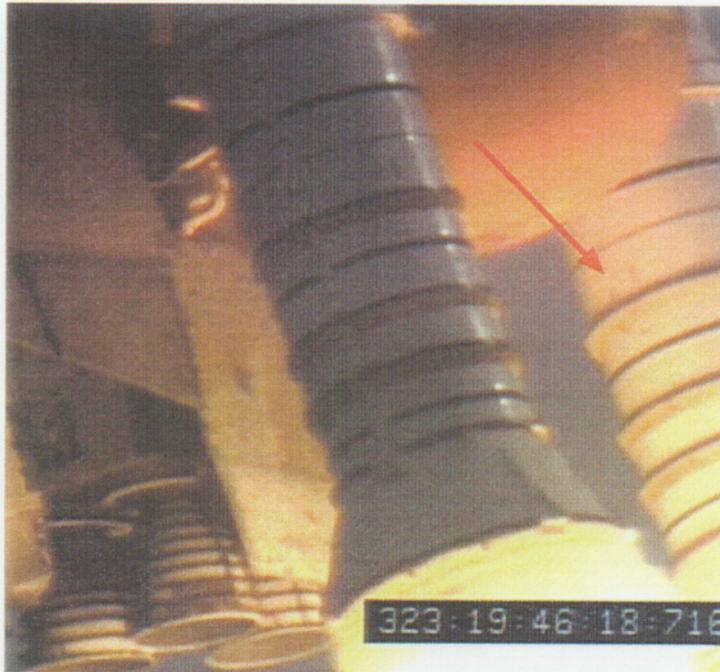
Figure 2.4 (A) Umbilical Purge Barrier Material

A piece of umbilical purge barrier material was seen to detach and travel toward the LSRB before falling aft (~19:46:18.7 UTC).

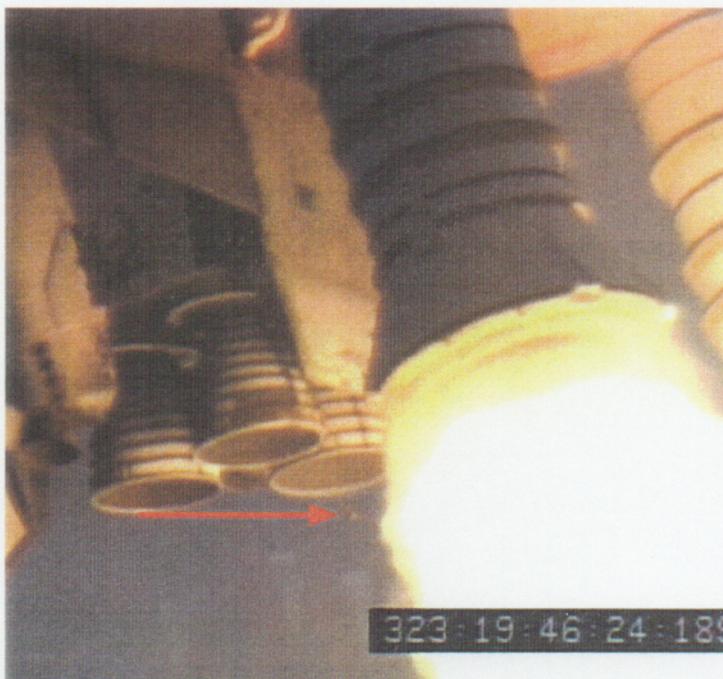
Figure 2.4 (B) Umbilical Purge Barrier Material Adhered to Base Heat Shield

After the roll maneuver, a single piece of umbilical purge barrier material, first seen aft of SSME #2, traveled forward and adhered to the base heat shield outboard of SSME #2. No base heat shield tile damage at this location was reported in the STS-87 KSC Orbiter Post Landing Inspection Debris Assessment report.

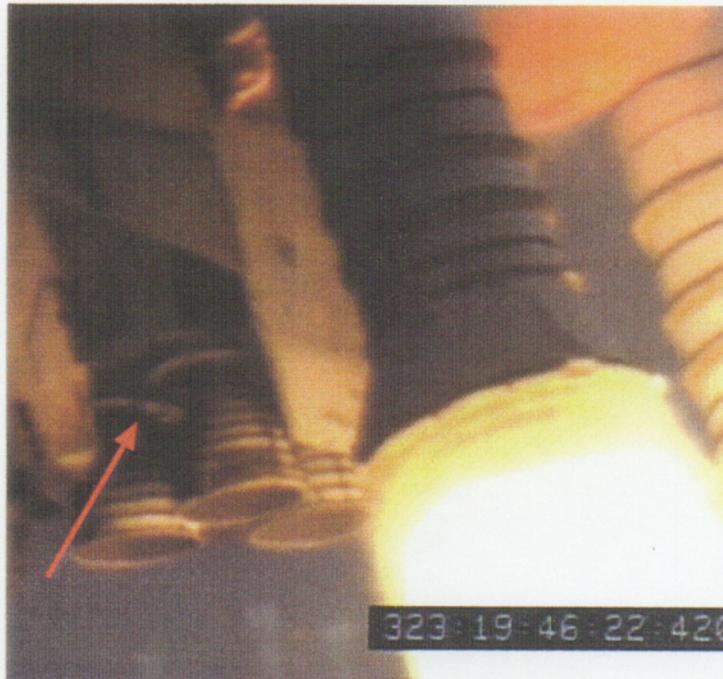
Figure 2.4 (C) Partially Detached Dome Mounted Heat Shield (DMHS) Closeout Blanket

A Dome Mounted Heat Shield (DMHS) closeout blanket was seen to partially detach at the 5 o'clock position of SSME #1 at ~19:46:20.7 UTC.

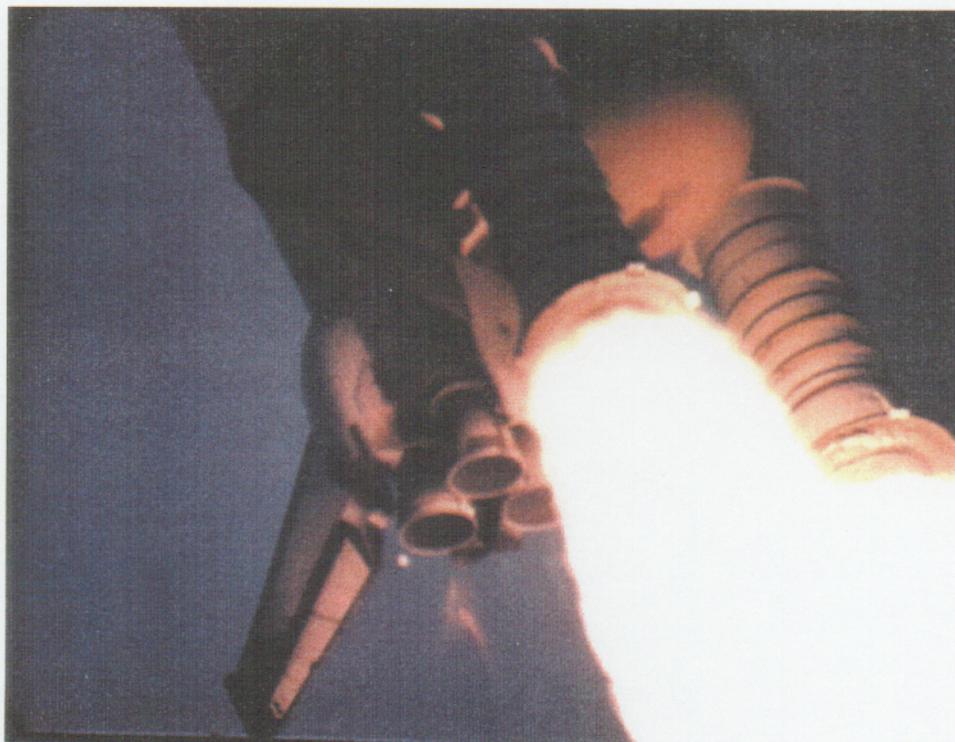
Figure 2.4 (D) Detached DMHS Closeout Blanket

The DMHS blanket tore loose and fell aft at approximately ~19:46:39 UTC. The falling blanket induced orange-colored streaks in the SSME exhaust plume. (KTV4B, KTV21B, ET204, ET207, E207, E213, E222, E223).

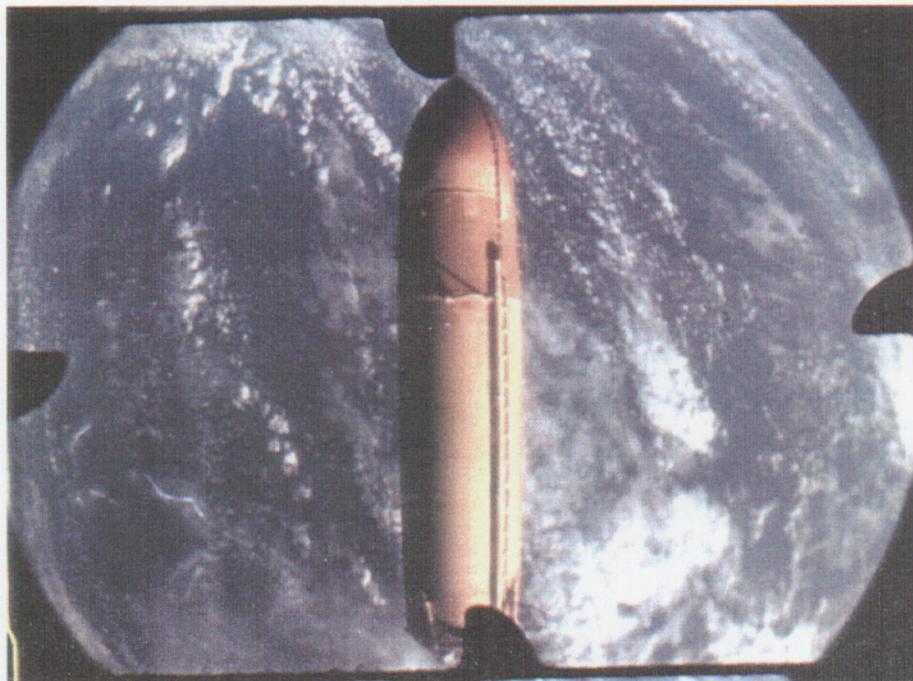
Figure 2.6.1.1 (A) 16mm Umbilical Well Camera Film (5mm Lens) of ET

No damage to the Orbiter side of the ET (+Z) or the visible forward portion of the SRBs was seen on the 16mm umbilical well films that would account for the tile damage found on the Orbiter after landing. No indications of vapor were seen on the ET film sequence. Although the GH2 vent on the ET intertank was not visible from the umbilical well camera perspective, it appeared that if venting similar to that seen on the downlink video had been present it should have been detected (see section 2.6.1.3). No unusual motions of the ET could be discerned during the 16mm film separation sequence when compared to identical views acquired on previous missions.

Less than usual divots were seen on the ET surface areas. Two light colored marks (possibly divots) were seen on the intertank acreage between the +Z aero vent and the RSS antenna. Small erosion marks or divots were seen on the LO2 aft feedline flange closeouts. A light area (possibly a divot) was seen on the -Y limb of the intertank near the LSRB forward attach fitting. Several divots were seen on the -Y thrust strut and flange closeout. Numerous light colored pieces of debris (probably insulation and frozen hydrogen) were seen throughout the ET separation sequence. No anomalies were noted on the face of the LH2 umbilical

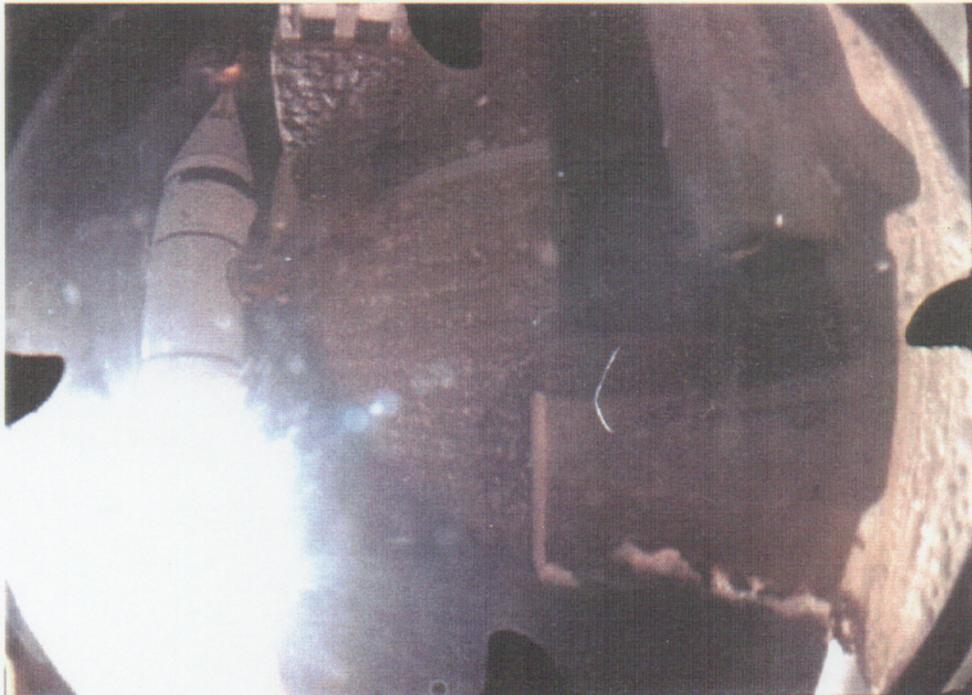
Figure 2.6.1.1 (B) 16mm Umbilical Well Camera Film (5mm Lens) View of SRB Separation

The LSRB separation appeared normal. The SRB nose caps were visible during SRB separation.

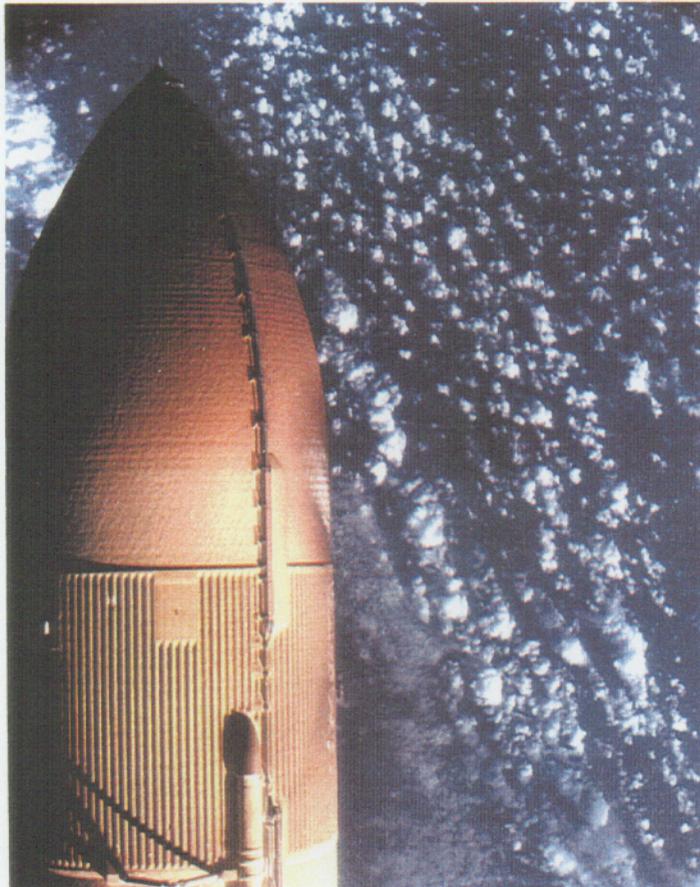
Figure 2.6.1.1 (C) 35mm Umbilical Well Camera Film View of Forward ET

Excellent quality views of the ET from the LO2 umbilical forward to the tip of the ET nose were acquired. As planned, a total of 59 image frames were recorded. Overall, the +Z ET TPS appeared to be in good condition. No anomalies were noted on the face of the LO2 umbilical (the LO2 umbilical interface plate appeared similar to previous mission views). The ET/Orbiter attach bipod closeouts appeared normal. The LO2 feedline, cable tray, PAL ramps, press lines, and ET nose cone appeared in good condition.

Multiple white-colored marks (TPS damage), including several divots, were seen on the on the 35 mm umbilical well film on the +Y ET thrust panel near the RSRB forward attach. Better views of this damage were acquired with the crew handheld photography. The investigation team concluded that the thrust panel damage near the RSRB forward attach accounted for the damage found on the fuselage tiles along the right side of Orbiter after landing. (The -Y ET thrust panel near the LSRB forward attach was not imaged on the 35mm umbilical well camera film). No indications of vapor were seen on the 35mm film. No unusual motions of the ET could be discerned on the 35 mm film when compared to identical views acquired on previous missions.

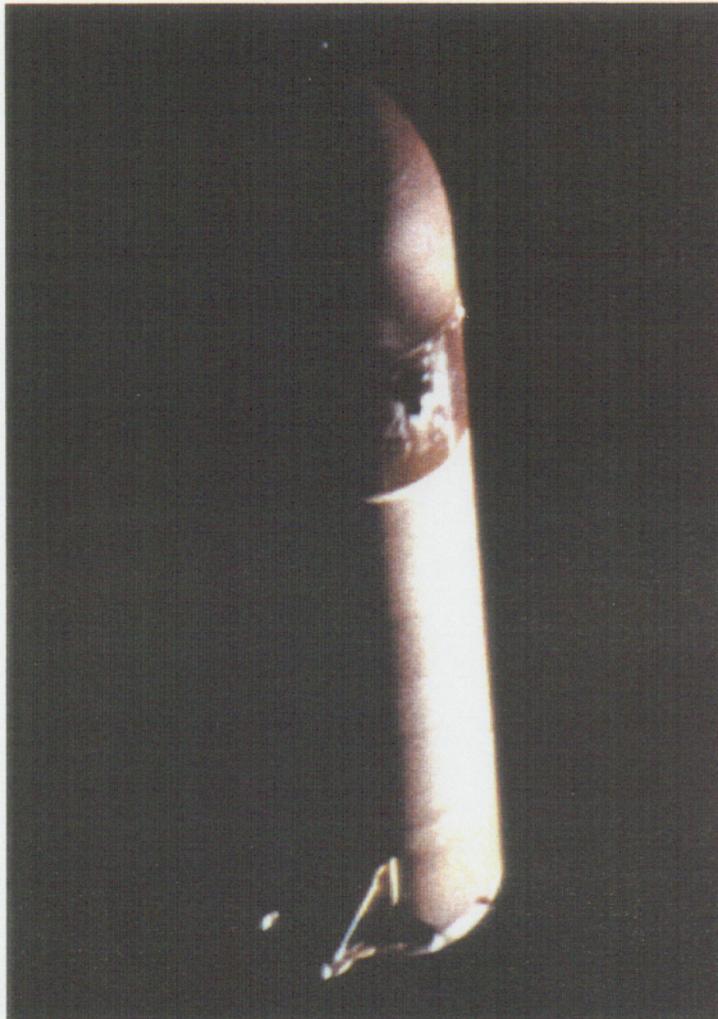
Figure 2.6.1.2 (A) Damage to the ET +Y Intertank Thrust Panel

The damage to the ET thrust panel TPS seen on the crew handheld photography was ultimately determined by the investigation board to be the probable cause of a significant portion of the Orbiter fuselage tile damage.

Damage to the ET intertank TPS was noted. The damaged areas are visible on both the +Y and -Y intertank thrust panels near the forward left and right SRB attach fittings and extend forward and aft from the attach points for almost the entire width of the intertank.

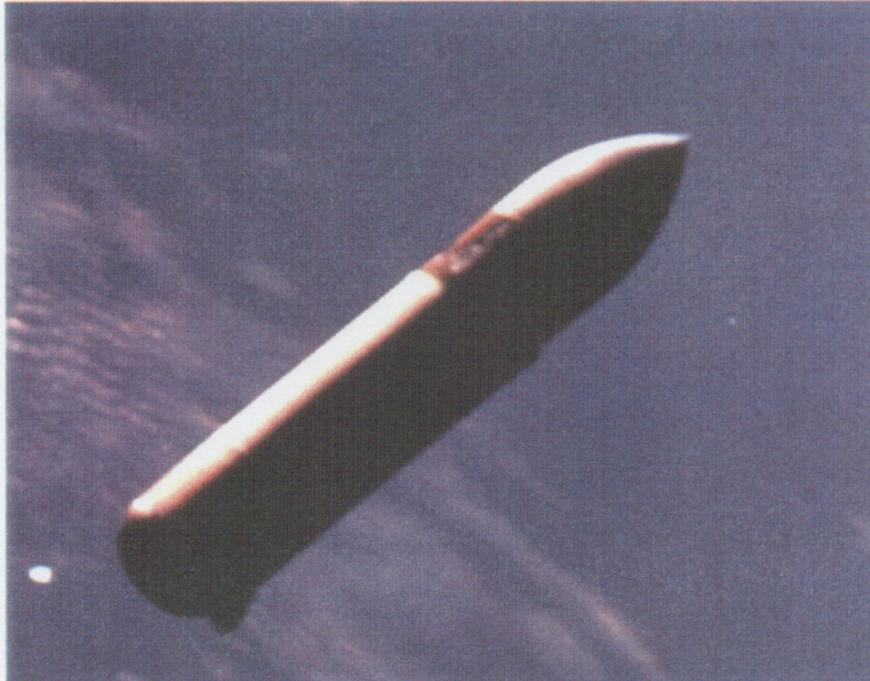
Figure 2.6.1.2 (B) Damage to the ET -Y Intertank Thrust Panel

The damaged areas appeared to consist of multiple white-colored divots. A separate large, bright, light-blue-colored area estimated to be approximately 100 inches in length, was noted on the ET intertank -Y/-Z axis. The presence of exposed substrate in the damaged area could not be confirmed from the imagery. No indication of structural damage was noted.

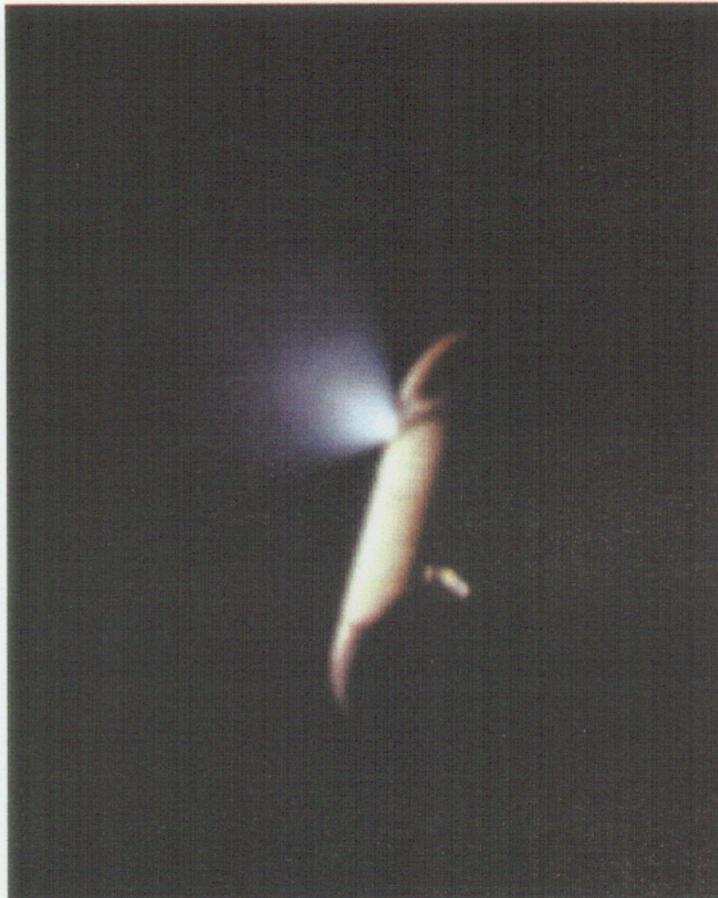
Figure 2.6.1.3 (A) ET Venting Seen on the Hasselblad Camera Film

Venting from the intertank in the vicinity of the GH2 vent (-Y axis) is visible on the Hasselblad film. The venting is present on two separate sequences of frames. After a close review of the STS-87 ET film it was determined that the first sign of ET venting was evident in the ninth frame (image reference S87-705-009). The distance to the ET was calculated to be 5336 feet on this image. This estimate was based on the measured image/object scale and the 250 mm lens used for the photography. The expected error is approximately $\pm 4\%$.

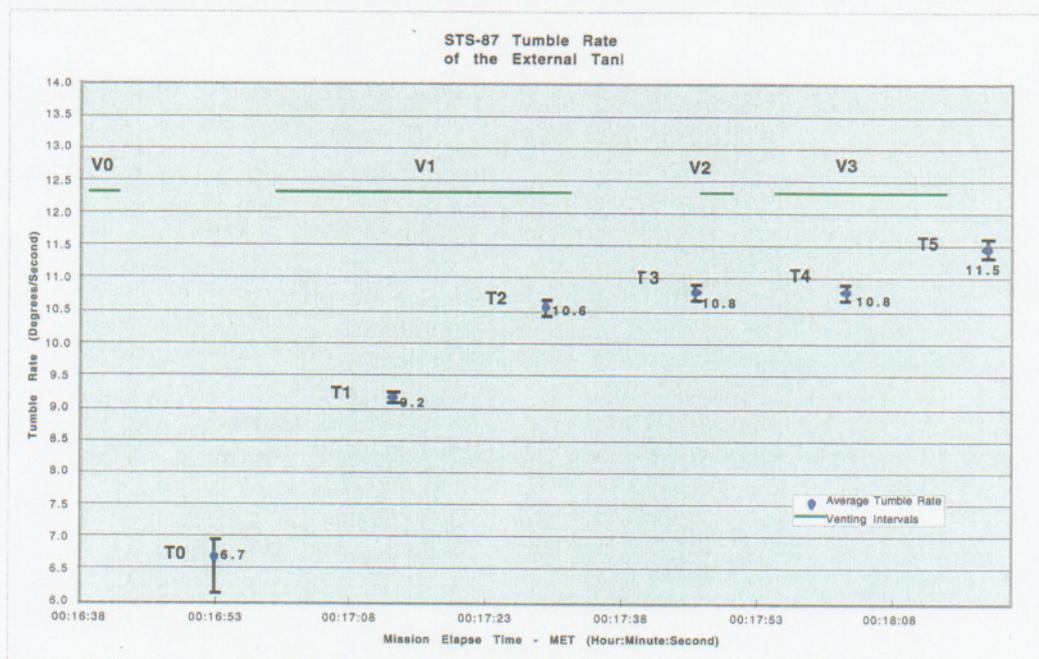
Figure 2.6.1.6 (A) ET Venting and Tumble Rates vs. MET

Figure 2.6.1.6 (A) shows the measured ET tumble rate versus MET. Each data point represents the average tumble rate over the preceding half cycle of ET tumble (180 degrees of rotation), denoted by T1 through T5. For example, for the first full half cycle, T1, the ET tumbled 180 degrees over the time interval from MET 16:52.8 to 17:12.4, for an average tumble rate of 9.2 degrees per second over that interval. The uncertainty in each of the T1 through T5 rates is ± 0.1 degrees per second. The initial average rate, T0, was measured over one quarter cycle of ET rotation, beginning about when the ET was first in view. The larger error bars for T0 ($+0.3, -0.6$) are due to the relatively poor quality of video at the start of the sequence.

Also shown on Figure 2.6.1.6 (A) are the four observed intervals of near-continuous venting, denoted by events V0 through V3. The most pronounced venting, V1, spans all of T2 and the majority of T1 and coincides with the observed ET angular acceleration over those intervals.

The major venting event, V1 began with an intense burst at 17:00 MET. The intense venting was continuous for at least 20 seconds, then the venting slowly tapered off and ends at MET 17:32. This event accounts for the observed increase in ET tumble rate from an average of approximately 6.7 degrees per second to 10.6 degrees per second, as shown in Figure 2.6.1.6 (A).

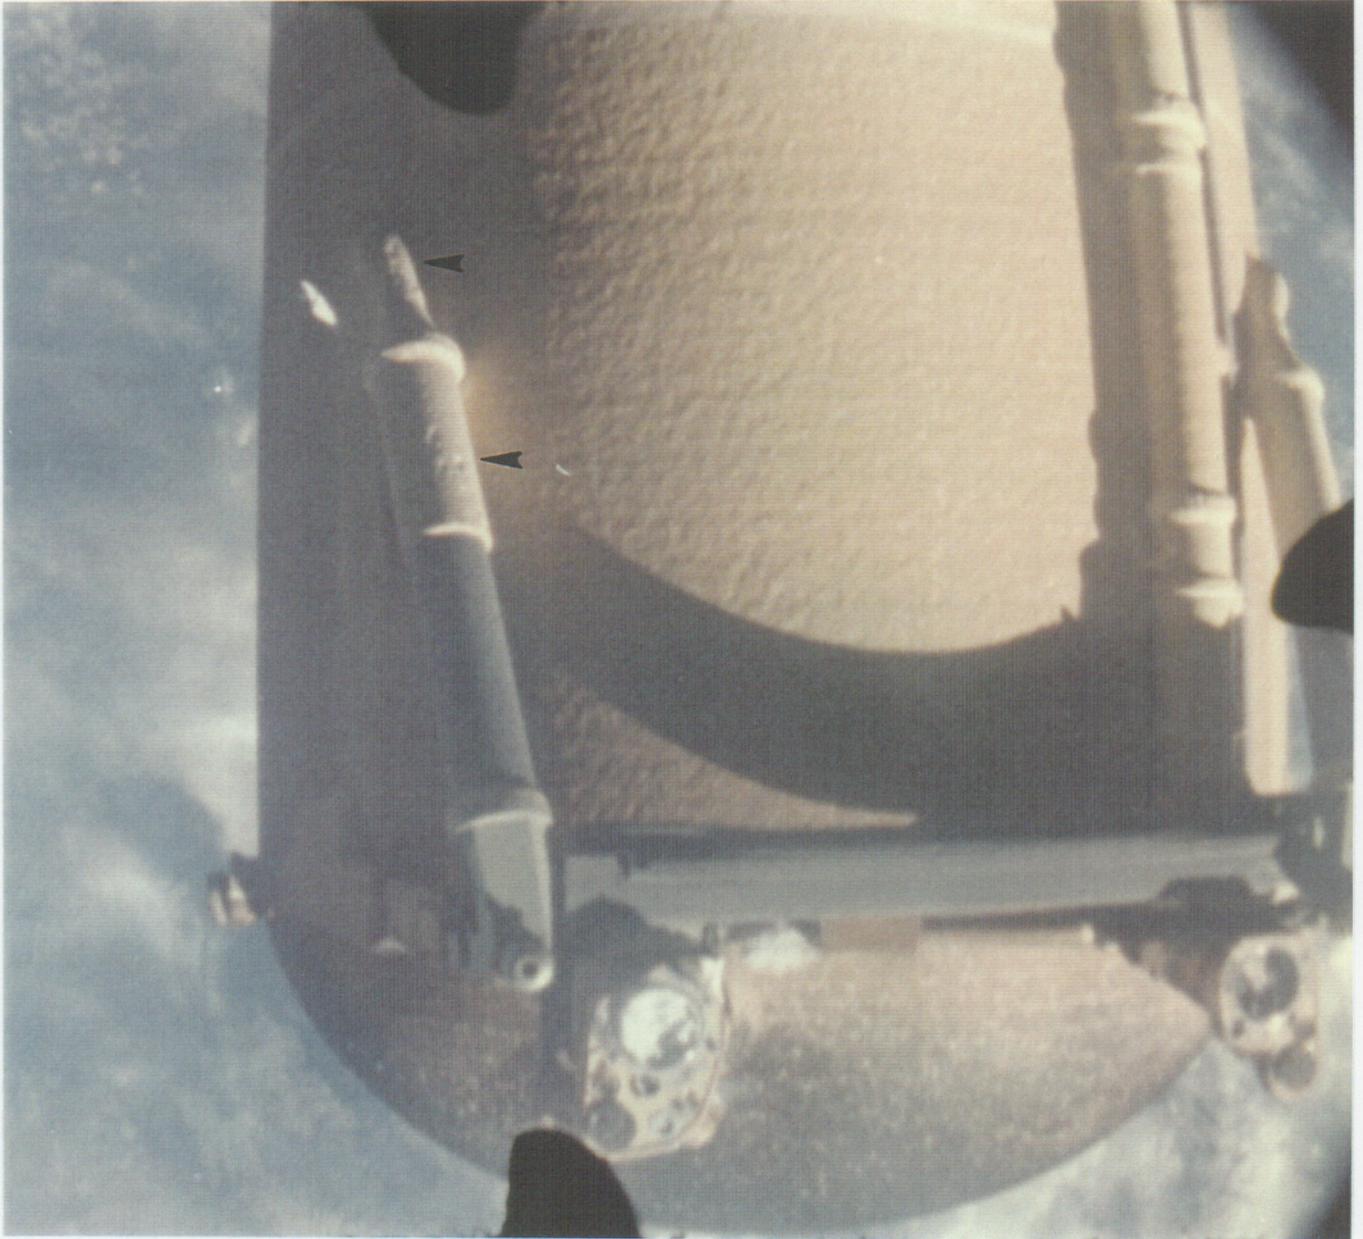
Photo 8: ET Separation from Orbiter

ET-89 separation from the Orbiter was normal. Foam on both thrust struts exhibited damage. Eight divots were detected on the -Y thrust strut and flange closeout. Some of these divots were fore-to-aft gouges and gave the appearance of being caused by debris impacts.

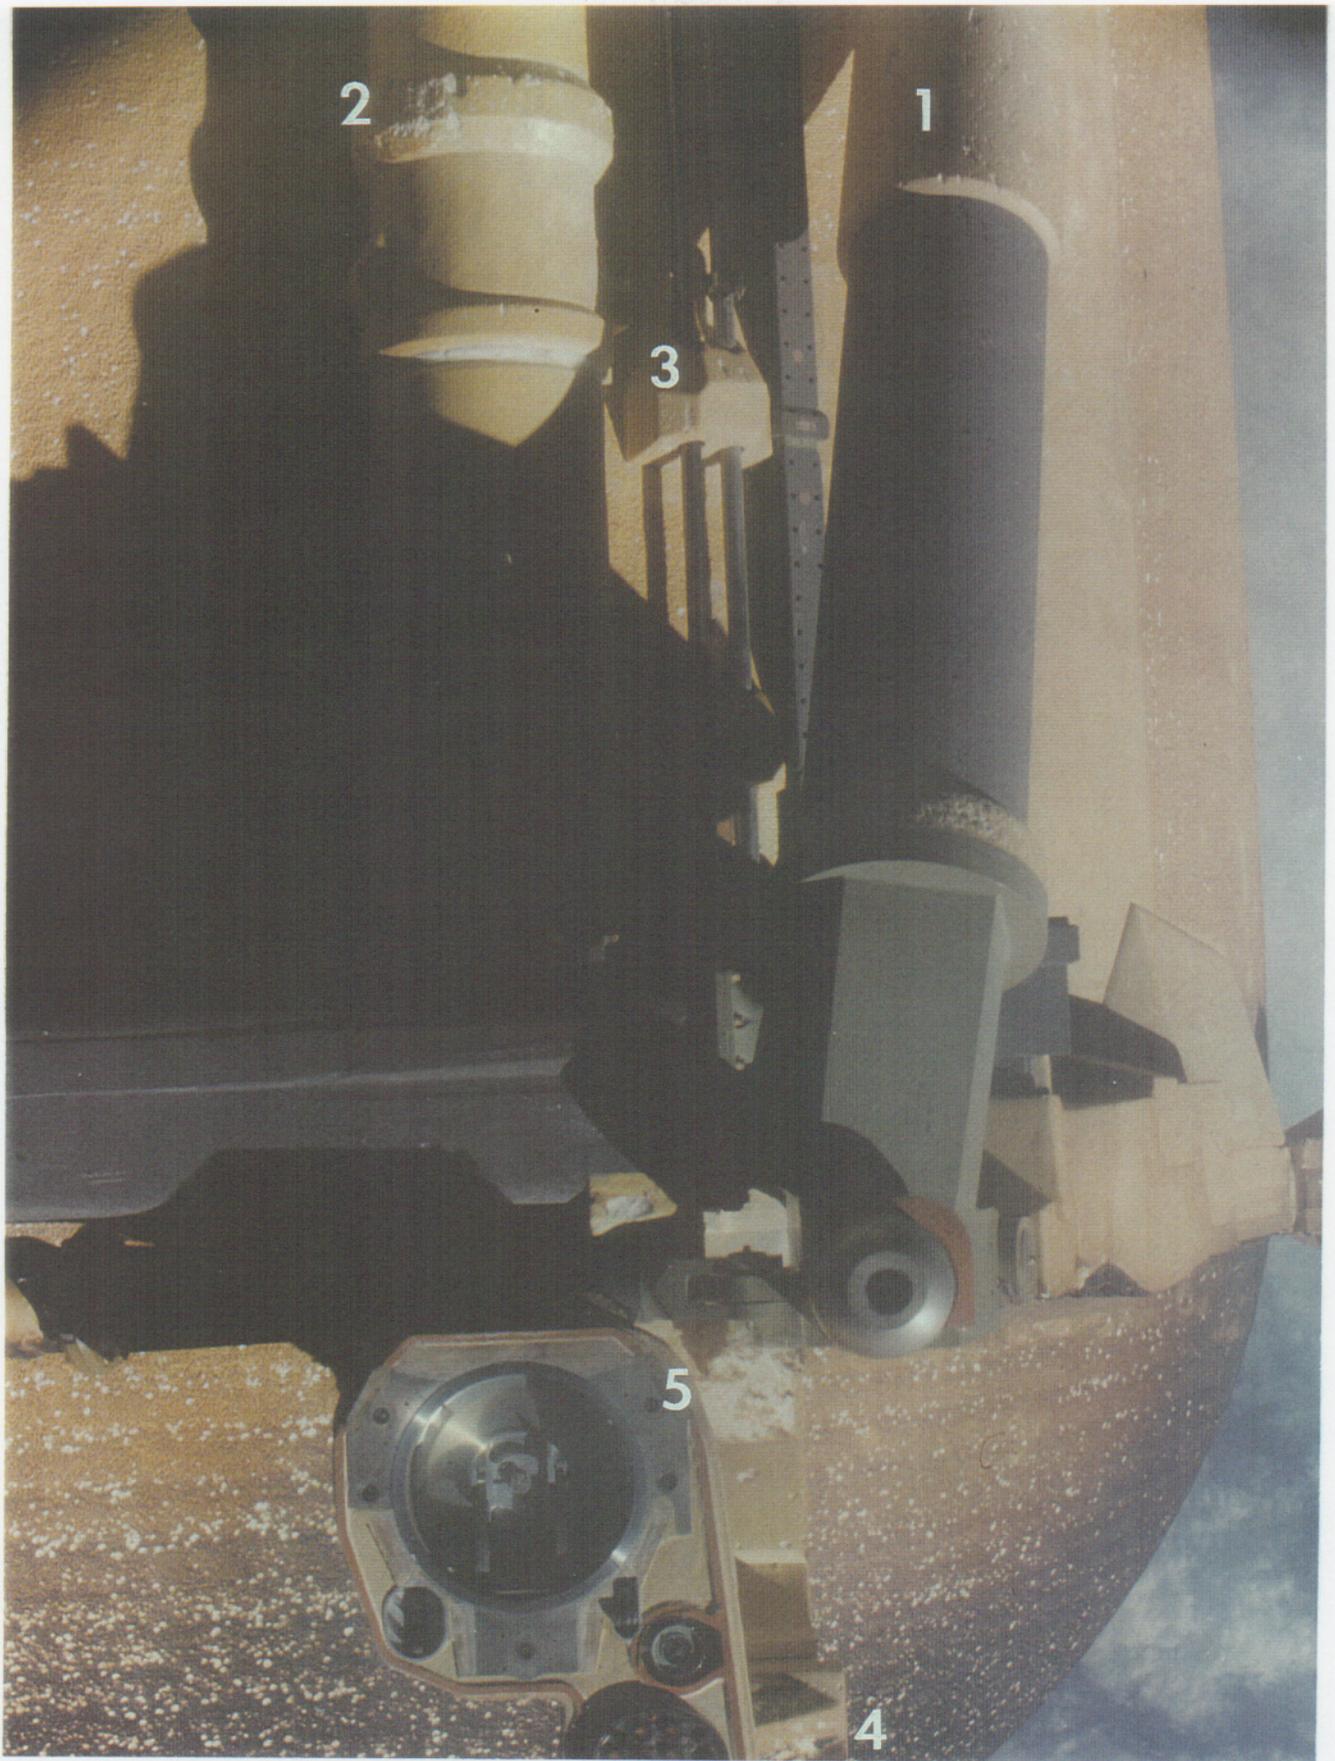
Photo 9: View from 35mm Umbilical Camera

Impact-type damage and fore-to-aft gouges were present in the TPS on the +Y thrust strut (1), LO2 feedline flange closeouts (2), and the pressurization line ramps (3). The LO2 ET/ORB umbilical appeared to be undamaged, though erosion and divots were visible in the horizontal (4) and vertical (5) sections of the cable tray. "Popcorn" type divots were greater in number on the aft dome and the lower LH2 tank acreage - an expected occurrence with the new (NCFI) foam.

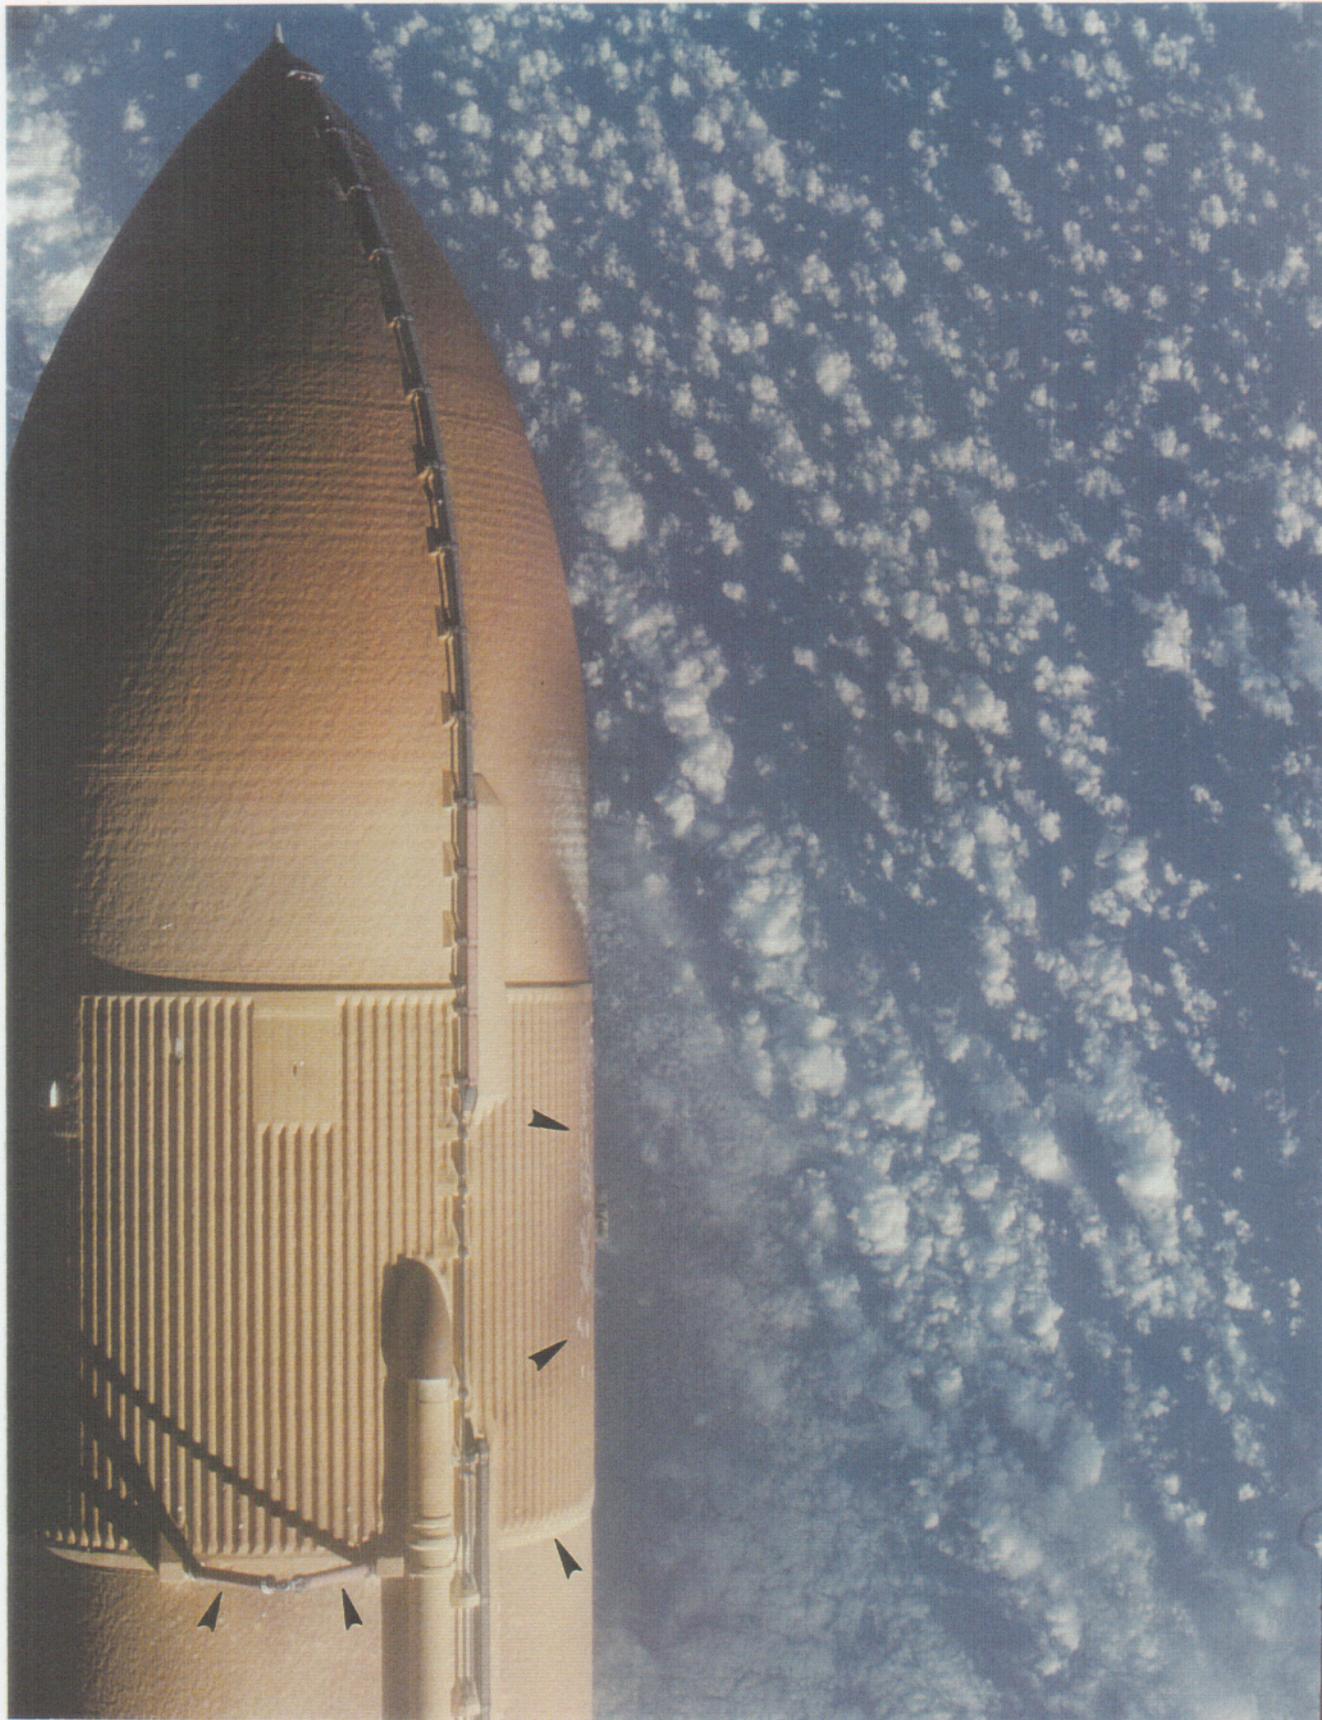
Photo 10: Thrust Panel Foam Damage

The bipod jack pad standoff closeouts were intact. However, numerous divots were visible in the +Y thrust panel TPS forward and aft of the ET/SRB forward attach point (the -Y thrust panel was in shadow and therefore not visible). One 8-inch diameter divot was detected in the LH2 tank-to-intertank flange closeout between the +Y thrust panel and the LO2 feedline. The BSM burn scar on the LO2 tank was typical.

As a result of this investigation, plug pull tests to verify material strength were performed on the ET-90 (STS-89) thrust panels. All of the test results were within specification. Nevertheless, the panels were then modified. The foam was machined/sanded to minimum drawing requirements above the rib tops and the rind was removed in the rib valleys to improve the stress/strain capability, eliminate a denser material layer, reduce the amount of potential debris material, and reduce the foam height above the panel ribs to decrease the cross-flow air loading on the foam. All of these measures were designed to eliminate or reduce the amount of TPS loss from the thrust panels, and in turn reduce the amount of damage to Orbiter tiles.

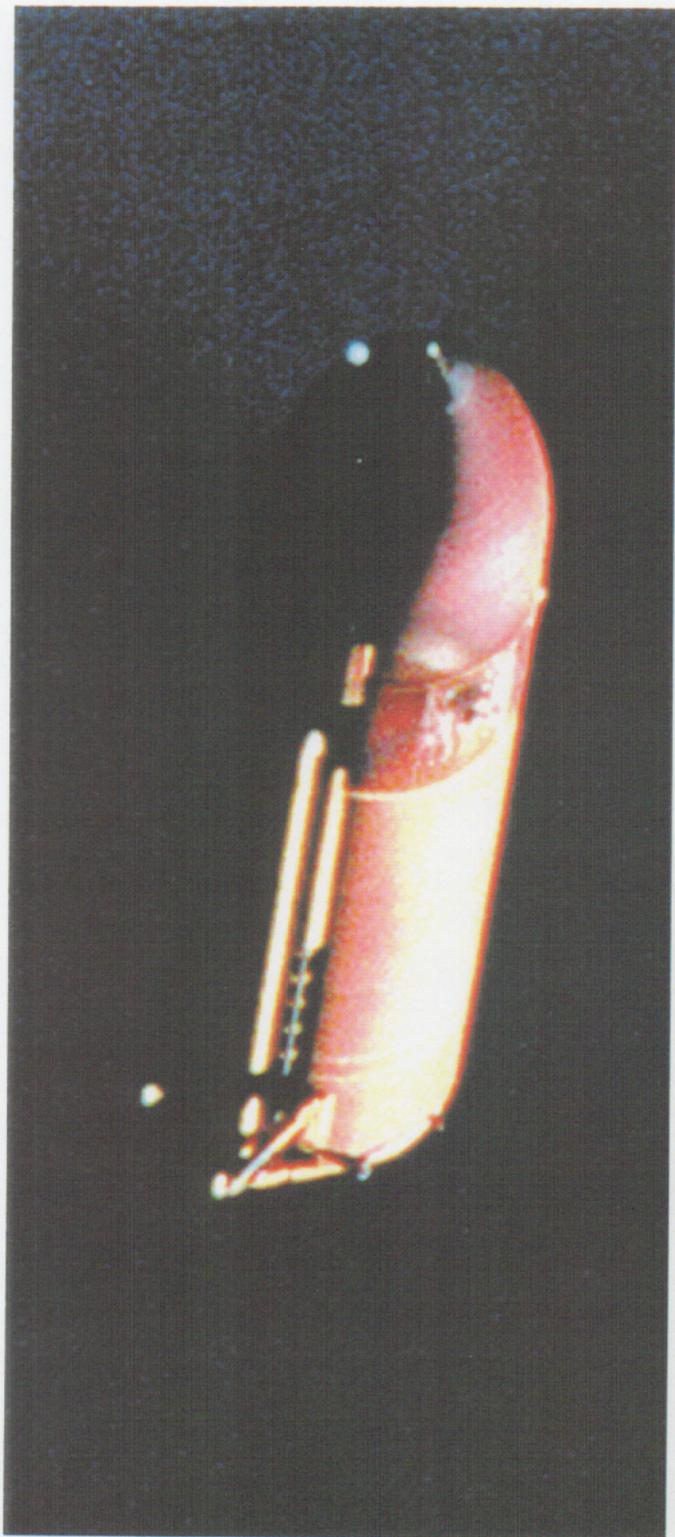
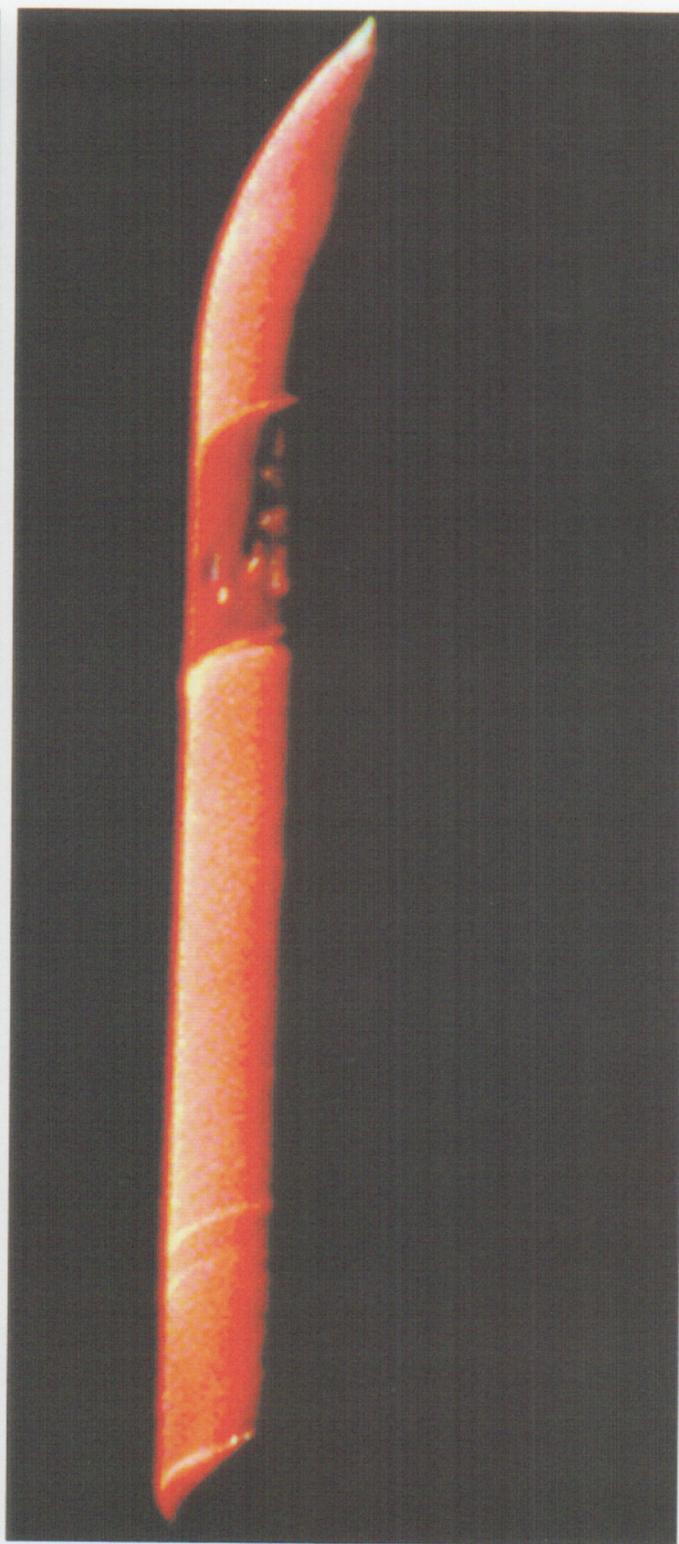
Photo 11: Crew Hand-Held Still Images

Still images of the ET after separation from the Orbiter were obtained by the crew using the 70mm camera. The ET was approximately 1.1 kilometers away when the first still frame was taken. These images showed conclusive proof that substantial amounts of TPS were missing from both ET thrust panels forward and aft of the ET/SRB attach fittings.

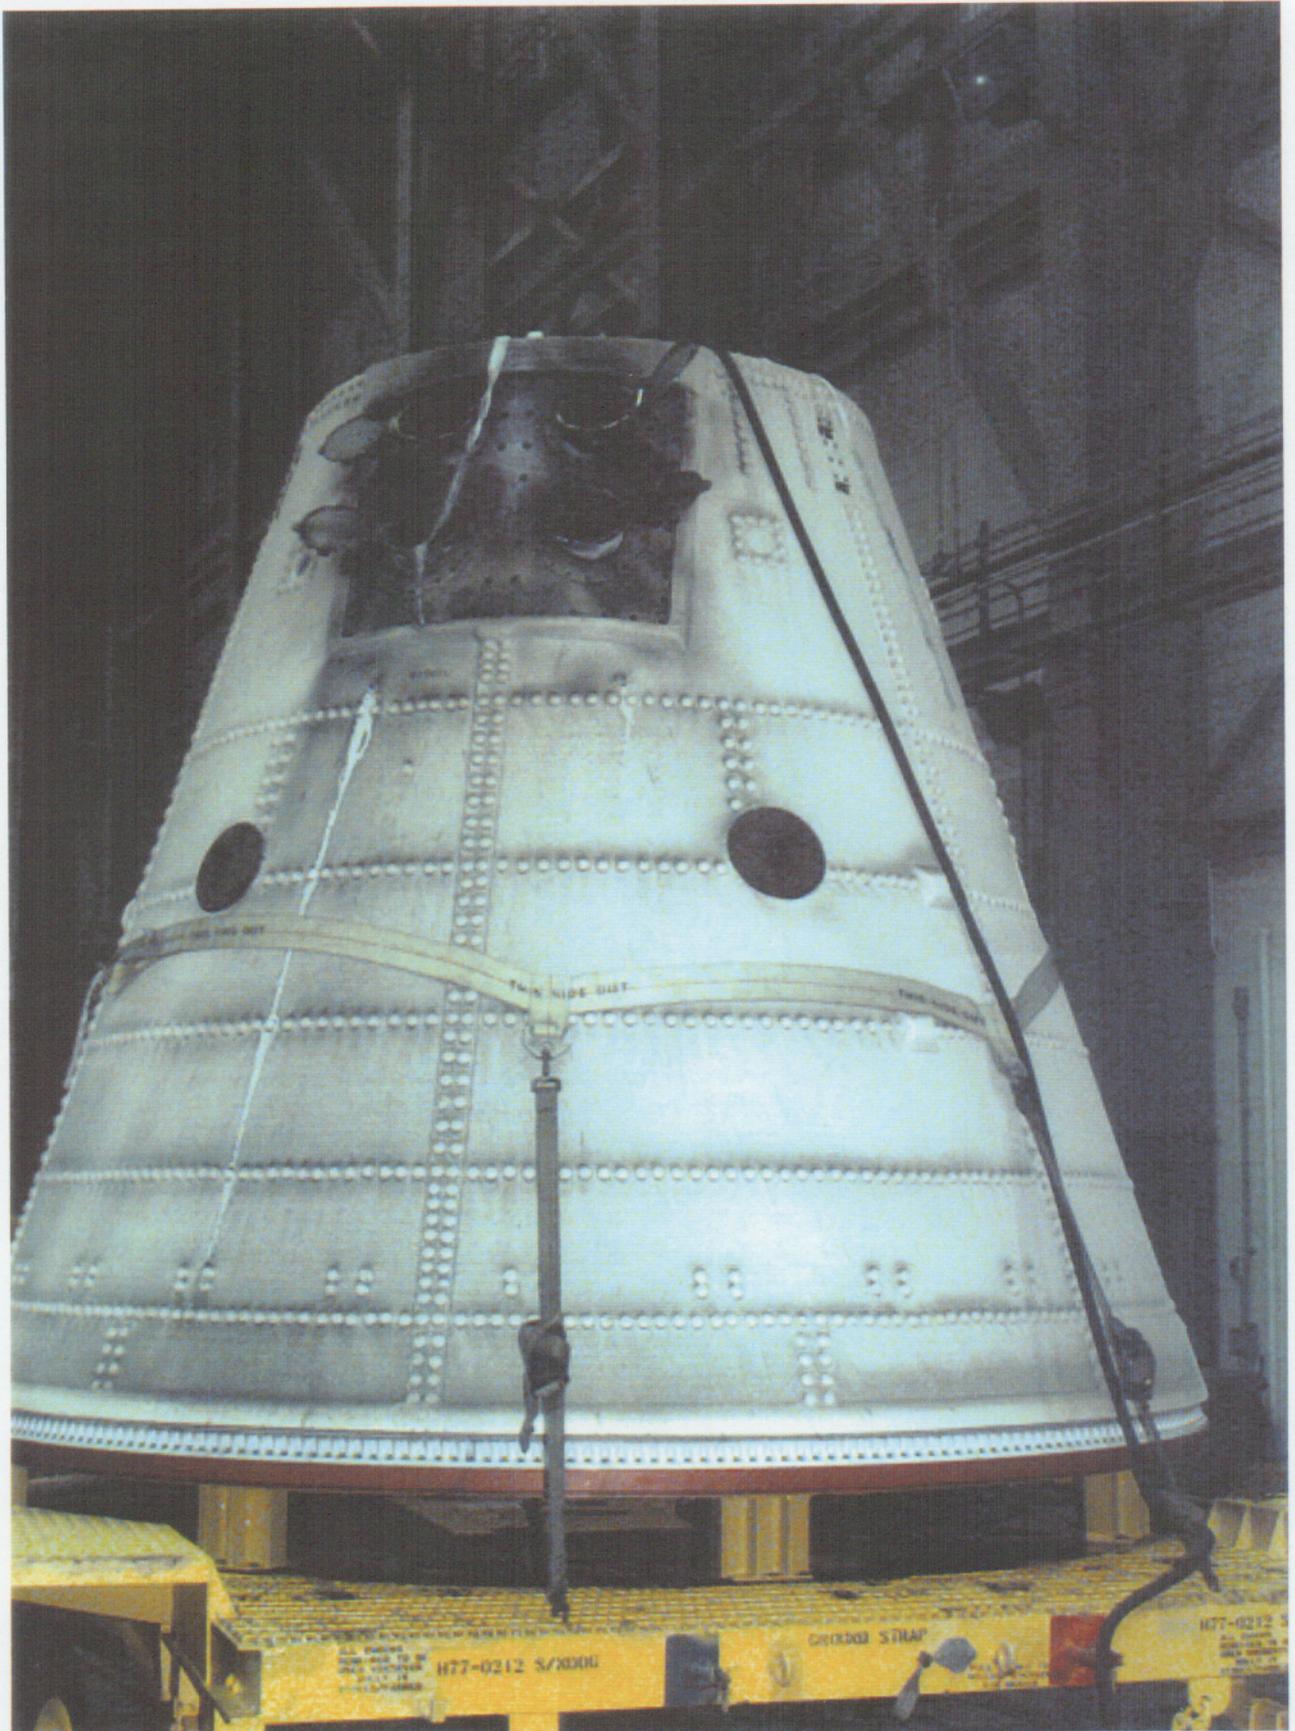
Photo 13: Frustum Post Flight Condition

Both frustums were in excellent condition. No TPS was missing and no debonds/unbonds were detected over fasteners. Virtually none of the Hypalon paint had blistered. All eight BSM aero heat shield covers had locked in the fully opened position though the attach rings on three of the four covers on the left frustum had been bent to varying degrees by parachute riser entanglement.
