Debris/Ice/TPS Assessment and Integrated Photographic Analysis of Shuttle Mission STS-87

Technical Memorandum-1998 - 206642

February 1998

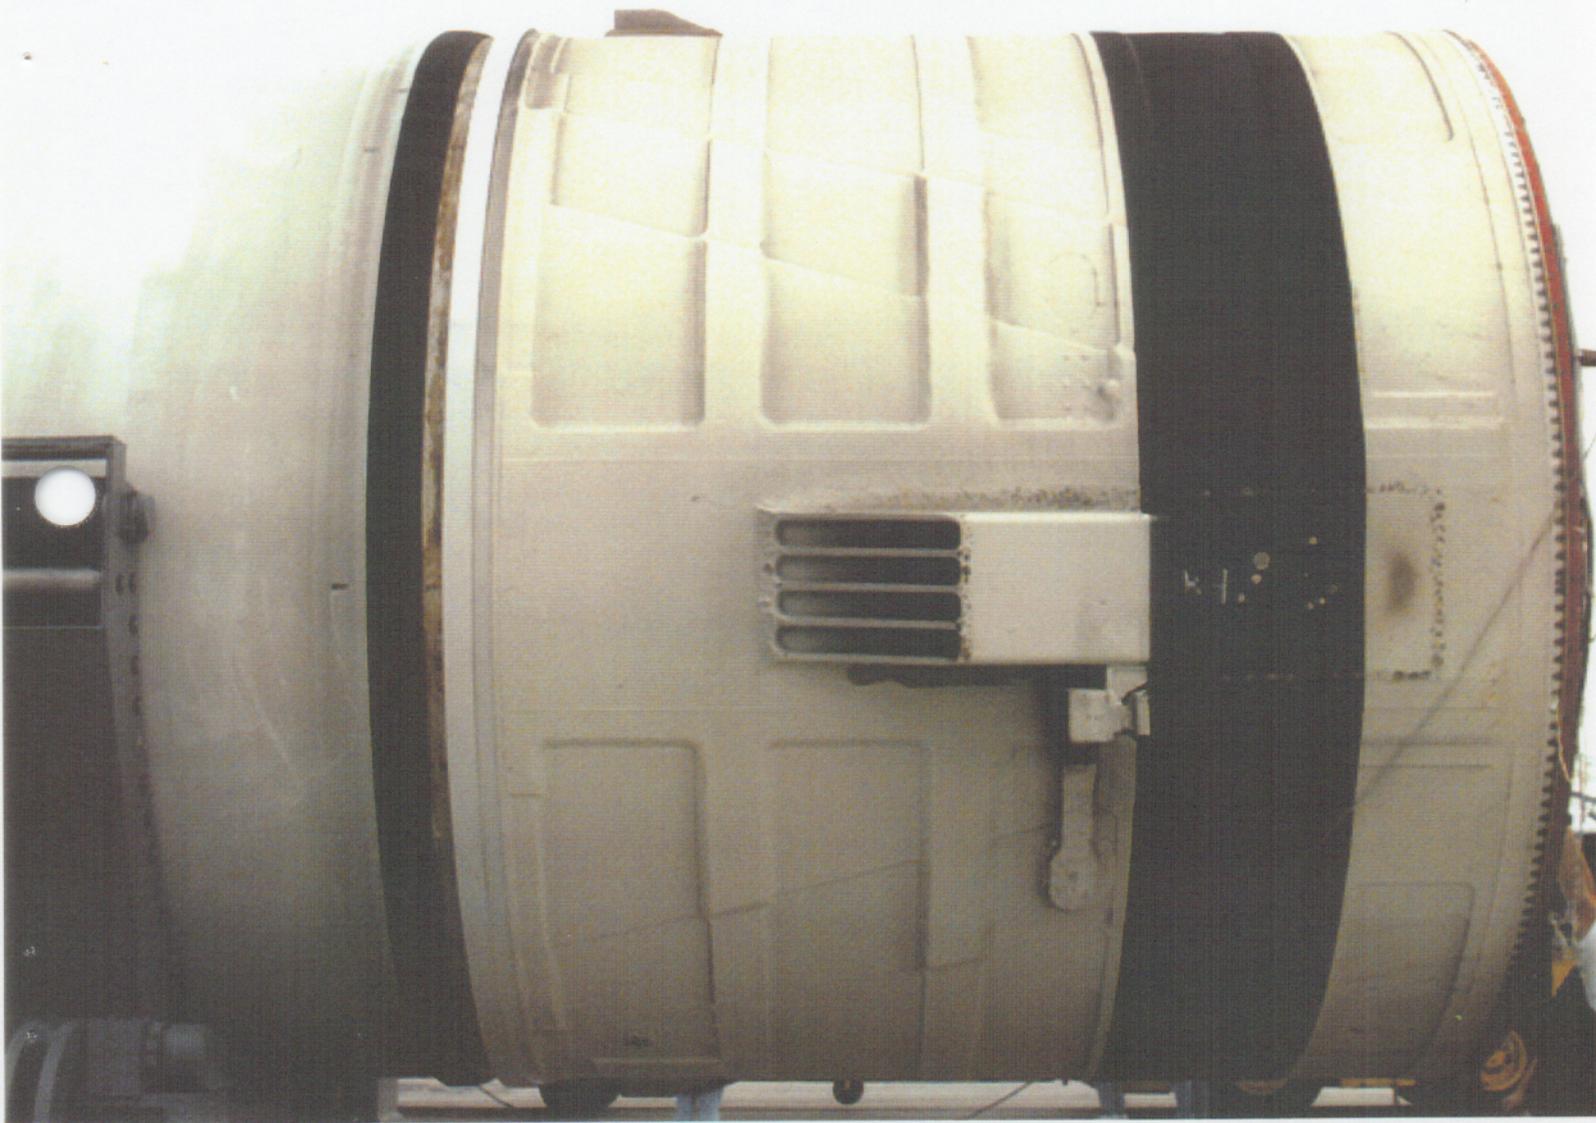
Photo 16: Forward Skirt Post Flight Condition

The forward skirts exhibited no debonds or missing TPS. RSS antennae covers/phenolic base plates were intact. Hypalon paint was blistered/missing over the areas where BTA closeouts had been applied. All frustum severance ring pins and retainer clips were intact.

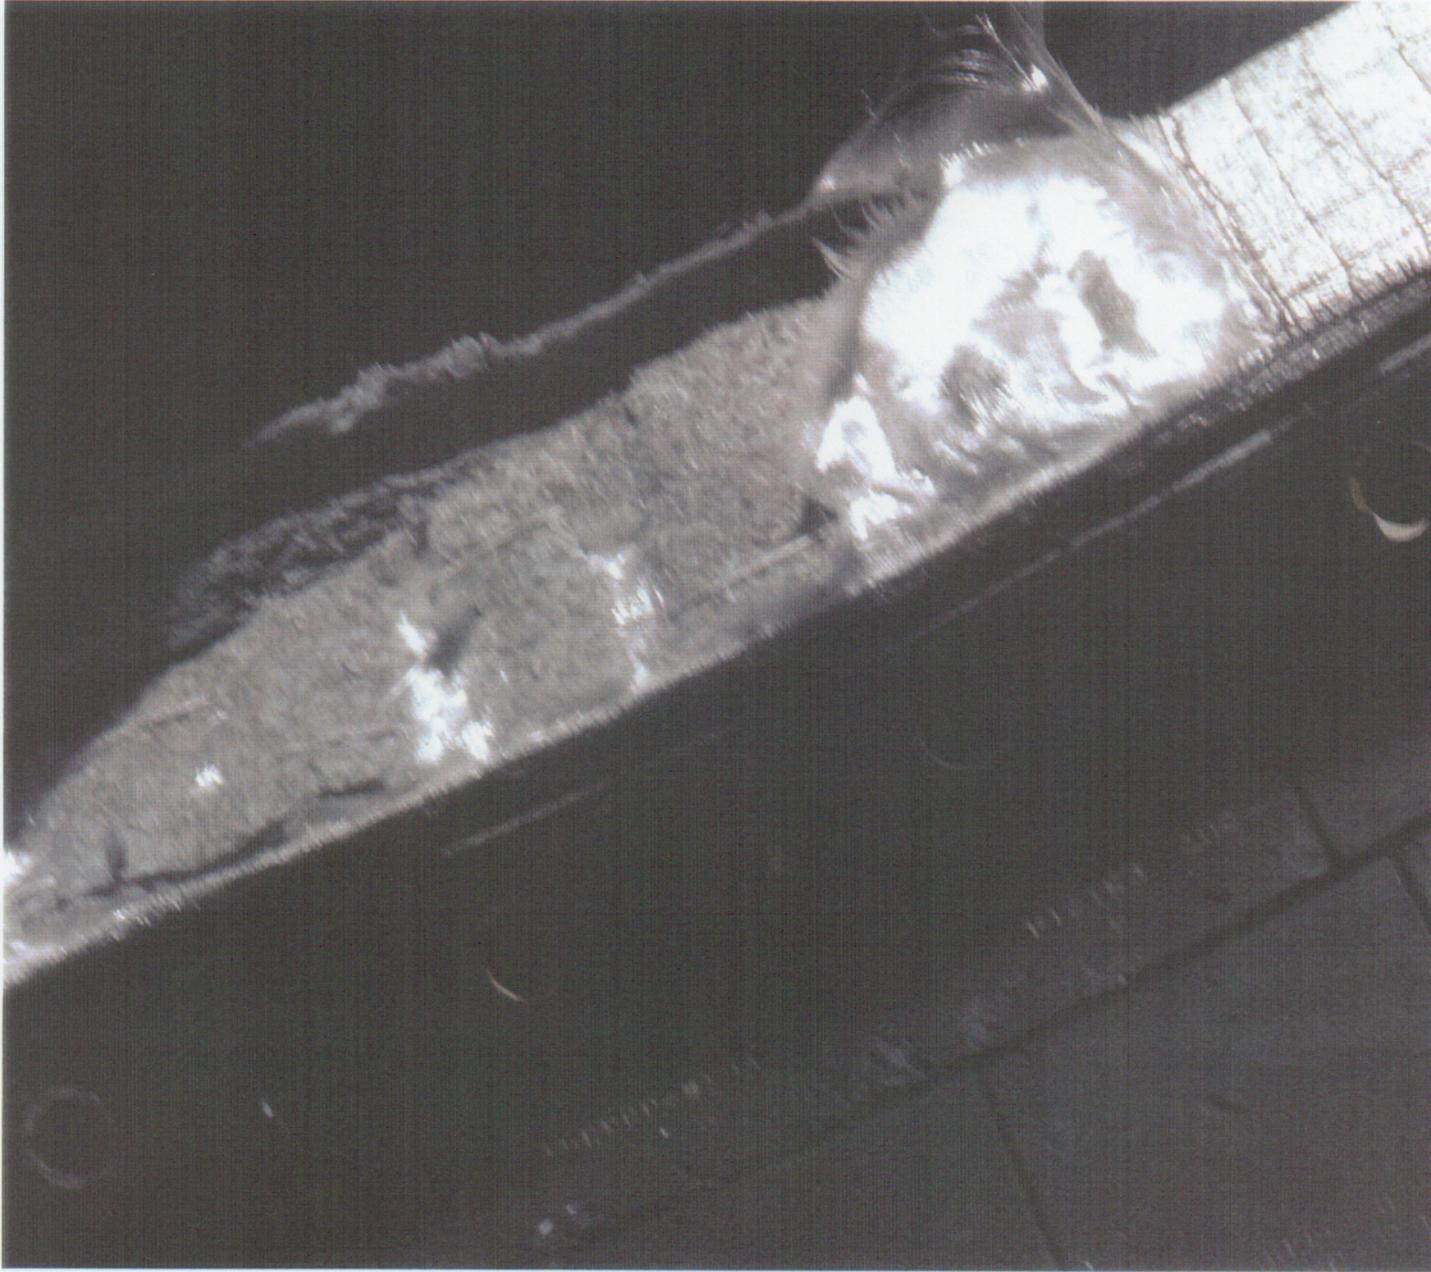
Photo 20: SSME #1 DMHS Blanket Damage

The blanket panels on SSME #1 at the 4-6:00 o'clock position were missing. The underlying batting material was torn and frayed. Loss of this material in flight was detected in the launch tracking films at T+39 seconds MET.

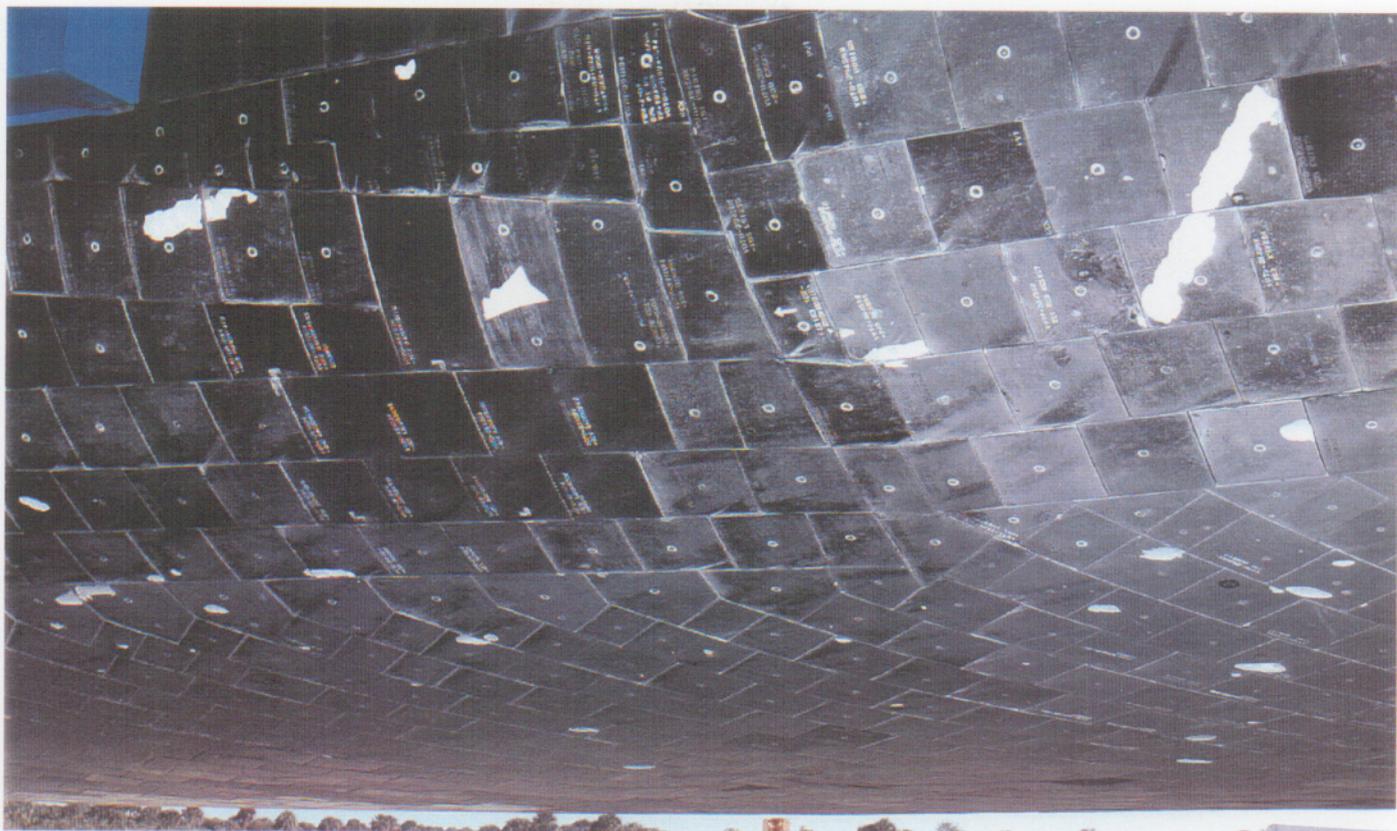
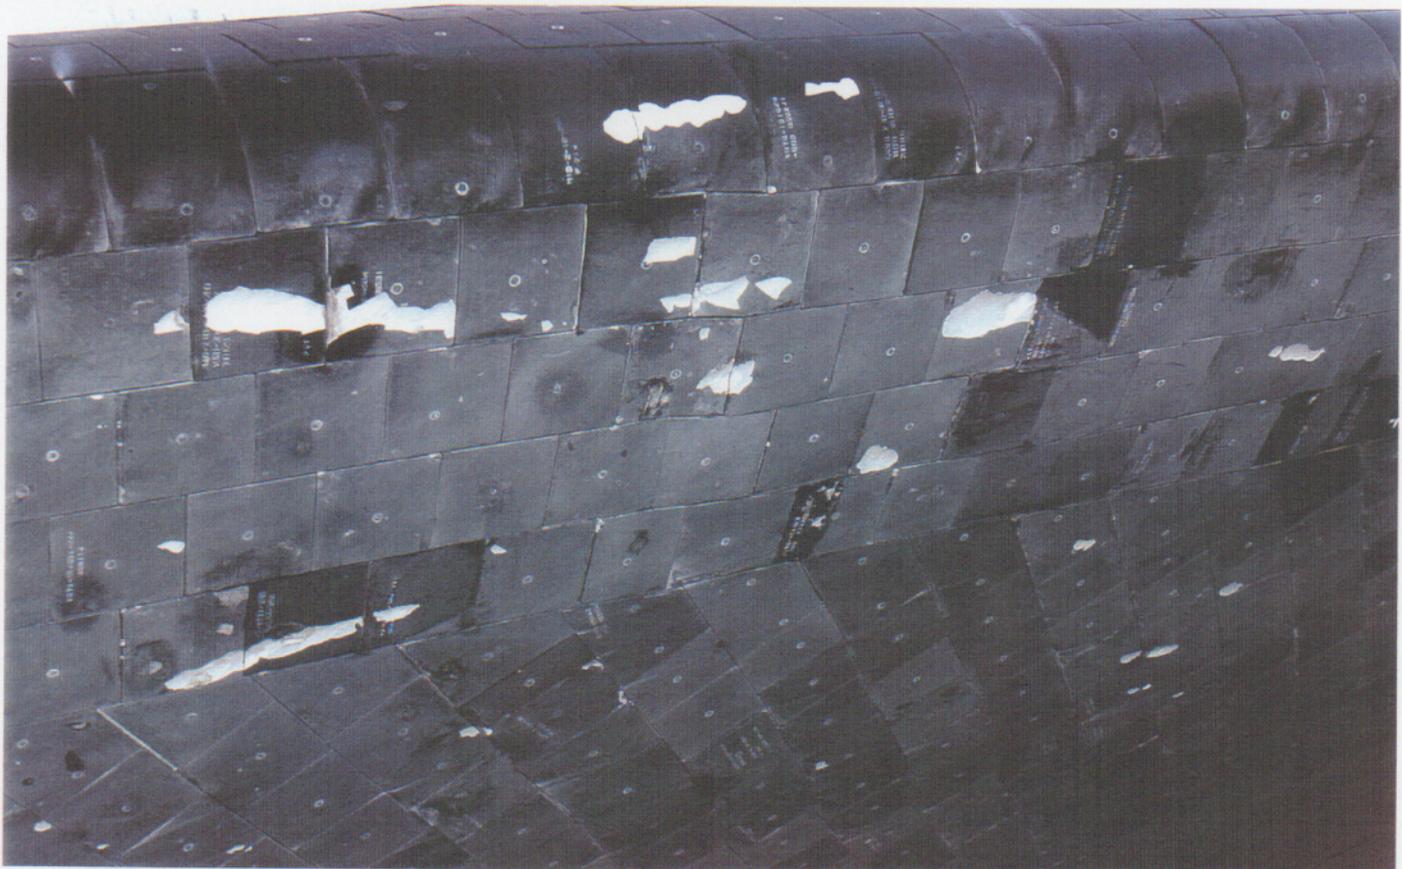
Photo 21: Lower Surface Tile Damage

The Orbiter lower surface sustained at least 244 significant hits, of which 109 had a major dimension of 1-inch or larger. Virtually all of this unusual damage was concentrated in the area between the nose landing gear and the main landing gear more or less symmetrically divided between left (top photo) and right (bottom photo) outboard sides. The largest lower surface tile damage site was located on the left glove. The site measured 15-inches long by 2-inches wide by 0.25-inches deep.

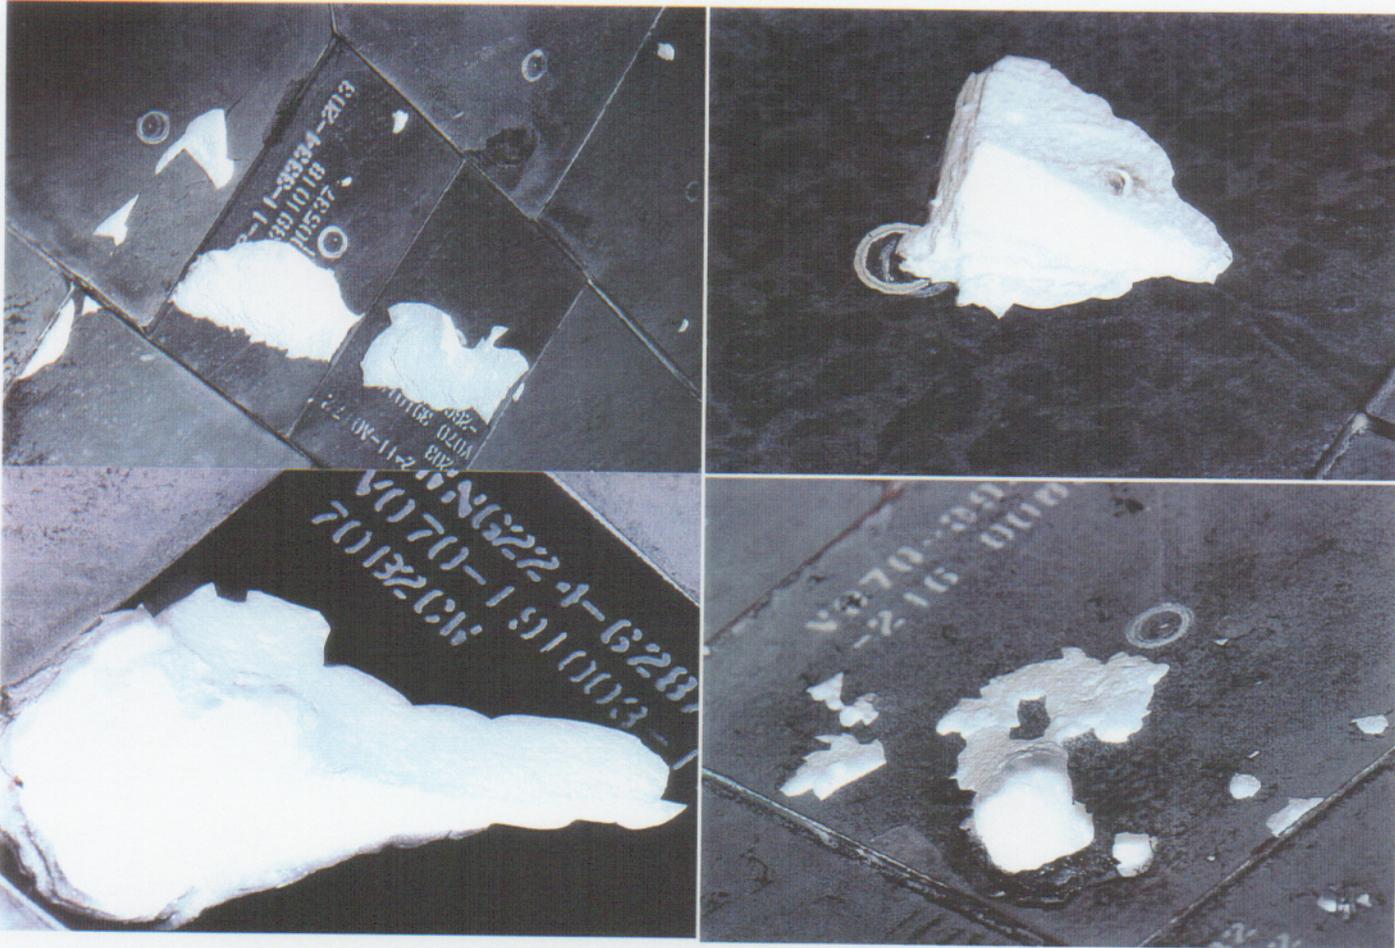
Photo 22: Lower Surface Tile Damage

The deepest lower surface tile damage site was located just forward of the left main landing gear well. It measured 4-inches long by 2-inches wide by 1.5-inches deep. Tile material in the damage sites showed signs of glazing and heat effects from re-entry. The damage sites with significant depth appeared to be generally aligned in a fore to aft direction. Many of these sites were affected by re-entry aerodynamic erosion.

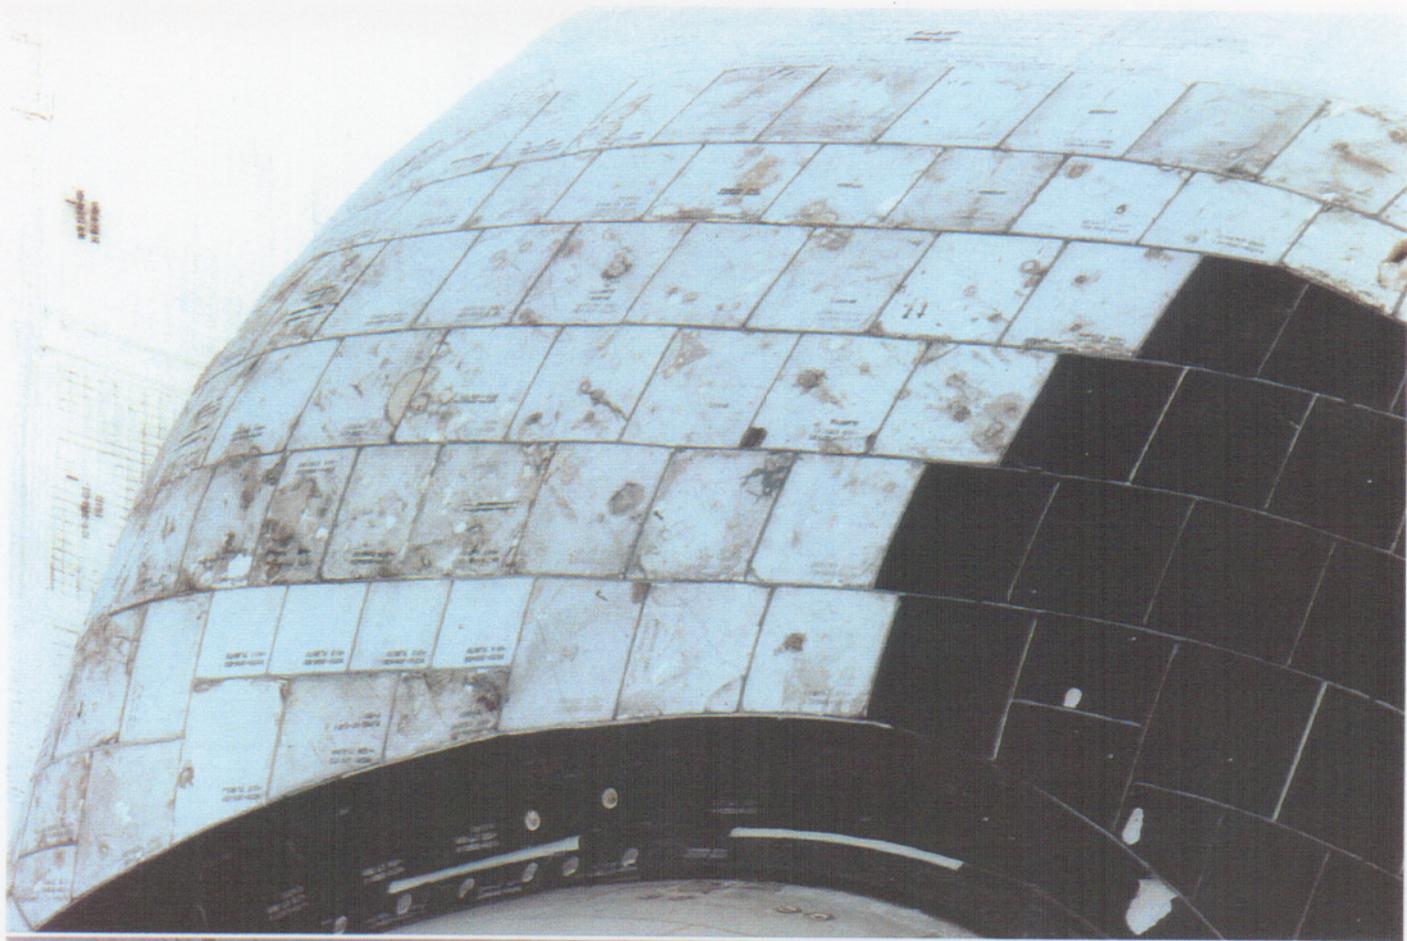
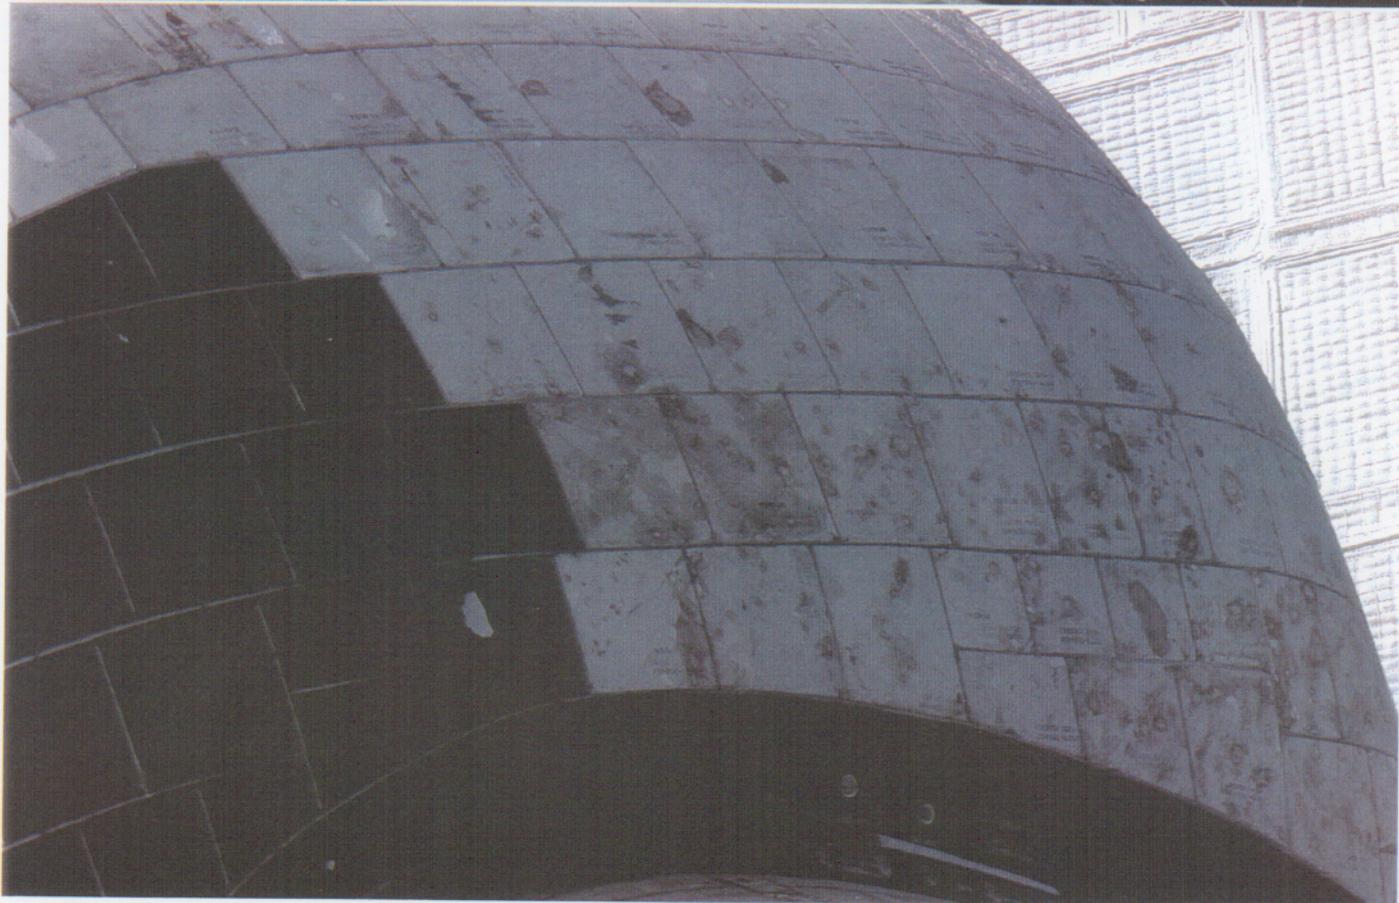
Photo 23: OMS Pod Tile Damage

Unusual tile damage occurred on the lower outboard leading edges of both OMS pods. There were 33 total hits, of which 14 were larger than 1-inch in size.
