Mission STS-100  
OV-105 Flight 16  
Thermal Protection System  
Post-Flight Assessment

October 2001

Thermal Protection System  
Orbiter Engineering

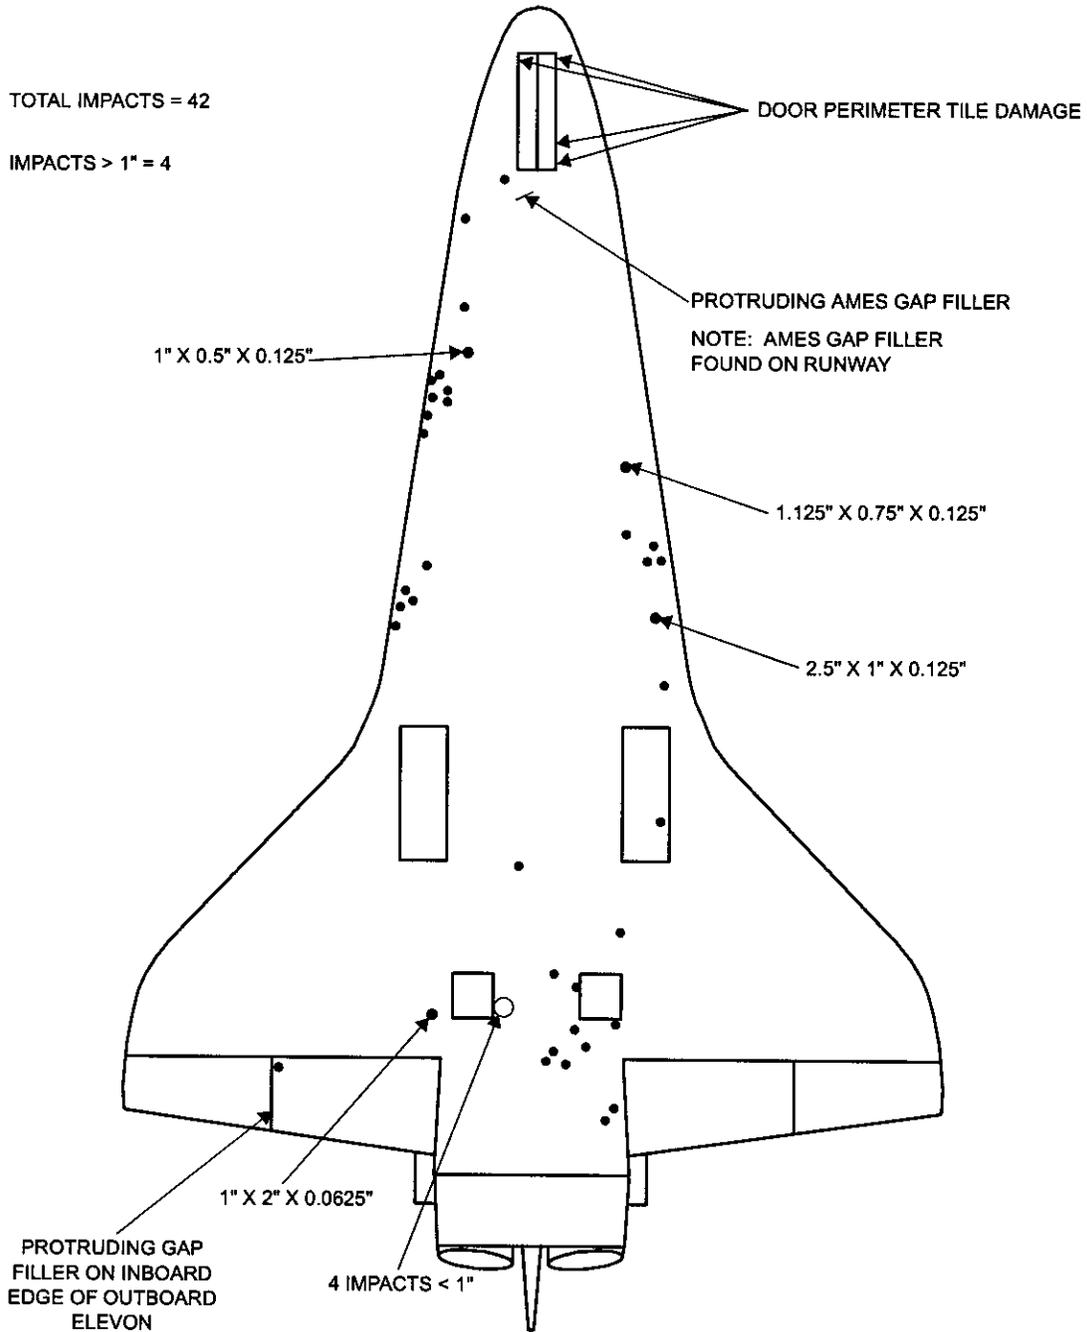
Figure 1. Lower Surface Debris Damage

The TPS on the lower surface was in good overall condition. The lower surface sustained only 42 impacts total, 4 of which were greater than 1 inch. The damage distribution on the lower surface was consistent side to side. The right side of the vehicle had a higher concentration of impacts aft of the NLGD while the left side had a higher concentration around the external tank doors. The previous flight of Endeavour showed a high concentration of impacts on the right hand lower surface. The largest impacts were along the LESS and aft of the right hand external tank doors.

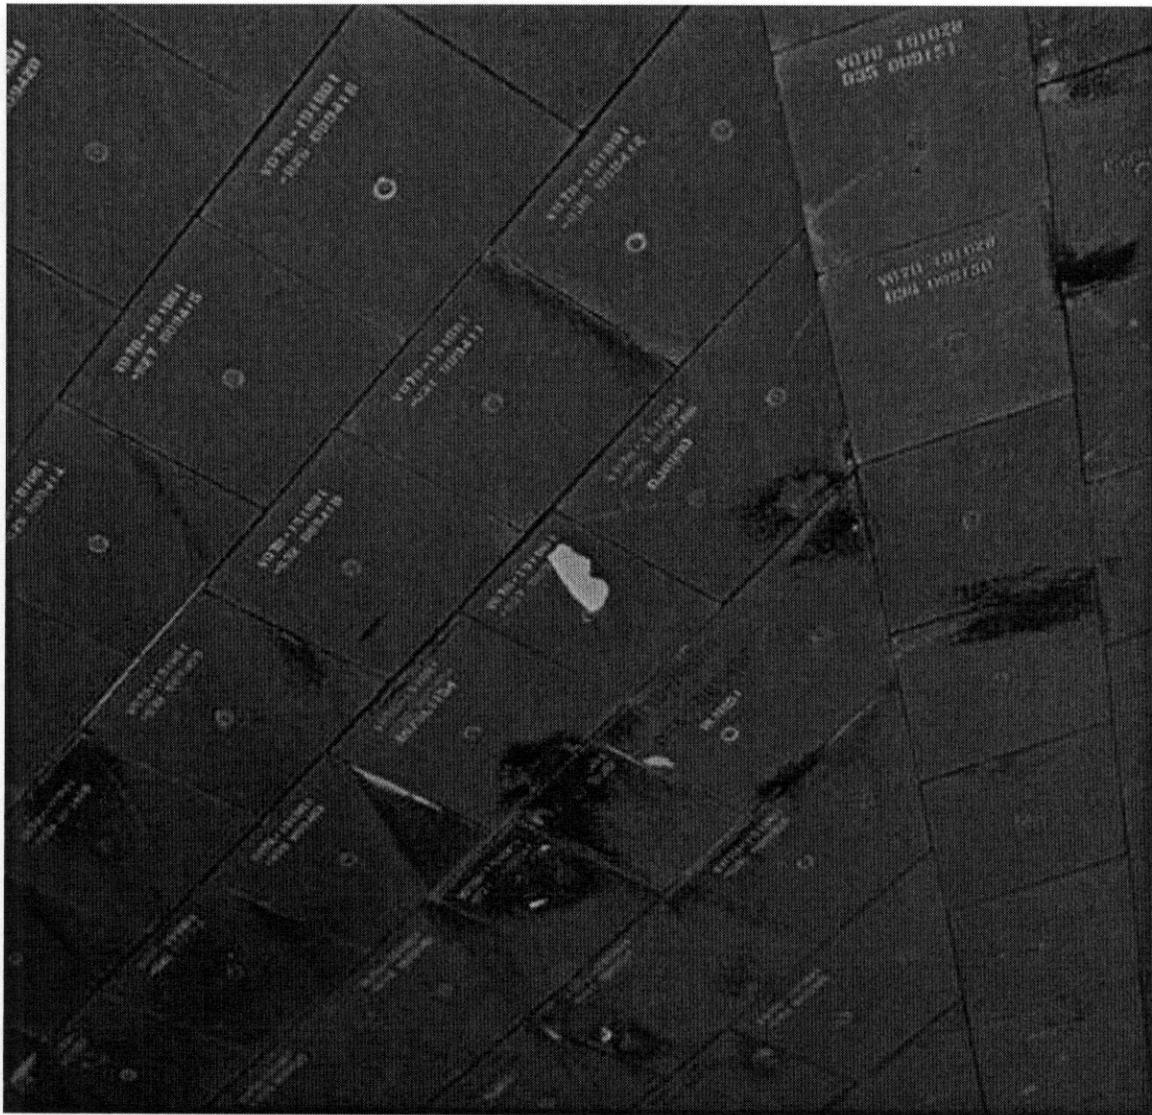
Photo 6. Large Damage On the V070-191001-037 Tile

The largest damage on the lower surface was to the V070-191001-037 tile (refer to [photo 6](#)) located on the left hand wing glove. The damage to the tile was approximately 2 inches by 1.2 inches by 0.100 inch in dimension. The damage was repairable per standard repair procedures.

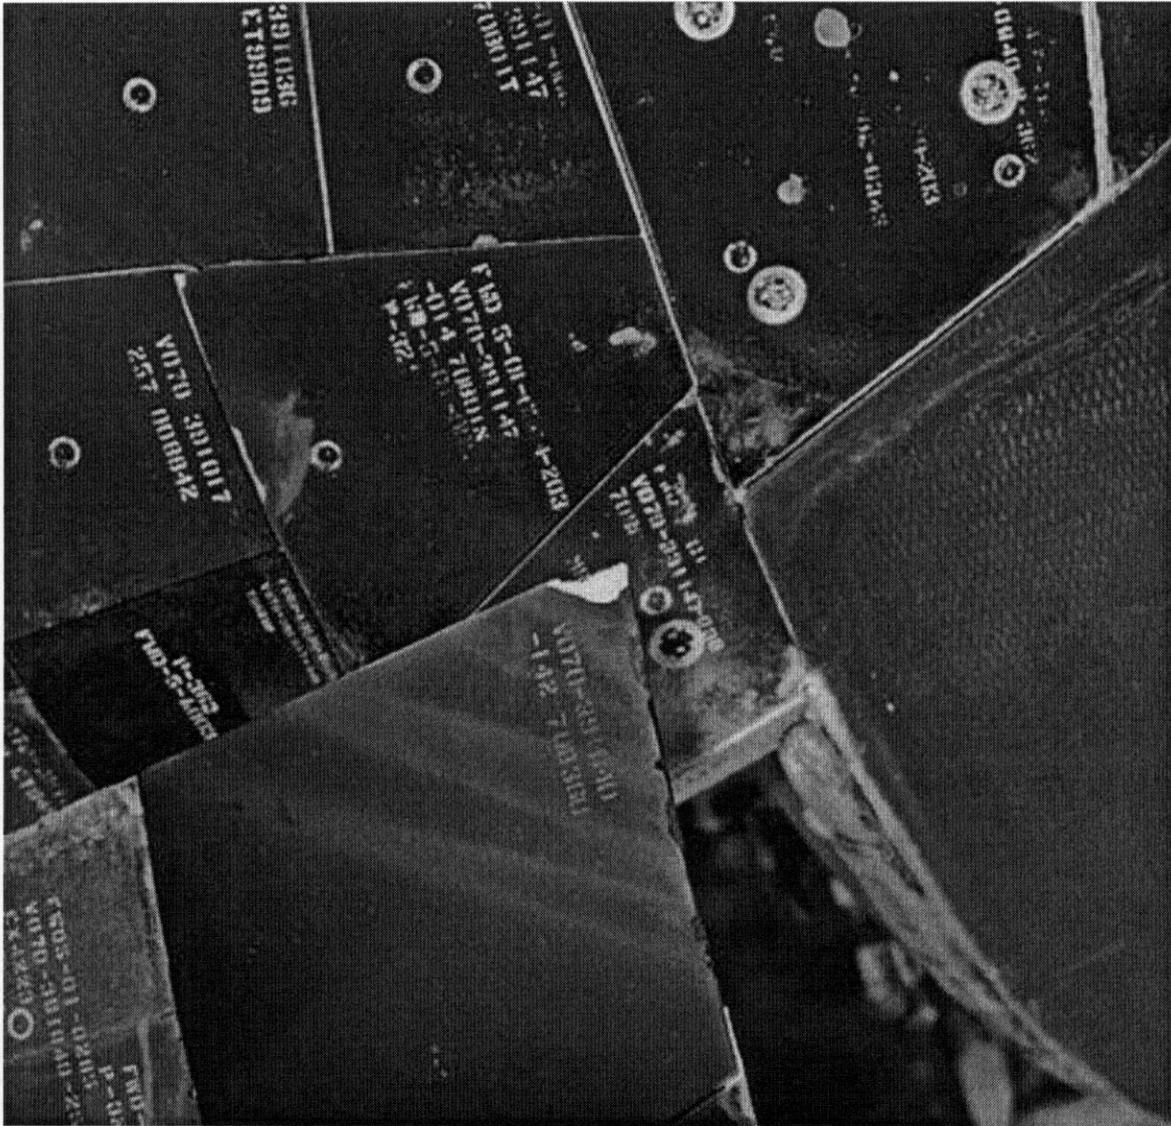
Photo 8. Damage to the V070-391040-142 Tile On the NLGD

Several tiles around the periphery of the NLGD had large damages. The V070-391040-141 and -142 tiles on the forward of the NLGD had large corner damages that were within limitations for standard repair procedures (refer to [photo 7](#) and [photo 8](#)).

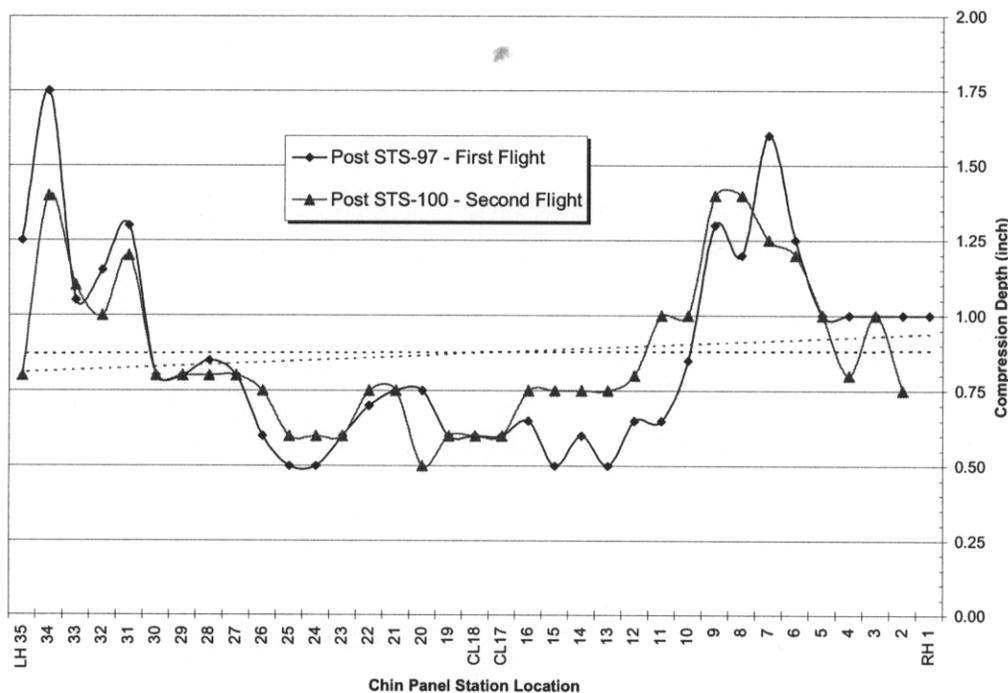
Figure 15. V070-399441 Gap Filler Compression Recession Measurements

The second flight of the V070-399441 gap filler installation was within expectations with minimal change from the preflight measurements as depicted in figure 15. The measurements along the nose-chin interface follow a general trend that is well below the trends from previous flights. This condition was accepted for another flight and will continue to be monitored.

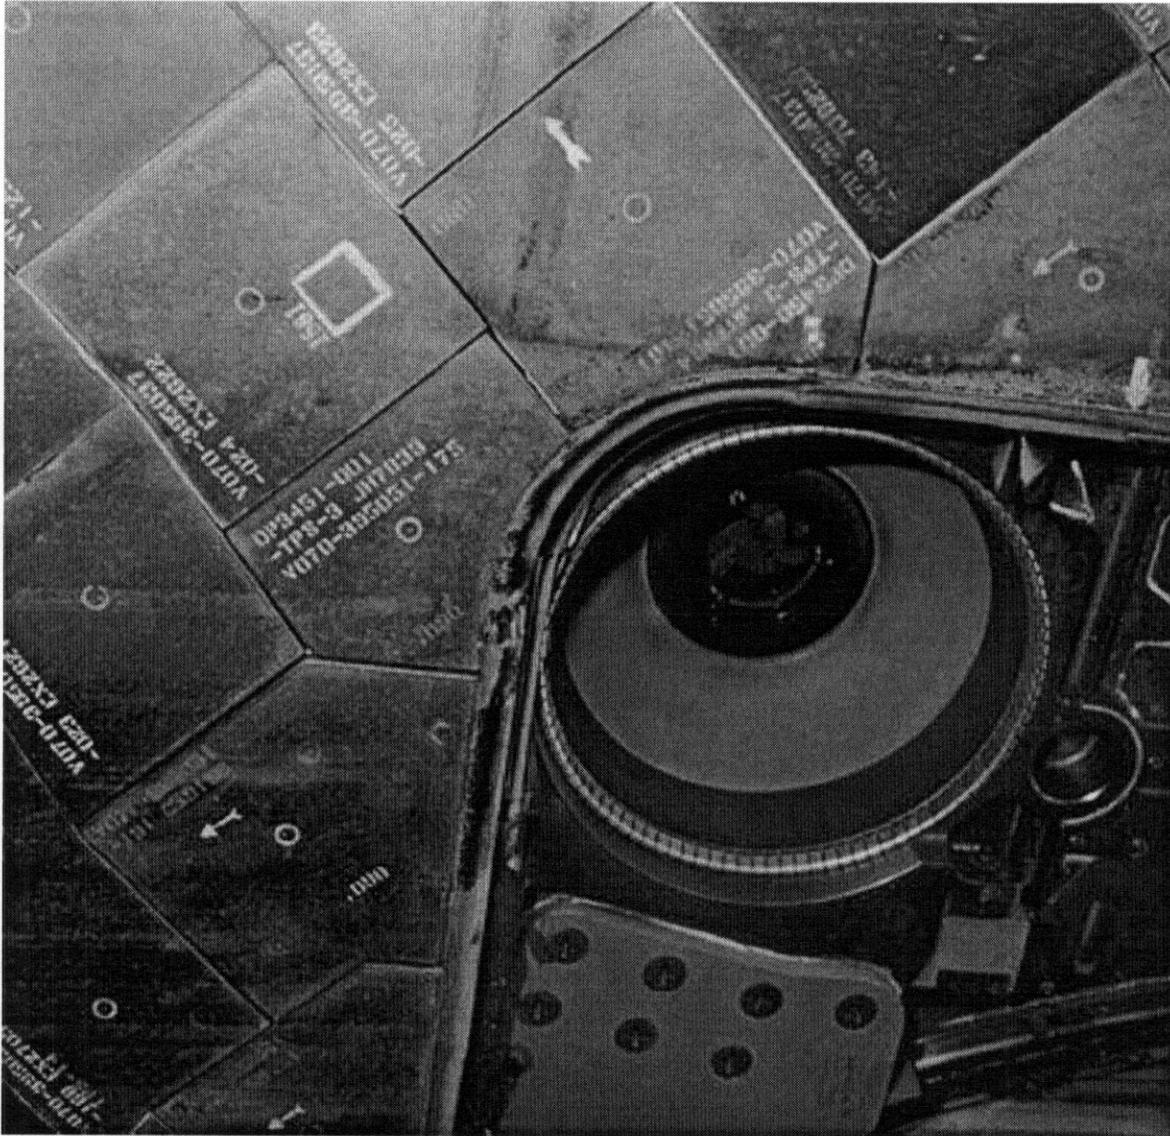
*Photo 11. ET Door Thermal Barrier Umbilical Purge Barrier Charring*

The ET door soft goods performed nominally, with only minimal frayed areas on each side. Typical charring was seen on the thermal barriers (refer to [photo 11](#)). Purge barriers being trapped in the door during closure generally results in charring of the exposed Mylar baggie film due to reentry heating. The resulting trapped purge barrier did not cause any flow or overtemperature to the substrate. All the barriers were removed post-flight 16 due to installation of a redesigned thermal barrier for evaluation purposes. The current design barriers were installed for flight 17 of OV-105 after the test set of barriers were removed (refer to [table 13](#) for ET door replacement history).

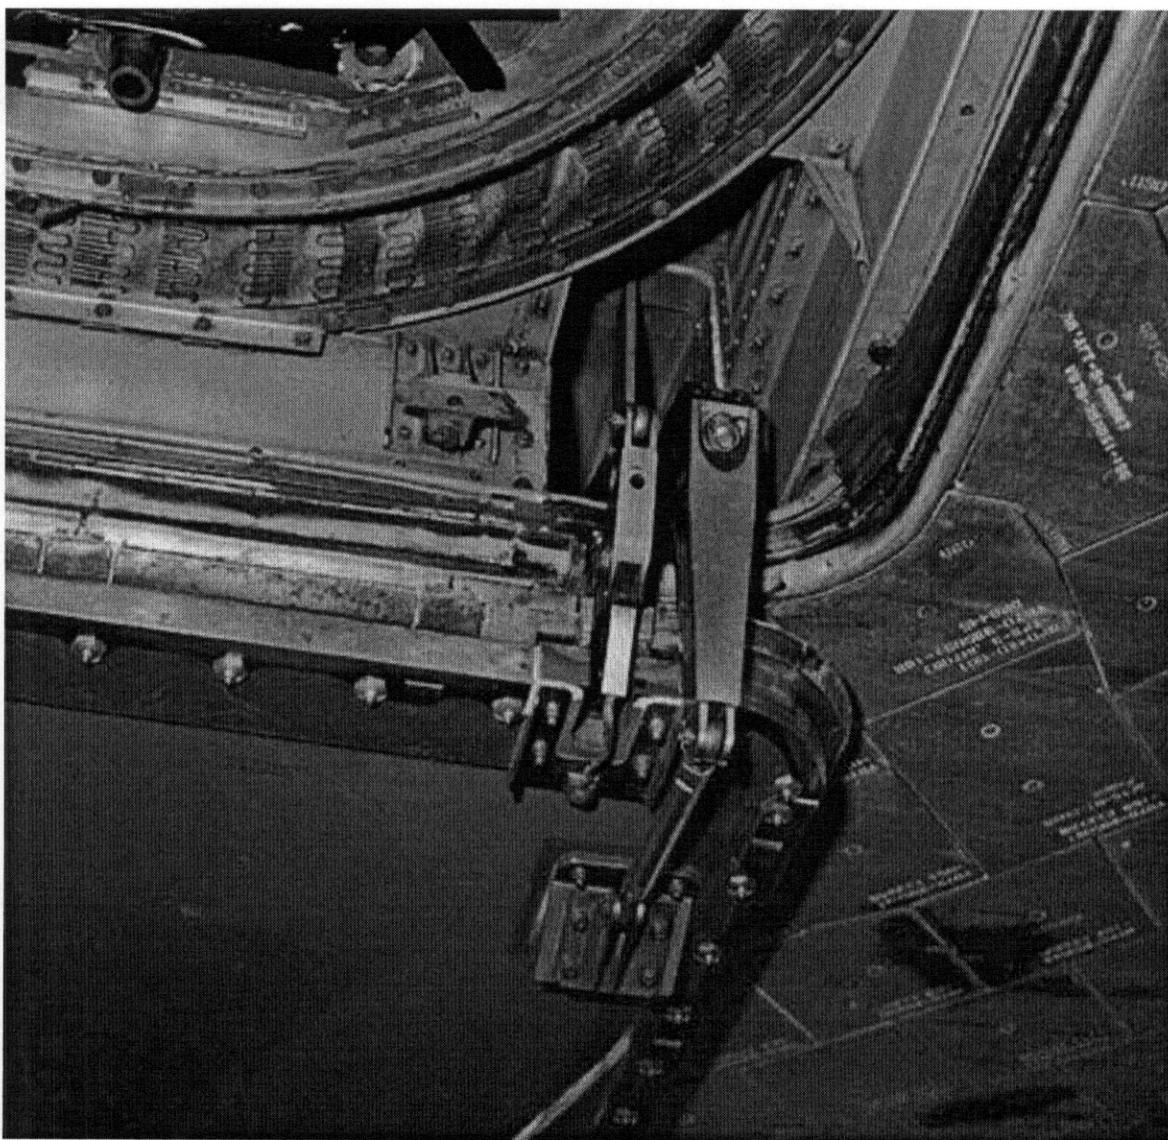
*Photo 12. ET Door Hinge Thermal Barrier Damage*

The right side ET door hinge thermal barrier, V070-398822-002, adjacent to the forward hinge had torn stitches and was protruding. (refer to [photo 12](#)). The barrier was removed and replaced.

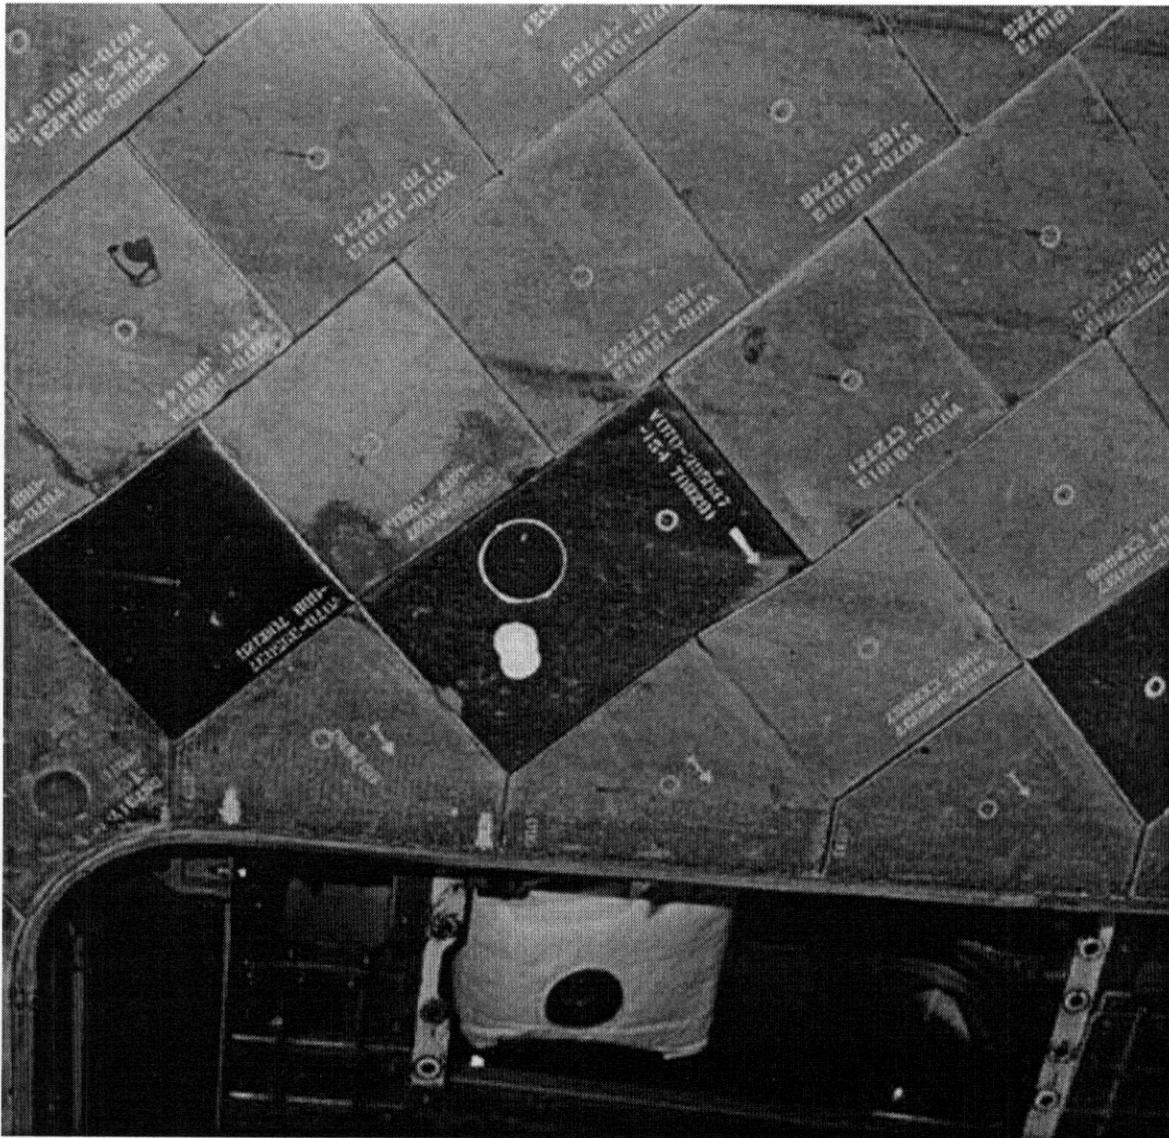
*Photo 13. Damage to the V070-395037-154 Tile Adjacent to the ET Door*

The largest tile damage that occurred due to flight in the ET door area was the V070-395037-154 tile (refer to [photo 13](#)). Several additional tiles were damaged by the installation of the ferry flight door prior to ferry flight from Dryden. These were the V070-395055-175, -176, -177 tiles on the left side ET door. Due to the damage on these tiles a shop aid request was initiated to fabricate a cover to protect these periphery tiles during installation of the ET ferry flight door.

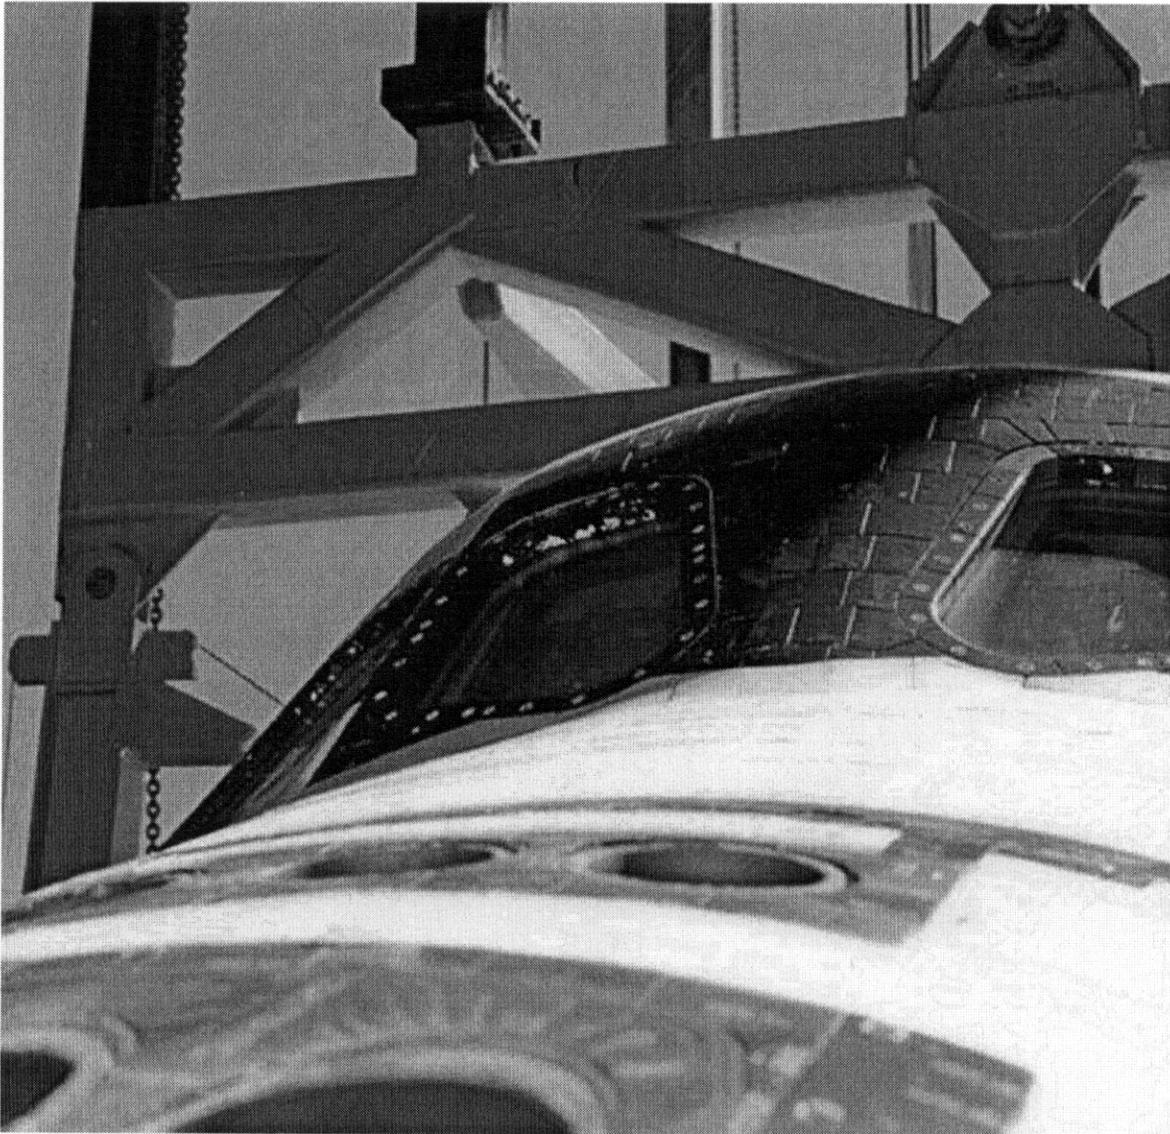
*Photo 14. Window Number 4 Carrier Panel Tile Damages*

Overall, the performance of the TPS on the upper surfaces was nominal. The amount of impacts was much higher than during previous flights. There were 48 impacts total, 8 of which were larger than 1 inch and all were concentrated in the window area. The largest area of damage occurred on the carrier panels adjacent to window number 4 (refer to [photo 14](#)). These damages resulted in the removal and replacement of three tiles (V070-390067-166, -172, and -174). Several other window carrier panel tile damages were large enough to require removal and replacement of the tiles (V070-390066-190 tile on window number 5, and the V070-390067-220 tile on window number 3).

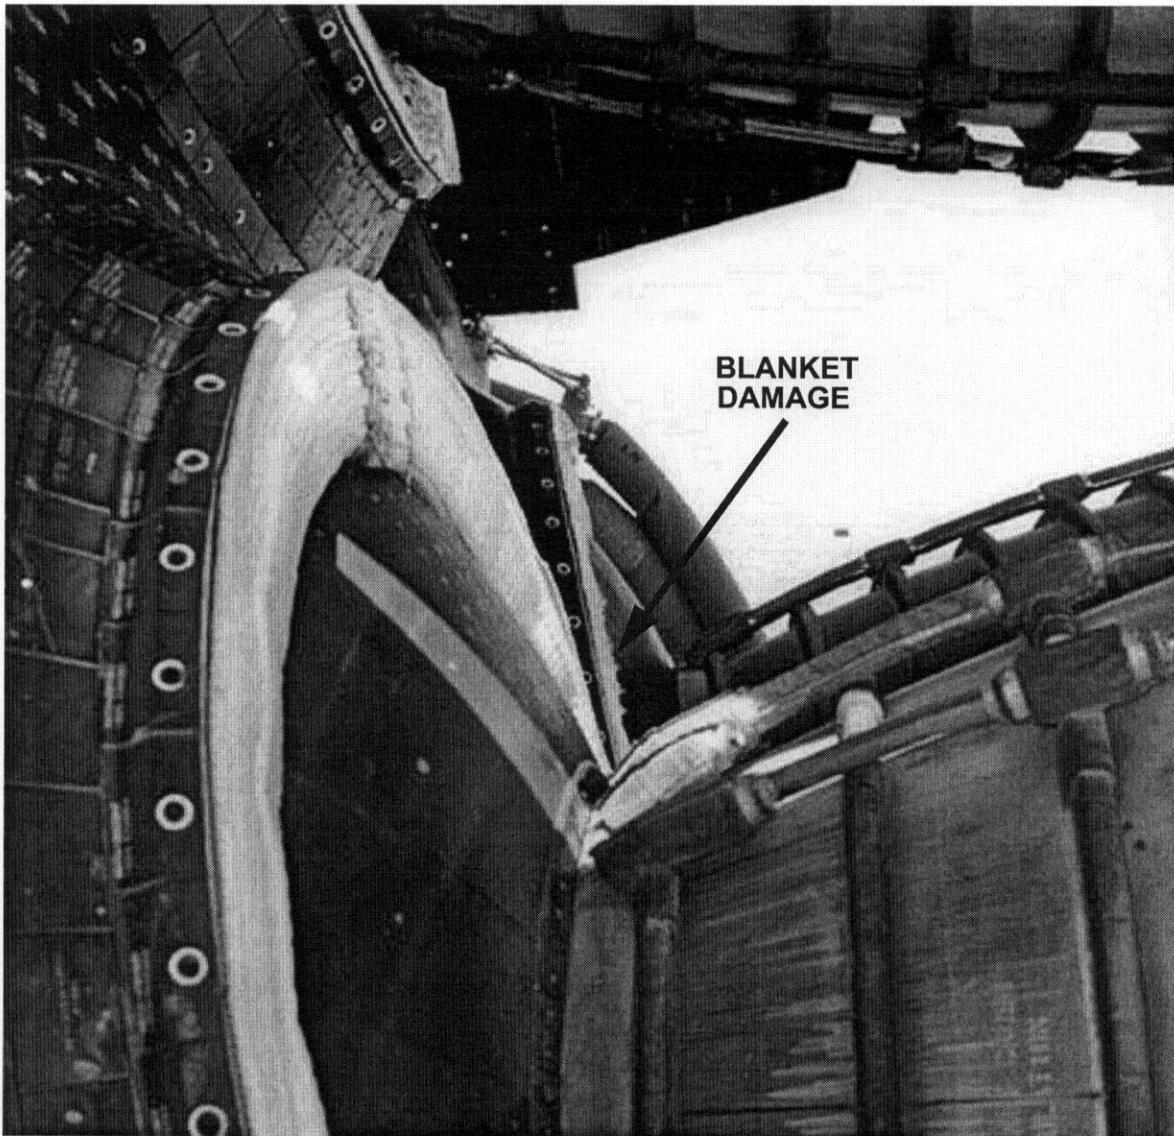
*Photo 17. Aft Base Heat Shield Blanket Damage*

TPS on the base heat shield was in nominal post-flight condition. The SSME dome mounted heat shield blankets were all in nominal condition with only one anomaly that occurred at the 10 o'clock position of engine number 3 (refer to [photo 17](#)). The blanket was removed and replaced post flight. No obvious defects were present on the AETB-8/TUFI tiles located between engine numbers 1, 2 and 3; typically referred to as the “shotgun blast area”. Typical peppering occurred on the dome heat shield tiles and was repairable per standard repair procedures.
