NASA-DoD Lead-Free Electronics Project IST Evaluation of Reliability

Thirty-three coupons were received and subjected to incoming inspection and prescreening prior to an Internal Stress Test (IST) evaluation for reliability. The coupons were identified with three digit numbers, sequentially starting with 121 through 153.

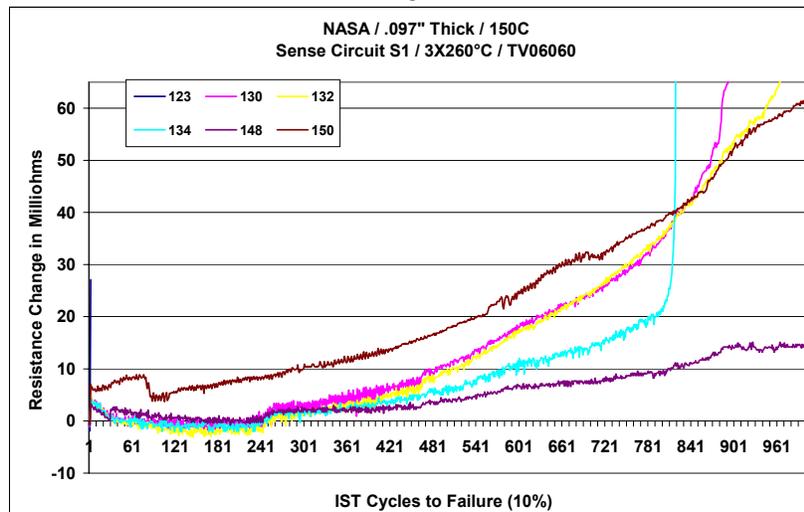
**Typical Resistance Graph Power Circuit S1 – 3X260°C - .040" Grid
 Graph 1**

Resistance graphs were processed for all test groups. The resistance graph demonstrates the damage accumulation (increase in resistance) at maximum test temperature (150°C) which is plotted against thermal cycles. The graphs generally demonstrated that most coupons exhibited a gradual increase in resistance until failure. Coupons that failed on the power circuit were more prone to accelerated damage accumulation after approximately 3% increase in resistance. The sample graph 1, coupons 134 in light blue, demonstrates an acceleration in damage accumulation after ~3% increase in resistance while the other circuit failed at a steady rate.

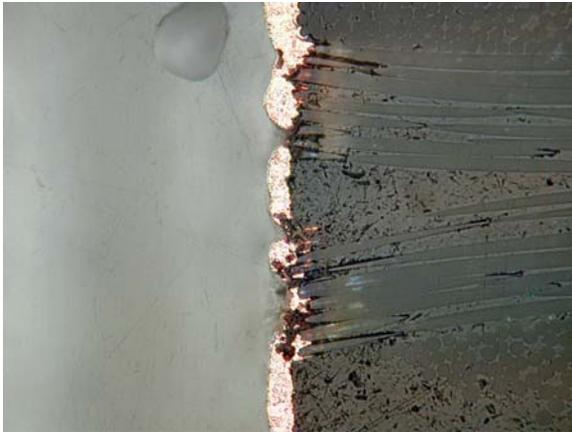
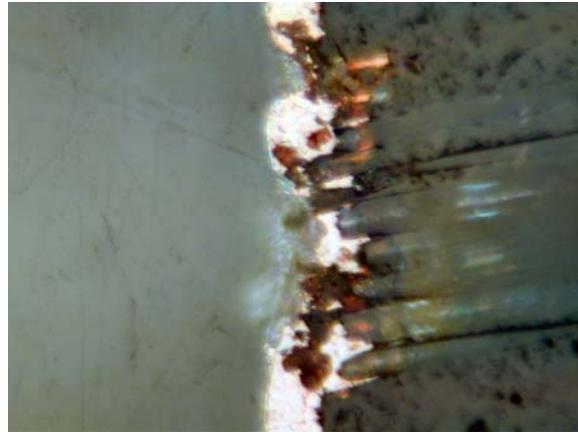
Photo 1

Thin Copper: Thin electrolytic copper in the barrel of the PTH is a primary influence in coupon reliability. Coupon 123 failed in three thermal cycles due to thin copper and plating voids. Coupons with very low copper, even if they pass electrical test (ET), tend to fail catastrophically in a few IST cycles. This has been classified as an “infant mortality” failure for the purpose of this study.

XS# 3727 – Coupon 123, Failed S1, Three IST Cycles, Tested As Received

1. Thin copper plating observed in coupon 123 is a quality liability. Boards with thin plating will be likely to fail during assembly or after a few thermal cycles. This catastrophic failure should occur within tens of thermal cycles making the condition easily identifiable in test data. If early failure occurs the reading could reasonably be edited out of the data with the justification that this condition is not a reflection of lead free assembly but rather a process variation.

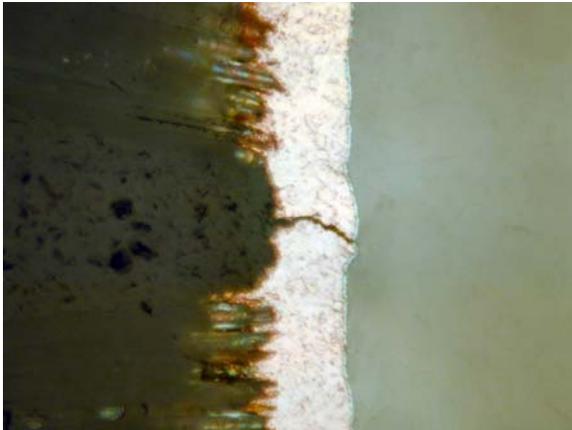
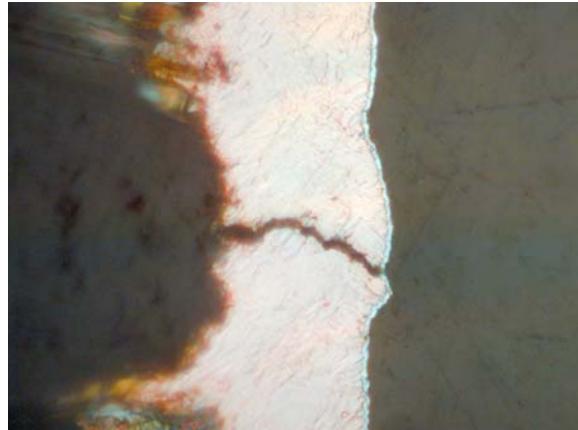
Photo 3

Metal Fatigue Barrel Cracks – Metal fatigue type barrel cracks are a wear out mechanism. The crack usually develops over time and transverse the copper of the interconnect at a 20 to 50 degree angle. A metal fatigue crack will typically propagate between copper crystals. These cracks are frequently closed at ambient. This type of failure mode is consistent with slowly accumulating resistance that does not accelerate during the life of the test. Robust coupons which survive thousands of IST cycles will present this failure mode.

Coupon 128 and 146 were preconditioned 3X230°C and demonstrated the typical metal fatigue type of wear out failure that is associated with a robust coupon.

XS# 3737 – Coupon 146, Failed S1, 169 IST Cycles, Precon 3X230°C

2. The barrel cracks observed in the two coupons that were preconditioned to tin-lead assembly temperatures (3X230°C) present the typical failure mode found in robust coupons that survive thousands of cycles. If the test boards fail in this manor the results would be considered to offer a fair comparison between tin-lead and lead-free assembly and rework.

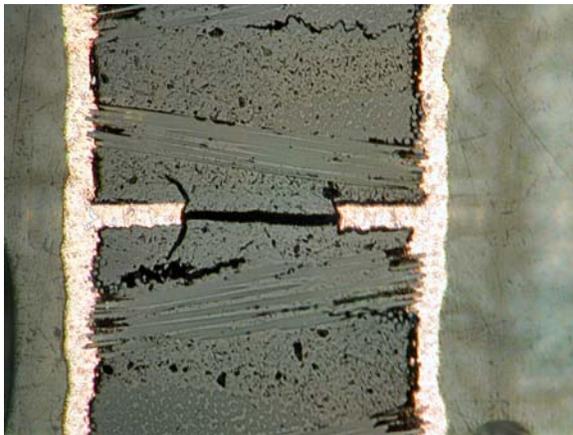
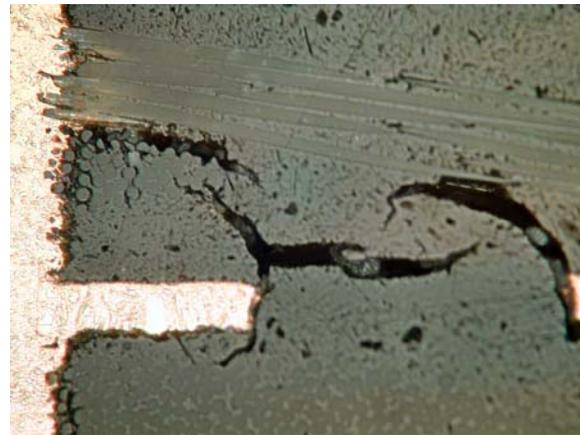
Coupon 137 did not fail by end of test at 1000 IST cycles. Microscopic evaluation demonstrated that this coupon presented a cohesive degradation of the dielectric material. Since this condition did not degrade the power or sense circuits in the IST coupon it is assumed that this condition was stress relieving.

XS# 3739 – Coupon 137, No Failure, 1000 IST Cycles, Precon 3X230°C
Photo 5 **Photo 6**

3. Capacitance measurements made on the coupon in the 30 pF range, which is too low to be sensitive to delamination and material degradation.
4. Coupon 137, preconditioned 3X260°C, had no failure in 1000 cycles but demonstrated cohesive degradation of the dielectric. Cohesive degradation may have artificially extended the thermal cycles to failure. Since capacitance measurements were found to be too low to be effective in the coupons, microsections will be required to be used as a referee for the presents of delamination. If boards are found to have extended cycles to failure after more aggressive assembly and rework than control boards or boards with less aggressive assembly and rework then delamination should be suspected and microsections processed.

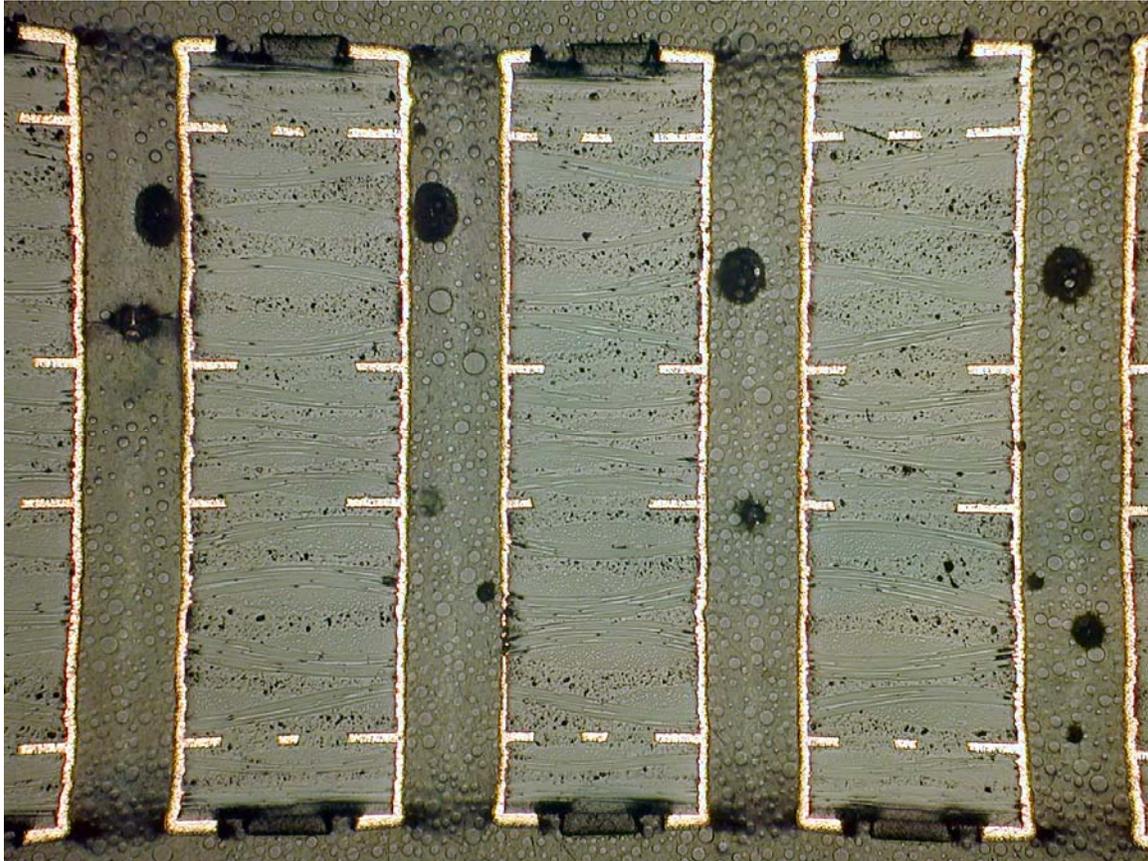
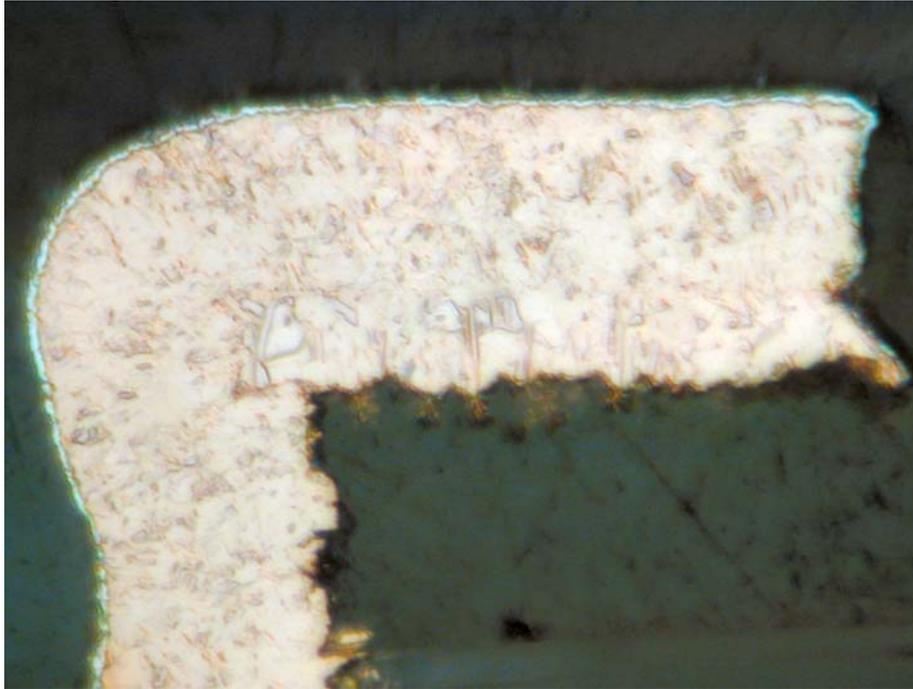
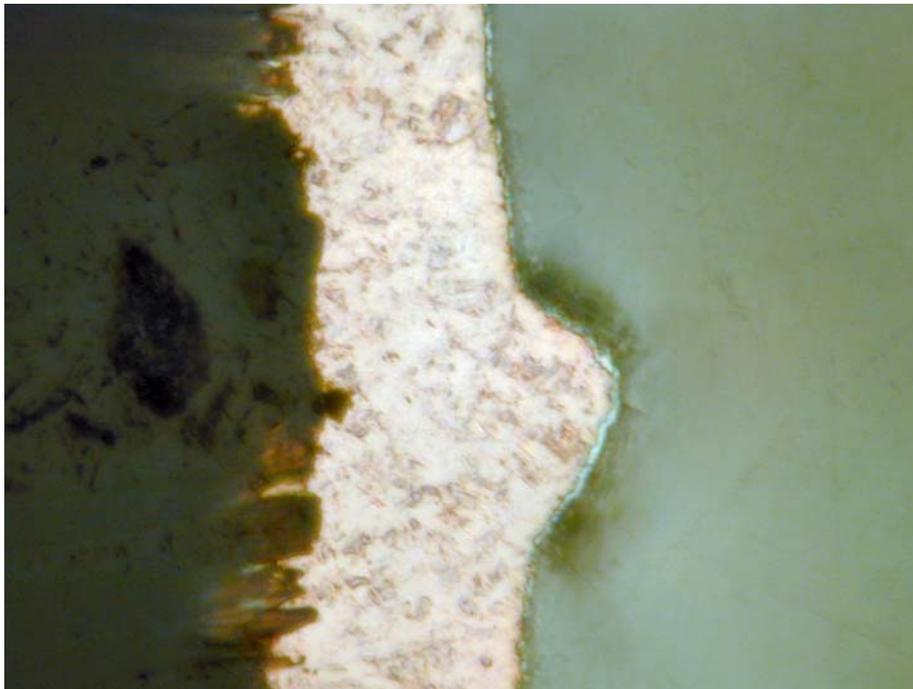
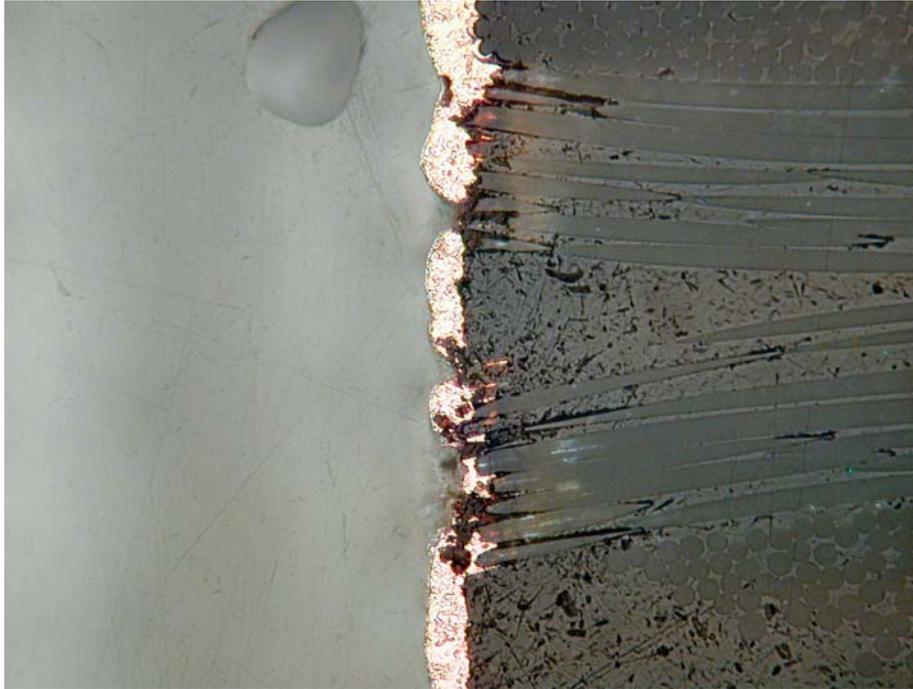
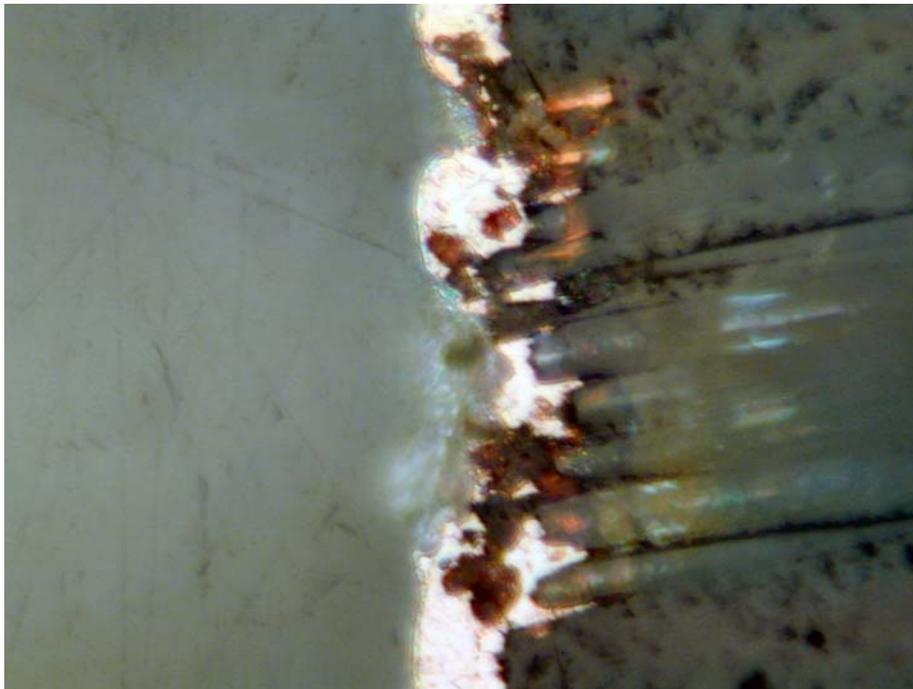
**XS# 3727 – Coupon 123, Failed S1, Three IST Cycles, Tested As Received
Photo 7**

**XS# 3727 – Coupon 123, Failed S1, Three IST Cycles, Tested As Received
Photo 8**

**XS# 3727 – Coupon 123, Failed S1, Three IST Cycles, Tested As Received
Photo 9**

XS# 3727 – Coupon 123, Failed S1, Three IST Cycles, Tested As Received
Photo 10

XS# 3727 – Coupon 123, Failed S1, Three IST Cycles, Tested As Received
Photo 11

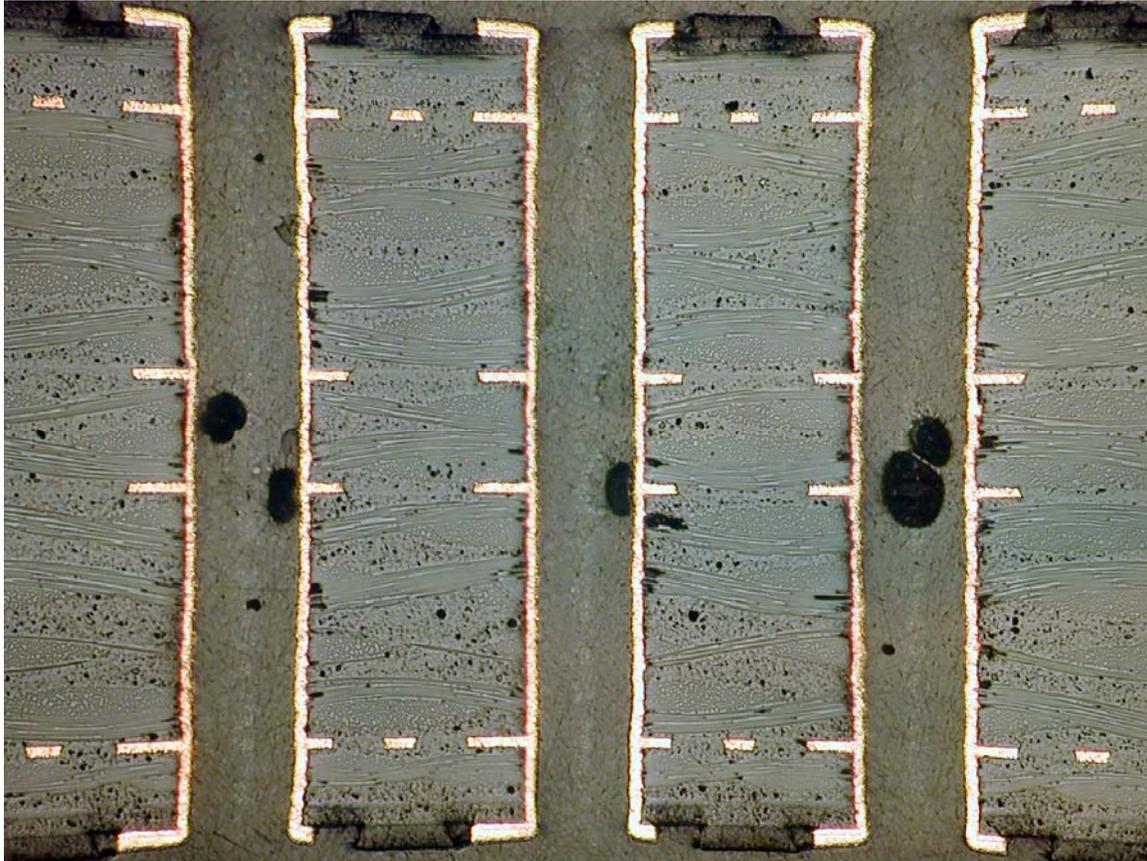
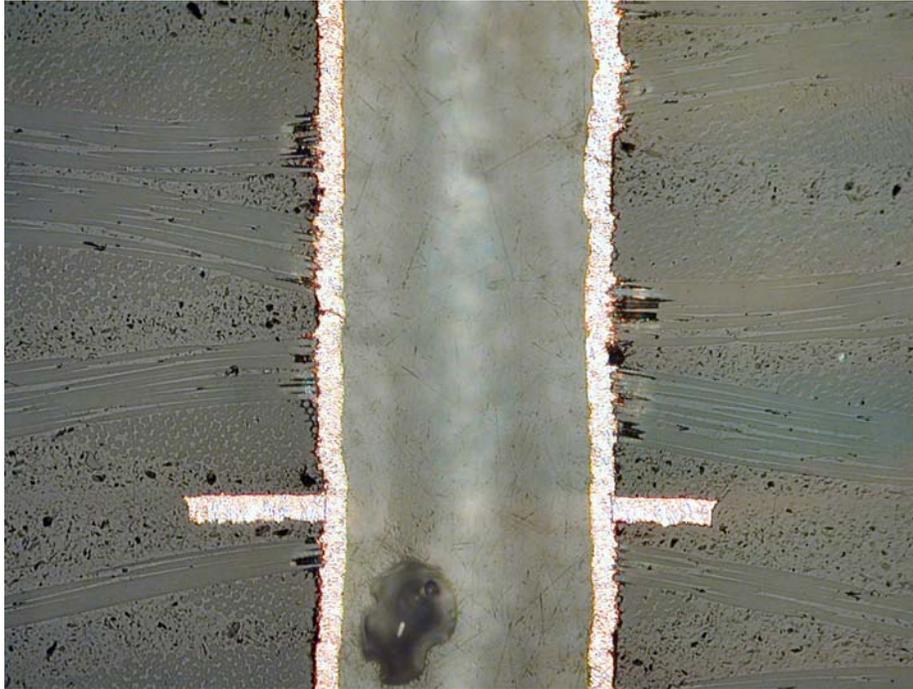
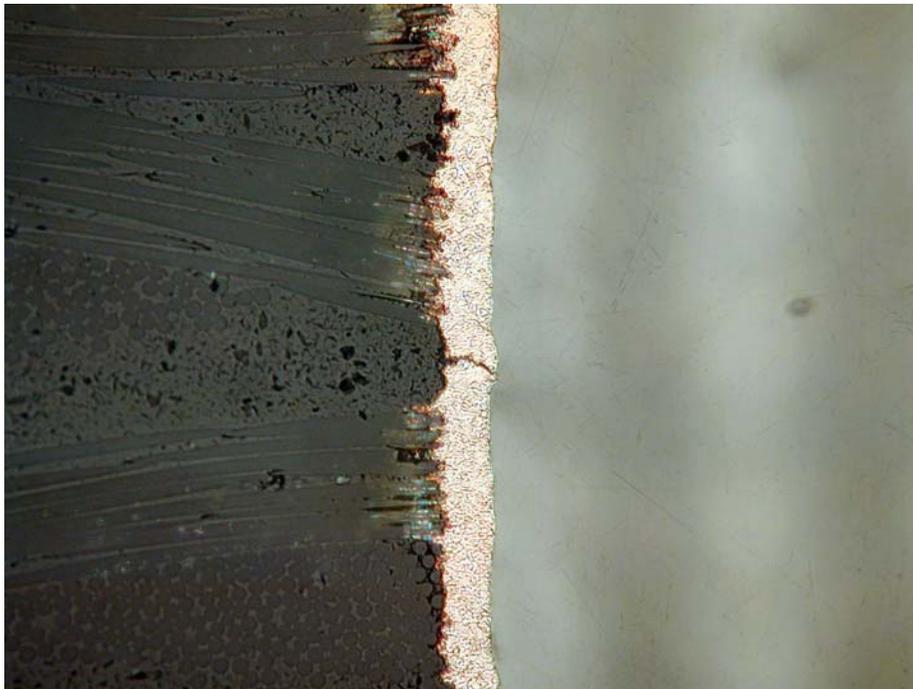
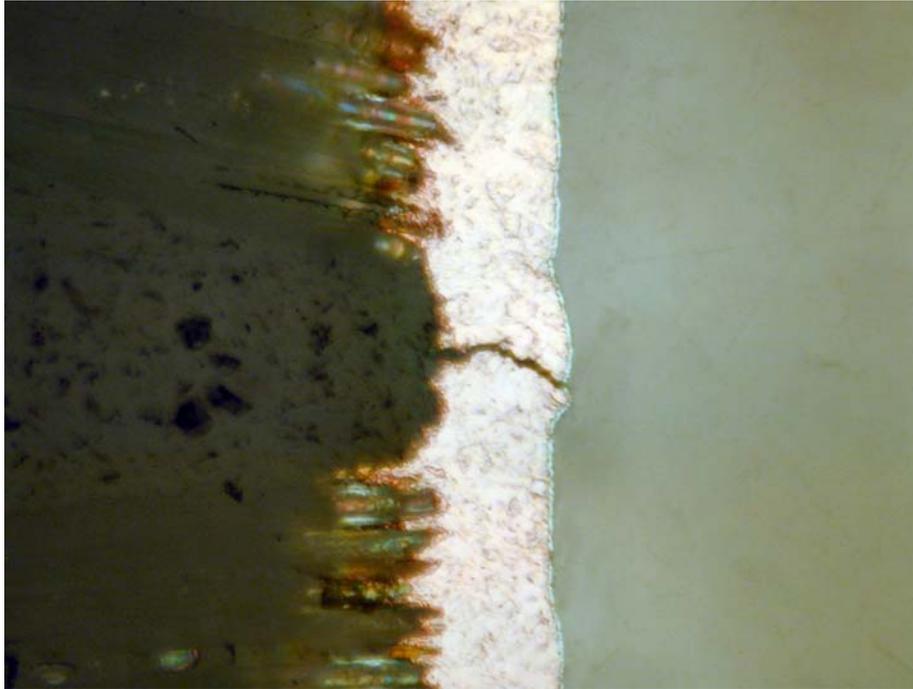
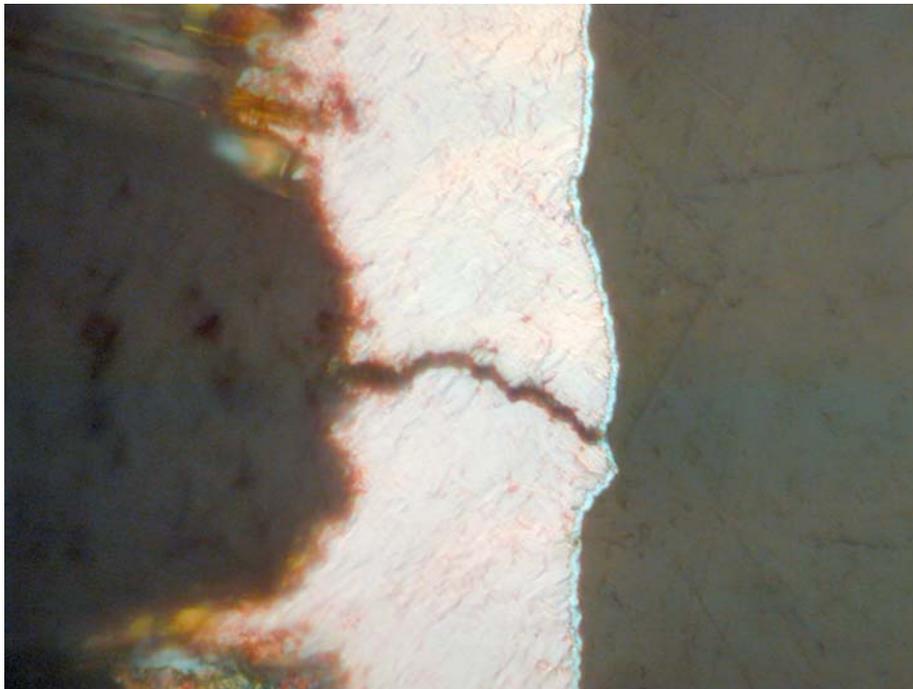
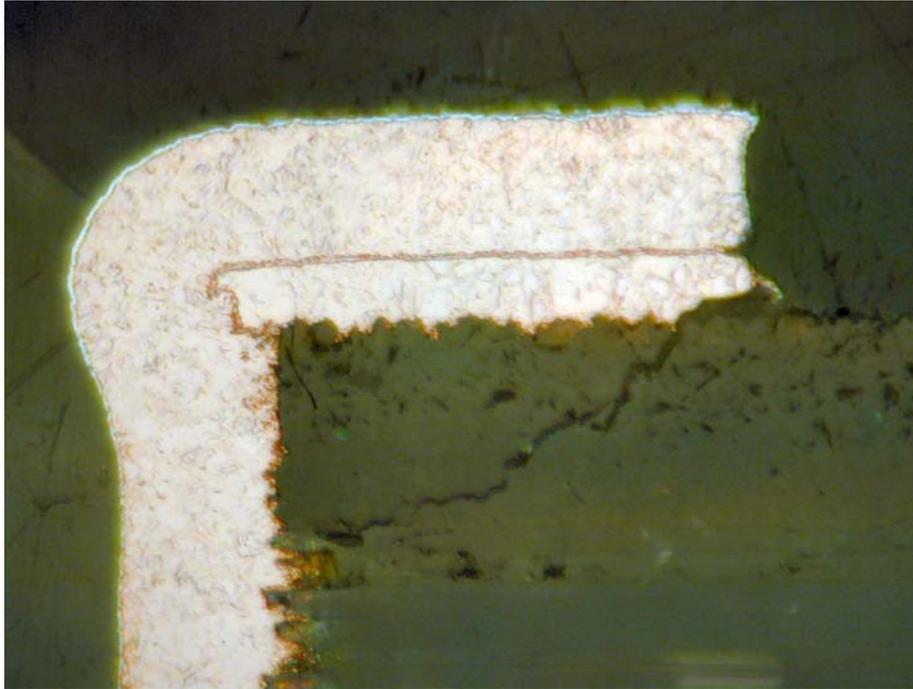
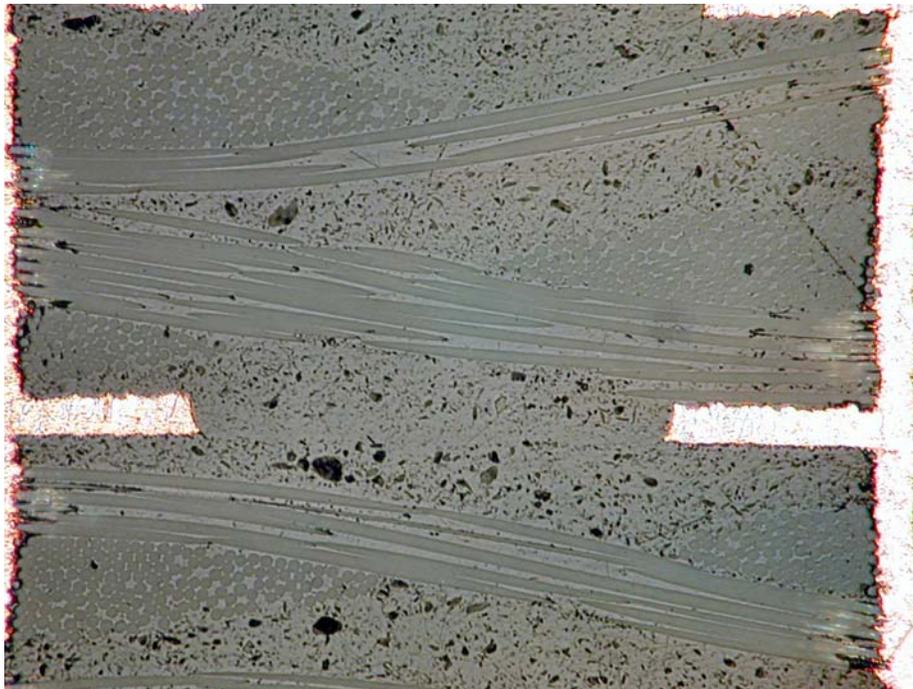
XS# 3737 – Coupon 146, Failed S1, 169 IST Cycles, Precon 3X230°C
Photo 12

XS# 3737 – Coupon 146, Failed S1, 169 IST Cycles, Precon 3X230°C
Photo 13

XS# 3737 – Coupon 146, Failed S1, 169 IST Cycles, Precon 3X230°C
Photo 14

XS# 3737 – Coupon 146, Failed S1, 169 IST Cycles, Precon 3X230°C
Photo 15

XS# 3737 – Coupon 146, Failed S1, 169 IST Cycles, Precon 3X230°C
Photo 16

XS# 3737 – Coupon 146, Failed S1, 169 IST Cycles, Precon 3X230°C
Photo 17

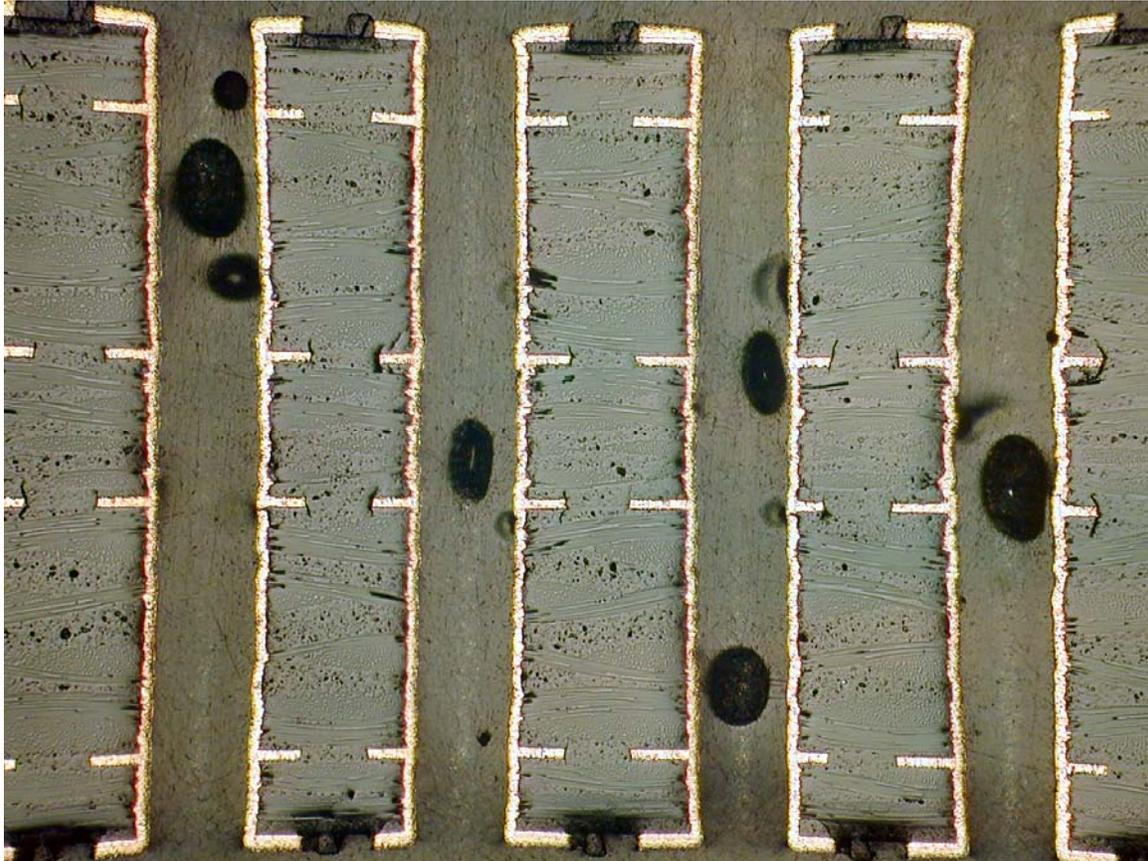
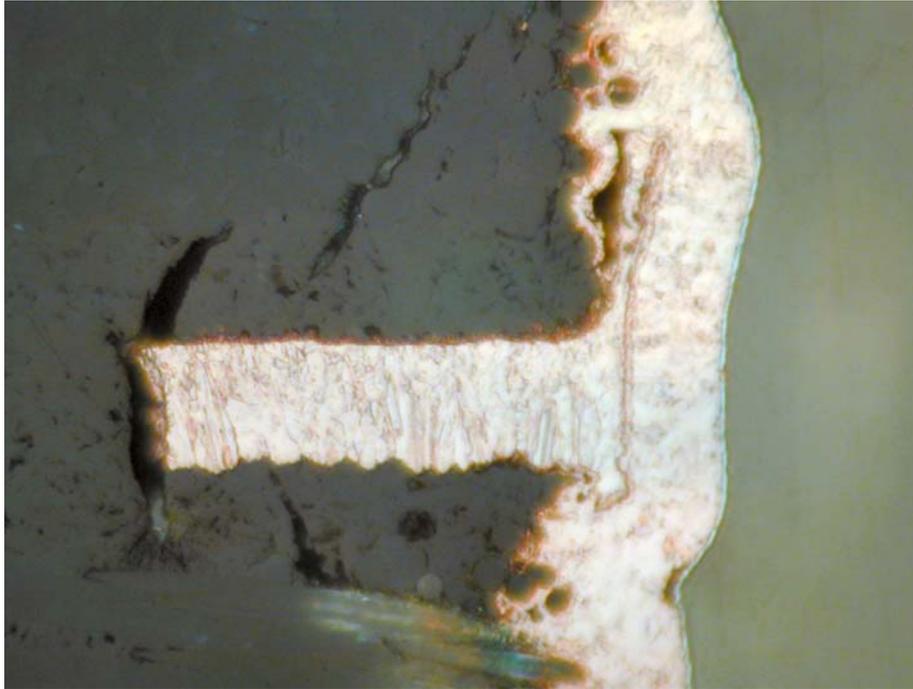
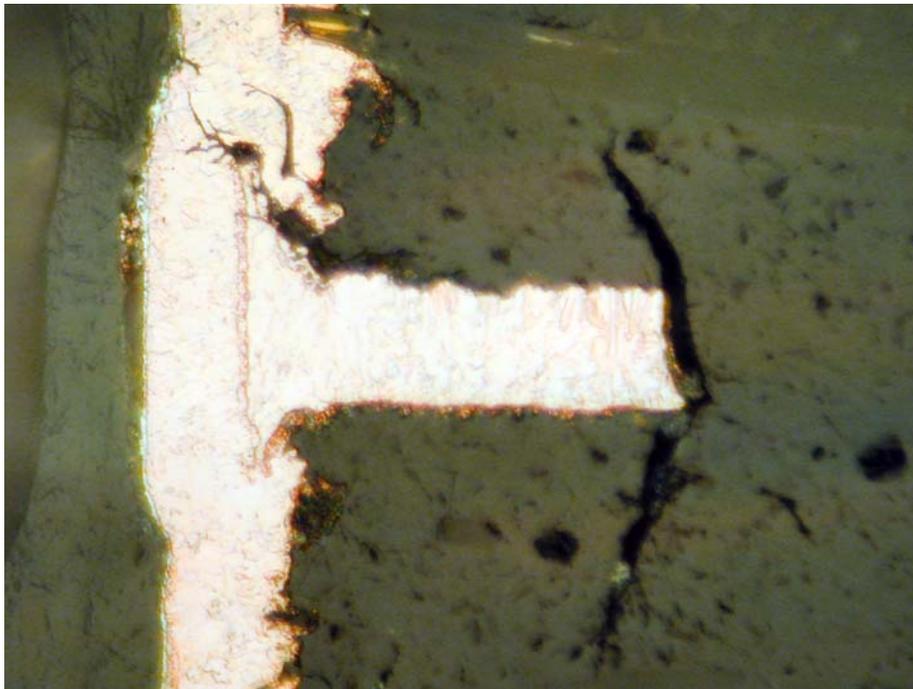
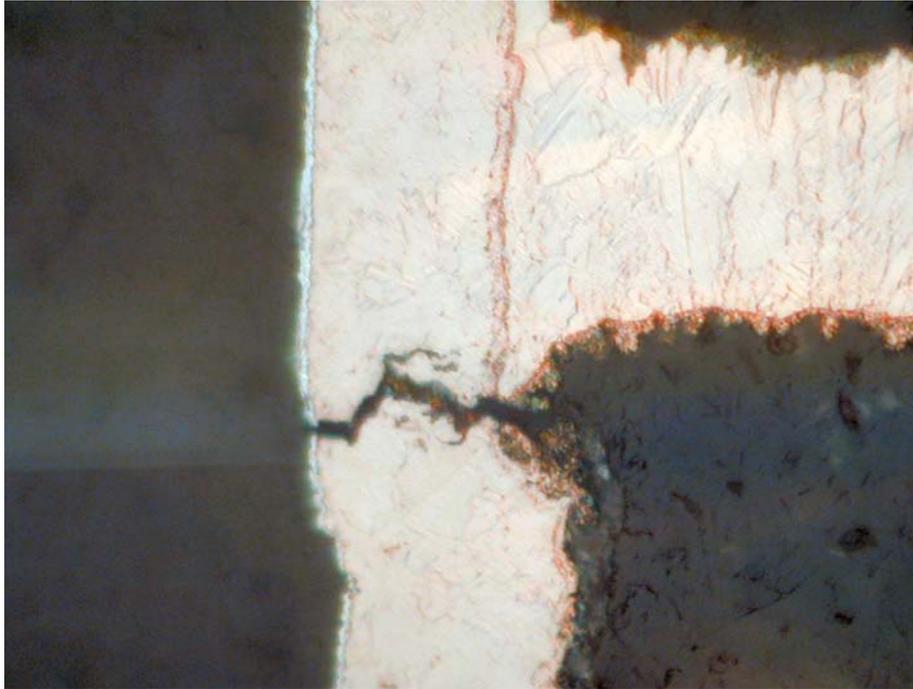
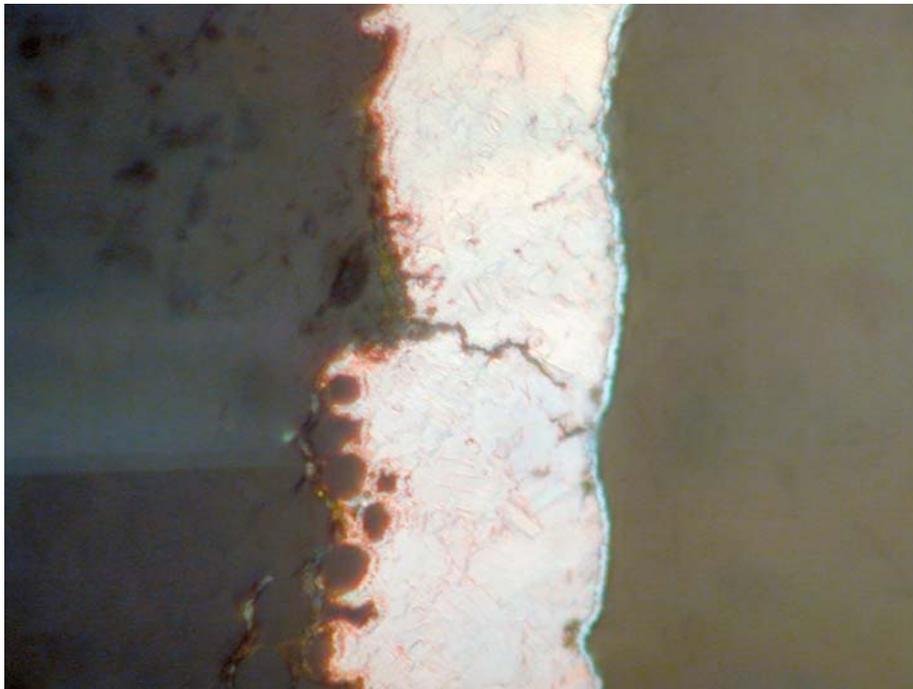
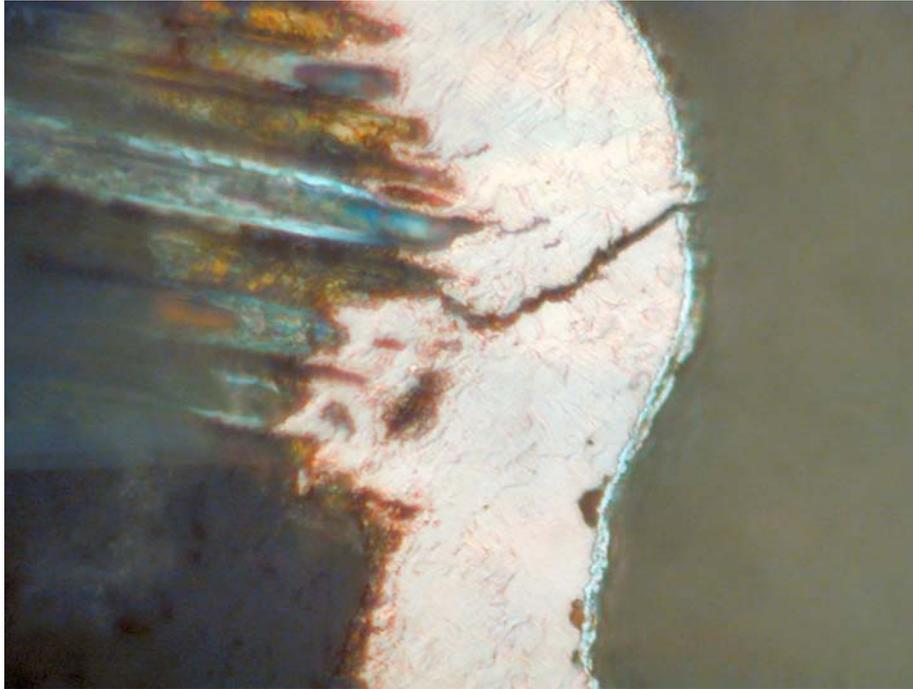
XS# 3738 – Coupon 128 Failed P2, 833 IST Cycles - Precon 3X230°C
Photo 19

XS# 3738 – Coupon 128 Failed P2, 833 IST Cycles - Precon 3X230°C
Photo 20

XS# 3738 – Coupon 128 Failed P2, 833 IST Cycles - Precon 3X230°C
Photo 21

XS# 3738 – Coupon 128 Failed P2, 833 IST Cycles- Precon 3X230°C
Photo 22

XS# 3738 – Coupon 128 Failed P2, 833 IST Cycles- Precon 3X230°C
Photo 23

XS# 3738 – Coupon 128 Failed P2, 833 IST Cycles - Precon 3X230°C
Photo 24

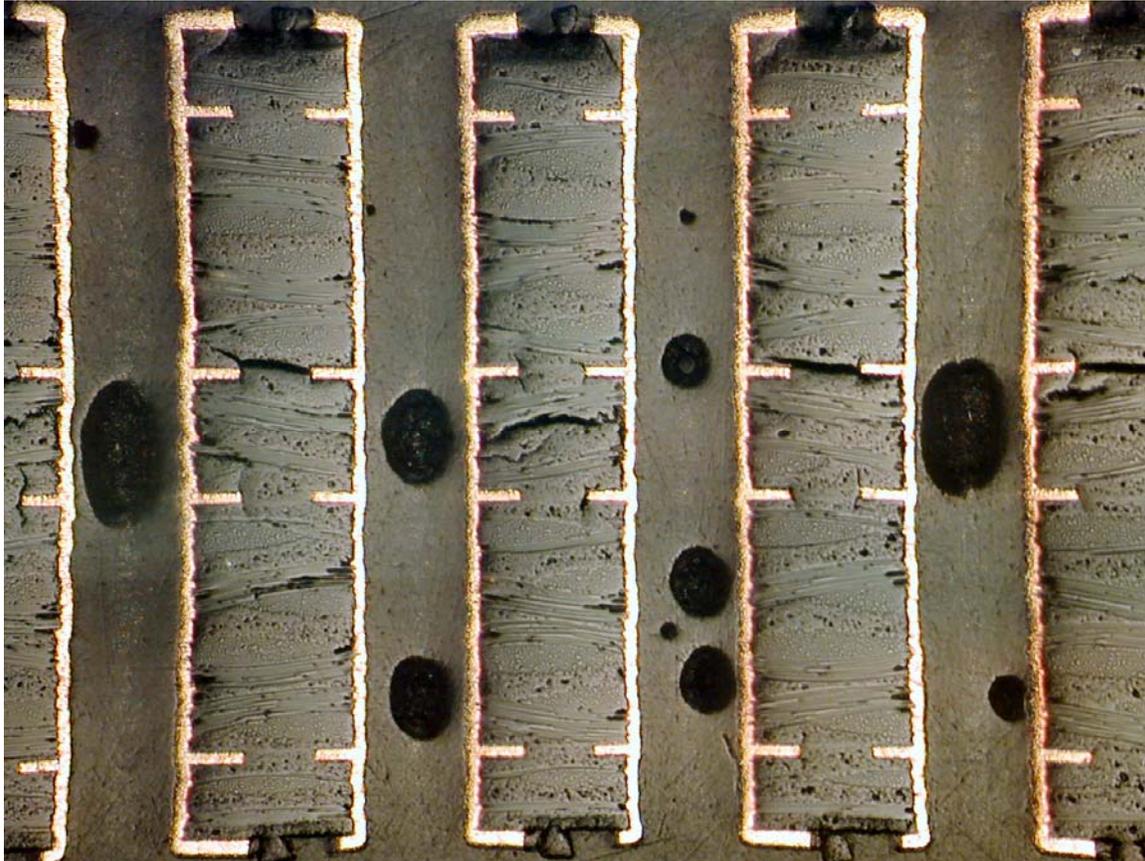
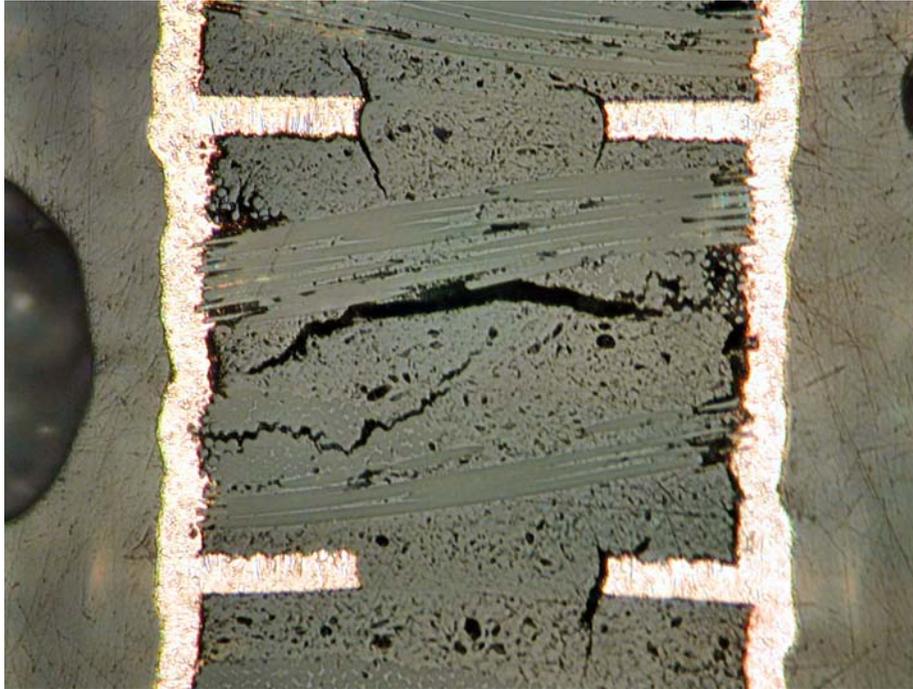
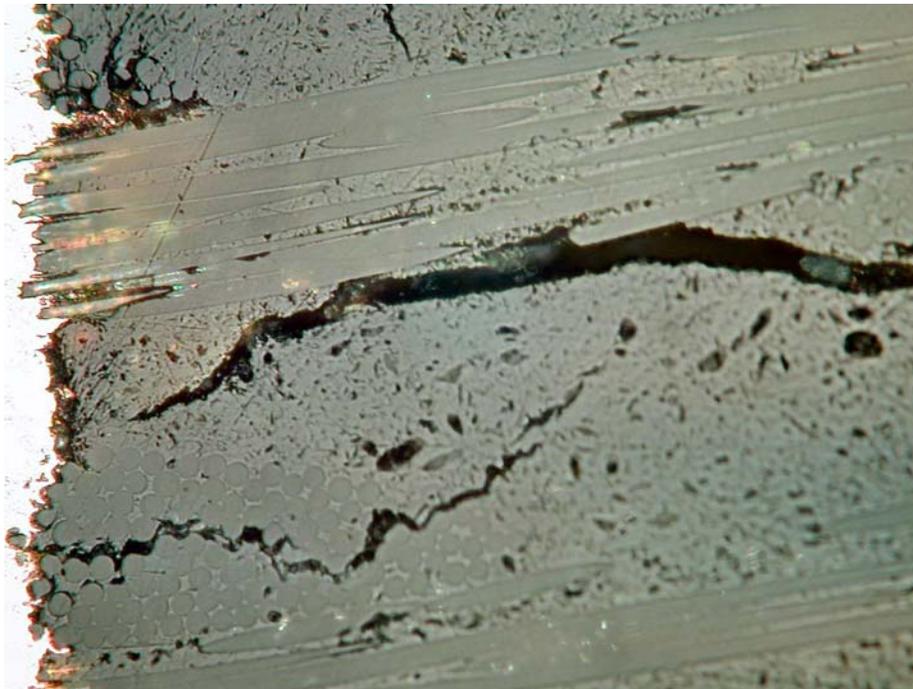
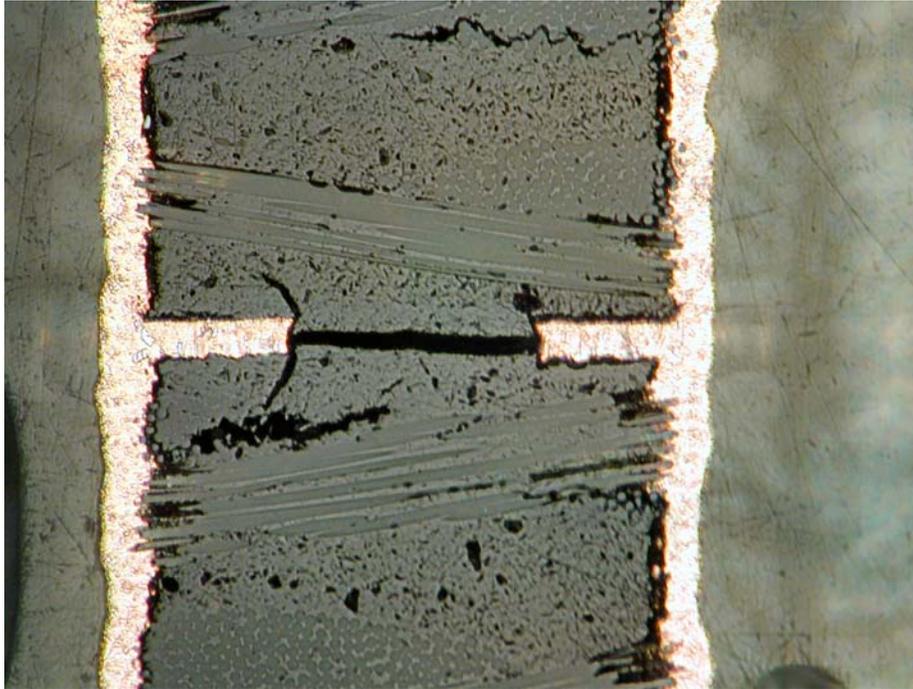
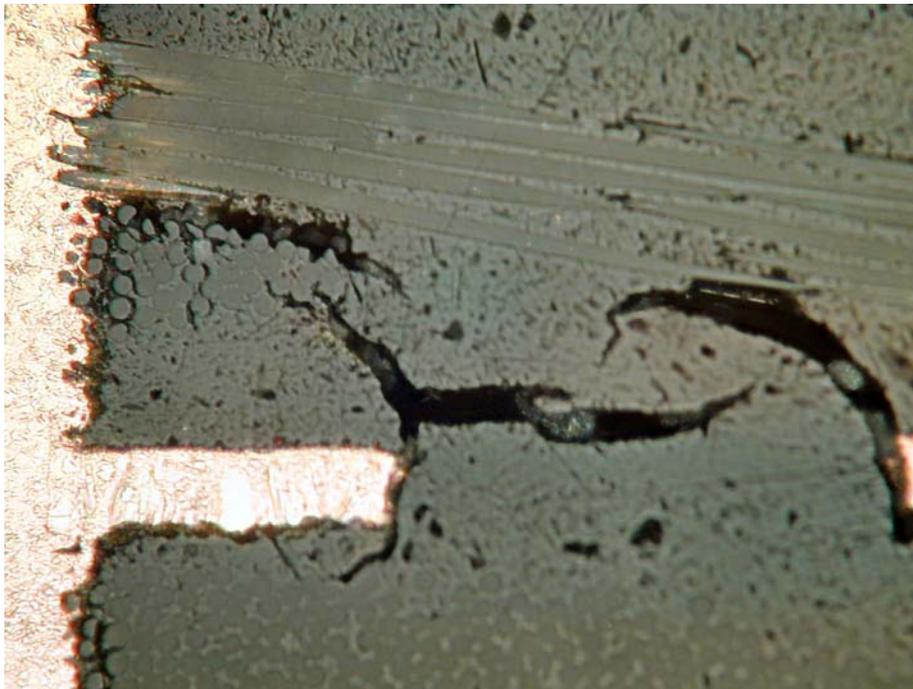
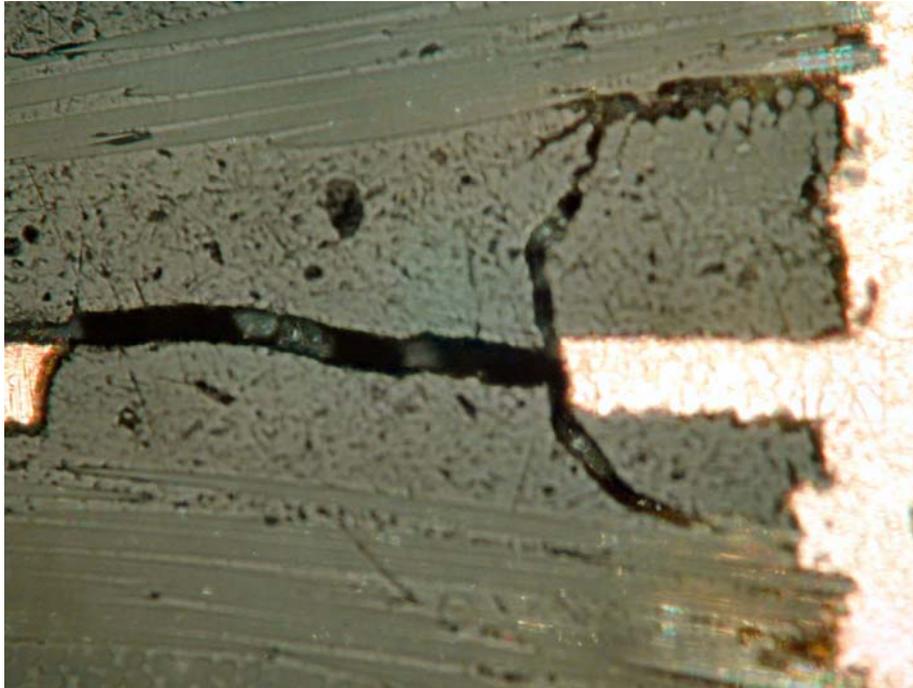
XS# 3739 – Coupon 137, No Failure, 1000 IST Cycles, Precon 3X230°C
Photo 25

XS# 3739 – Coupon 137, No Failure, 1000 IST Cycles, Precon 3X230°C
Photo 26

XS# 3739 – Coupon 137, No Failure, 1000 IST Cycles, Precon 3X230°C
Photo 27

XS# 3739 – Coupon 137, No Failure, 1000 IST Cycles, Precon 3X230°C
Photo 28

XS# 3739 – Coupon 137, No Failure, 1000 IST Cycles, Precon 3X230°C
Photo 29

XS# 3739 – Coupon 137, No Failure, 1000 IST Cycles, Precon 3X230°C
Photo 30
