Joint Test Report

For Validation of Alternative Low-Emission Surface Preparation/Depainting Technologies for Structural Steel

NAP2.PROJ.JTR.DEP.PL.02.16.07.F

February 16, 2007

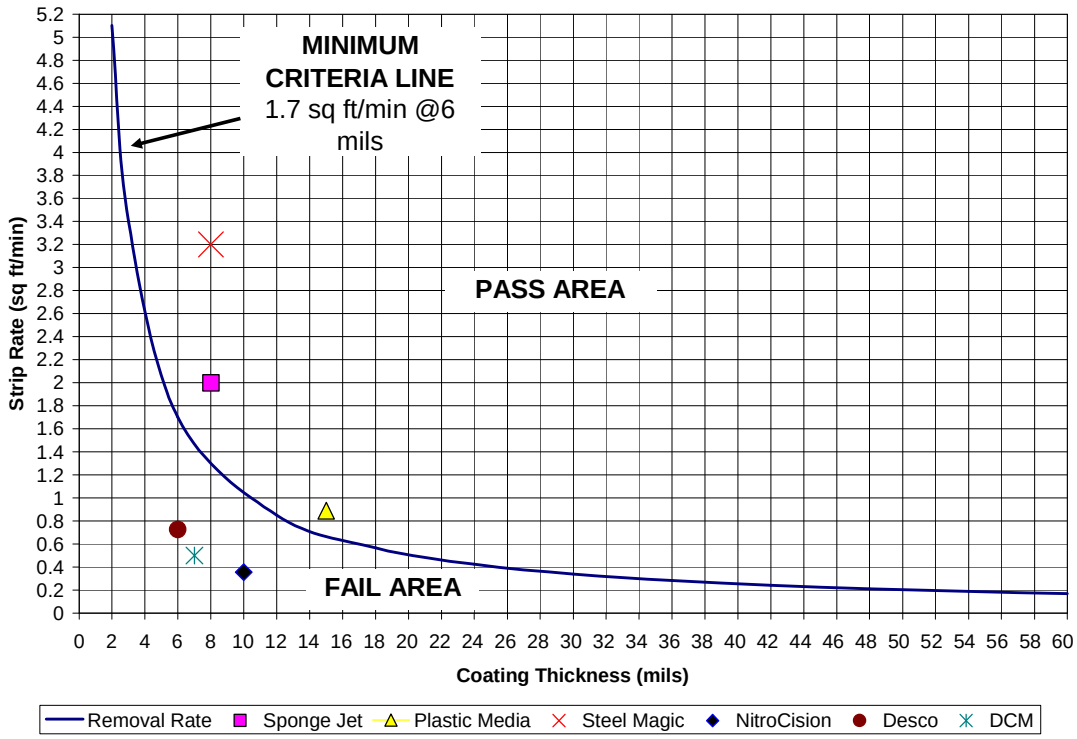
Figure 5-2 Flame Deflector Coating Removal Strip Rate

Table 5-2 Flame Deflector Strip Rate Results (Based on 16 sq ft)				
Depainting Technology	***Coating Thickness (mils)***	***Time (min)***	***Strip Rate (ft^2/min)***	***Pass Criteria?***
Quickstrip®-A	15	18	0.9	Yes
Steel-Magic®	8	5	3.2	Yes
Sponge-Jet®	8	8	2.0	Yes
NitroJet®	10	45	0.4	No
DESCO	6	22	0.8	No
DCM	7	32	0.5	No

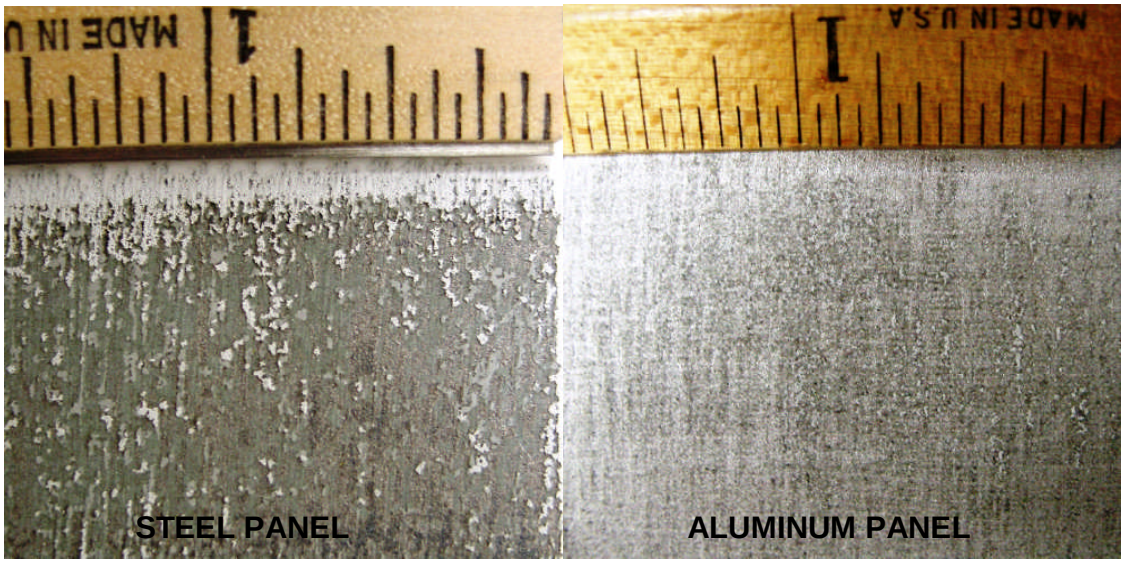
Figure 6-2 Laser Depainted Surfaces

As seen in the following photographs, the PLCRS system did not achieve the minimum requirements of surface cleaning established in the JTP Section 3.2.3 during the demonstration (Figure 6-2). The laser depainting showed better performance on the aluminum coated substrate, but trace amounts of coating still remain on the surface.

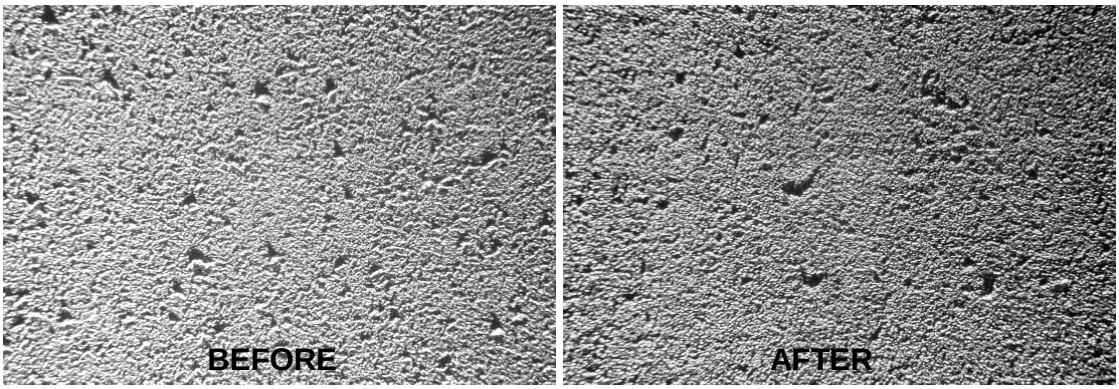
Figure 6-3 Surface Roughness on Aluminum Panel

There were no measurable changes to the before and after surface profile measurements. Before and after magnified photographs show similar surface roughness (Figure 6-3).

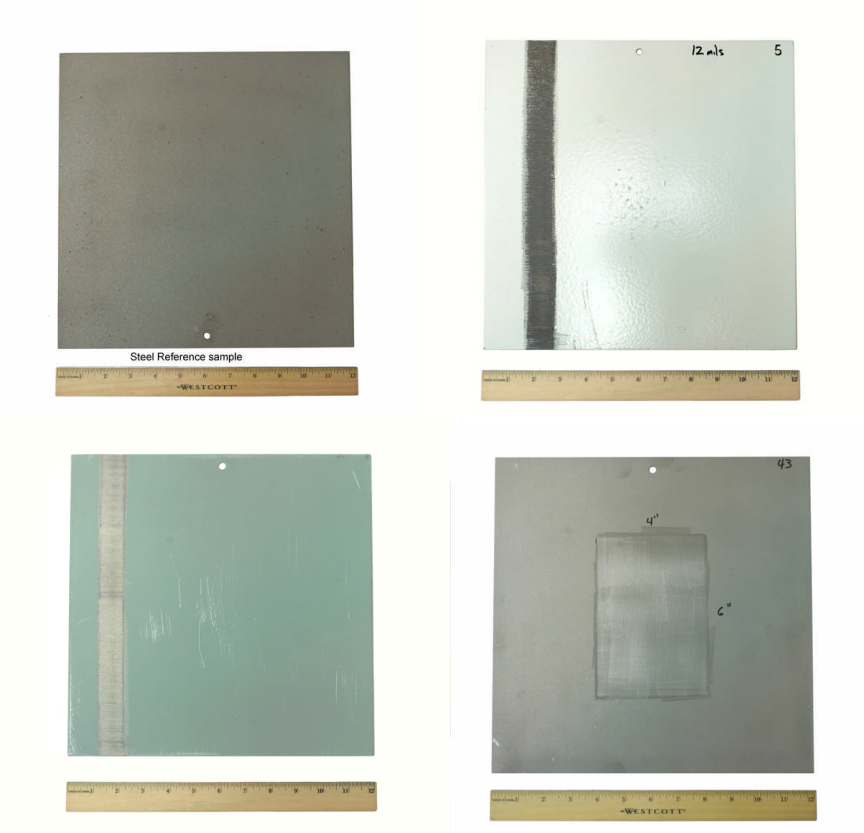
3.1 The panels were photographed as-received (Figure 1), showing the bare steel reference surface along with the epoxy plus primer, primer only, and bare aluminum samples. The two coated steel panels have a linear strip where the coating was removed with the laser. The bare aluminum sample has a square section that was exposed to the laser, but no coating was removed.

Figure 1
As-received panels showing the steel reference (upper left), white epoxy painted (upper right; includes primer underneath), green primer only (lower left), and bare aluminum (lower right). Scale is standard (inches).

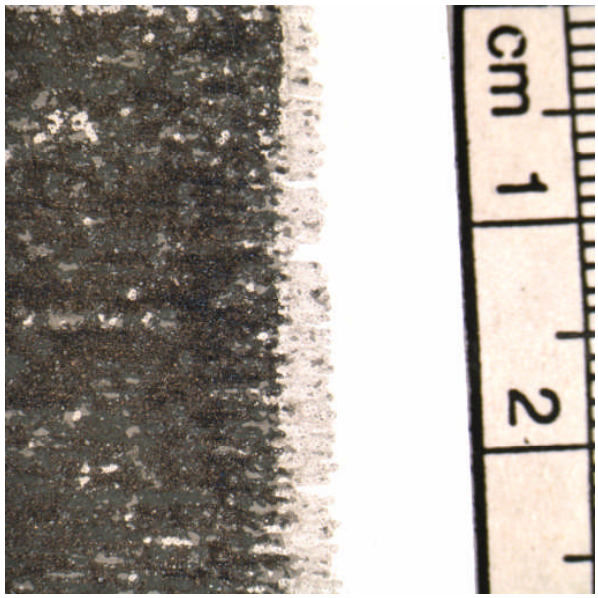
3.2 Optical stereomicroscopic examination showed that the laser treated surfaces of both the painted and primed steel samples had islands of residual coating still embedded in the course contours of the surface, and the exposed base metal appeared slightly coarser than the steel reference. The aluminum sample surface exposed to the laser showed macroscopic delineations along the length of the treated area that appear to correspond to the width of each laser pass. Higher magnification optical inspection revealed subtle changes in color, but little difference in the surface morphology. The original matte grey finish of the untreated area was brighter in the areas exposed to the laser, likely due to removal of prolonged oxidation on the surface (Figures 2-5).

Figure 3
Surface morphology of the painted/primed steel sample. Magnification: 5X

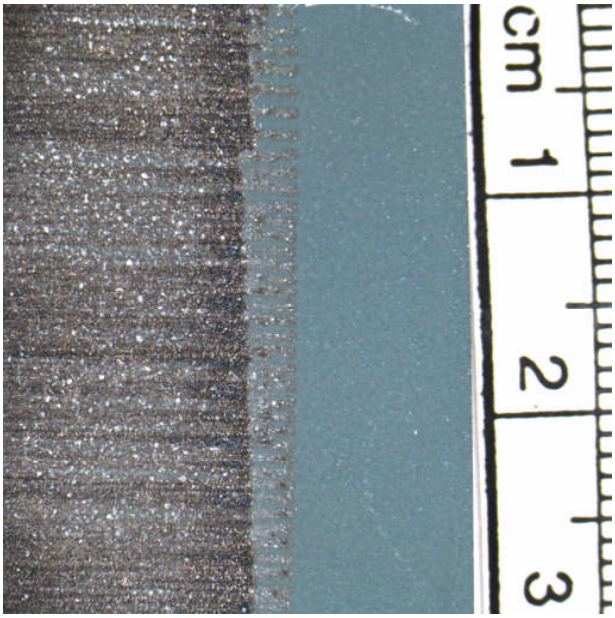
Figure 4
Surface morphology of the primed steel sample. Magnification: 5X

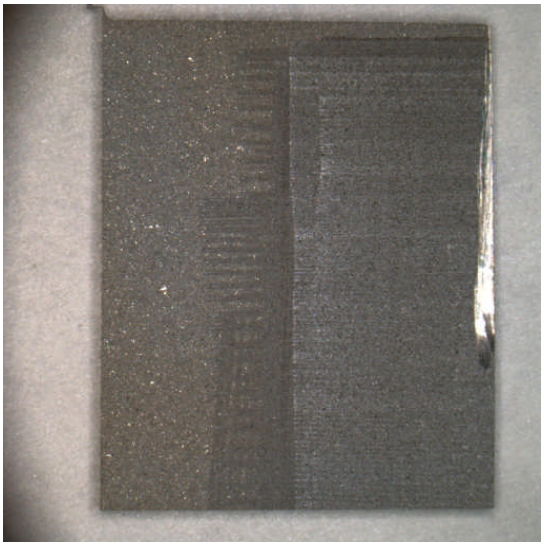
Figure 5
Surface morphology of the aluminum reference sample showing the laser treated surface (left) adjacent to the untreated side (right). Magnification: 5X

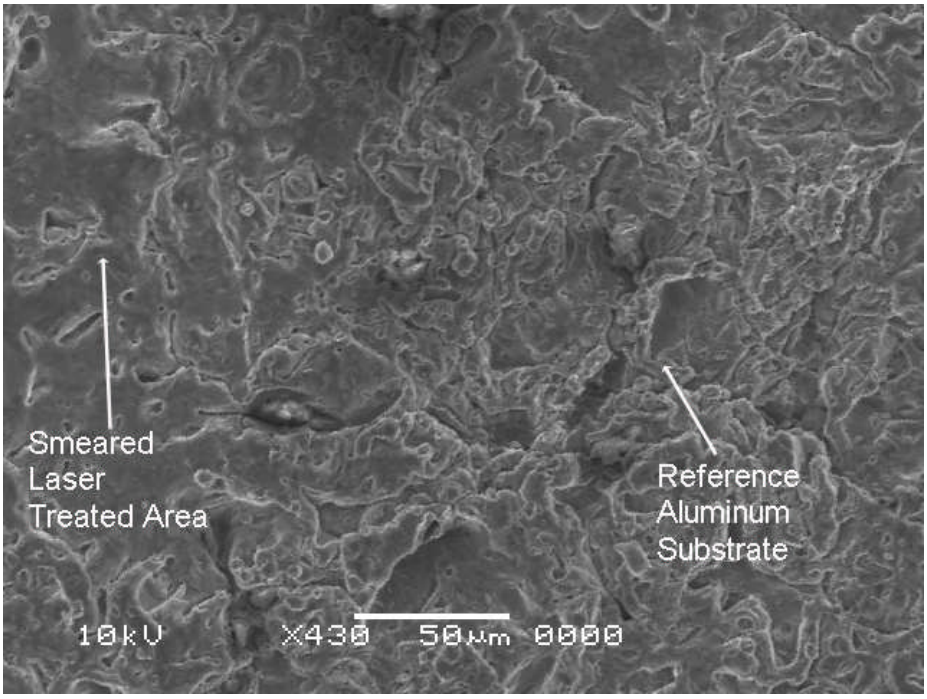
3.3 The surfaces were cleaned and analyzed via SEM. The surfaces of both the aluminum and steel exposed to the laser showed slight mechanical deformation (smearing) compared to the reference samples (Figure 6-9). The steel specimens also showed the smeared regions containing islands of residual coating not removed by the laser.

Figure 6
SEM micrograph of aluminum sample, showing the laser treated substrate on the left and the virgin base metal on the right. Magnification: 430X

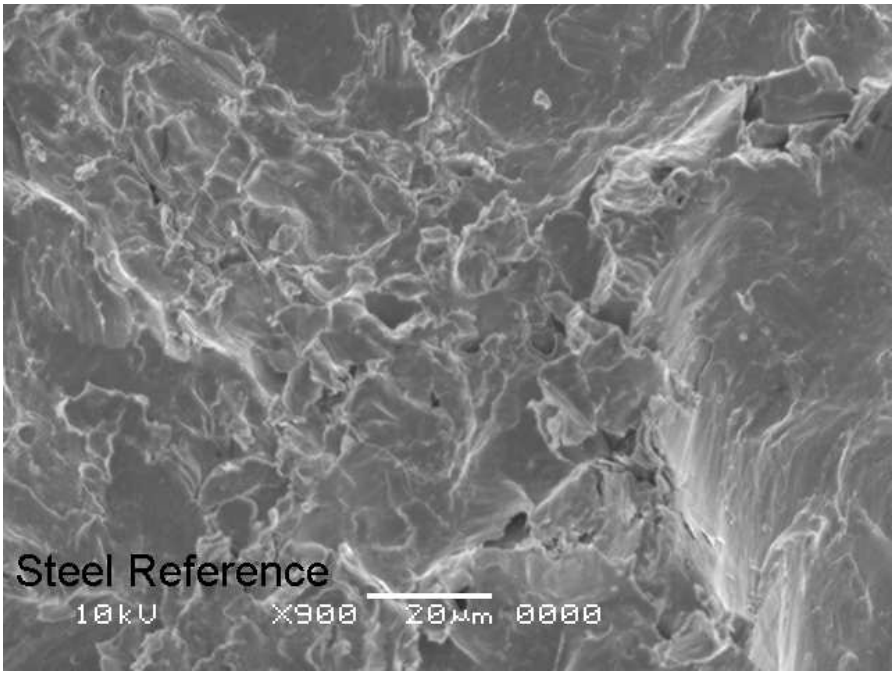
Figure 7
SEM micrograph of steel substrate reference, not exposed to the laser.
Magnification: 900X

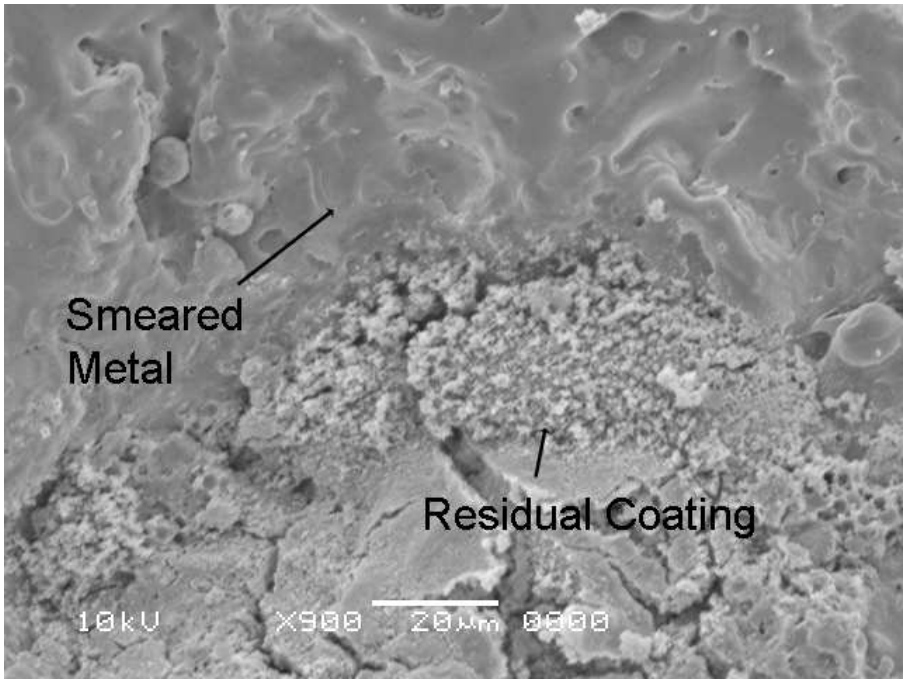
Figure 8
SEM micrograph showing the smeared surface and residual coating of the primed and painted sample exposed to the laser de-paint process. Magnification: 900X

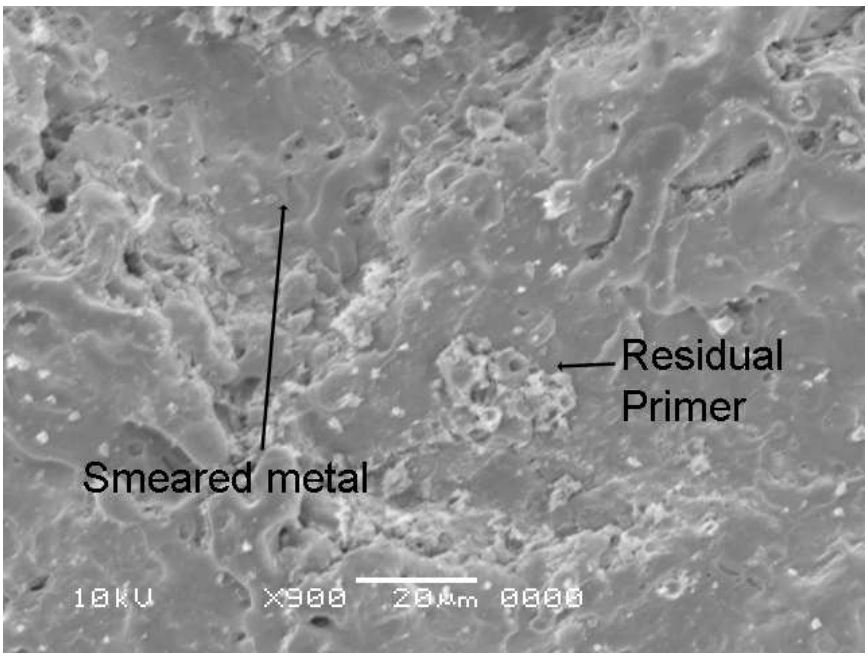
Figure 9
SEM micrograph showing the smeared surface and residual coating of the steel sample with only the green primer applied. Magnification: 900X
