NASA-DoD Lead-Free Electronics Project

2010 Aircraft Airworthiness and Sustainment (AA&S) Conference

May 13, 2010

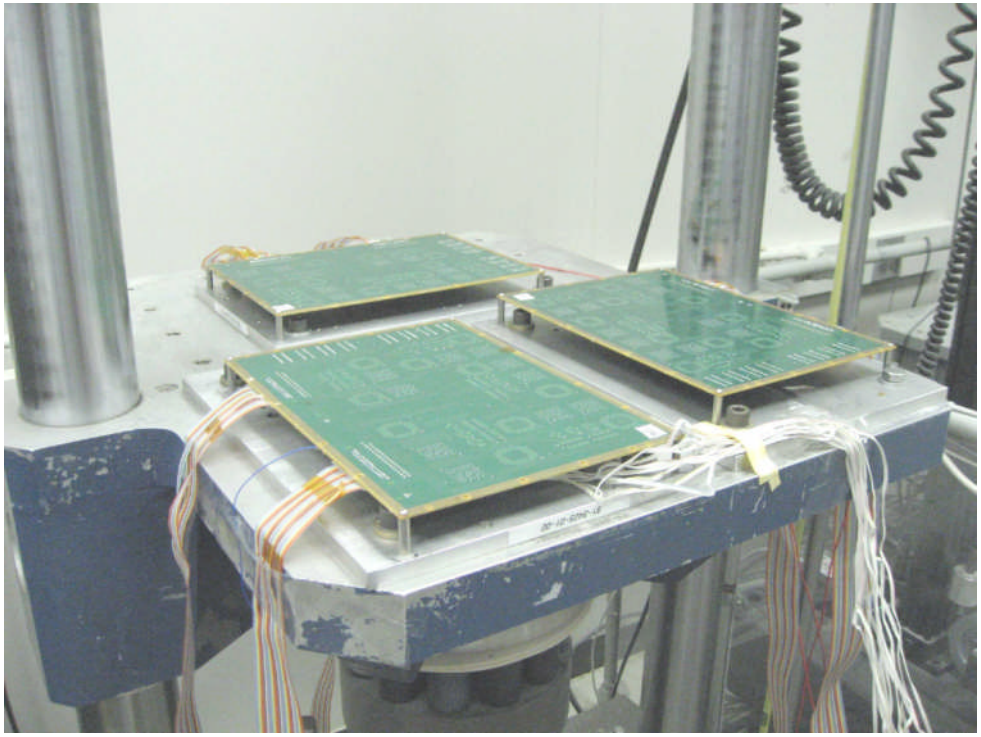
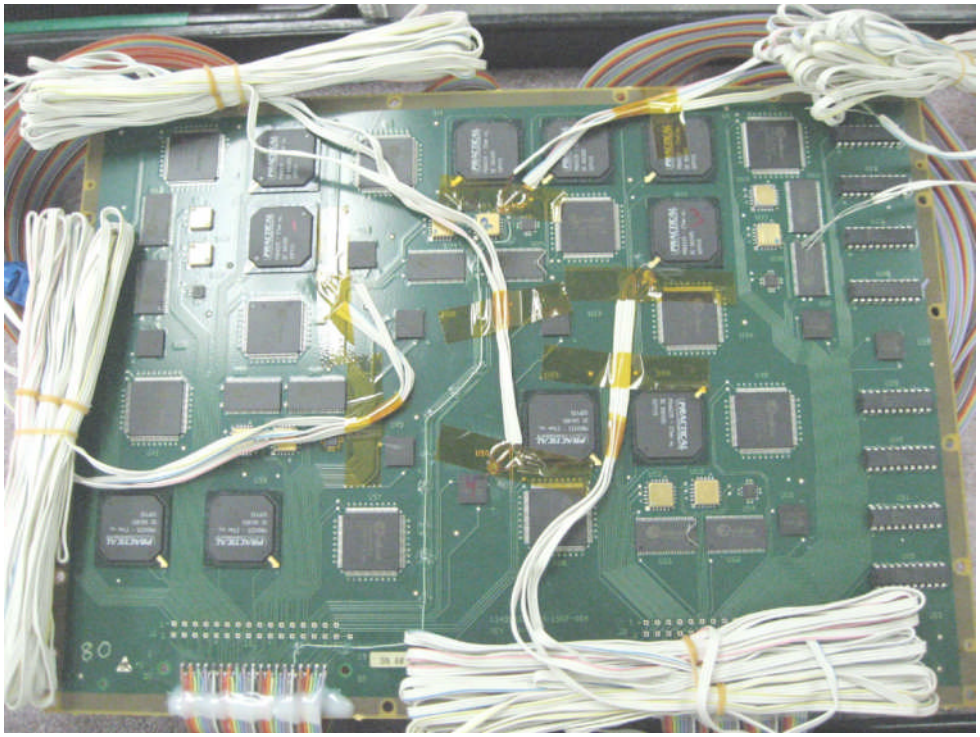
- Shock parameters: 500 G, 2.0 ms duration (340 G for cards 80, 82, 87 for first
- 10 drops)
- Number of drops: 20
- 9 cards in total / 3 cards tested per drop
- Each card monitored for shock response
- Each card monitored for resistance
- Cards 80, 83, 86 monitored for strain

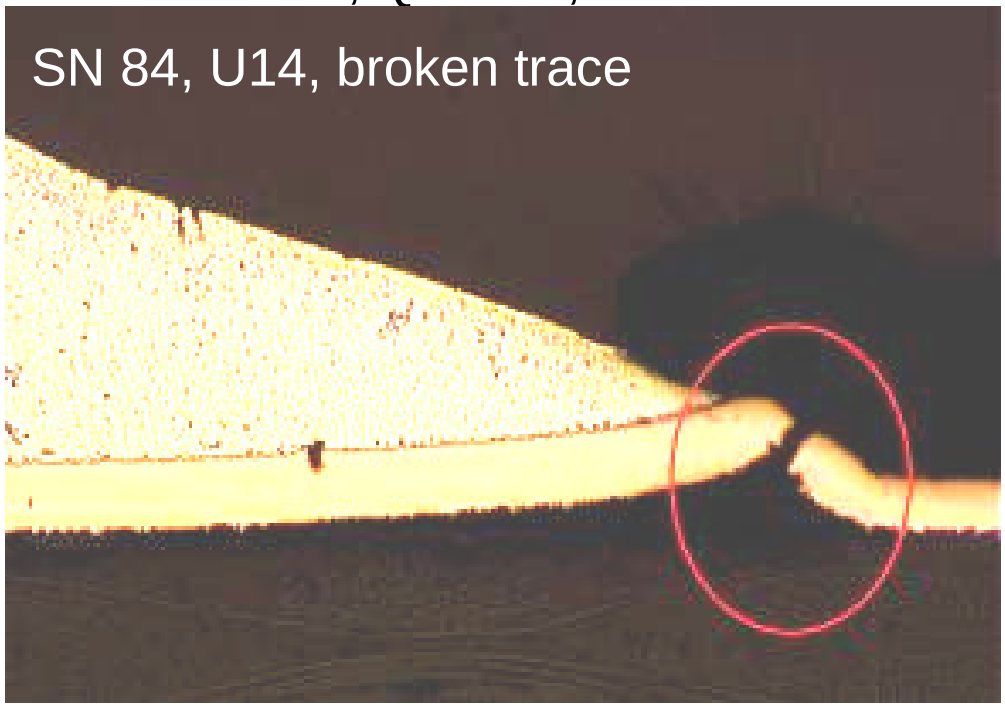
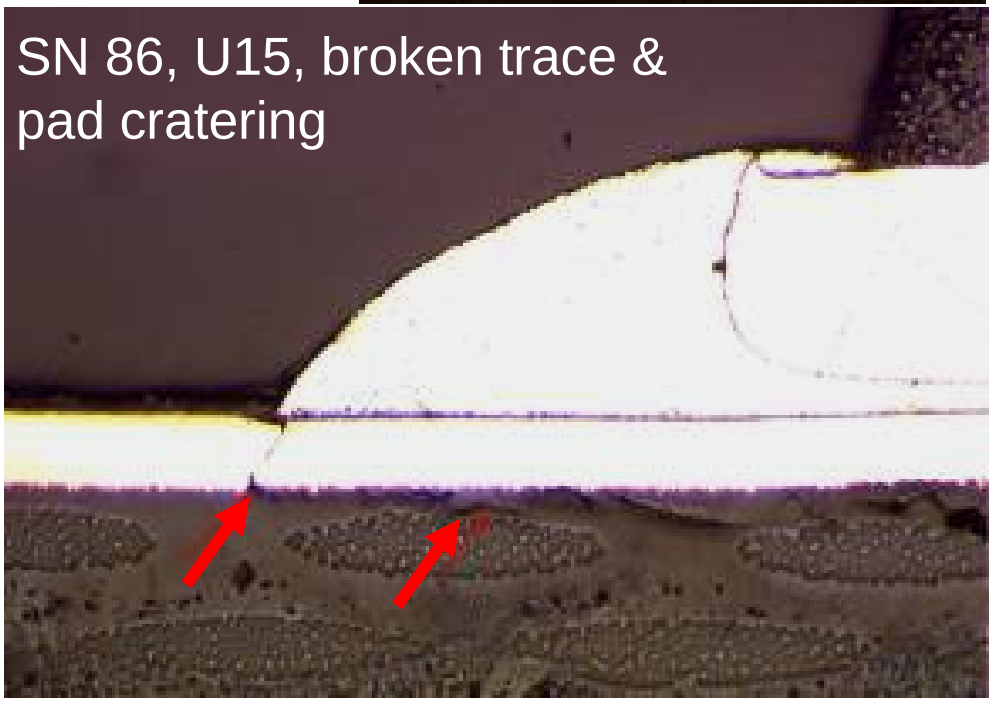
- Only component to have significant failures – BGA 225
- The 4 non-BGA samples that had an electrical failure had the following rework histories:
  - SN 85, TQFP 144, U57 was reworked once
  - SN 85, PDIP-20, U8 was reworked once
  - SN 84, CLCC-20, U14 was not reworked
  - SN 86, QFN-20, U15 was reworked twice

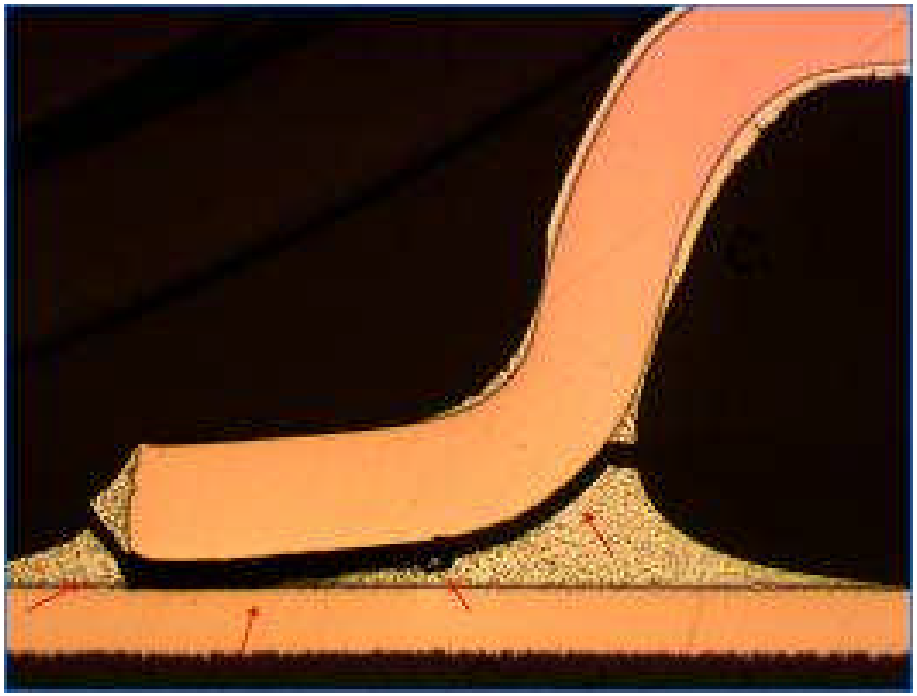
SN67, U31, left lead solder crack, 100x

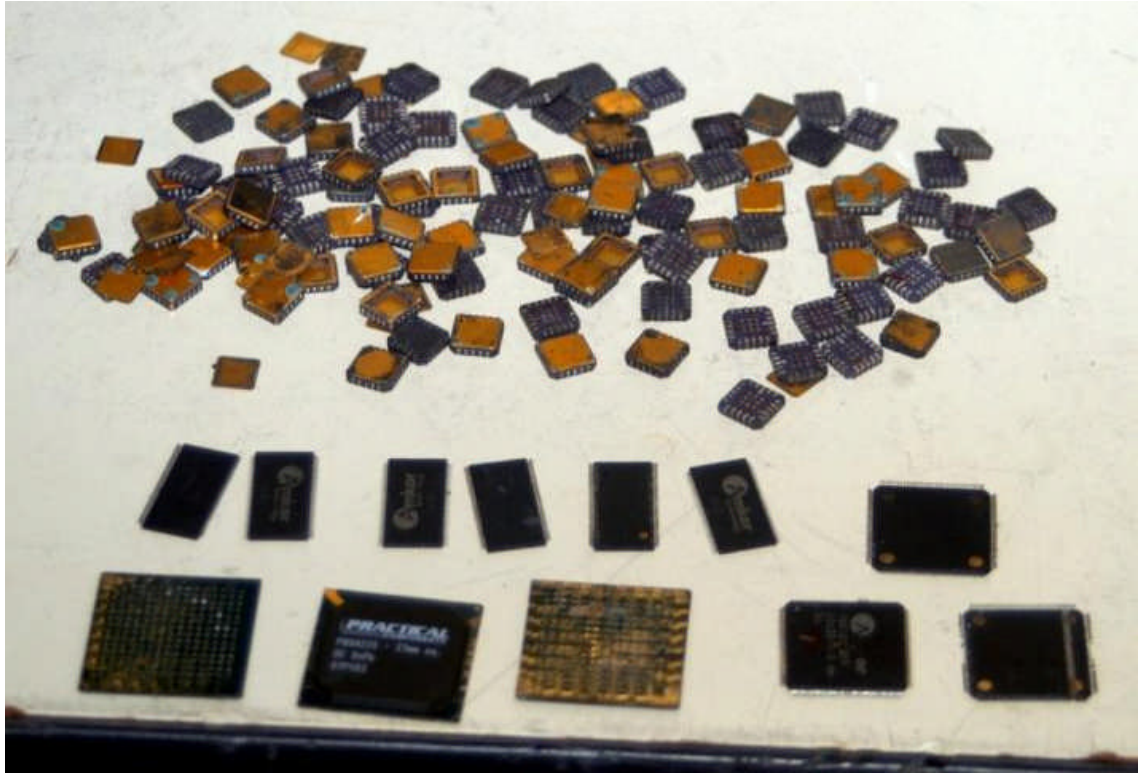
Overall, the component type had the greatest effect on solder joint reliability performance.

- The plated-through-hole components proved to be more reliable than the surface mount technology components.
- The plated-through-holes (PTH), PDIP-20, TQFP-144 and QFN-20 components per-formed the best.
- The BGA-225 components performed the worst.

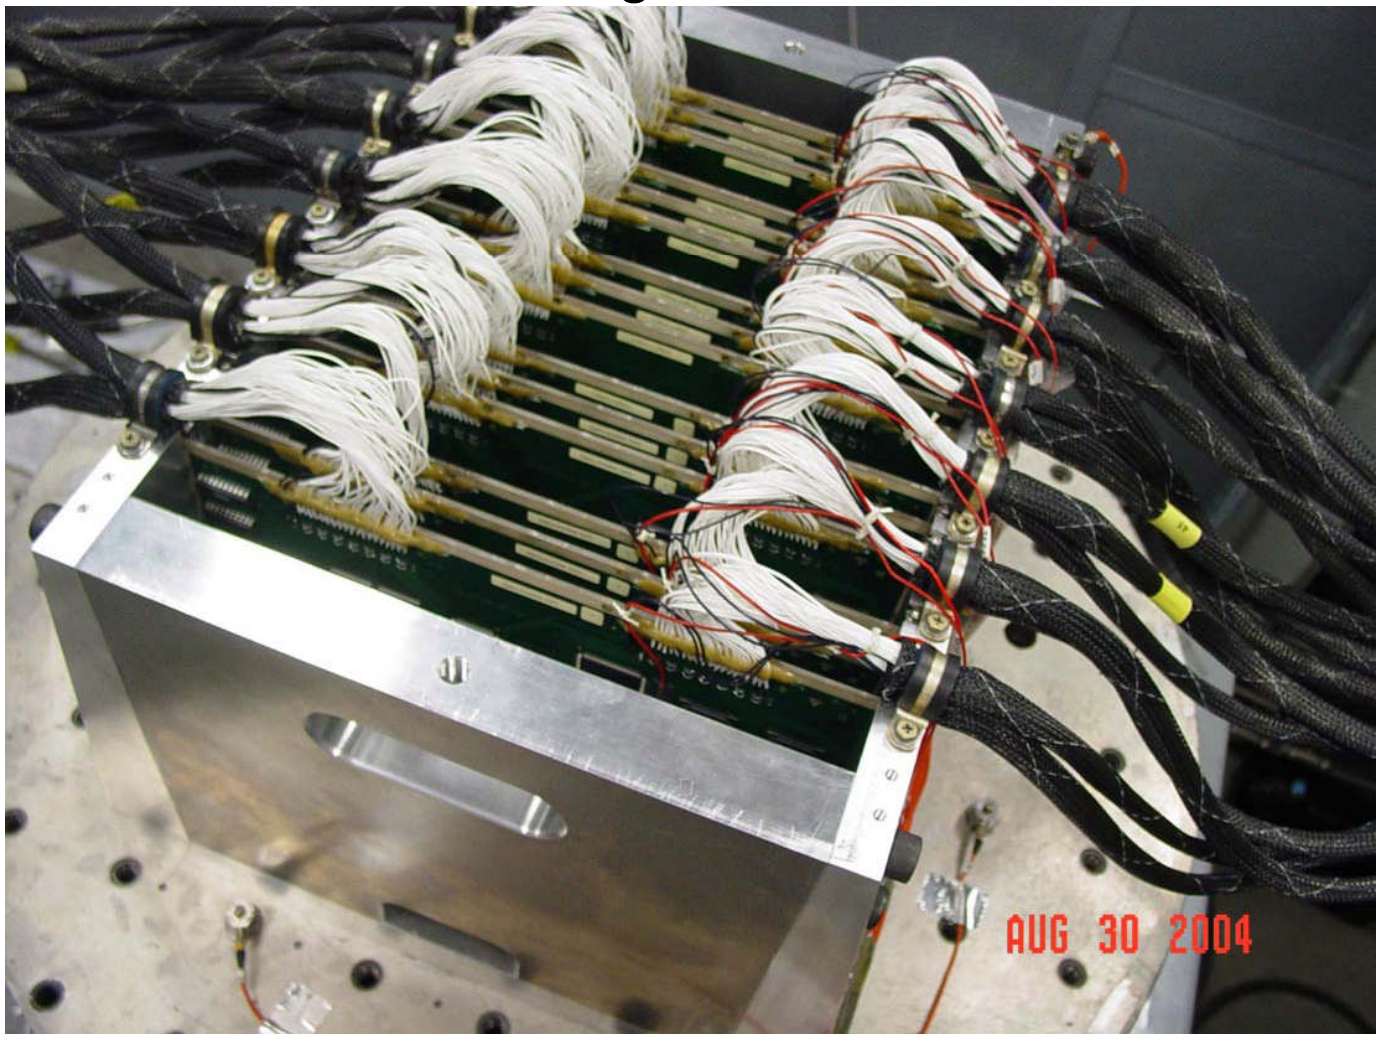
- Very early PDIP failures were observed.
- At an initial glance, the data does not look much different than the JCAA/JGPP test results.
- There does seem to be a big difference between solder alloys.
