NASA-DoD LEAD-FREE ELECTRONICS PROJECT: JOINT TEST REPORT

Kurt Kessel
ITB, Inc.
NASA Technology Evaluation for Environmental Risk Mitigation (TEERM) Principal Center
Kennedy Space Center, FL, USA
kurt.r.kessel@nasa.gov
{On behalf of the NASA-DoD Lead-Free Electronics Project Consortium}

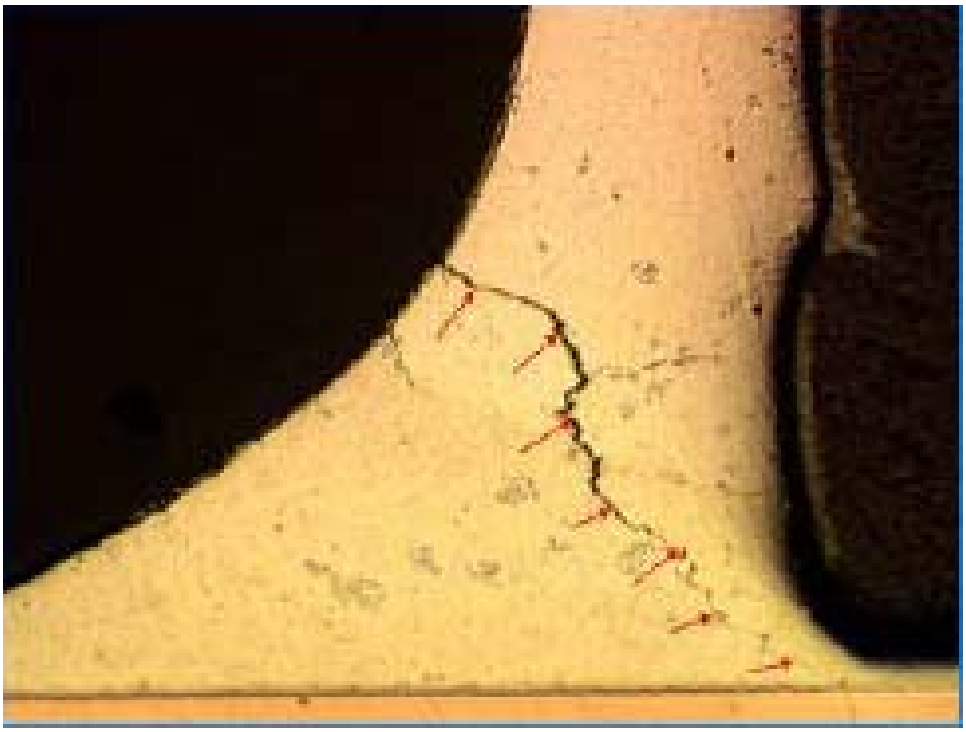
Figure 5 - SN63 U52, Left Side Pad

All of the tested CLCC-20s had SAC305 component finish. None of these solder joints were reworked. Solder cracks we observed around every solder joint. The cross sections of all CCLC-20 packages were performed on corner pads. Each cross section revealed cracking across the length of the solder, see Figure 5. SN67 also showed voiding, in this case the crack traveled along the void, see Figure 6.

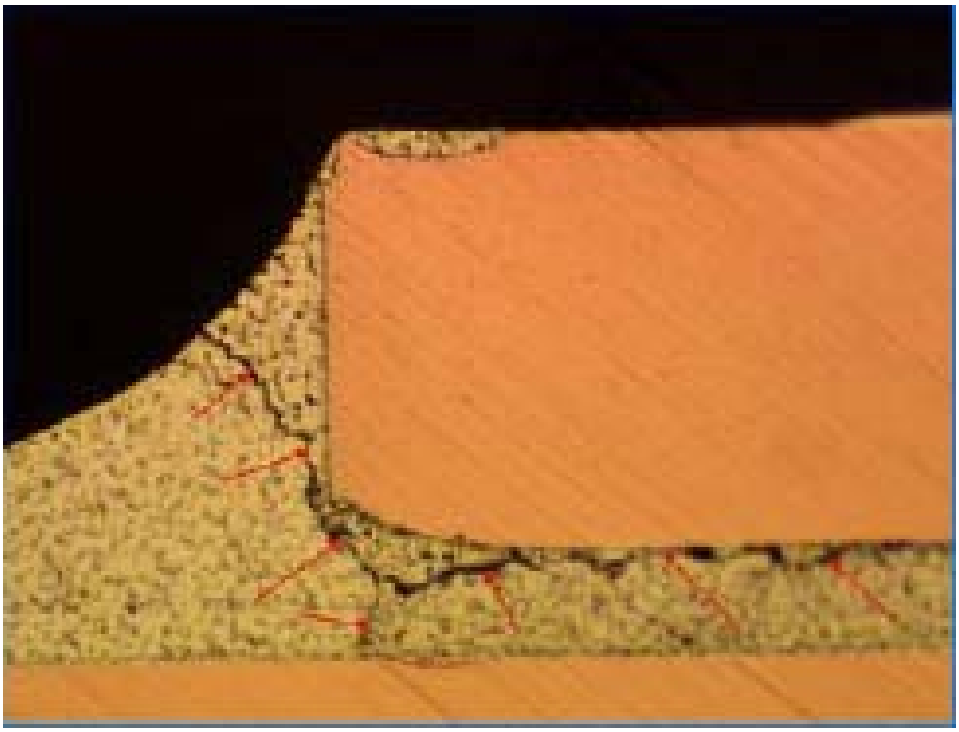
Figure 7 - SN63 U54, Left Side Pad

All of the QFN-20 packages were fabricated using Sn finish and were exposed to one or two reworks with SnPb solder. Approximately half of the solder joints exhibited cracks which ran along the component pad. There does not appear to be a correlation between the cracked solder and the number of re-work cycles to which the part was exposed. Cross sections of the QFN-20 packages reveal that the cracks propagated along the component pad, see Figure 7 and Figure 8.

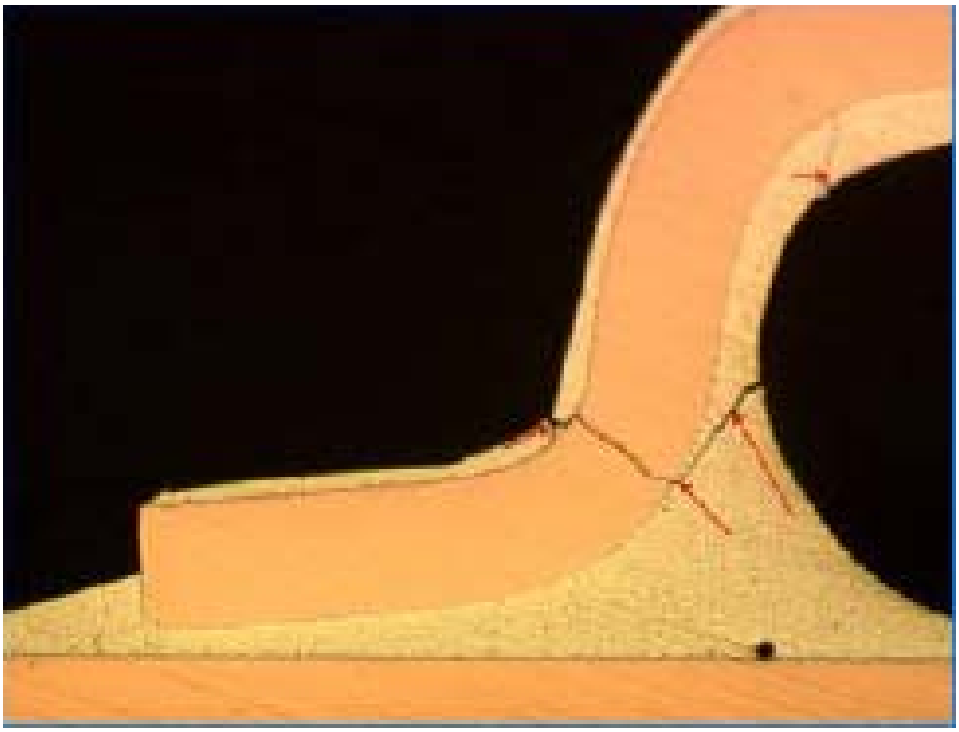
Figure 9 - SN63 U41. Left Lead

Cross-sectioning revealed cracks in the actual copper leads of the TQFP-144 packages. This damage was observed only on parts which were not reworked and therefore the solder joint was Pb-free. This is to be expected as the Pb-free solder is stiffer than the SnPb solder and transfers the stress to the weaker copper leads. Figure 9 and Figure 10 illustrate TQFP-144 packages which were not reworked and therefore contain only Pb-free solders.

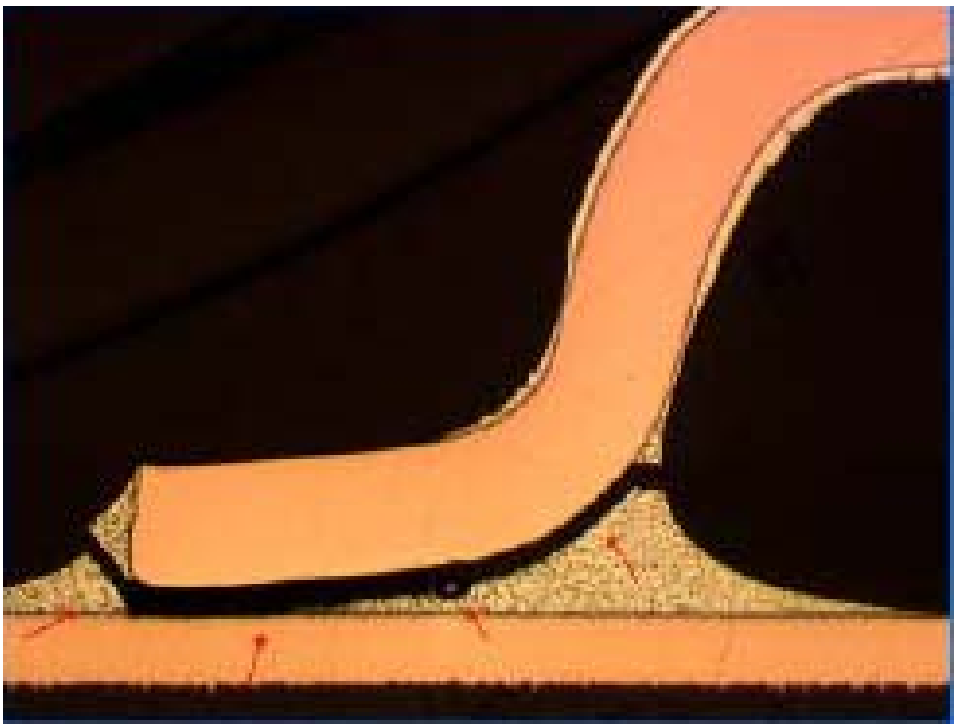
Figure 11 - SN67 U31 Left Lead

Cross-sections of TQFP-144 packages which were re-worked, either once or twice, revealed cracked solder joints in all cases. However, all of the leads on these samples survived, see Figure 11 and Figure 12.

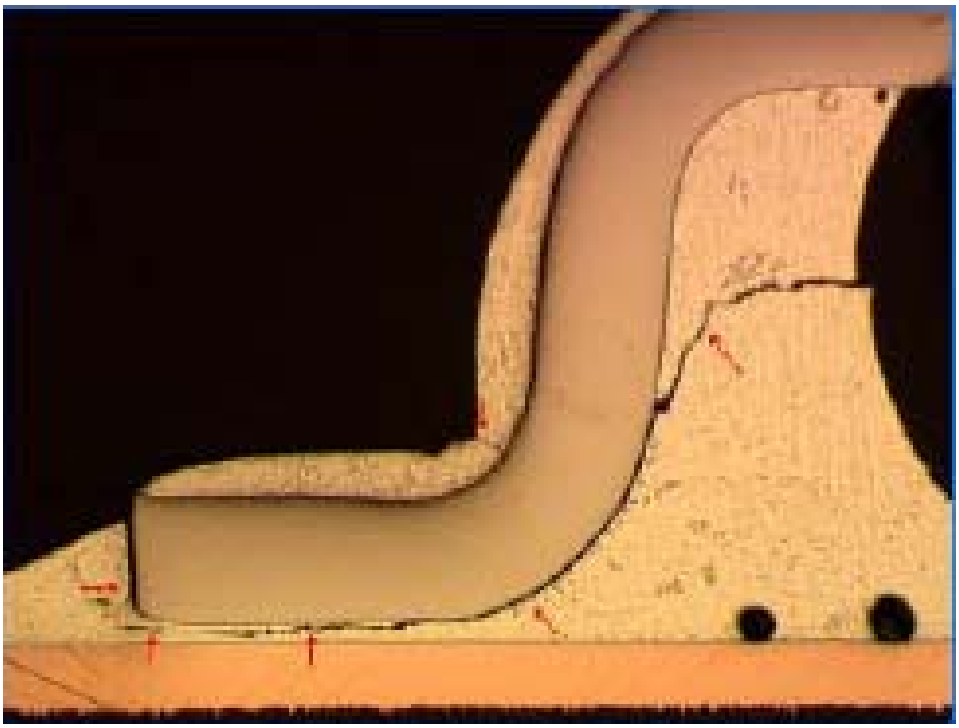
Figure 13 - SN79 U12, Left Lead

SN79 U12 (Figure 13) and SN66 U62 (Figure 14) are examples of TSOPs which did not undergo any re-work. They have Sn and SnBi finishes respectively. Both experienced sever solder cracking in leads on both sides of the component.

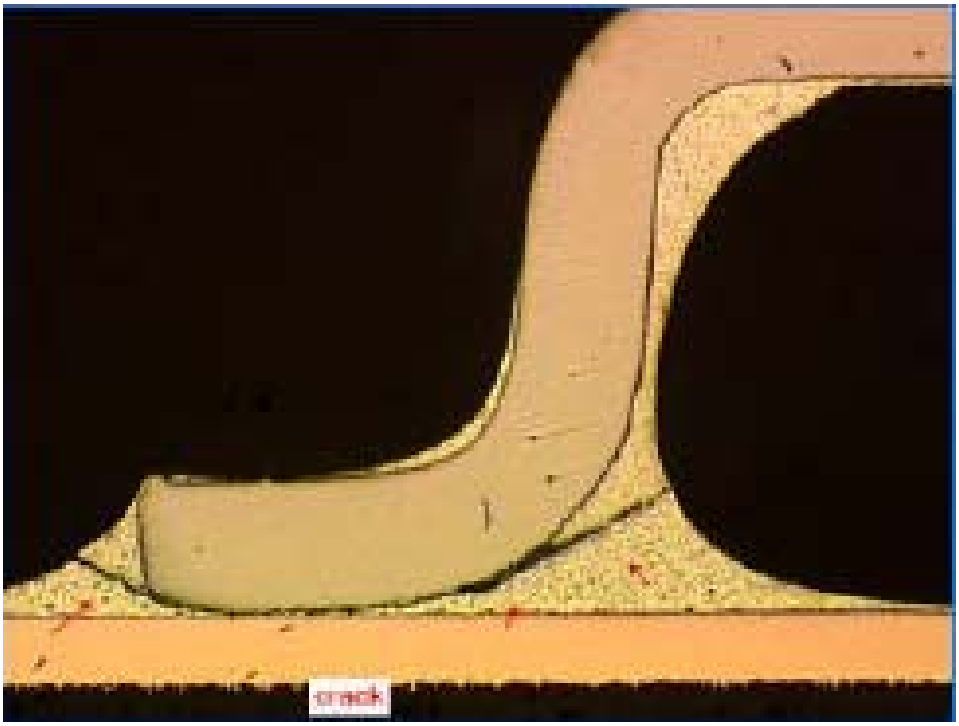
Figure 15 - SN65 U62, Left Lead

SN65 U62 (Figure 15) and SN63 U61 (Figure 16) are examples of parts which underwent one re-work cycle with SnPb solder. They have Sn and SnBi finishes respectively and both components

showed significant cracking within the solder at both sides of the component. This is consistent with all parts which have undergone one re-work cycle.

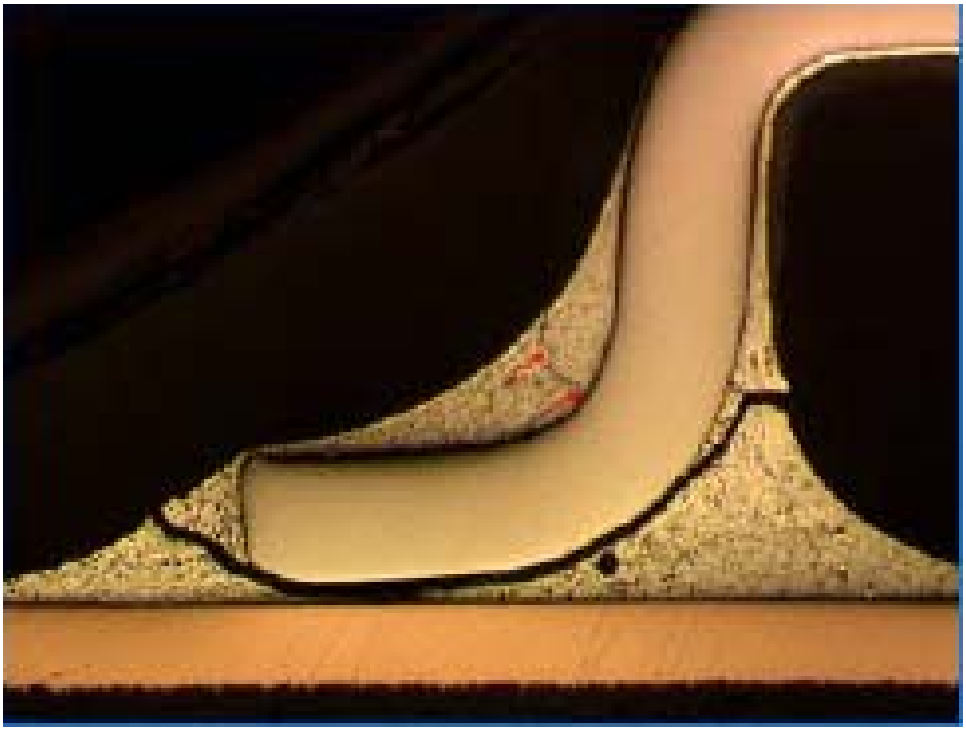
Figure 17 - SN63 U16, Left Lead

SN63 U16 (Figure 17) and SN68 U29 (Figure 18) were both re-worked twice with SnPb solder. SN63 U16 is finished with SnBi and SN68 U29 is finished with Sn. The SnBi part experienced extensive solder cracking through-out. The Sn finished part experienced solder cracking at one side of the component.

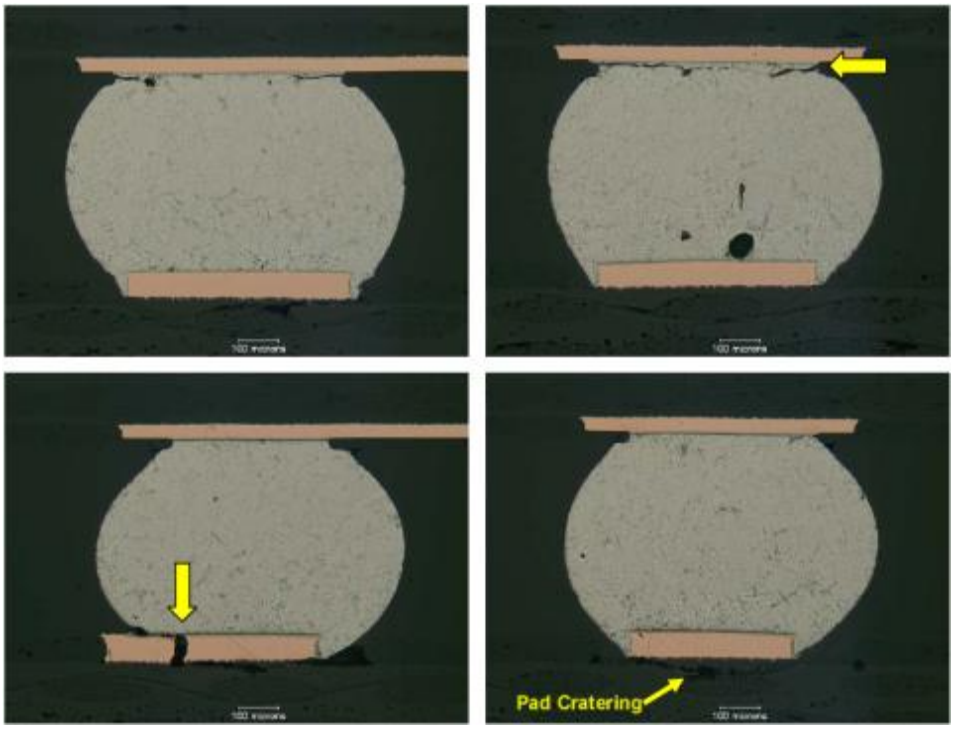
Microsections made at the end of Mechanical Shock Testing showed that the corner solder joints failed first. The SnPb/SnPb sections showed pad cratering, PWB trace cracking, and solder joint cracking on the component side (Figure 20).

Figure 20 - Test Vehicle 34 - Four Corner Balls of BGA U6 (SnPb Solder/SnPb Balls)

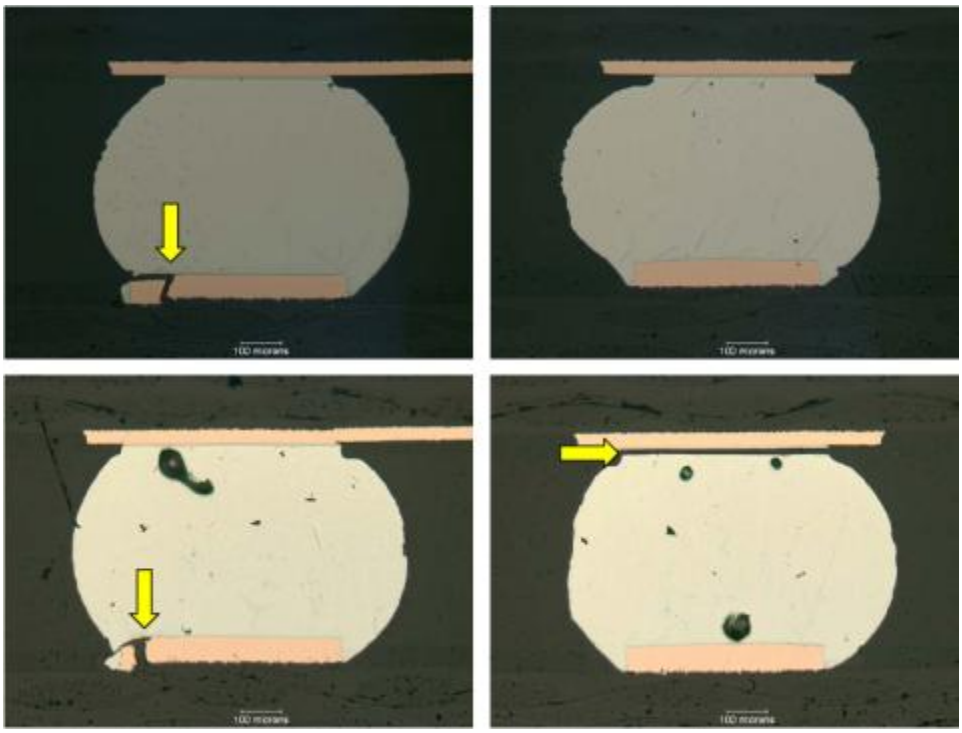
The SAC305/SAC405 sections showed PWB trace cracking and solder joint cracking at the component side intermetallic layer (Figure 21). Which failure mechanism occurred first could not be determined from the microsections.

Figure 21 - Test Vehicle 89 - Four Corner Balls of BGA U2 (SAC305 Solder/SAC405 Balls)

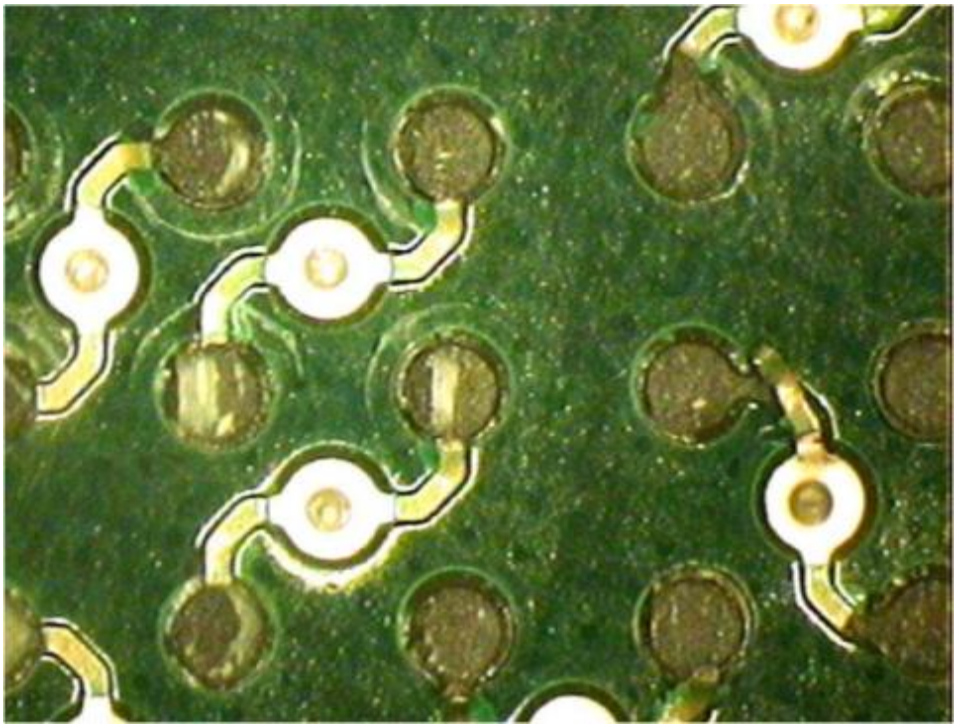
Surprisingly, on the SnPb/SnPb BGA's that fell off, almost 100% of the solder joints failed by pad cratering. The BGA balls and associated PWB copper pads were missing from the test vehicles (Figure 22 and Figure 23).

Figure 22 - Test Vehicle 30 BGA U2 with Missing Pads (SnPb Solder/SnPb Balls)

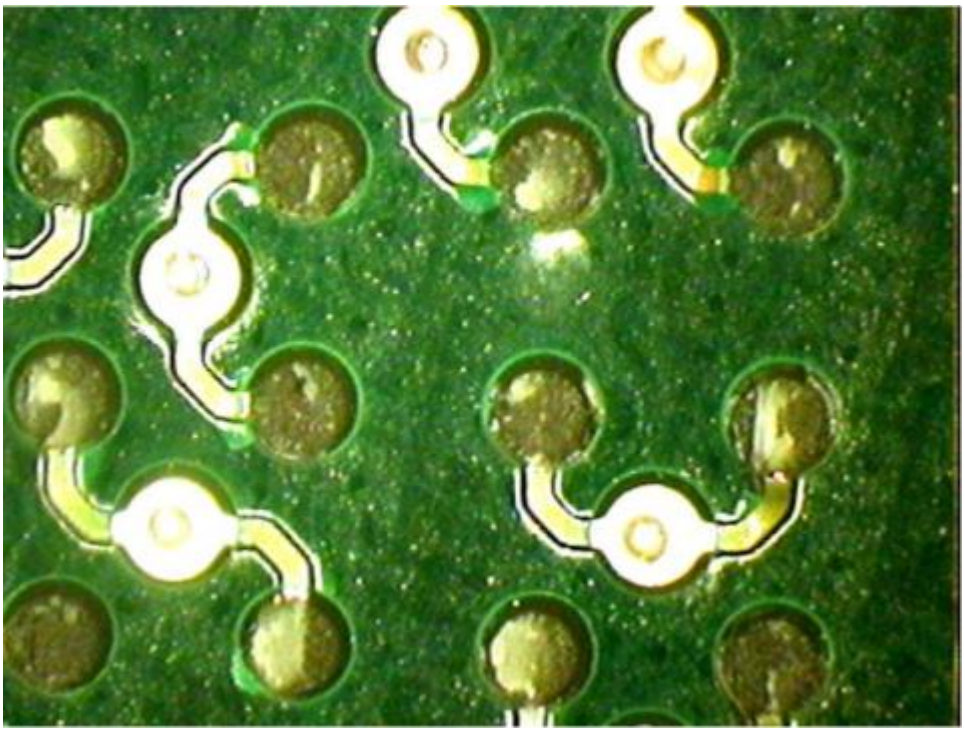
Figure 23 - Test Vehicle 30 BGA U4 with Missing Pads (SnPb Solder/SnPb Balls)

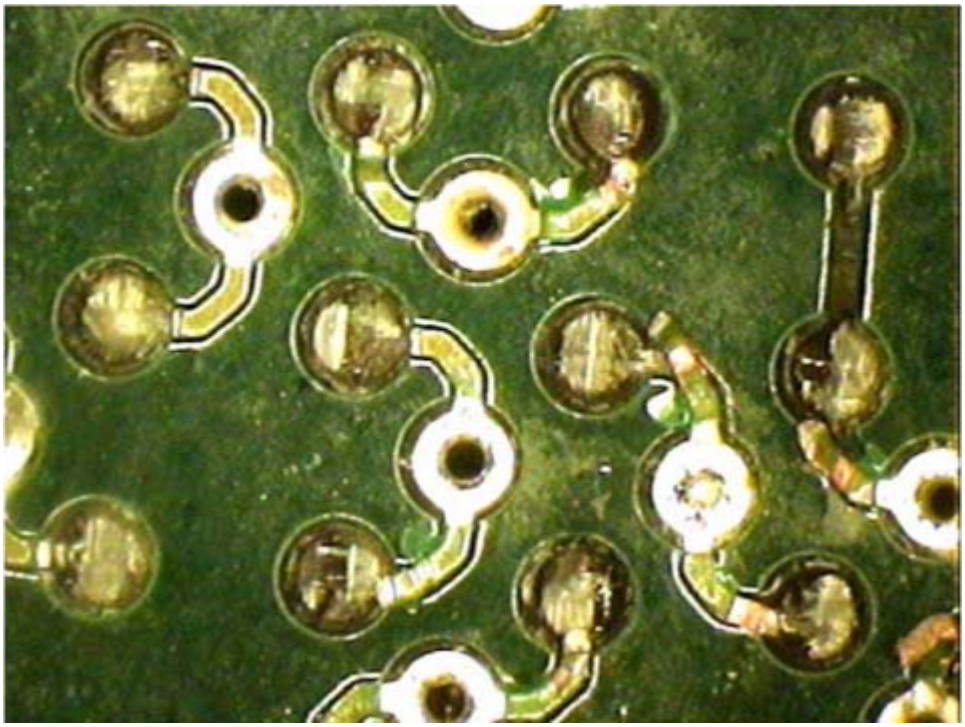
of the remaining balls also showed signs of PWB pad cratering). The balance of the BGA balls and associated PWB copper pads were missing from the test vehicle (Figure 24 and Figure 25).

Figure 24 - Test Vehicle 193 BGA U21 with Missing Pads (Flux Only/SAC405 Balls)

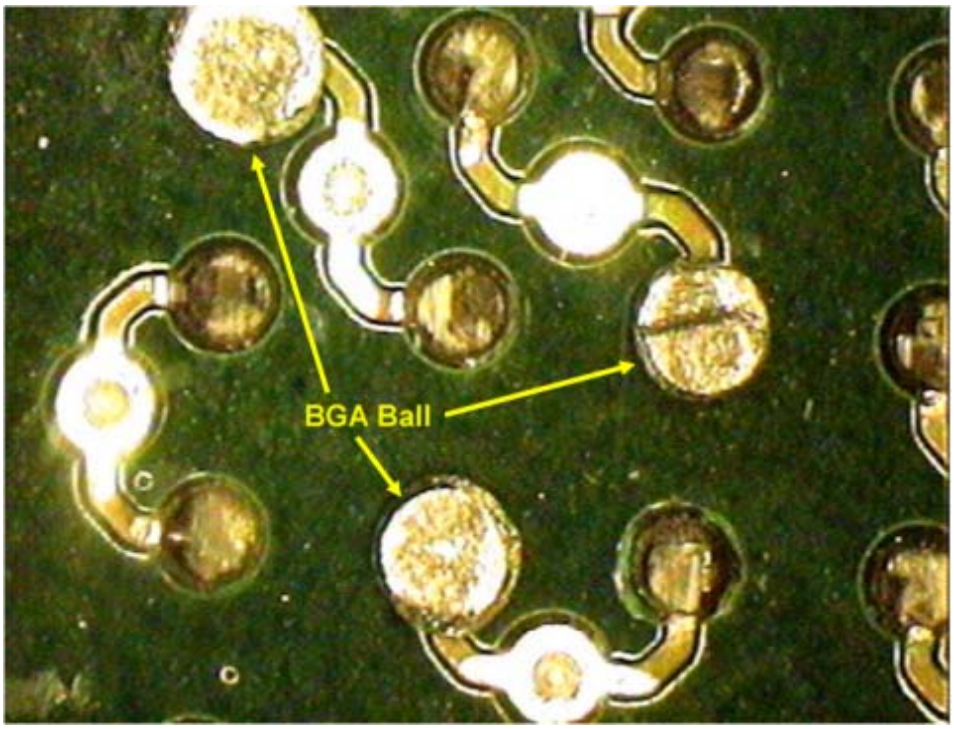
Figure 25 - Test Vehicle 193 BGA U21 with Missing Pads (Flux Only/SAC405 Balls)

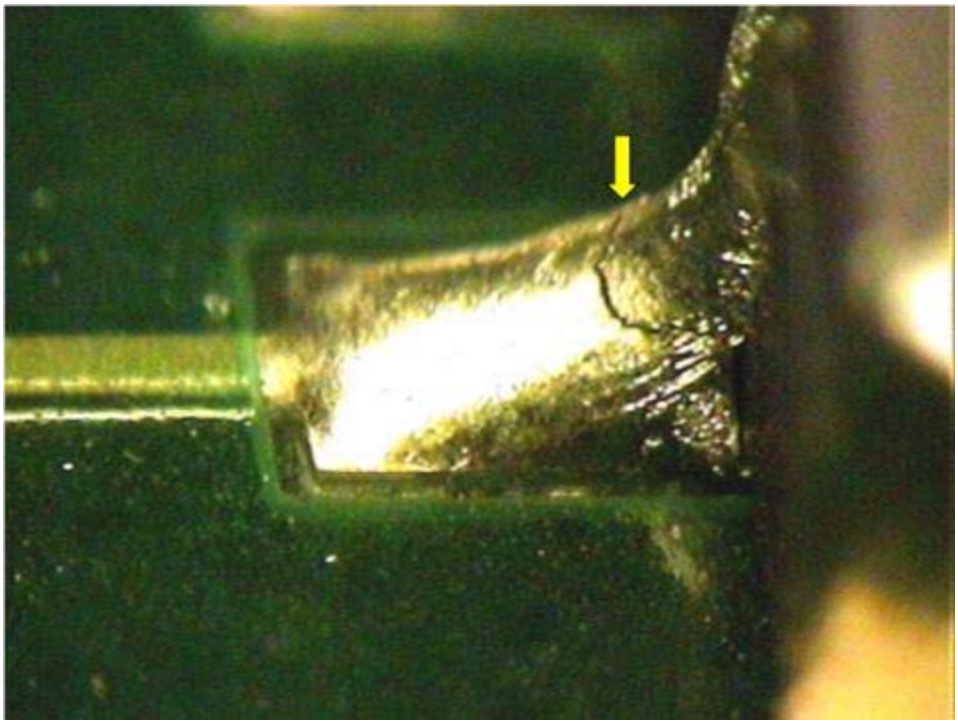
Test vehicle inspections made at the end of Mechanical Shock Testing showed cracks in a CLCC solder joint (Figure 27).

Figure 27 - Test Vehicle 191 CLCC U10 (Cracked SAC305/SnPb Solder Joint)

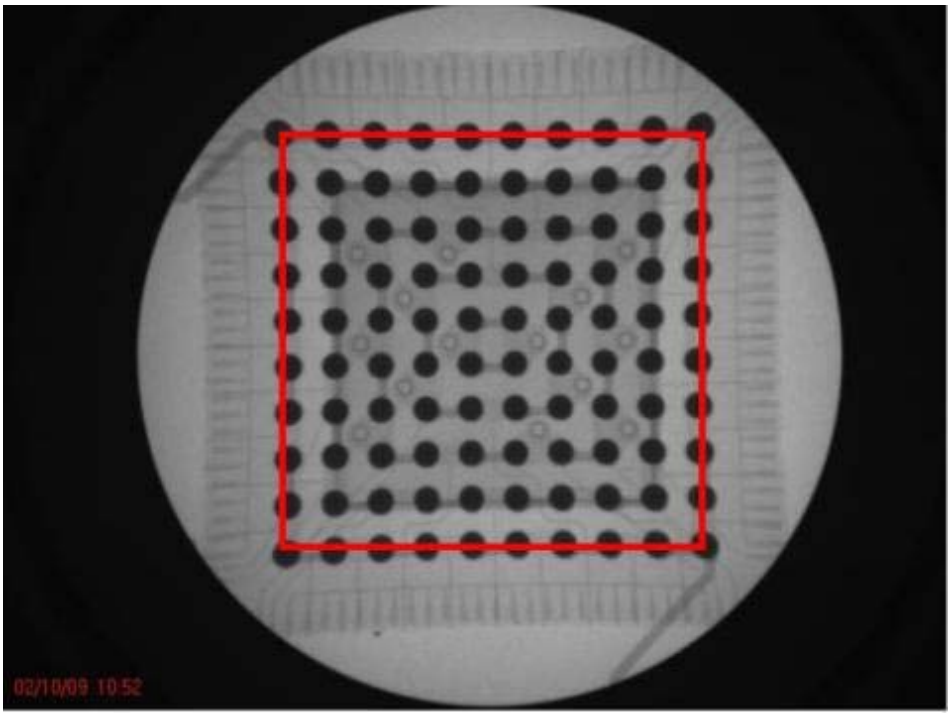
The CSP daisy chain pattern on the test vehicles was incorrect with the result that only the outer perimeter balls of each CSP formed an electrically continuous path (Figure 28). In order for a CSP to be detected as failed, both legs of the outer perimeter needed to fail.

Figure 28 - X-Ray of a CSP-100
Showing that only the outer balls form a daisy-chain (Red Lines).

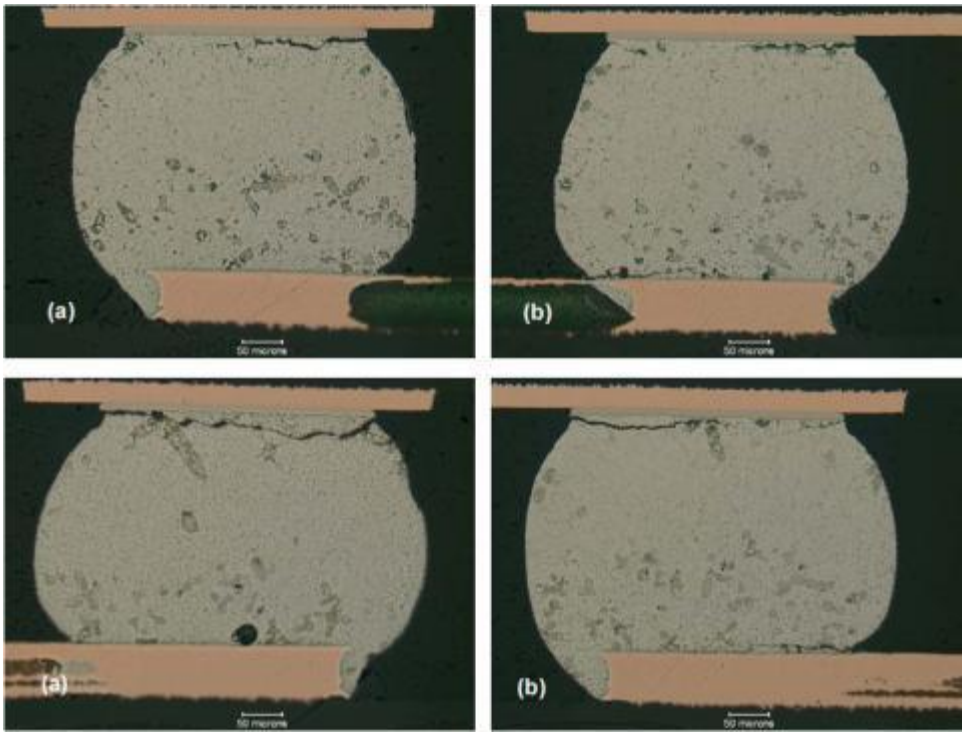
The combination of SAC305 solder/SAC105 balls generally performed as well as the SnPb/SnPb controls in mechanical shock. Microsections made at the end of the test showed that the corner solder joints failed first. The SnPb/SnPb solder joints formed cracks primarily on the component side (Figure 29). The SAC305/SAC105 solder joints formed cracks primarily on the component side and also showed evidence of pad cratering (Figure 30).

Figure 29 - Test Vehicle 34 – CSP U33
(a) Corner Ball, (b) Ball Adjacent to Corner Ball (SnPb Solder/SnPb Balls)

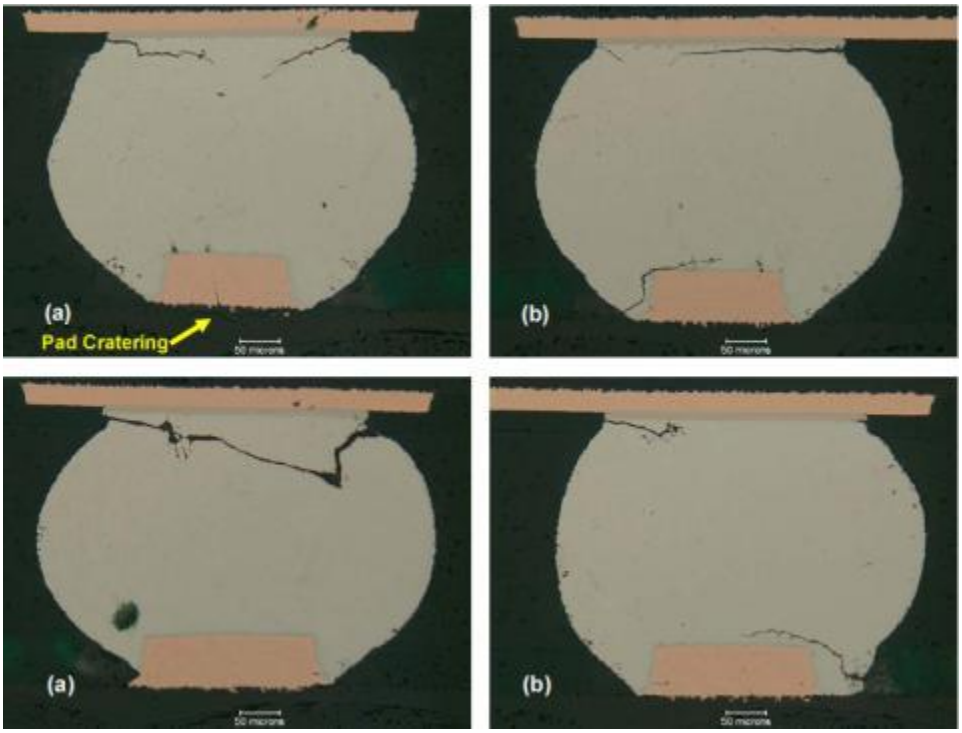
Figure 30 - Test Vehicle 89 – CSP U33
(a) Corner Ball, (b) Ball Adjacent to Corner Ball (SAC305 Solder/SAC105 Balls)

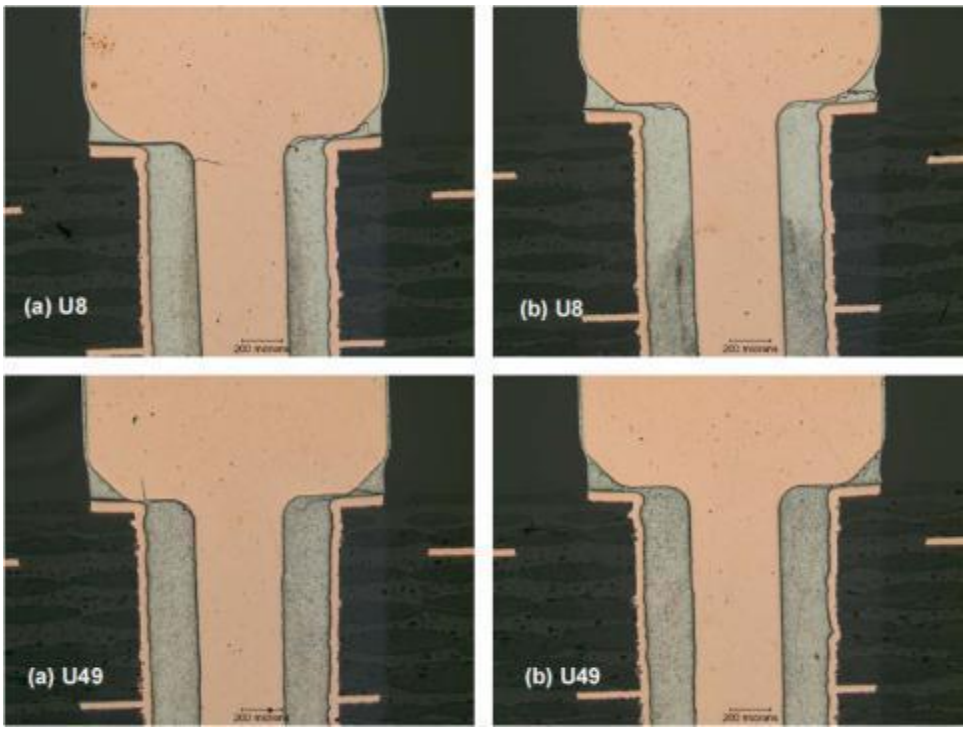
The combination of SN100C solder/Sn component finish generally performed as well as the SnPb/SnPb controls in mechanical shock although some of the SN100C/Sn solder joints failed early. Microsections made at the end of the test showed that the corner solder joints failed before the other solder joints. The topside solder fillet would crack first followed by cracking of the lead where it necks down at the top of the PTH (Figure 31 and Figure 32).

Figure 31 - Test Vehicle 34 – PDIPs U8 and U49 (a) Corner Lead, (b) Lead Adjacent to Corner Lead (SnPb Solder/SnPb Finish)

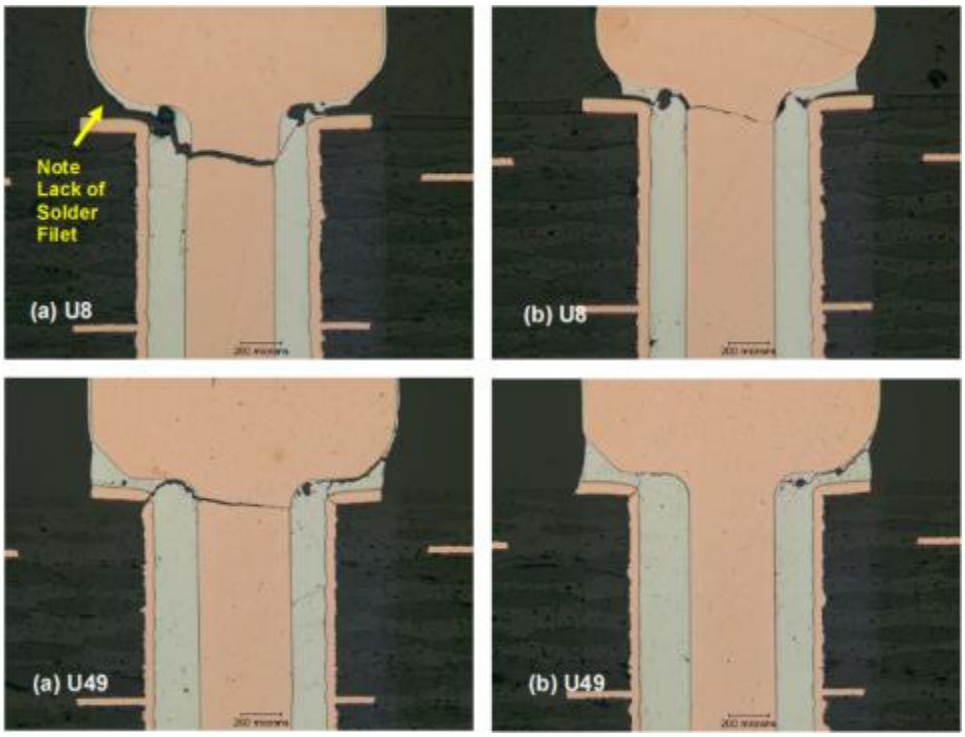
Figure 32 - Test Vehicle 89 – PDIPs U8 and U49 (a) Corner Lead, (b) Lead Adjacent to Corner Lead (SN100C Solder/Sn Finish)

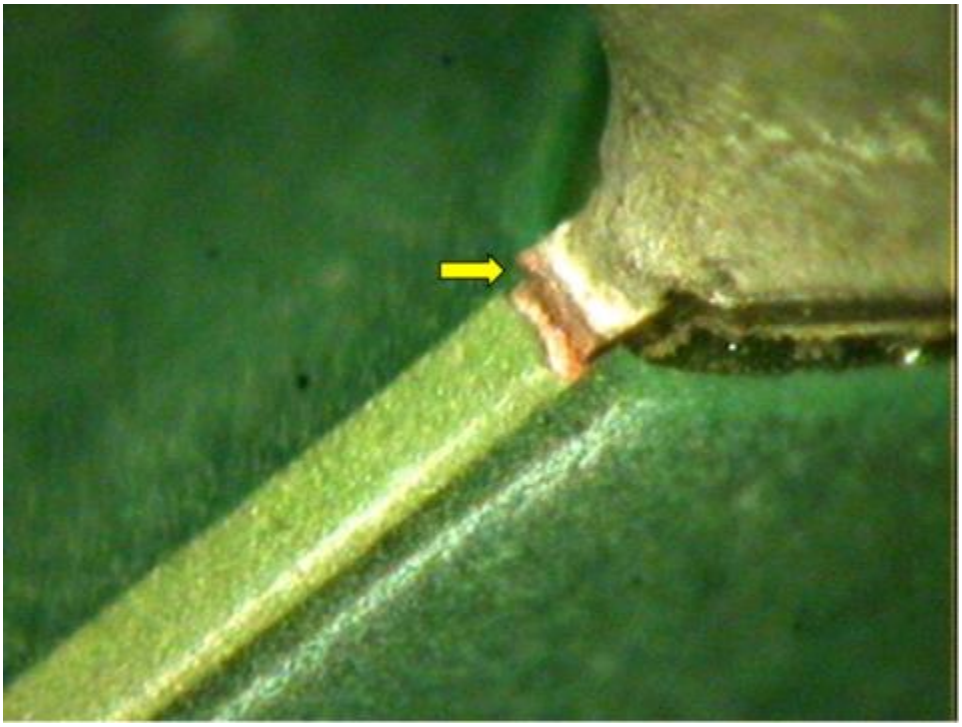
Figure 34 - Test Vehicle 89 PDIP U38 (Cracked Trace, SN100C)

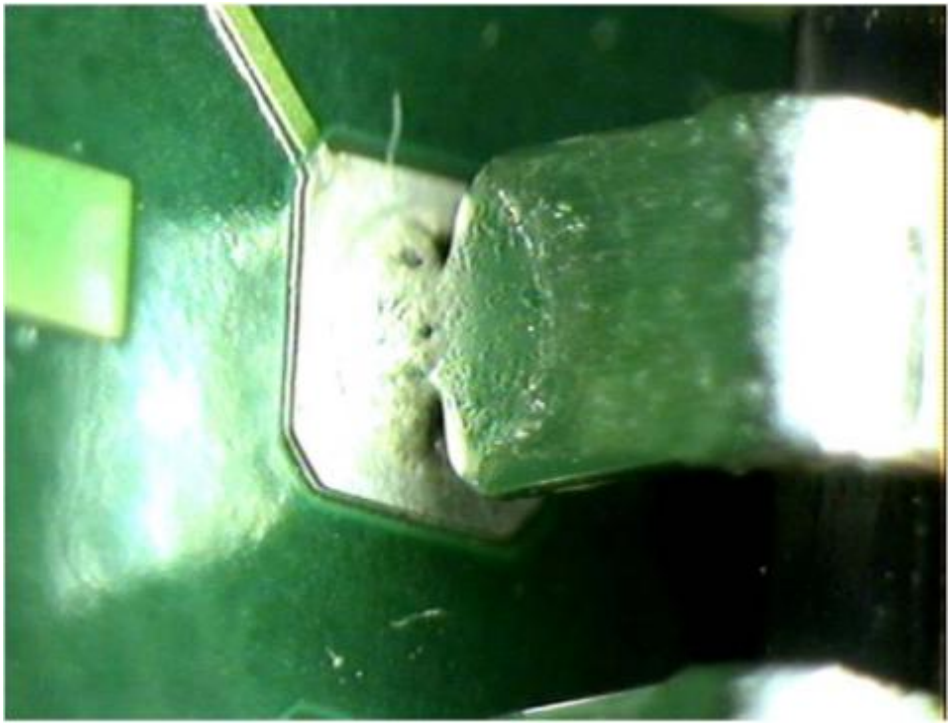
Figure 35 - Test Vehicle 89 PDIP U51 (SN100C)

Several of the earliest failures on the "Manufactured" test vehicles were SN100C/Sn solder joints. One possible cause is that some of the SN100C joints did not have a substantial topside solder filet (Figure 35). This could have resulted in a point of high stress concentration where the PDIP lead necked down resulting in premature failure of the lead. The trace cracking mentioned above is another possible cause for the early failures. Many of the PDIP's that failed early exhibited both failure modes so it could not be definitely determined which occurred first.

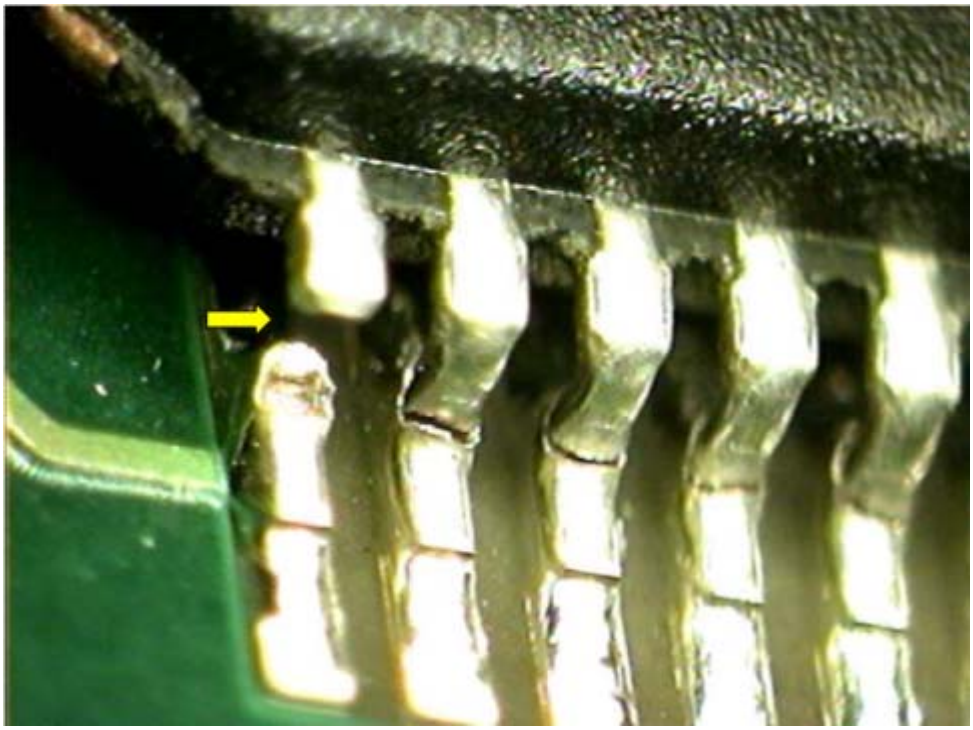
Most of the TQFP-144's had broken and/or missing leads at the end of the test (Figure 36). Since most of the failures appeared to be due to broken leads, the scatter in the test data for all of the TQFP solder/finish combinations was small. SAC305/Sn was equivalent in performance to SnPb/Sn, SnPb/NiPdAu (on immersion Ag), and SnPb/NiPdAu (on ENIG). SAC305/NiPdAu was superior to the SnPb/Sn controls in performance.

Figure 36 - Test Vehicle 89 TQFP U3 (Cracked Leads, Missing Lead)

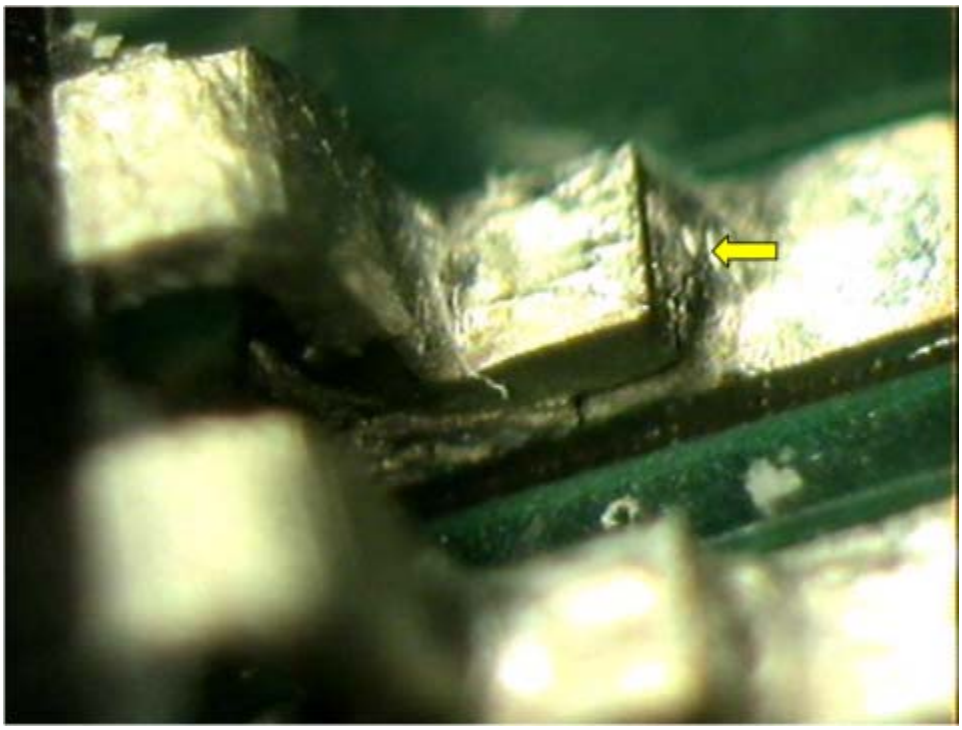
Test vehicle inspection made at the end of Mechanical Shock Testing showed cracks in a TSOP solder joint (Figure 40).

Figure 40 - Test Vehicle 34 TSOP U61 (Cracked SnPb/SnPb Solder Joint)

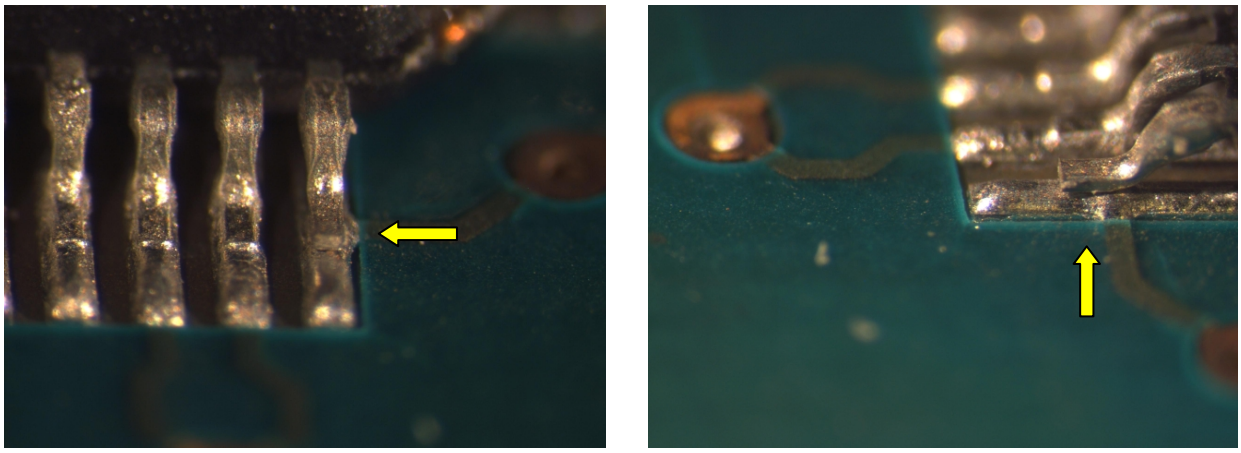
Component location U34 is a TQFP-144 component from SnPb manufactured (Batch C), soldered with SnPb on SnPb dip component finish. This component did not have a signal and failed before one complete cycle. Figure 41 is the optical micrograph showing insufficient solder observed on lead 72 at 49X magnification.

Figure 41 - TV21 U34; Optical Micrograph, Insufficient Solder Observed

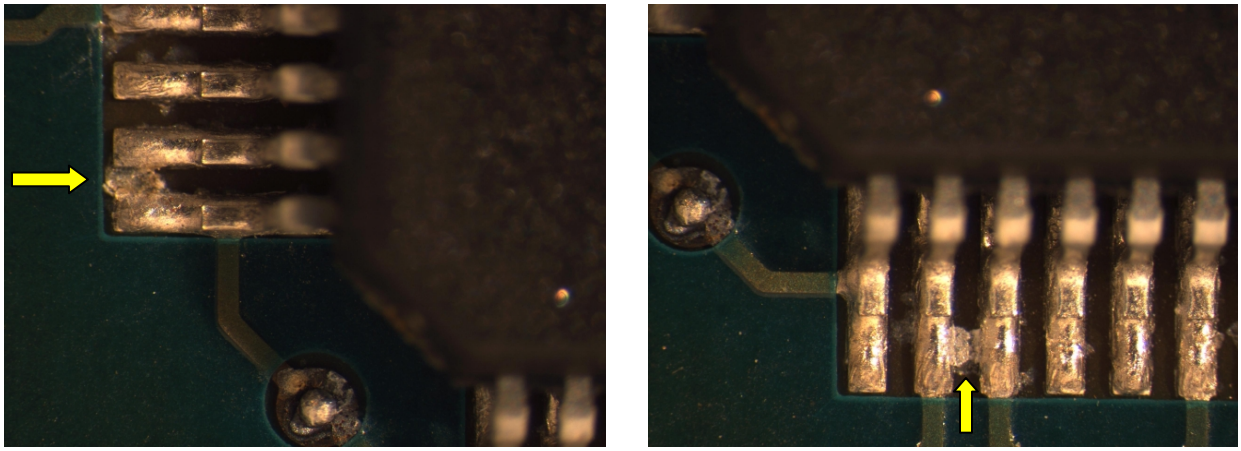
Component location U57 is a TQFP-144 component from SnPb manufactured (Batch C), soldered with SnPb on SnPb dip component finish. This component failed at cycle one. Figure 42 is the optical micrograph of residue that was found between leads in two locations. The image on the left shows residue between leads 35 and 36, magnified at 38X. The image on the right shows residue between leads 38 and 39, magnified at 38X.

Figure 42 - TV21 U57; Optical Micrograph, Residue between Leads

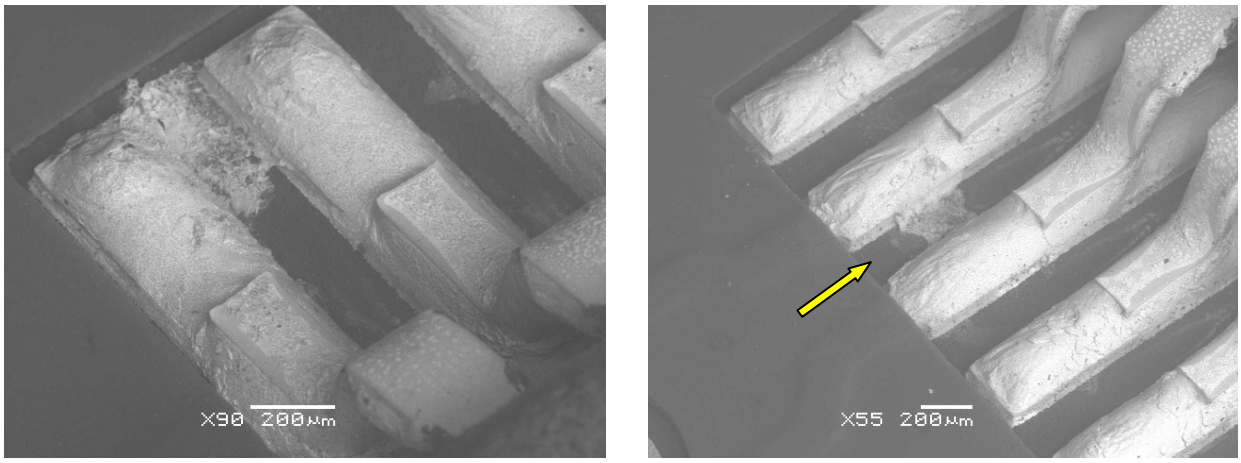
Figure 43 shows Scanning Electron Microscope (SEM) images taken of the residue found from the images in Figure 42. The image on the left shows the residue that was found between leads 35 and 36, magnified at 90X. The image on the right shows the residue found between leads 38 and 39, magnified at 55X.

Figure 43 - TV21 U57; Optical Micrograph, Residue between Leads

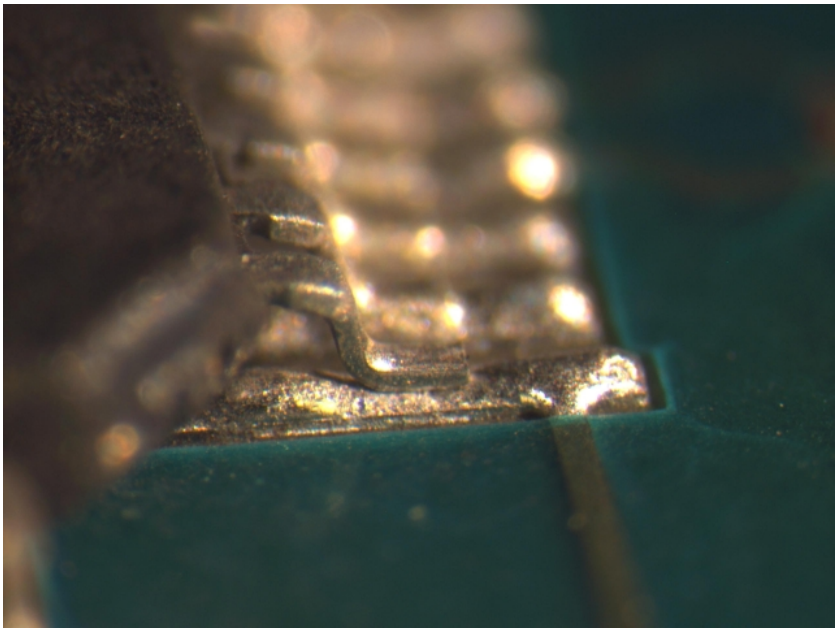
The possible cause for the immediate failure at cycle one can be found in the Figure 44. The Optical micrograph shows component lead 1 does not contact solder on PWB pad at 49X magnification.

Figure 44 - TV21 U57; Optical Micrograph, Component Lead 1

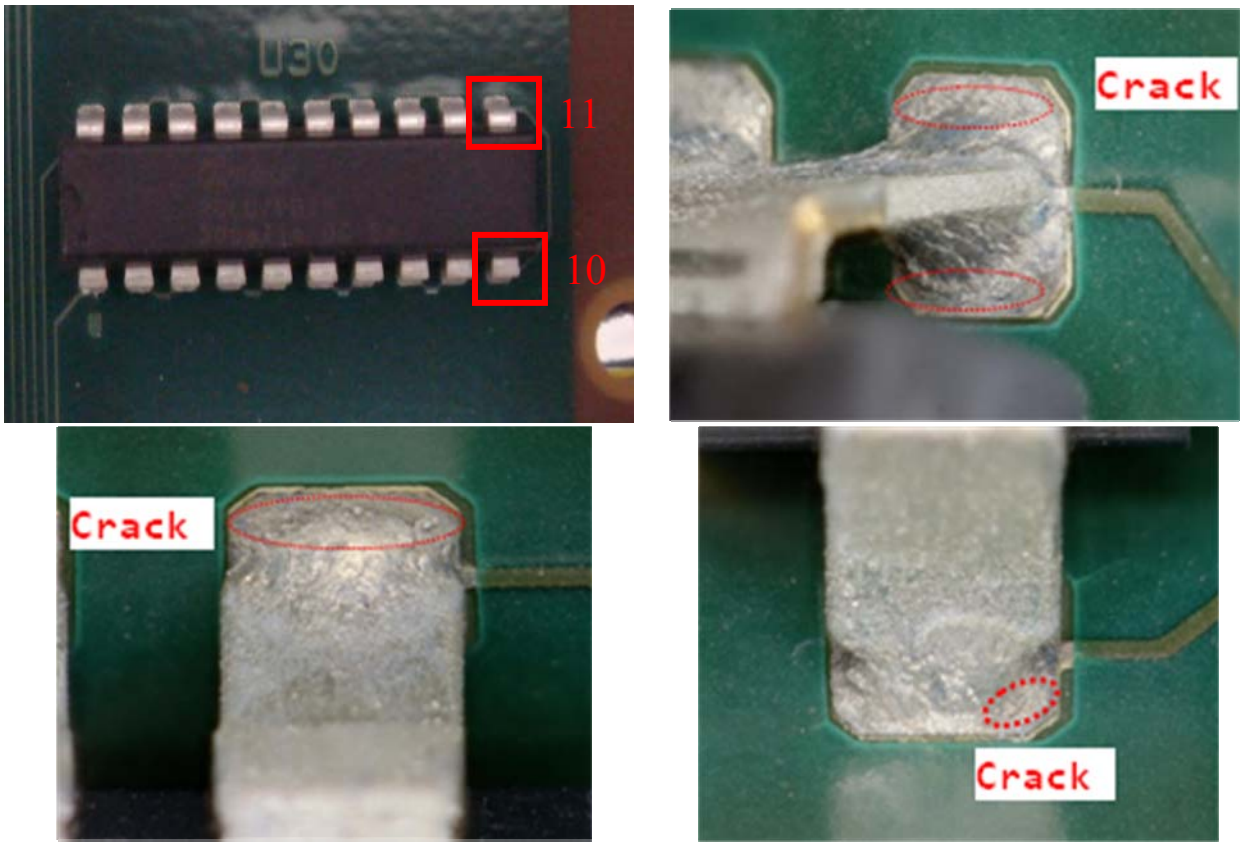
Figure 45 is an optical micrograph of a PDIP-20 component. The red boxes highlight the two leads that were magnified to indicate observed cracking in the solder joints. The image in the upper right is of lead 11, which indicates two areas with cracking. The image in the bottom left is the top portion of lead 11 and the bottom right image is of lead 10 showing a small crack near the pad. Crack has not caused an electrical failure, yet.

Figure 45 - TV23 U30; Optical Micrograph, PDIP-20

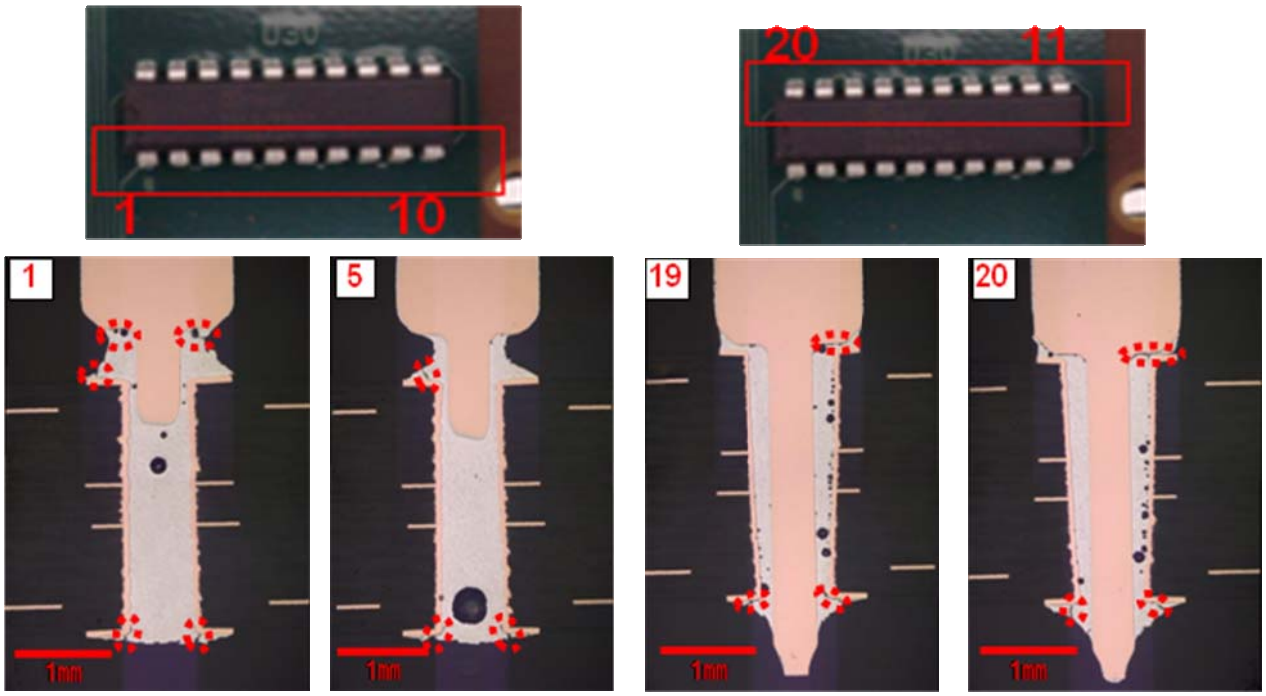
Figure 46 shows cross-sectional micrographs of PDIP-20 leads where the two images on the top are indicating the lead numbering. The cross-sections of leads 1, 5, 19 and 20 were selected as an example of the leads that had large quantities of voids, relative to the other component leads. The dotted lines indicate solder cracks that were found; no break off solder was found during failure analysis.

Figure 46 - TV23 U30; Cross-Sectional Micrographs of PDIP-20 Leads
