NASA-DoD LEAD-FREE ELECTRONICS PROJECT: JOINT TEST REPORT

Kurt Kessel
ITB, Inc.
NASA Technology Evaluation for Environmental Risk Mitigation (TEERM) Principal Center
Kennedy Space Center, FL, USA
kurt.r.kessel@nasa.gov
{On behalf of the NASA-DoD Lead-Free Electronics Project Consortium}

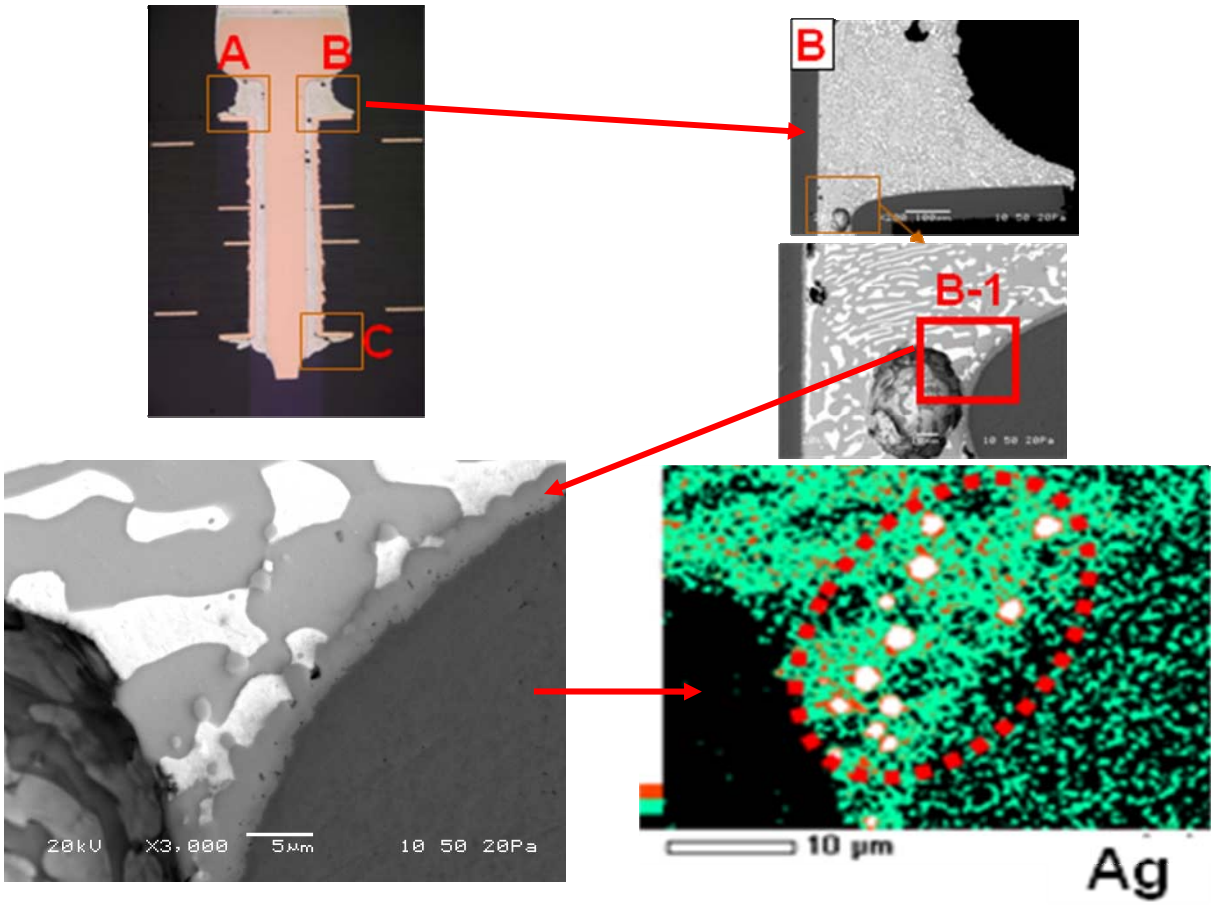
The micrographs in Figure 47 show progression of analysis for lead 9 of PDIP-20 component beginning with upper left and following the arrows to the image on the bottom right. This analysis found silver (bottom right) within the solder joint. The source of the silver may have been the immersion silver board finish.

Figure 47 - TV23 U30; Micrographs, Lead 9 of PDIP-20

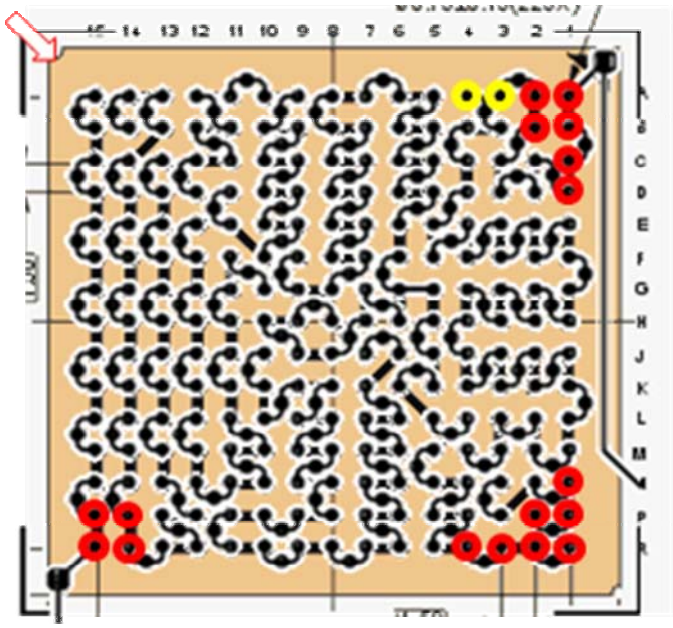
Component location U43 is a BGA-225 from the SnPb manufactured (Batch C), soldered with SnPb with SAC405 component finish located near the center of the test vehicle. This component failed at 120 cycles of combined environments. In Figure 48, yellow circles indicate solder joints with high resistance and red circles indicating failed solder joints that are open.

Figure 48 - TV23 U43; FA Results, BGA-225, Location U43

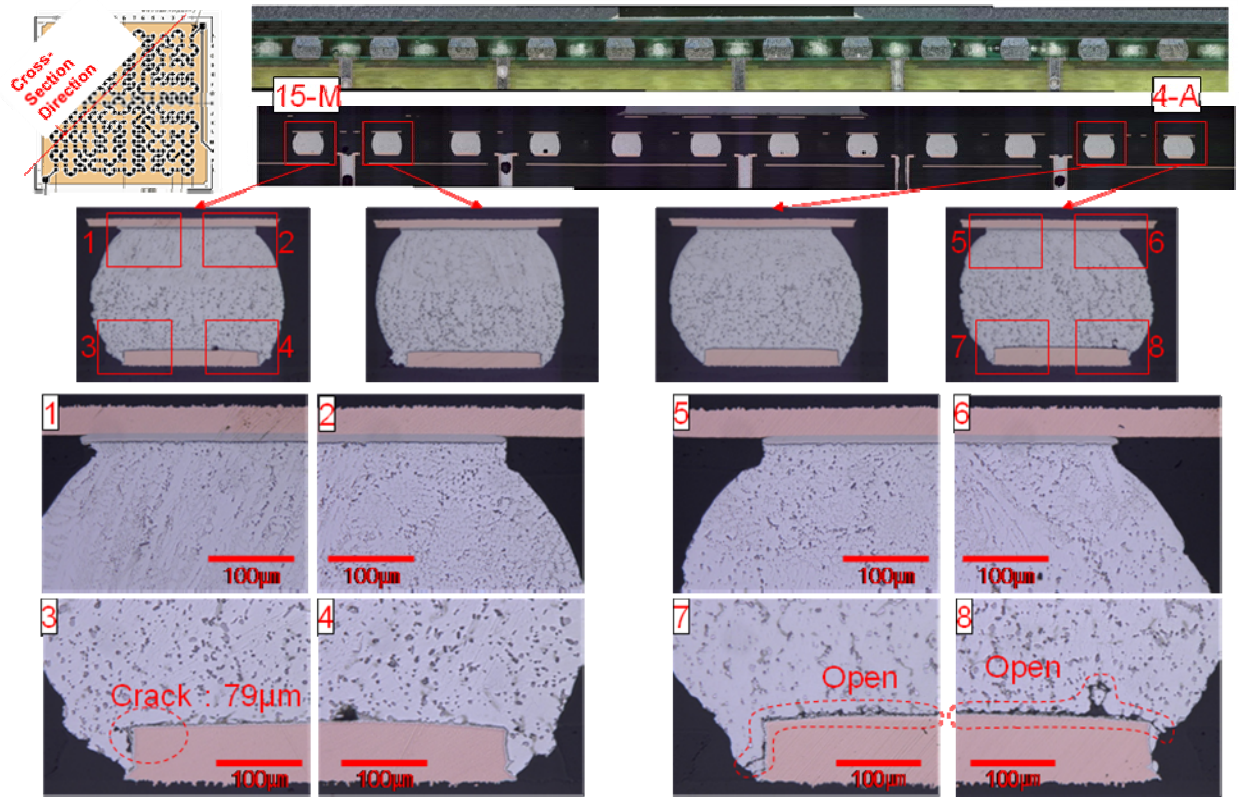
Figure 49 - TV23 U43; Cross-Sectional Micrographs

Cross-sectional micrographs in Figure 49 show different solder structure in lands on board (3, 4, 7, 8) and lands on component (1, 2, 5, 6). Cracking to open along land on board observed at 3-A.

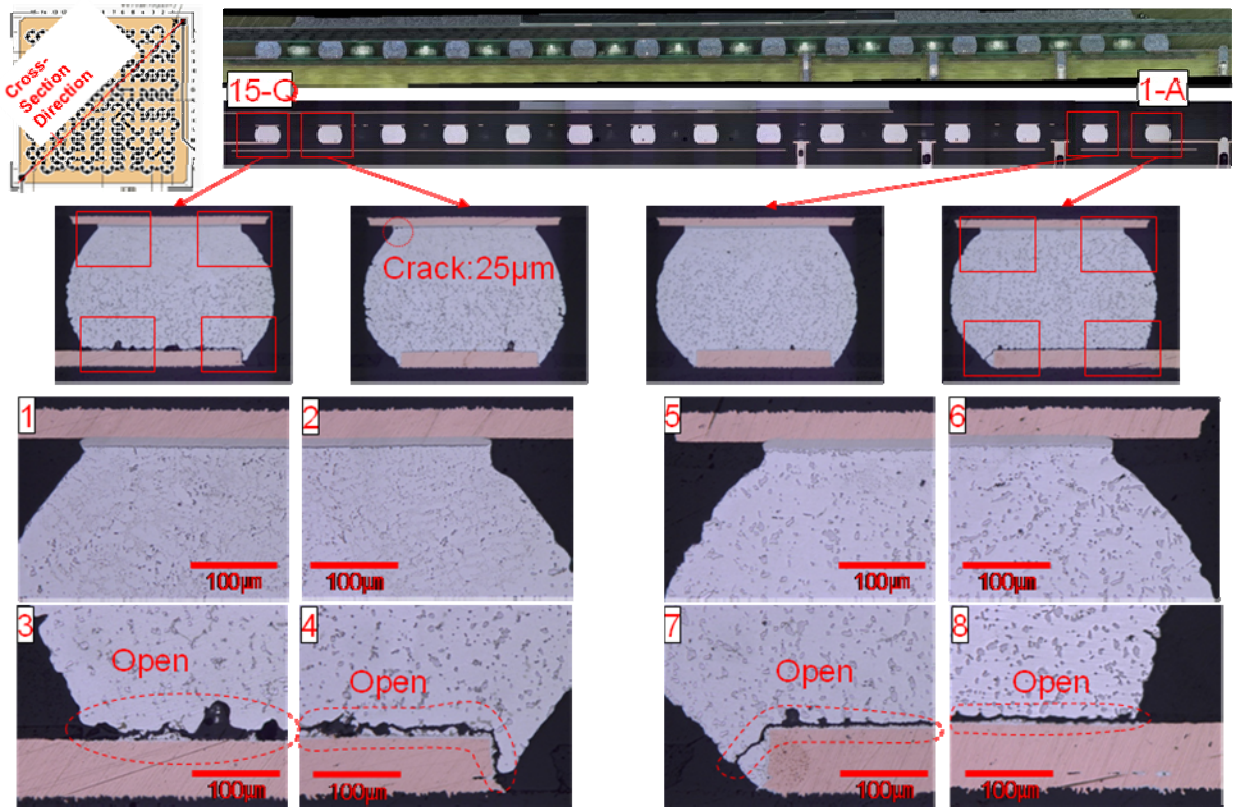
Figure 50 - TV23 U43; Cross-Sectional Micrographs

Cross-sectional micrographs in Figure 50 show different solder structure in lands on board (3, 4) and lands on component (1, 2). Cracking to open along land on board observed at 1-A and 15-Q.

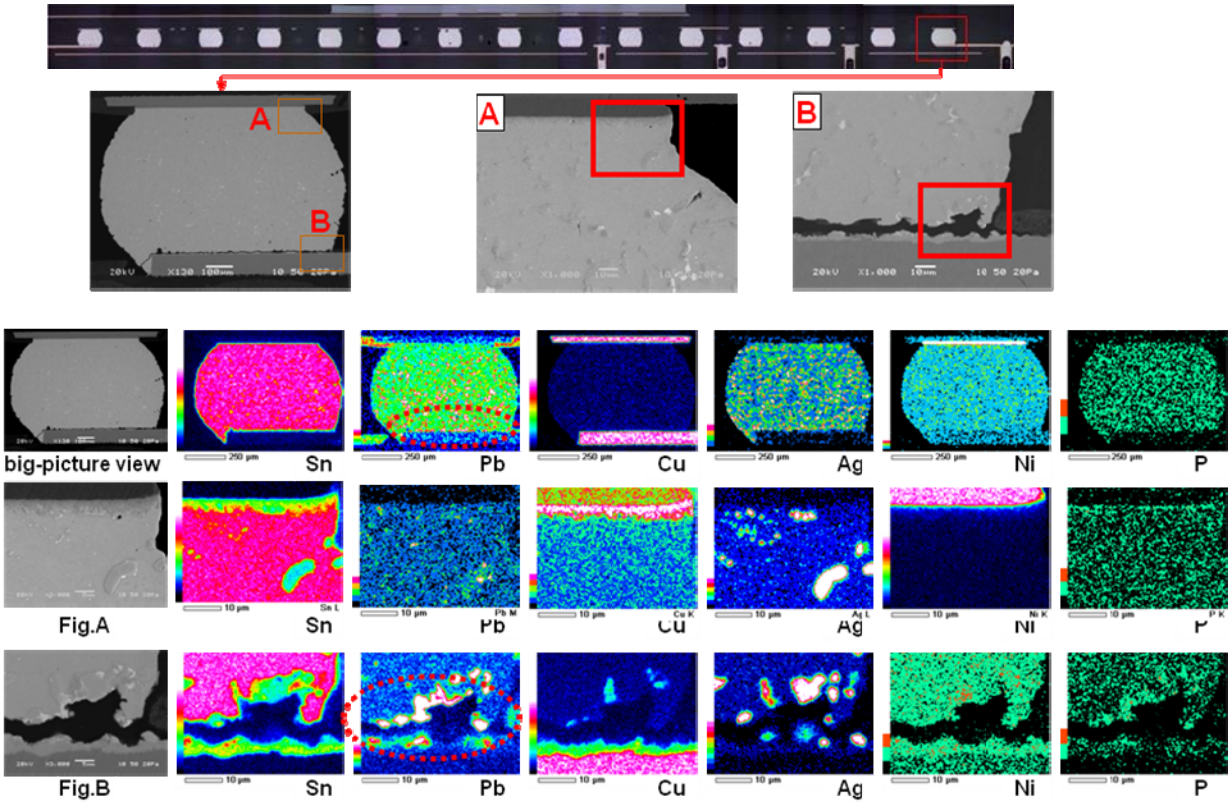
Figure 51 - TV23 U43; SEM Mapping

In Figure 51 SEM mapping shows segregation of Pb around land on board. Cracking found in the part Pb segregated.

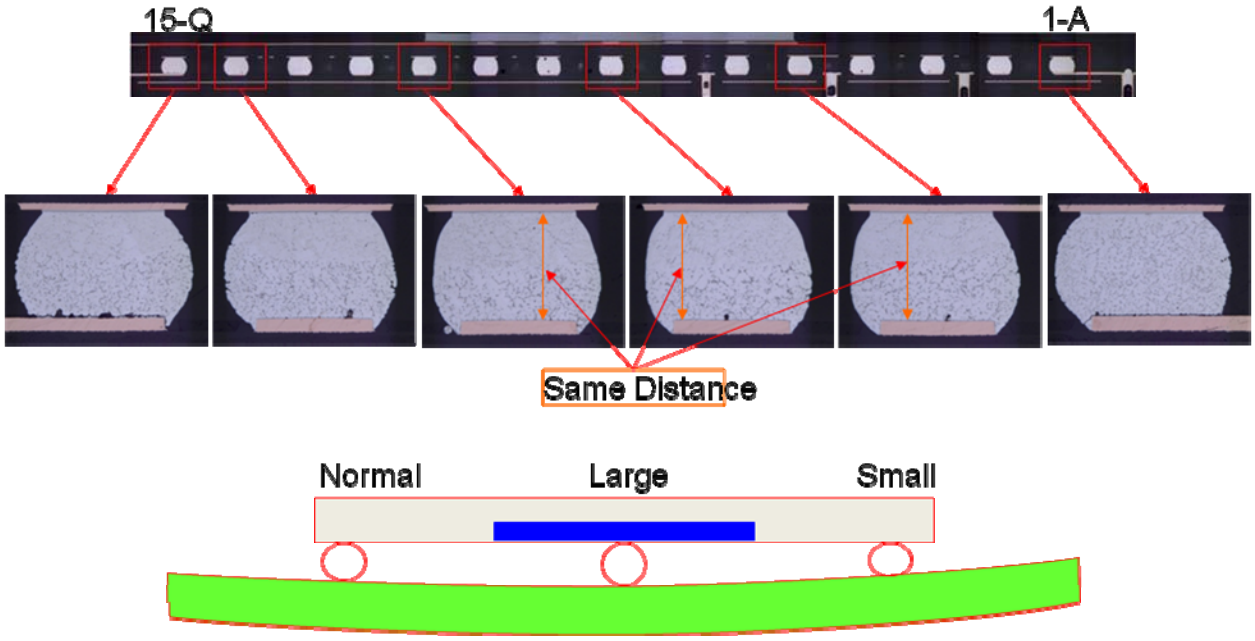
In Figure 52 the distance between component and board at each sphere is almost the same under the chip in the center. The distance becomes smaller further to the end. Comparing the distance at [1-A] and [15-Q], [1-A] has smaller distance.

Figure 52 - TV23 U43; Cross-Sectional Micrographs Show Warping

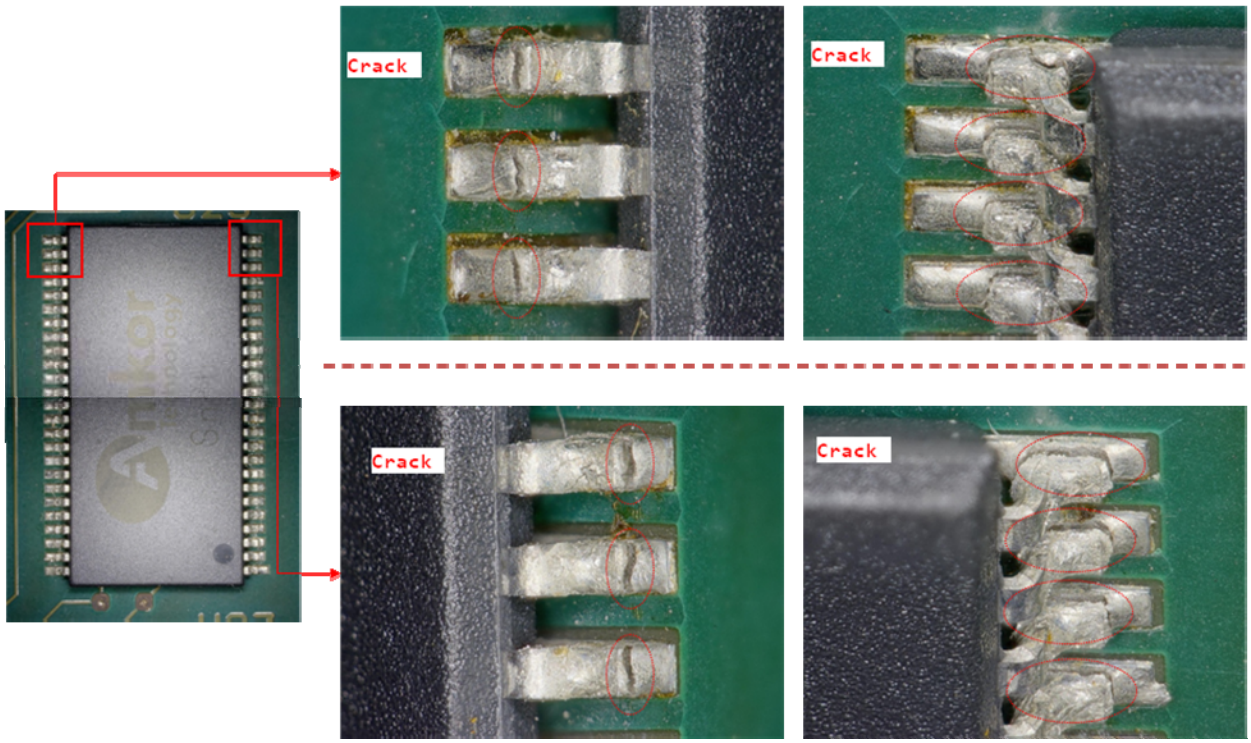
Figure 53 - TV72 U29; Visual Inspection Showing Cracked Solder Joints

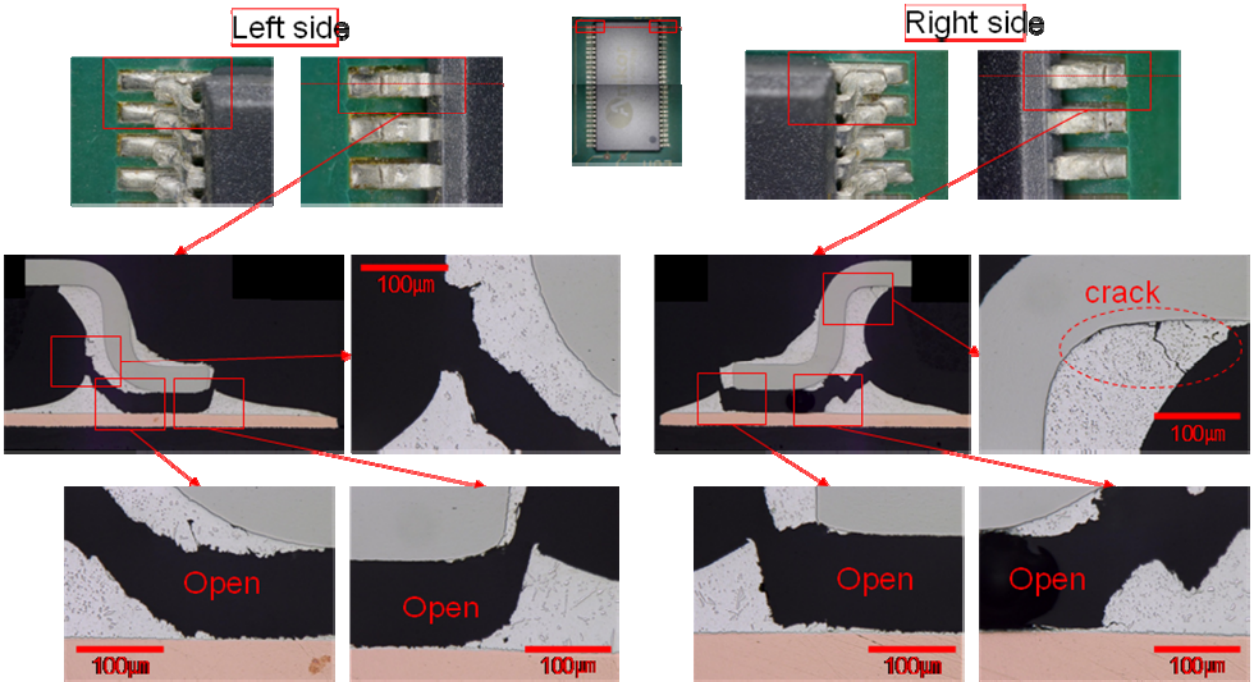
Figure 54 - TV72 U29; Cross-Section Micrographs Showing Open Solder Joints

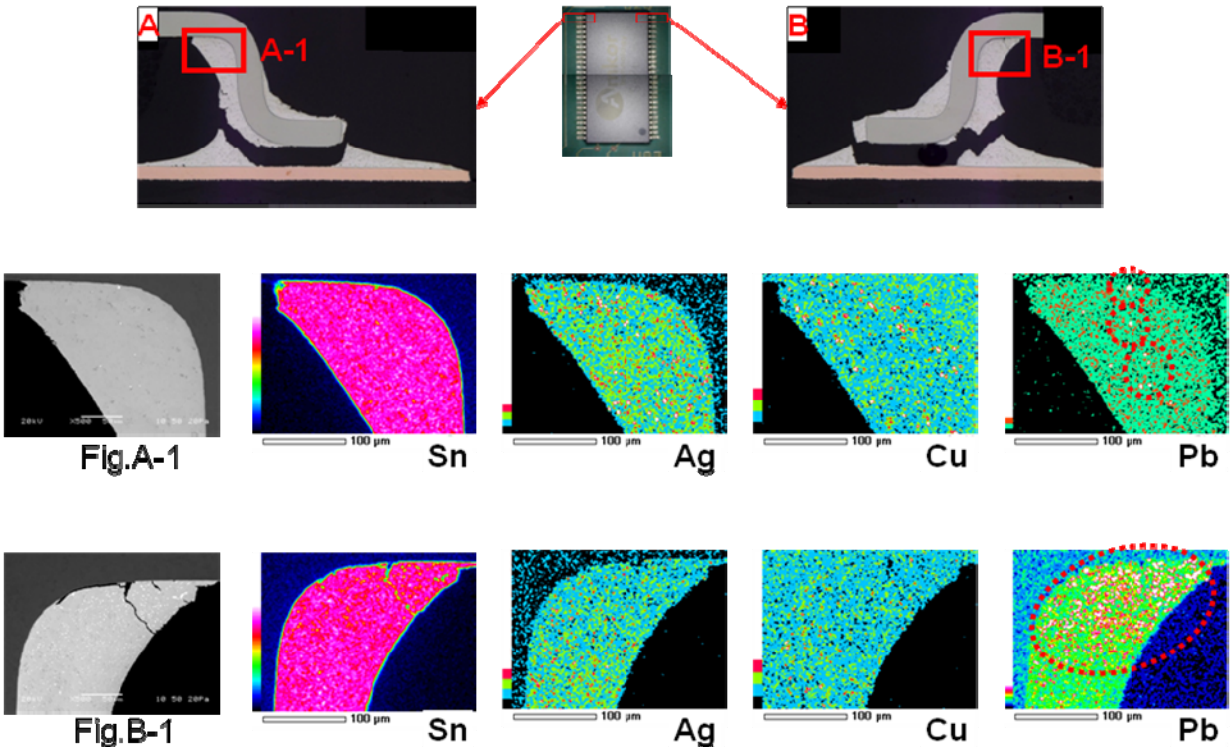
Figure 55 - TV72 U29; SEM Mapping, Pb was Found Around Upper Part of the Both Leads

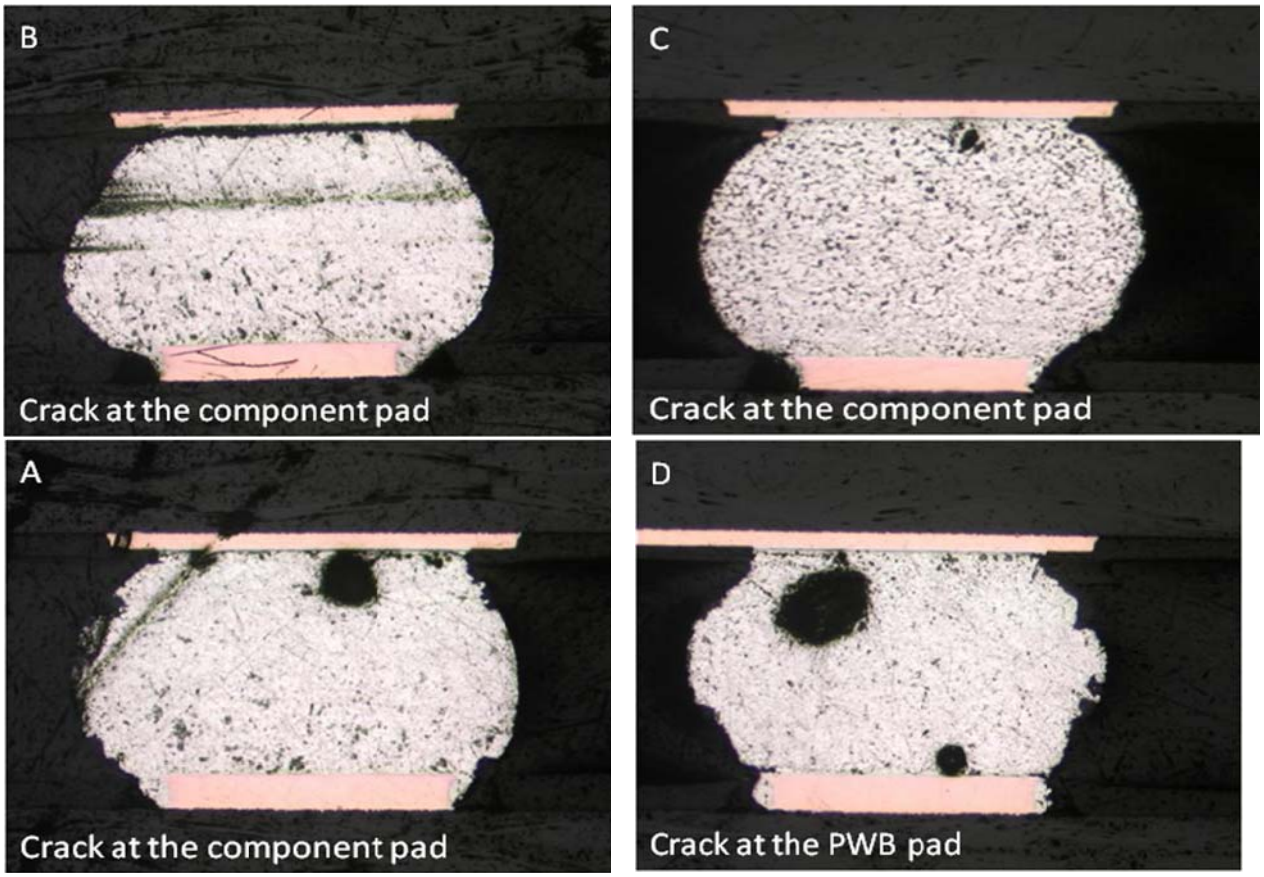
Figure 57 shows cross-sectional micrographs of corner solder balls depicting cracks at component pads on views A, B and C. Crack at the PWB pad detected on view D.

Figure 57 - TV117 U4; Cross-Sectional Micrographs of Corner Solder Balls

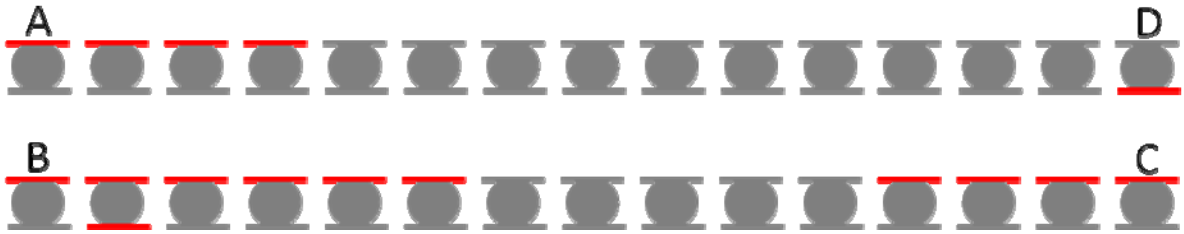
There was a progression of cracking between sides A/D and B/C, which can be visually represented in Figure 58. Red on top of the solder ball is cracking observed at the component interface. Red on the bottom of the solder ball is cracking observed at the PWB pad interface. Red on both the top and bottom of the solder ball is cracking observed at both the component and PWB pad interface. No red indicates an intact solder joint.

For this BGA-225 component, cracking was observed on both the second and third rows in from the perimeter row. No cracking was observed on solder balls beneath the component die.

Figure 58 - TV117 U4; Diagram Showing Progression of Cracking in Component

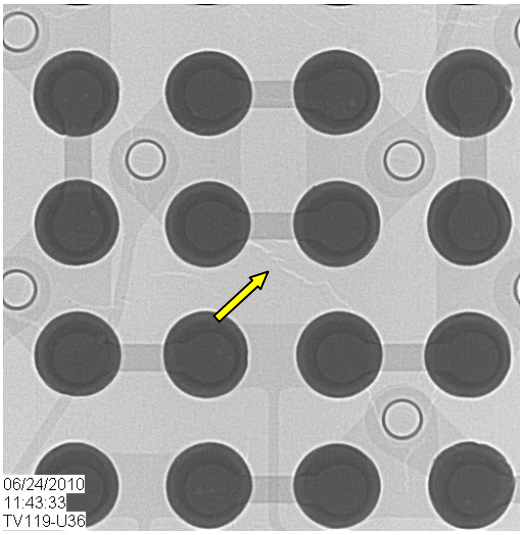
Figure 59 is an x-ray image of the center region of the CSP-100 component in location U36. The PCB solder mask has a crack and is not homogeneous.

Figure 59 - TV119 U36; X-Ray Image, CSP-100

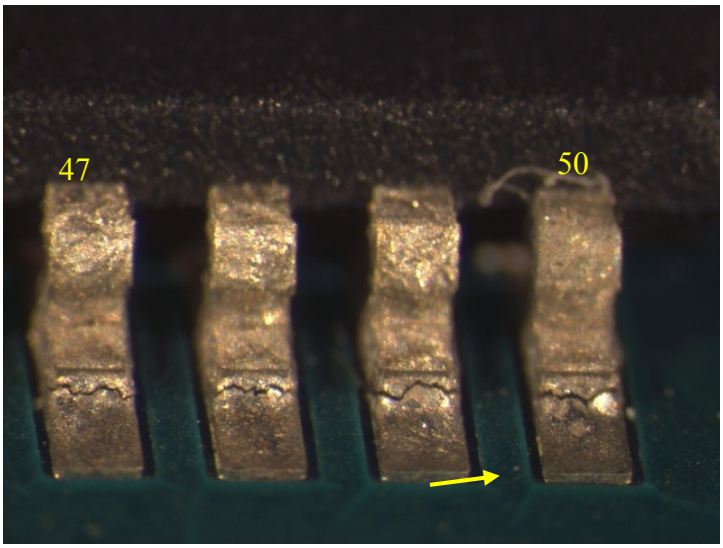
Figure 62, an optical micrograph at 49X magnification showing cracked solder joints and cracks in the solder mask between leads 47 and 50.

Figure 62 - TV119 U39; Optical Micrograph at 49X Magnification

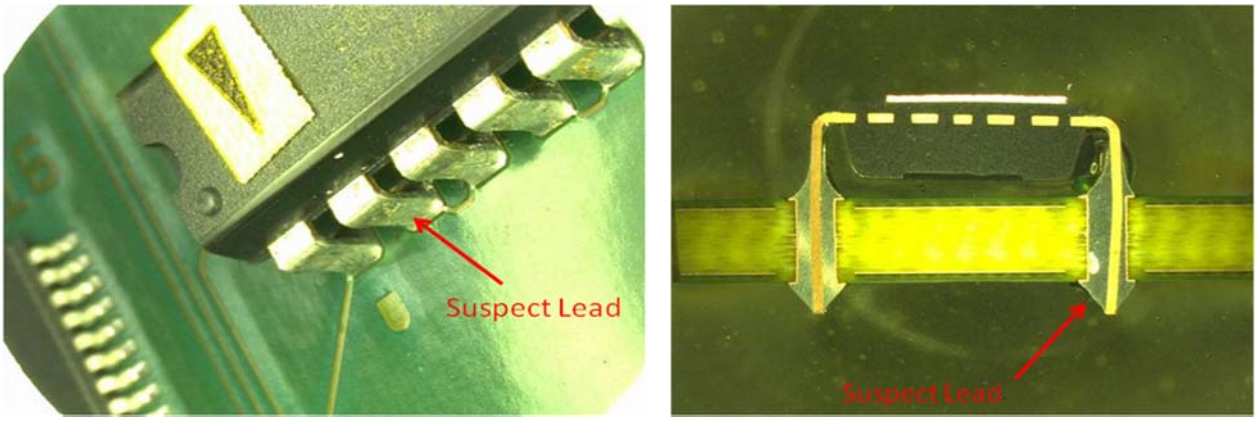
Component location U11 is a PDIP-20 from SnPb rework (Batch B), soldered with SnPb on SnPb component finish. This component had a damaged pad from the rework process and failed after 398 cycles. For the optical micrograph in Figure 67, on the left shows the suspect lead. Cross-sectional micrograph on the right is the suspect lead.

Figure 67 - TV140 U11; Optical Micrograph

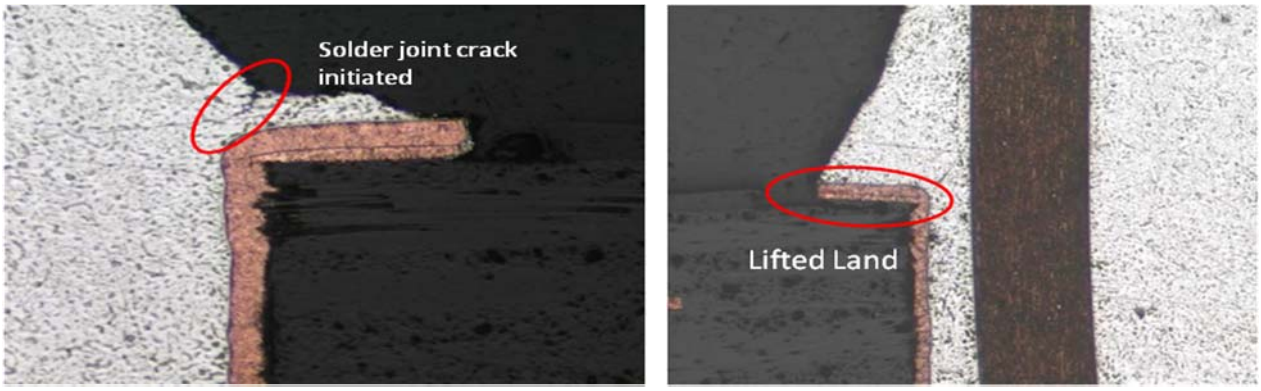
Figure 68 shows the cross-sectional micrographs of the suspect lead in the PDIP-20 component showing solder joint crack initiation and lifted land.

Figure 68 - TV140 U11; Cross-Sectional Micrographs, Suspect PDIP-20 Lead

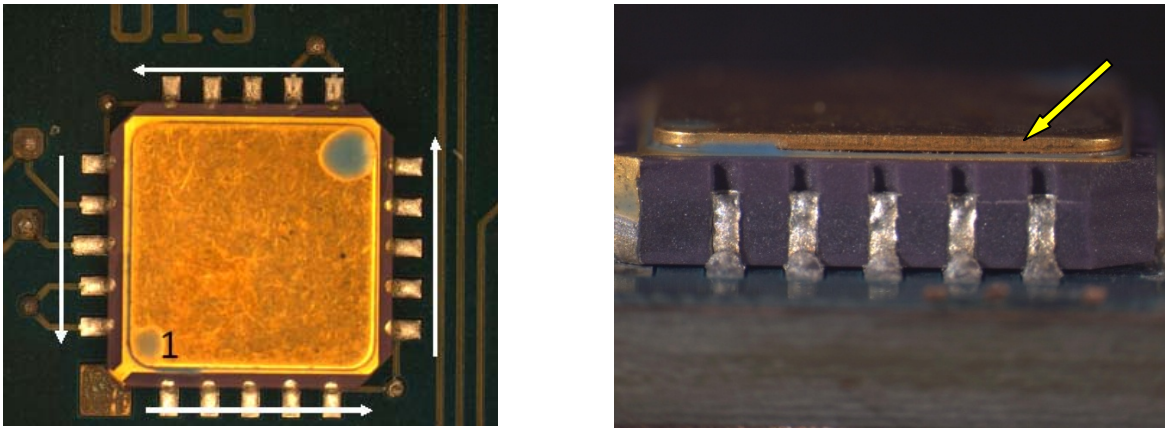
Figure 69, optical micrograph, on the left shows the CLCC package lead numbering. Micrograph on the right shows an improperly sealed lid on the side for leads 1 – 5 where lead 1 is on the left at 19X magnification.

Figure 69 - TV142 U13; Optical Micrograph, CLCC Package Lead

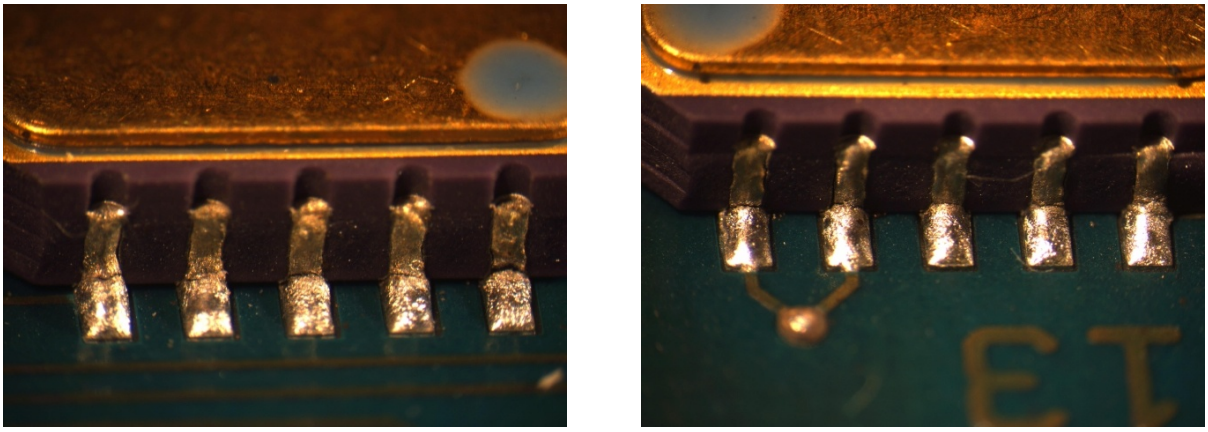
Figure 70 - TV142 U13 Optical Micrographs of CLCC-20 Leads at 24X Magnification

For Figure 70, on the left are leads 6 – 10 starting with lead 6 on the left and on the right are leads 11 – 15 starting with lead 11 on the left. Minor solder cracking is visible.

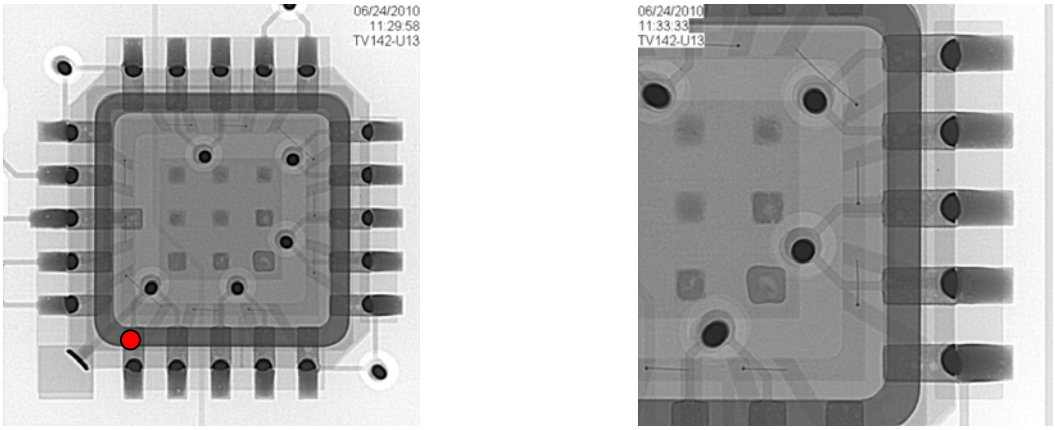
Figure 71 - TV142 U13 X-Ray Inspection of CLCC-20 Component.

In Figure 71, on the left is the overall x-ray image and on the right is an x-ray of leads 6 – 10 with lead 6 being on the bottom.

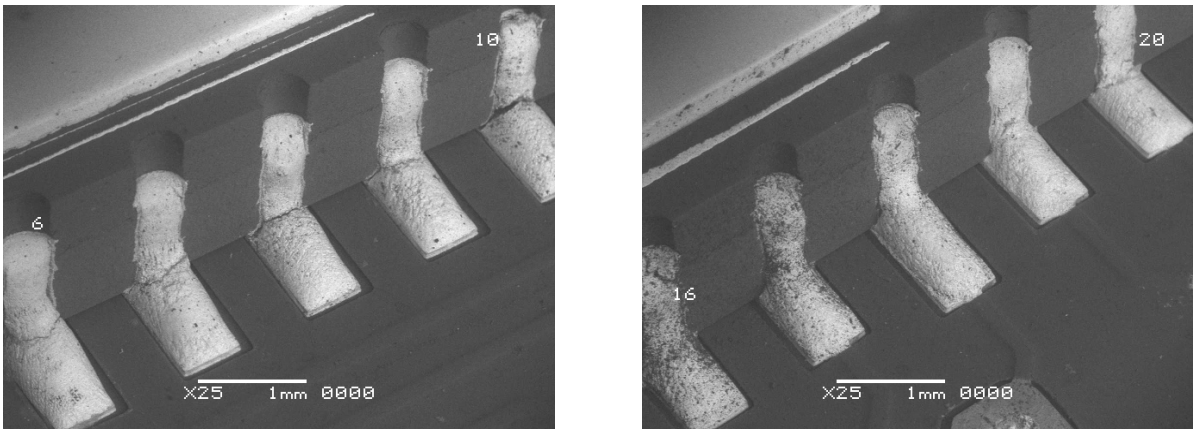
Figure 72 - TV142 U13 SEM Images of Component at 25X Magnification

In Figure 72 on the left are leads 6 – 10 which have some visible solder cracks and on the right are leads 16 – 20 and do not have solder cracks.

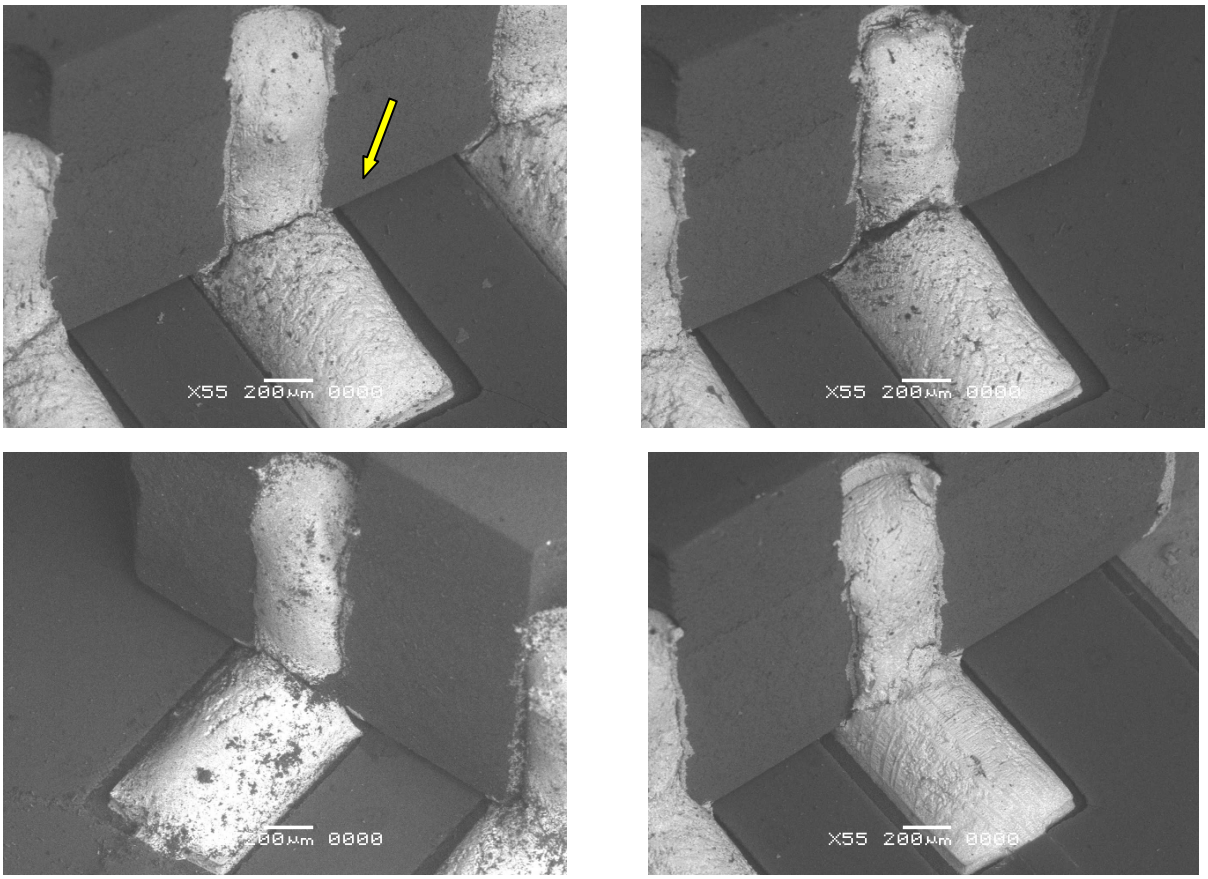
Figure 73 - TV142 U13 SEM Images of Selected Leads at 55X Magnification.

In Figure 73, the upper left image is lead 8 where the arrow indicates a solder crack. The upper right image is lead 10 where a solder crack is also visible. The lower left image is lead 11 and the lower right image is lead 20.

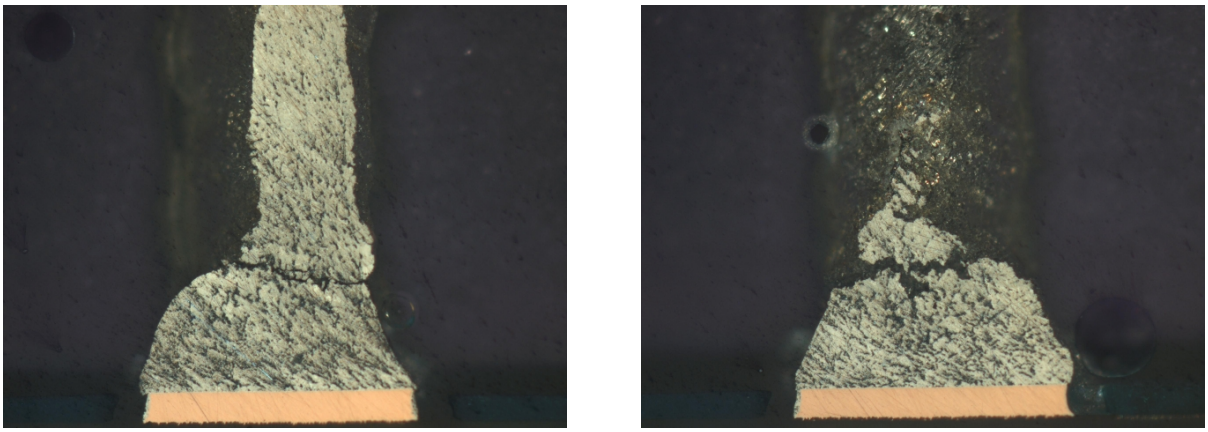
Figure 75 - TV142 U13; Cross-Sectional Micrographs of Lead 1 and Lead 5

Figure 75, cross-sectional micrographs of lead 1 (left) and lead 5 (right) solder joints, grinding level A, at 136X magnification.

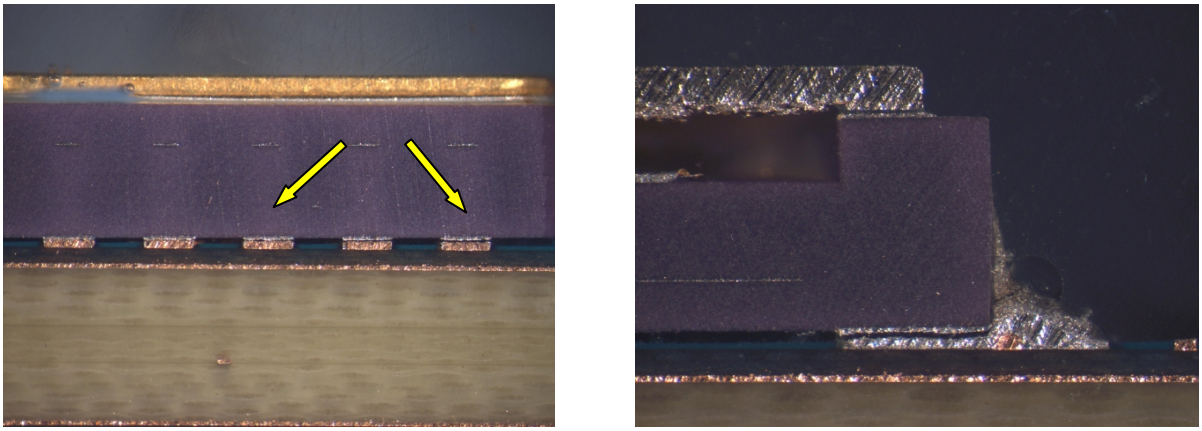
Figure 76 - TV142 U13; Cross-Sectional Micrograph

Figure 76, cross-sectional micrograph, on the left shows grinding level A of leads 1 – 5 where the arrows indicate separation of the solder joints from the copper pads at 24X magnification. Micrograph on the right is lead 6 at 38X magnification just prior to grinding to level B.

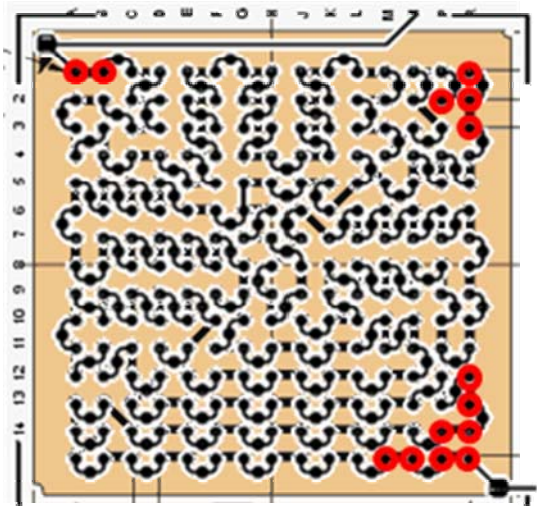
Figure 78 - TV158 U6; FA Results

Component location U6 is a reworked SnPb BGA-225 component soldered with SnPb solder paste, removed and replaced with a SAC405 BGA-225 component soldered with SnPb solder paste on an ENIG PWB. This component failed during the first cycle.

In Figure 78, the red circles indicate failed solder joints that are open.

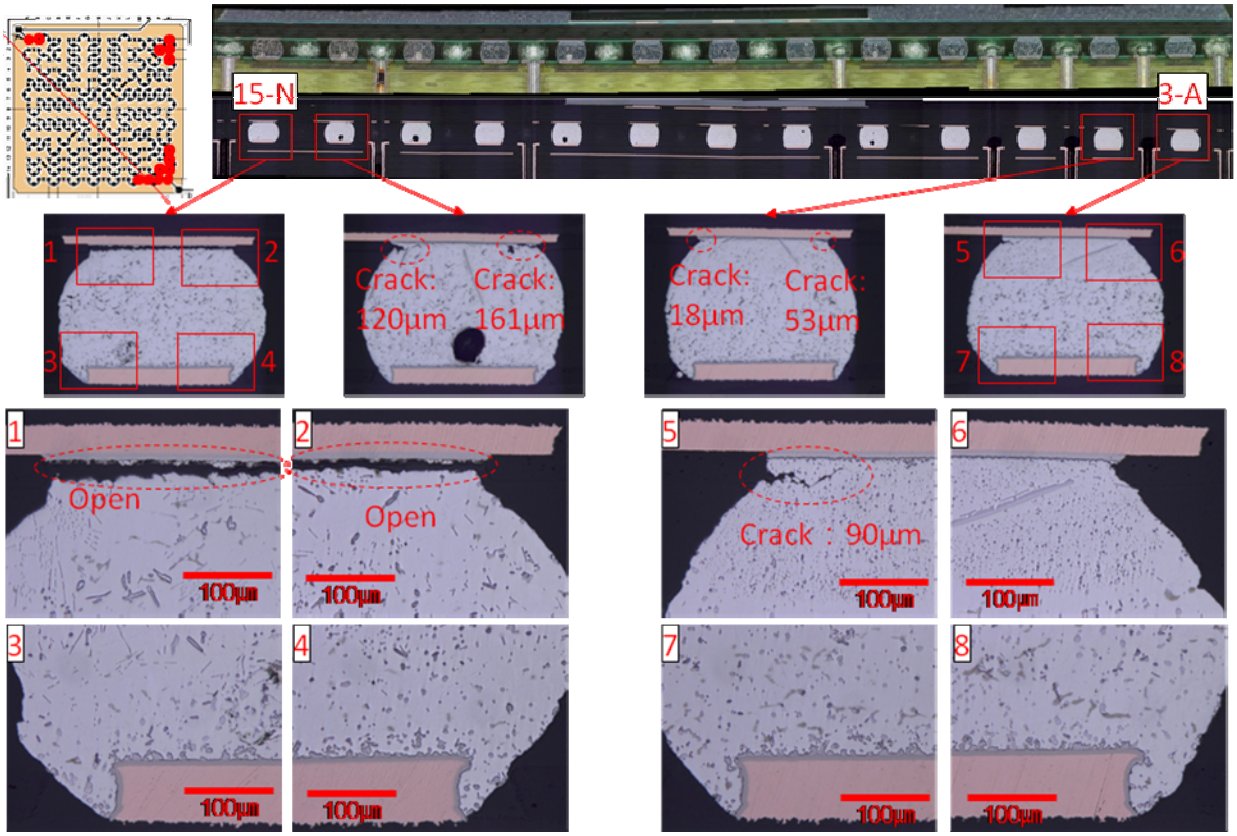
Figure 79 - TV158 U6; Cross-Sectional Micrographs

The cross-sectional micrographs in Figure 79 show different solder structure in lands on board (7, 8) and lands on component (5, 6). Cracking to open along component land observed at 15-N.

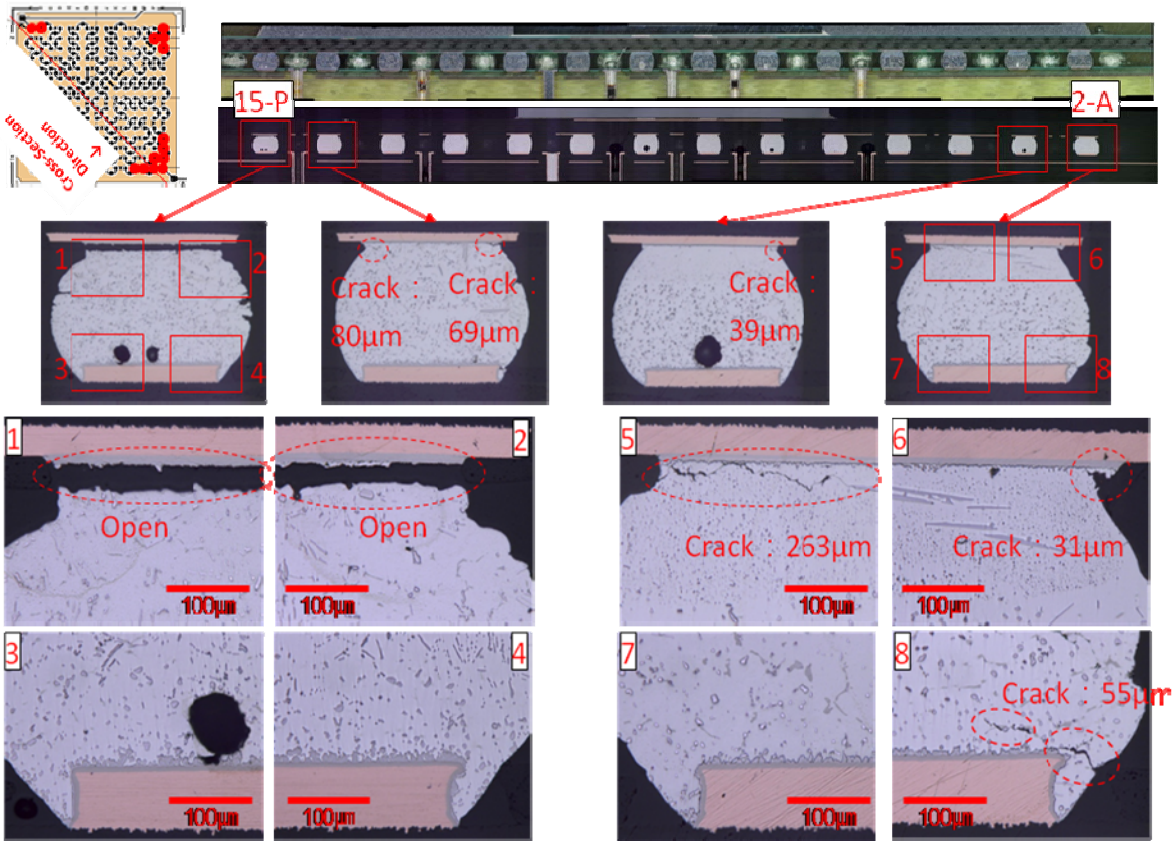
Figure 80 - TV158 U6; Cross-Sectional Micrographs

Figure 80 cross-sectional micrographs show different solder structure in lands on board (1, 2, 7, 8) and lands on component (3, 4, 5, 6). Cracking to open along PWB land found at 15-P.

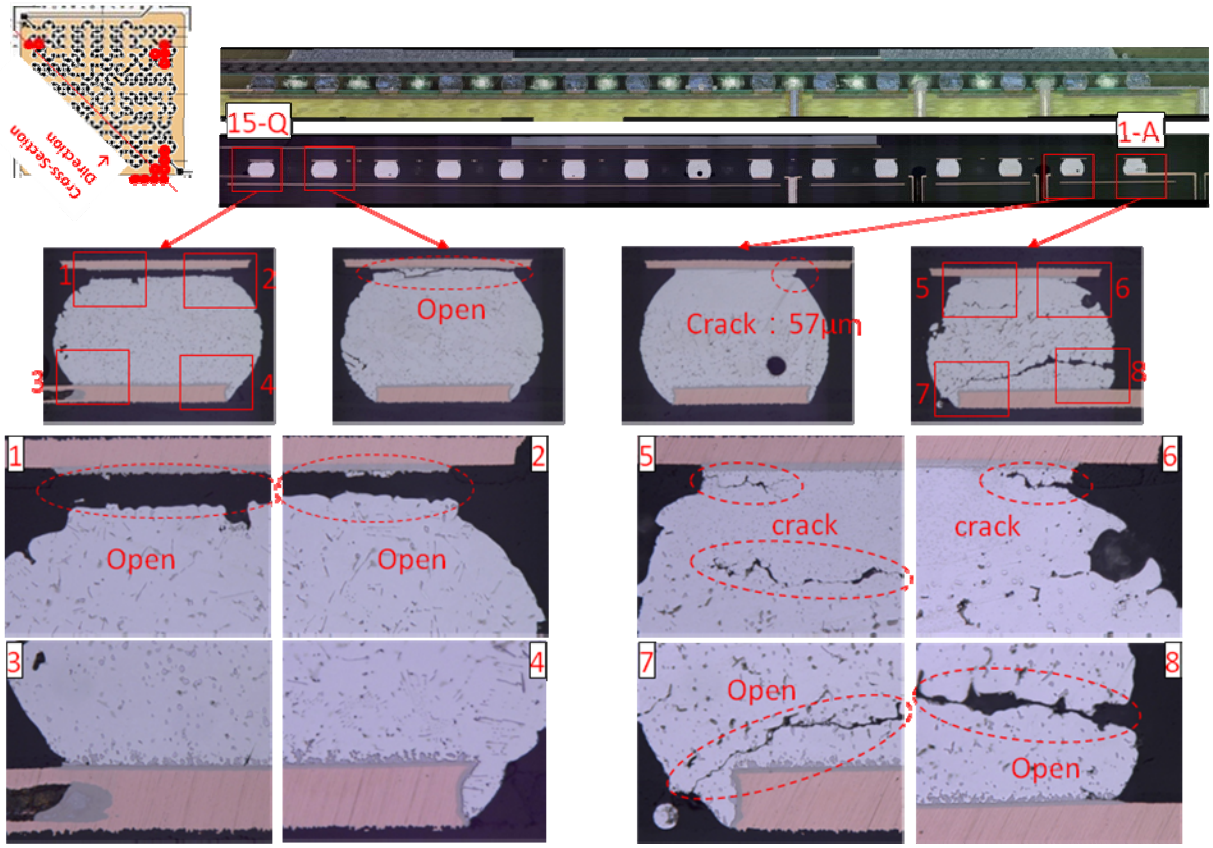
Figure 81 - TV158 U6; Cross-Sectional Micrographs

Cross-sectional micrographs in Figure 81 show different solder structure in lands on board (7, 8) and lands on component (5, 6). Cracking to open inside solder found at 1-A. Open joint along land on component found at 15-N.

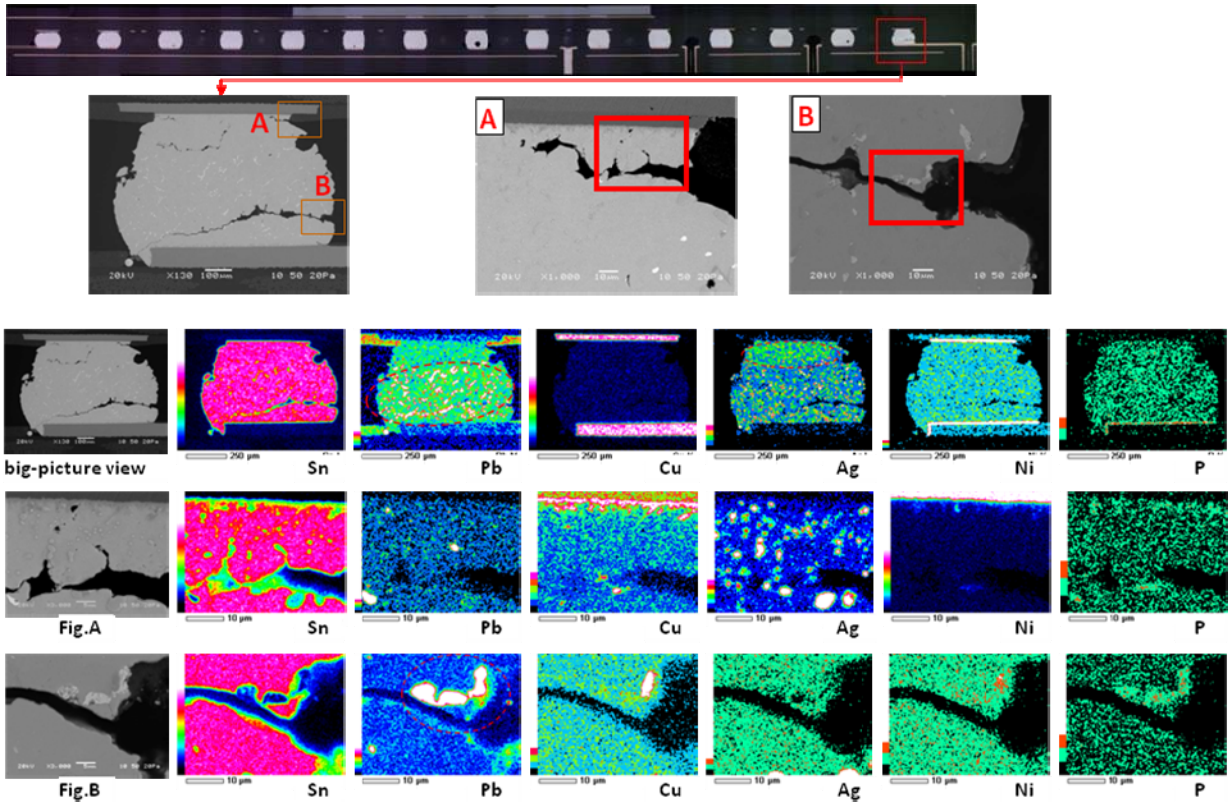
Figure 82 - TV158 U6; SEM Mapping

SEM mapping in Figure 82 shows segregation of Ag around land on component and segregation of Pb around PWB land. Higher concentrations of Pb detected in the cracking / breaking area.

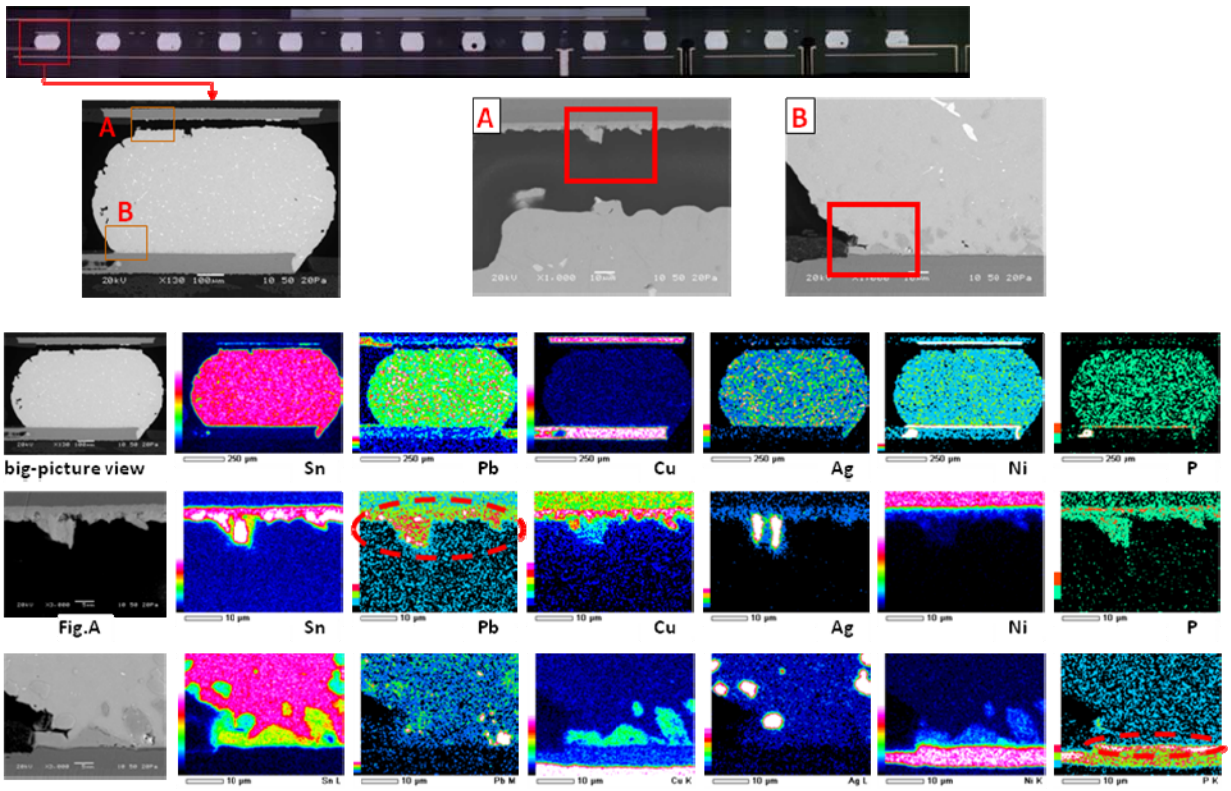
Figure 83 - TV158 U6; SEM Mapping

SEM mapping in Figure 83 shows solder is well blended over all except around component land where higher levels of Pb and cracking were found. Segregation of P from the ENIG board finish, however, no cracking detected.
