NASA-DoD LEAD-FREE ELECTRONICS PROJECT: JOINT TEST REPORT

Kurt Kessel
ITB, Inc.
NASA Technology Evaluation for Environmental Risk Mitigation (TEERM) Principal Center
Kennedy Space Center, FL, USA
kurt.r.kessel@nasa.gov
{On behalf of the NASA-DoD Lead-Free Electronics Project Consortium}

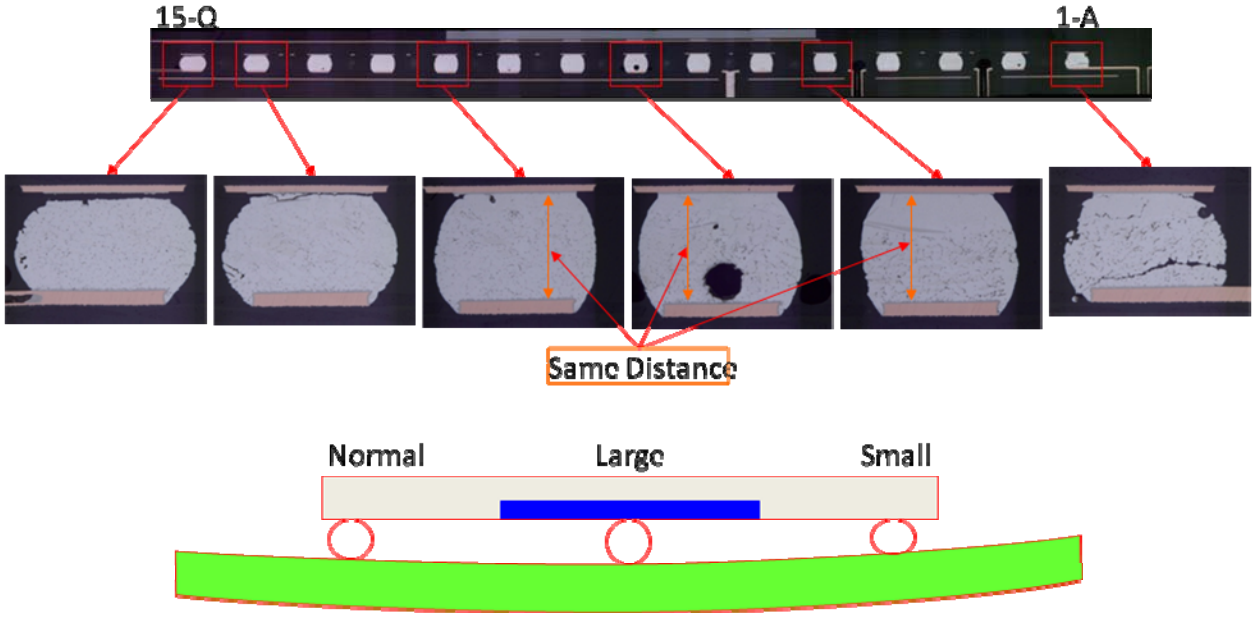
Figure 84 - TV158 U6; Cross-Sectional Micrographs Show Warping on BGA-225

In Figure 84 the distance between component and board at each sphere is almost the same under the chip in the center. The distance becomes smaller further to the end. Comparing the distance at [1-A] and [15-Q], [1-A] has smaller distance.

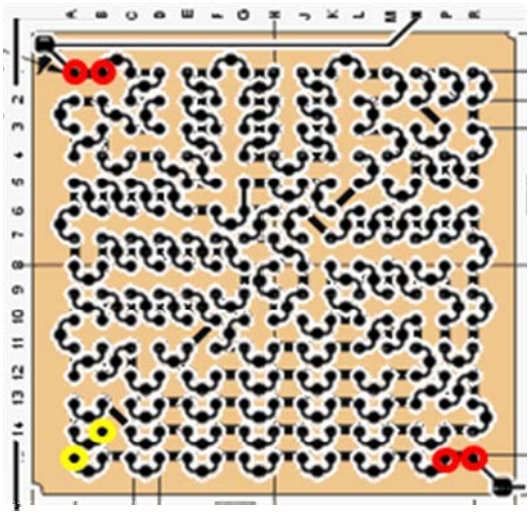
Figure 85 - TV180 U21; FA Results

Component location U21 is a reworked BGA-225 soldered with SAC305 on SAC405 component finish and replaced with SAC405 BGA-225 soldered with flux only. This component failed on cycle one and was reworked prior to combine environments testing.

In Figure 85 the yellow circles are solder joints with high resistance and red circles are failed solder joints that are open.

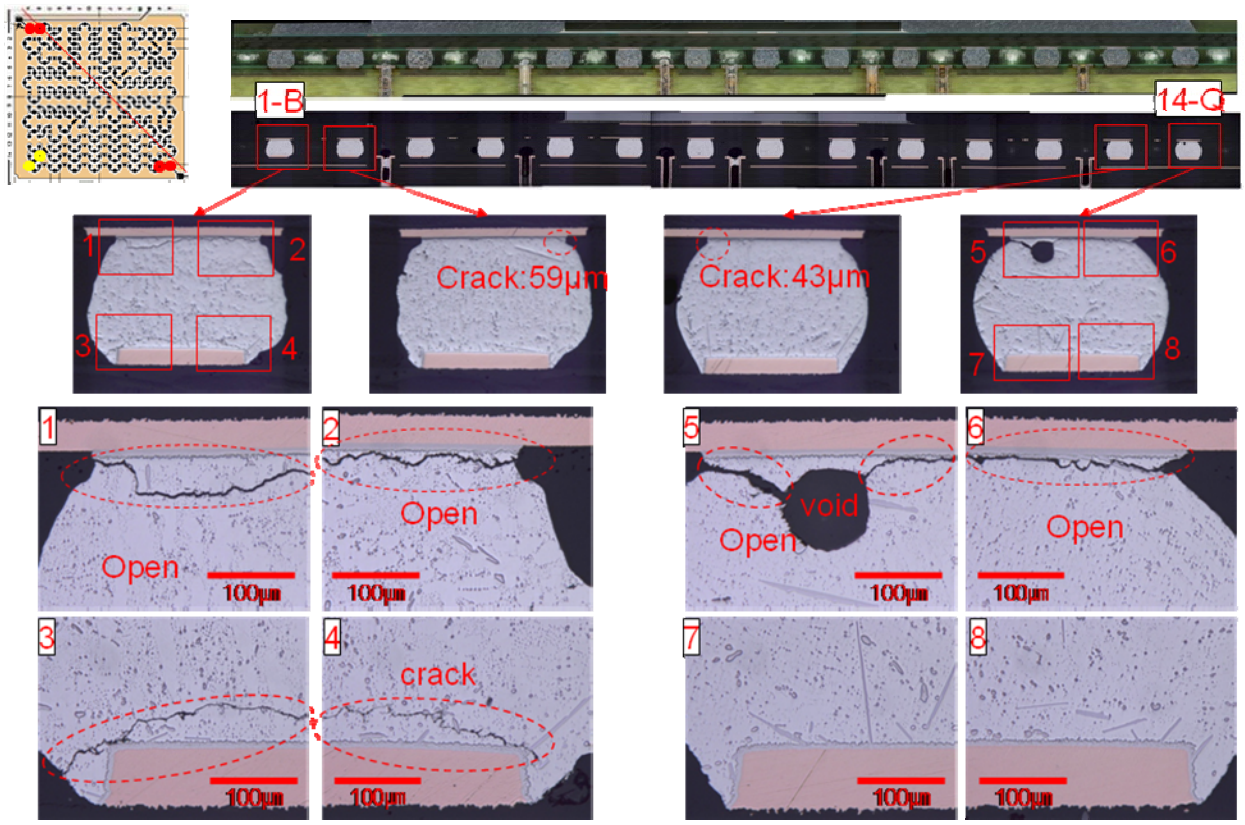
Figure 86 - TV180 U21; Cross-Sectional Micrographs

In Figure 86, the cross-sectional micrographs show cracking to opens on board side (1, 2, 5, 6).

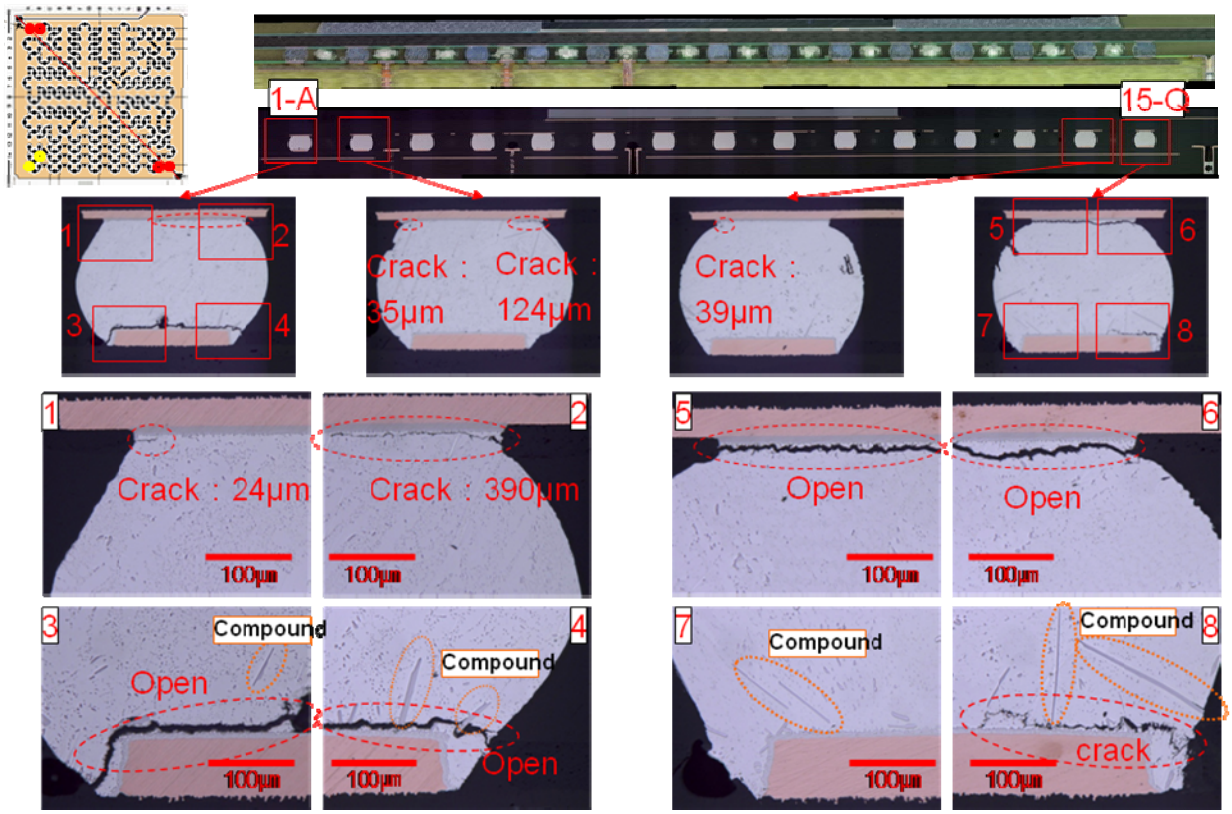
Figure 87 - TV180 U21; Cross-Sectional Micrographs

In Figure 87, the cross-sectional micrographs show cracking to open solder joints around both land on board and component (3, 4, 5, 6). Large intermetallic compounds observed around land on board (3, 4, 7, 8).

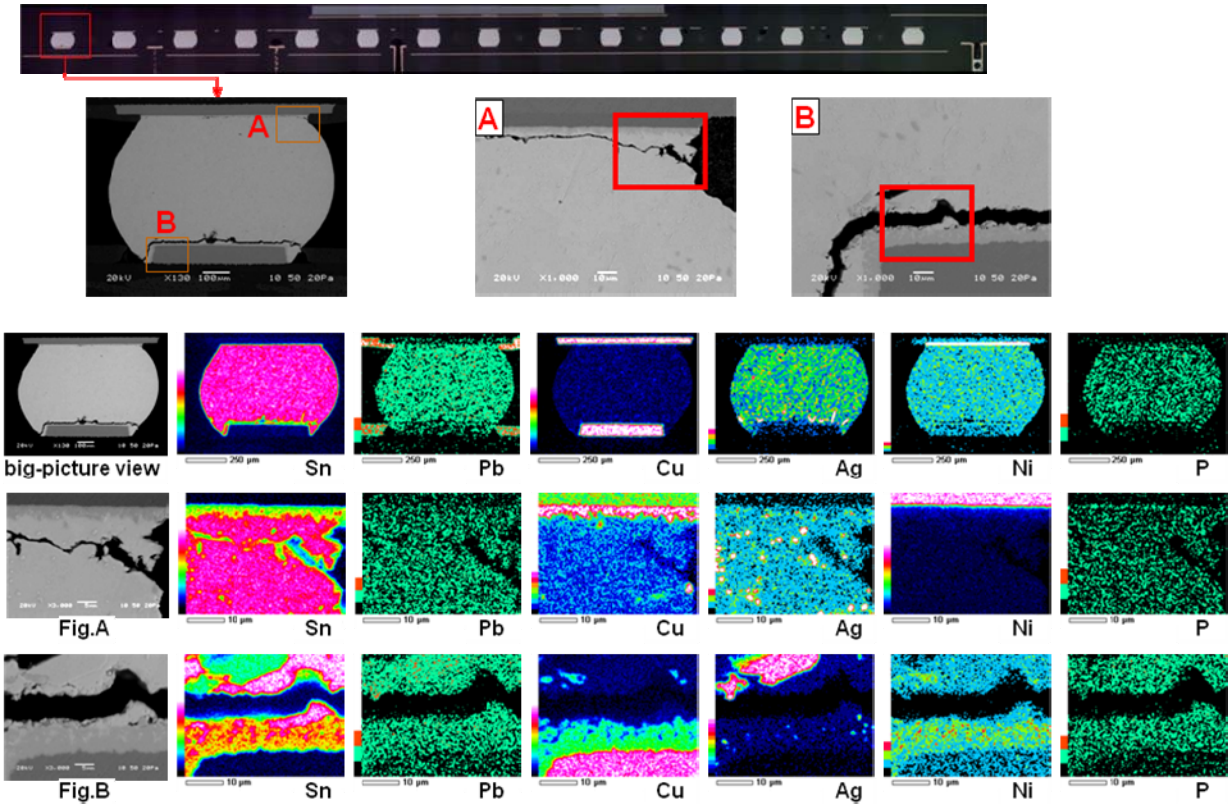
Figure 88 - TV180 U21; SEM Mapping

SEM mapping in Figure 88 shows cracks inside solder as well as cracking to open between IMC and solder, or inside solder.

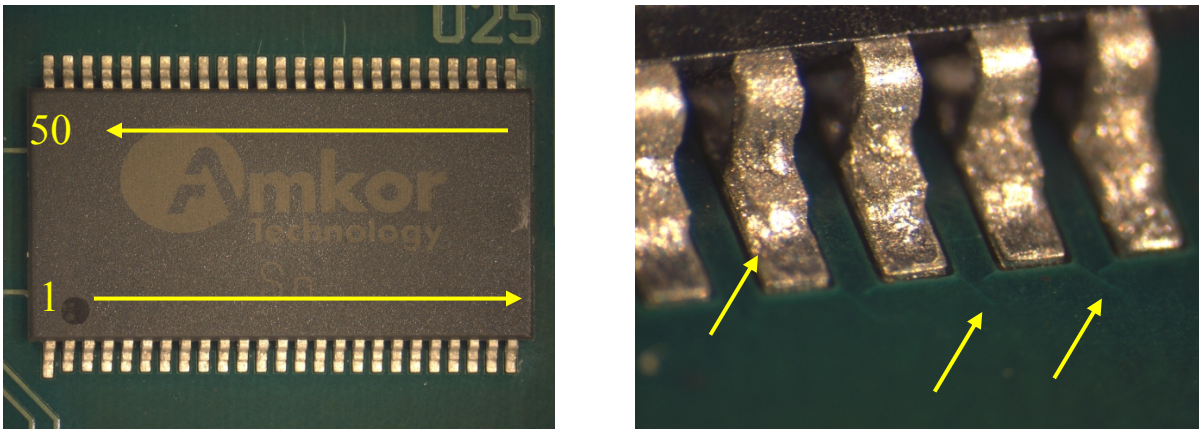
Figure 94 - TV181 U25; Optical Micrographs

In Figure 94, the optical micrograph on the left is the lead numbering and the image on the right is of leads 21-25. The arrows indicate cracked solder mask and the arrow on lead 22 indicates a solder disturbance at 49X magnification.

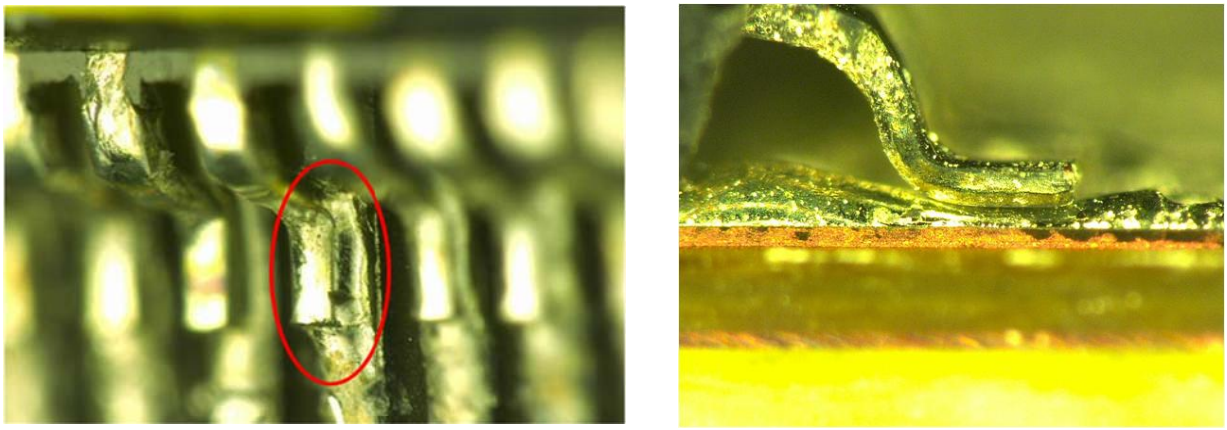
Figure 100 - TV183 U 41; Optical Micrographs of Suspect Lead

Component location U41 is a TQFP-144 from lead-free rework (Batch A), soldered with SAC 305 on SAC305 dip component finish. This component failed on cycle one and was not reworked.

Figure 100 shows inadequate solder joint resulting in no connection between the lead and the pad.

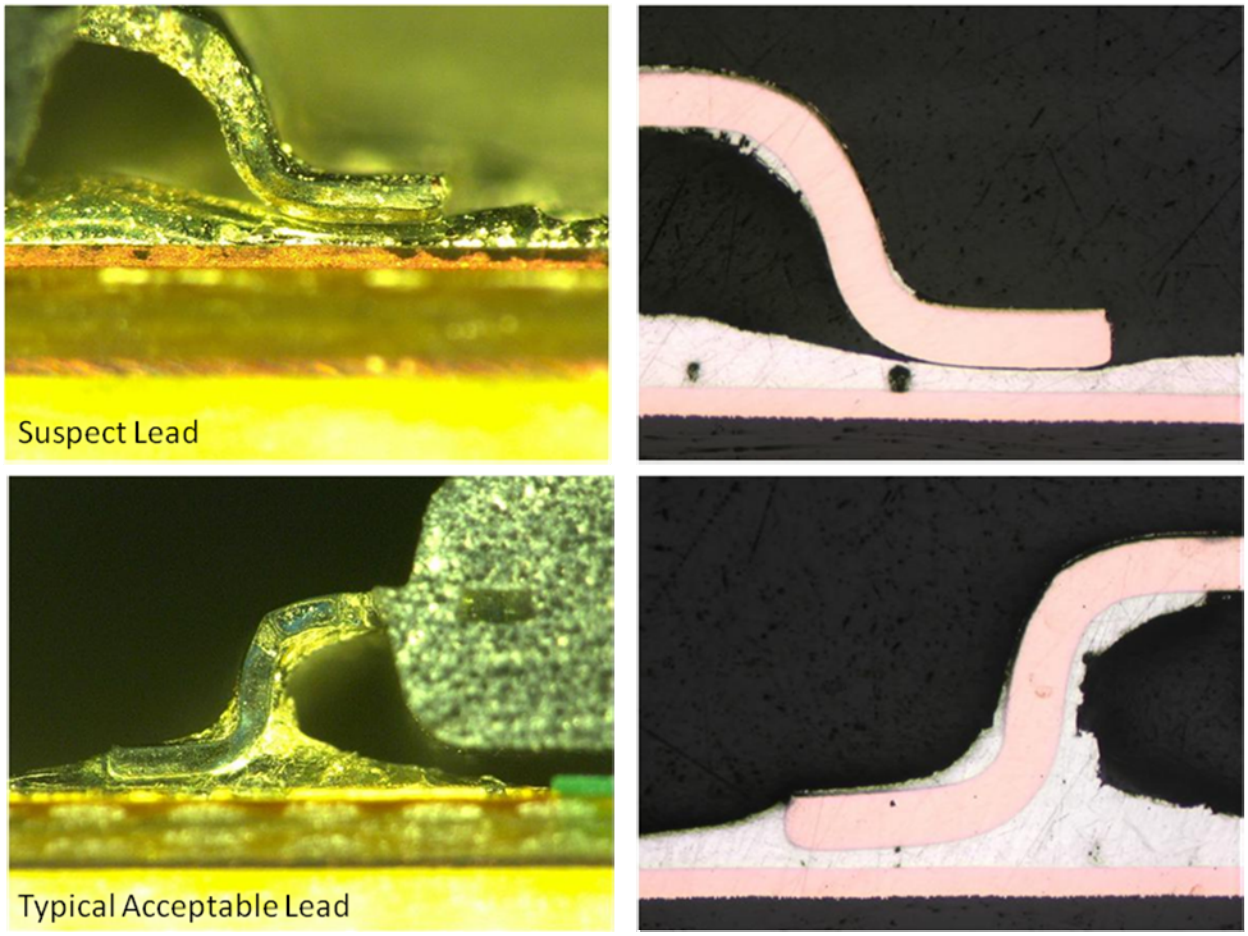
Figure 101 - TV183 U 41; Cross-Sectional Micrographs

Figure 101 shows cross-sectional micrographs of component leads comparing suspect lead to a typical acceptable lead.

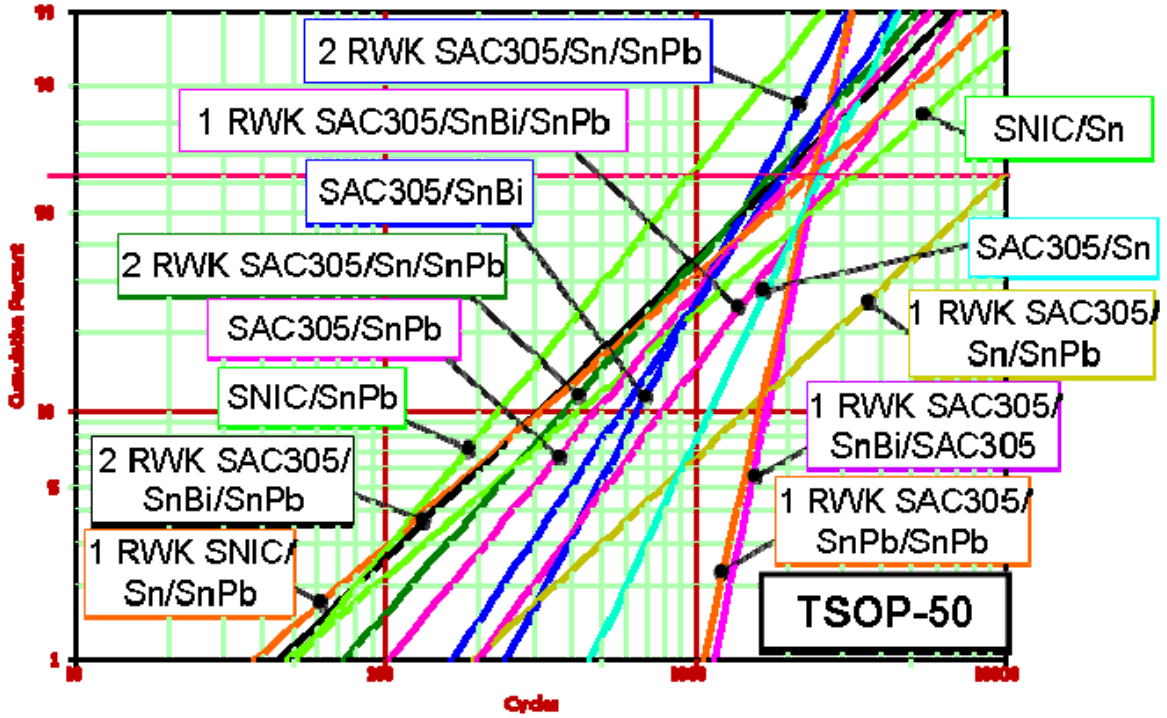
Figure 110 - Reworked TSOP-50 Weibull Plot

The TSOP-50 components had accumulated 71.5% population failure after the completion of 3600 thermal cycles. TSOP-50 components had nine different combinations (SAC/SnPb, SAC/SnBi, SAC/Sn, SNIC/SnPb, SNIC/SnBi, SNIC/Sn, SnPb/SnBi, SnPb/Sn, SnPb/SnPb) tested. The lead (Pb) containing combinations slightly out performed the Pb-free combinations tested. The rework TSOP-50 components exhibited significantly different trends compared to those on the manufactured test vehicle. These results require further statistical review before drawing any conclusions. The Weibull plots in Figure 109 and Figure 110 summarize the TSOP-50 thermal cycle test results.

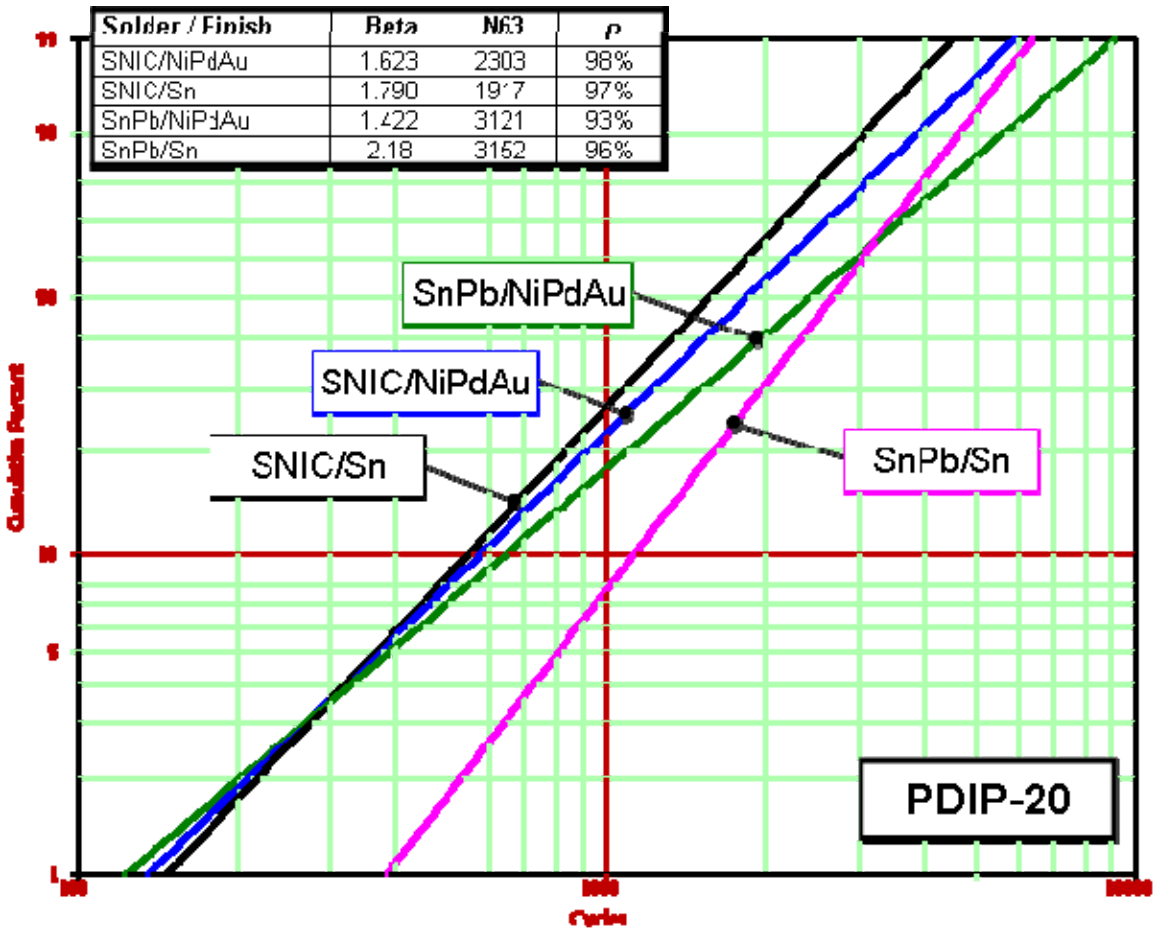
Figure 111 - PDIP-20 Weibull Plot

The PDIP-20 components had accumulated 72.7% population failure after the completion of 3600 thermal cycles. The solder joint failure behavior of the PDIP-20 components was a surprise to the consortia team as the PDIP-20 failure rate documented in the JCAA/JGPP investigation results was only 8% after 4743 total thermal cycles. PDIP-20 components had four different combinations (SNIC/Sn, SNIC/NiPdAu, SnPb/NiPdAu, SnPb/Sn) tested and the results showed statistically significant differences in thermal cycle reliability. The SnPb/Sn combination registered the best performance. The reworked PDIP-20 component thermal cycle performance was not statistically different than a non-reworked PDIP-20 component. Additional resources will be focused on determining the exact root cause of the unexpected PDIP-20 failure rates. The Weibull plots in Figure 111 and Figure 112 summarize the PDIP-20 thermal cycle test results.

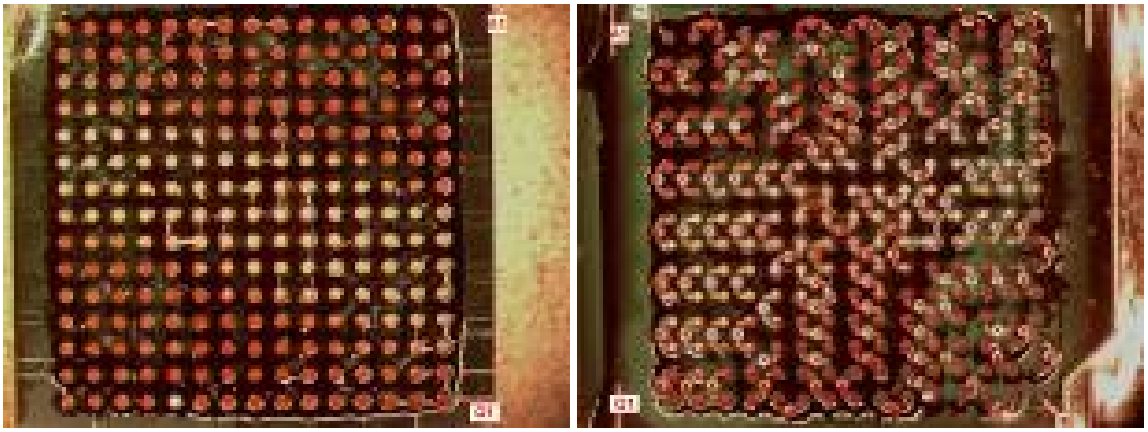
The main focus of the NASA drop test failure analysis was the 225 I/O plastic BGAs. This was because the vast majority of electrical failures on the test vehicle were these larger PBGAs. All CSPs electrically passed drop testing. For the PBGAs there was a wide range in number of drops until failure: 40% failed electrically within less than 6 drops and 99% failed electrically by 20 drops. Less than 1% of non-BGA components electrically failed after 20 drops. Pad cratering was the predominant failure mode for all samples destructively analyzed. Dye-and-pry and cross-sections of failed joints are shown below; Figure 114 and Figure 115.

Figure 114 - Typical Pad Cratering seen on BGA225 after Dye-and-Pry

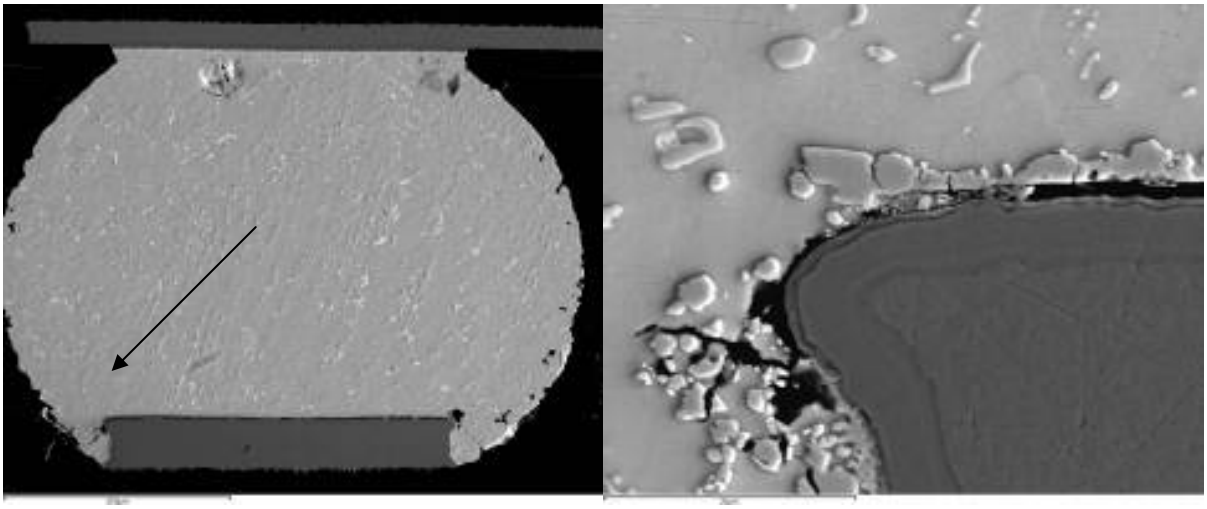
An Additional mechanism that caused electrical failure in mixed solder joints was crack propagation through a low melting Sn+Pb+Ag_3Sn ternary and/or Sn+Pb+Ag_3Sn +Cu_6Sn_5 quaternary eutectic accumulation layer at the board or component interface depending on sample history. In as-assembled condition the crack grew between the intermetallic layer and the bulk solder at the board side and after rework the more susceptible location was the interface between the intermetallic layer and the bulk solder at the component side; Figure 116. For the ENIG finished boards the predominant failure modes were brittle intermetallic cracking on both board and component sides.

Figure 116 - SEM of Brittle Intermetallic Failure on BGA225

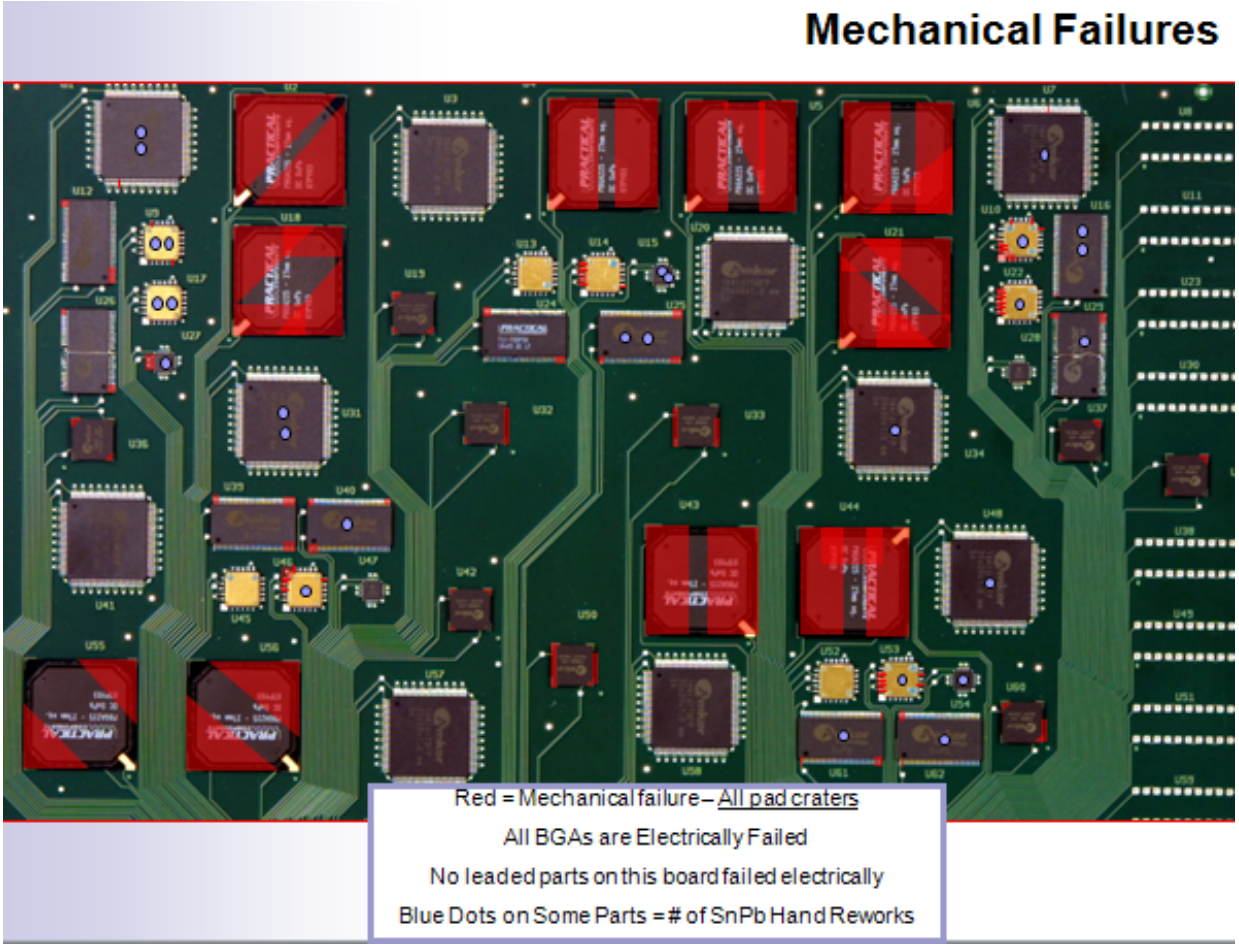
Figure 117 – Mechanical Failure Mapping

One of the cards tested, which had no electrically failing leaded parts, was chosen for dye & pry of all 63 parts in order to map the mechanical damage. Figure 117 summarizes the mechanical failure (red overlay) of one board after 20 drops at 500G. In-situ electrical data on BGAs showed that some PBGAs failed after as little as 5 drops – this implies that mechanical failure may have occurred after even fewer drops. Interesting to note that the board was held by posts in the 4 corners and as such the strain is not symmetrical across the card.

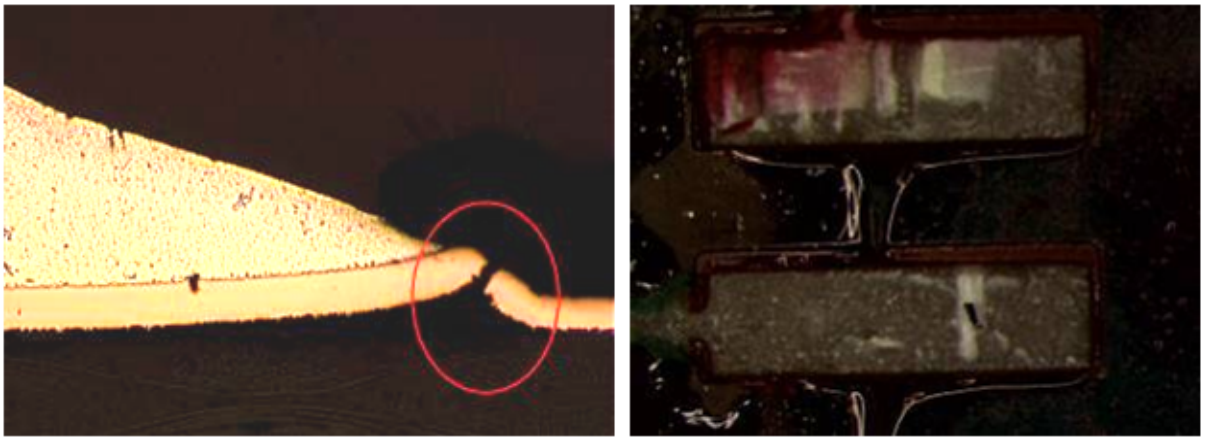
Pad cratering was the predominant failure mechanism in all components, as observed through both dye-and-pry and cross sectioning; Figure 118. In two cases the pad cratering was significant enough to break the trace and cause an electrical failure. However in most cases the trace remained intact and therefore no electrical failure was detected.

Figure 118 - Pad Cratering seen on CLCC-20

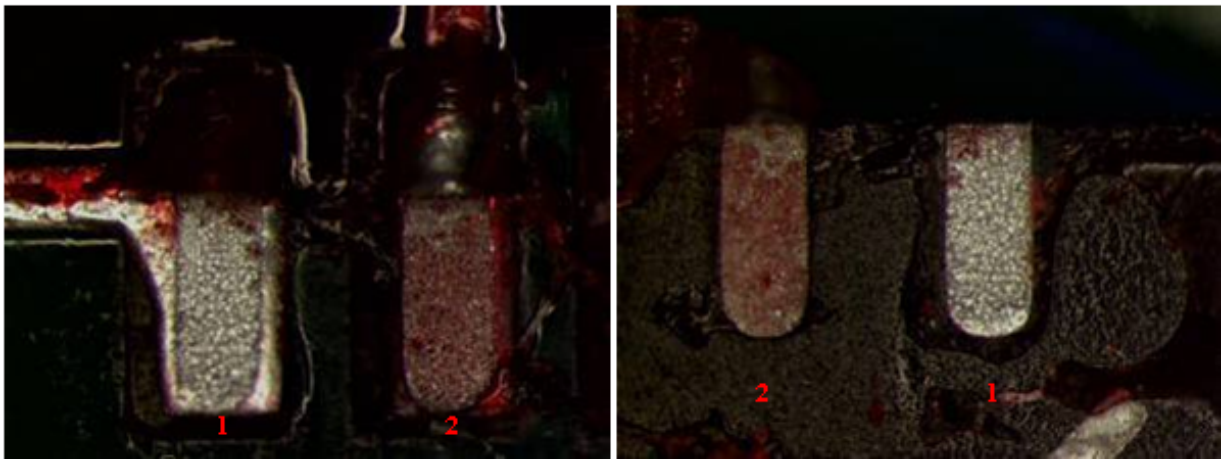
A small number of the analyzed solder joints had signs of solder fracture; however only in one case did this lead to an electrical failure; Figure 119. This indicates that, for the most part, the solder fractures did not penetrate through the entire solder joint.

Figure 119 - Dye and Pry of a QFN-20 showing dye penetration through the bulk solder

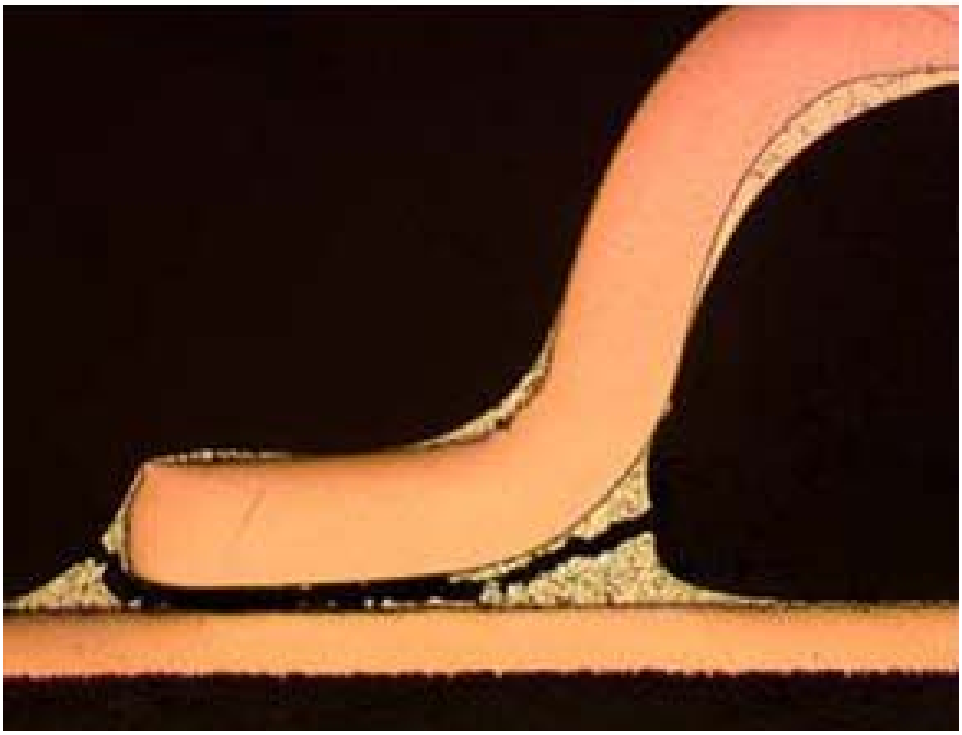
Figure 120 – Fatigue Failure of TQFP-144 with 1x Rework as seen through cross sectioning
