**STS-107 (BI116)  
FLIGHT READINESS REVIEW**

**January 9, 2003**

**Solid Rocket Booster**

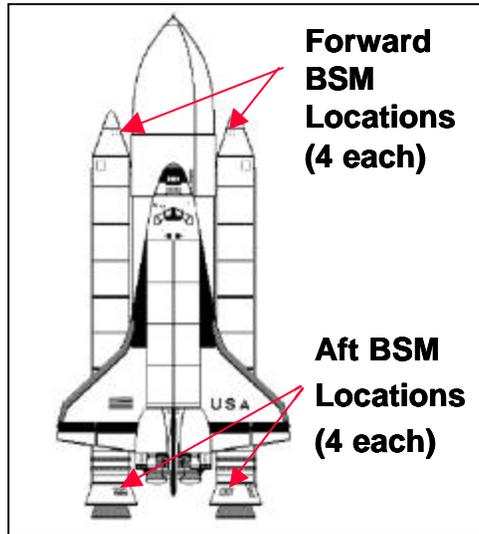
BSM Orientation

- Five small paint chips detected in propellant premix for SRB BSM propellant batch at vendor
  - Identified prior to mix operation
  - Chips loosened from painted lip of 400 gallon mix bowl when chemical addition cover removed

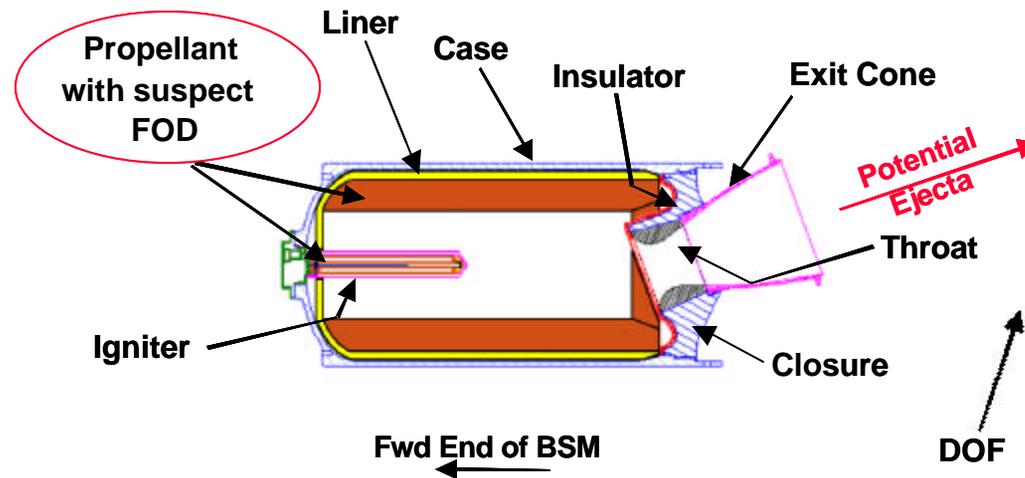
Forward BSM Cross Section

- Test program initiated to determine thermal effects of BSM propellant burn on imbedded paint
  - Seven successful window bomb tests performed on propellant samples
    - Window bomb testing allows high speed photography of propellant during burn
    - Propellant cast into  $\frac{1}{4}$  by  $\frac{1}{4}$  by  $\frac{1}{2}$  inch samples with paint chips inserted prior to cure
    - Paint chips inserted both horizontally and vertically to flame front
- Photographic review shows paint burning with red glow of a heated carbonized structure when released into flow stream
