APPENDIX B. MSFC PHOTOGRAPHIC ANALYSIS SUMMARY

Space Shuttle Mission STS-101

Engineering Photographic Analysis Summary Report Marshall Space Flight Center

Prepared: June 21, 2000

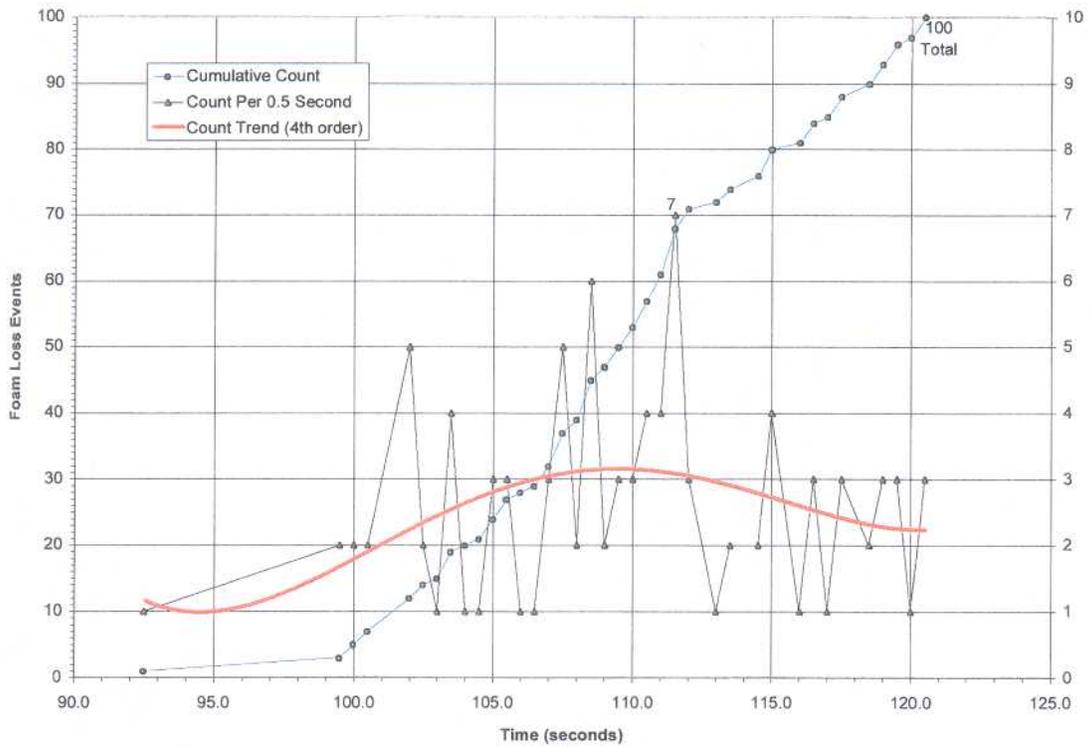
Figure 15. STS-101 -Y Thrust Panel: Foam Loss Event Timeline

Figure 14 illustrates all tabulated foam loss events on the -Y Thrust Panel of the ET for flight STS-101. White lines in the figure enclose vented areas. There were 100 total foam loss events recorded. The number of events recorded during each 0.5 second time interval and the total number of events from approximately T+90.0 seconds are shown in Figure 15. Using a fourth order polynomial approximation to trend the count data, the maximum foam loss activity appears to peak just after T+ 110.0 seconds. The maximum number of events recorded during any 0.5 second time interval was seven. Figure 16 and Table 3 compare vented and non-vented areas.

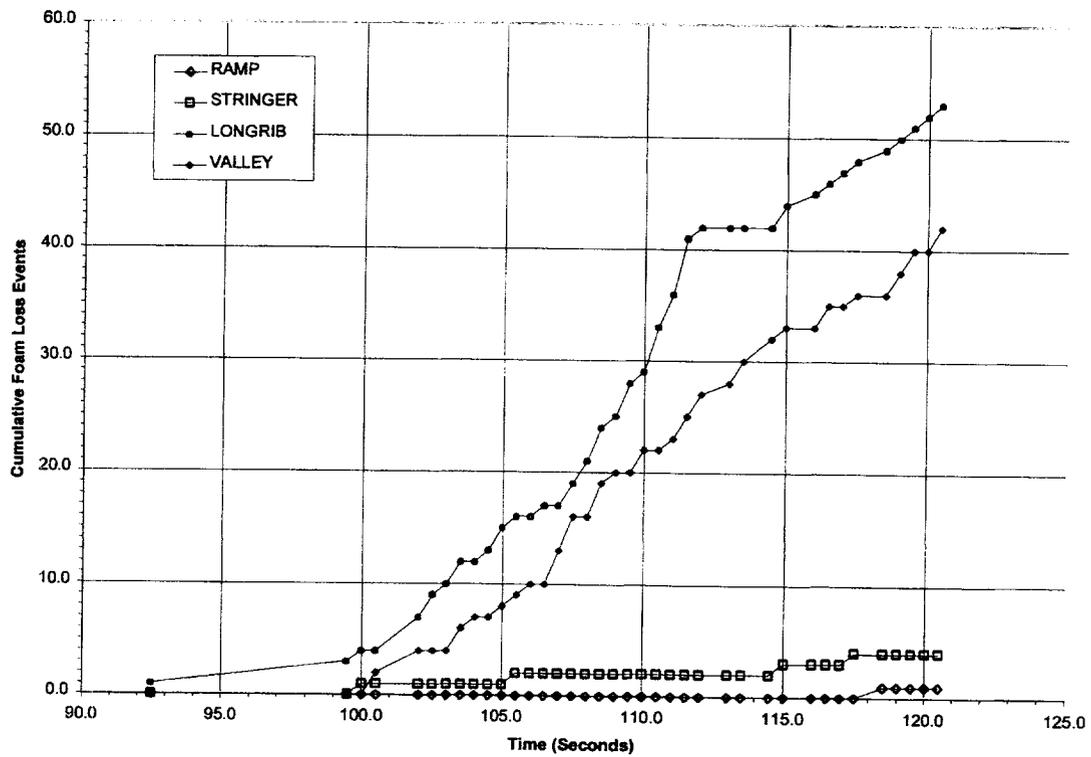
Figure 17. STS-101 -Y Thrust Panel: Foam Loss Timeline for Categories of Events

Figure 17 illustrates the timeline for accumulated foam loss in each category and Table 4 shows the final count for each category.

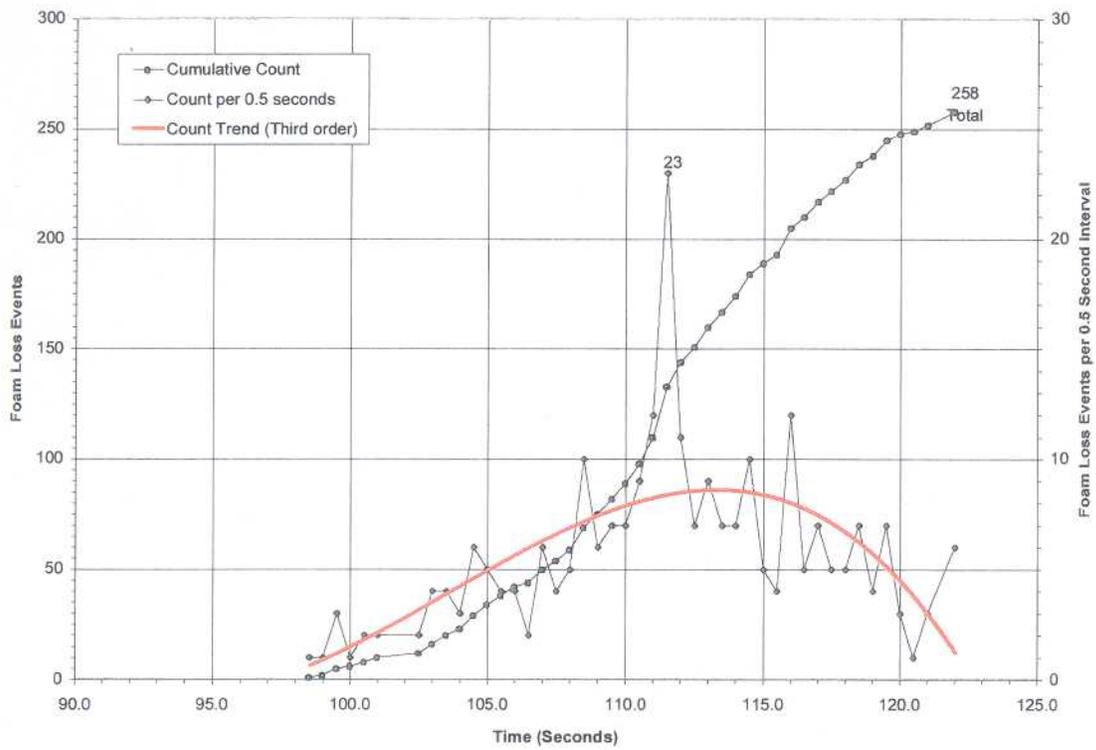
Figure 19. STS-101 +Y Thrust Panel: Foam Loss Event Timeline

Figure 18 illustrates all tabulated foam loss events on the +Y Thrust Panel of the ET for flight STS-101. White lines in the figure enclose vented areas. There were 258 total foam loss events recorded. The number of events recorded during each 0.5 second time interval and the total number of events from approximately T+90.0 seconds are shown in Figure 19. Using a third order polynomial approximation to trend the count data, the maximum foam loss activity appears to peak at approximately T+ 110.0 seconds. The maximum number of events recorded during any 0.5 second time interval was 23. Table 5 and Figure 20 compare vented and non-vented areas.

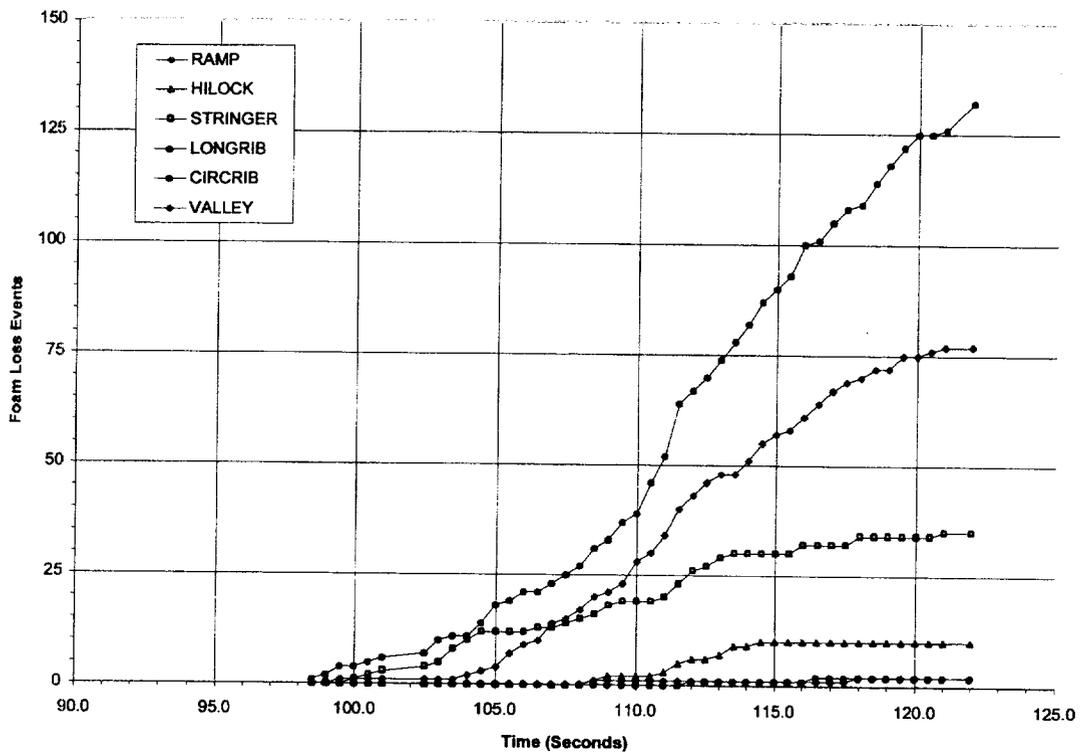
Figure 21. STS-101 +Y Thrust Panel: Foam Loss Timeline for Categories of Events

Figure 21 illustrates the timeline for accumulated foam loss in each category and Table 6 shows the final count for each category.
