Mission STS-100  
OV-105 Flight 16  
Thermal Protection System  
Post-Flight Assessment

October 2001

Thermal Protection System  
Orbiter Engineering

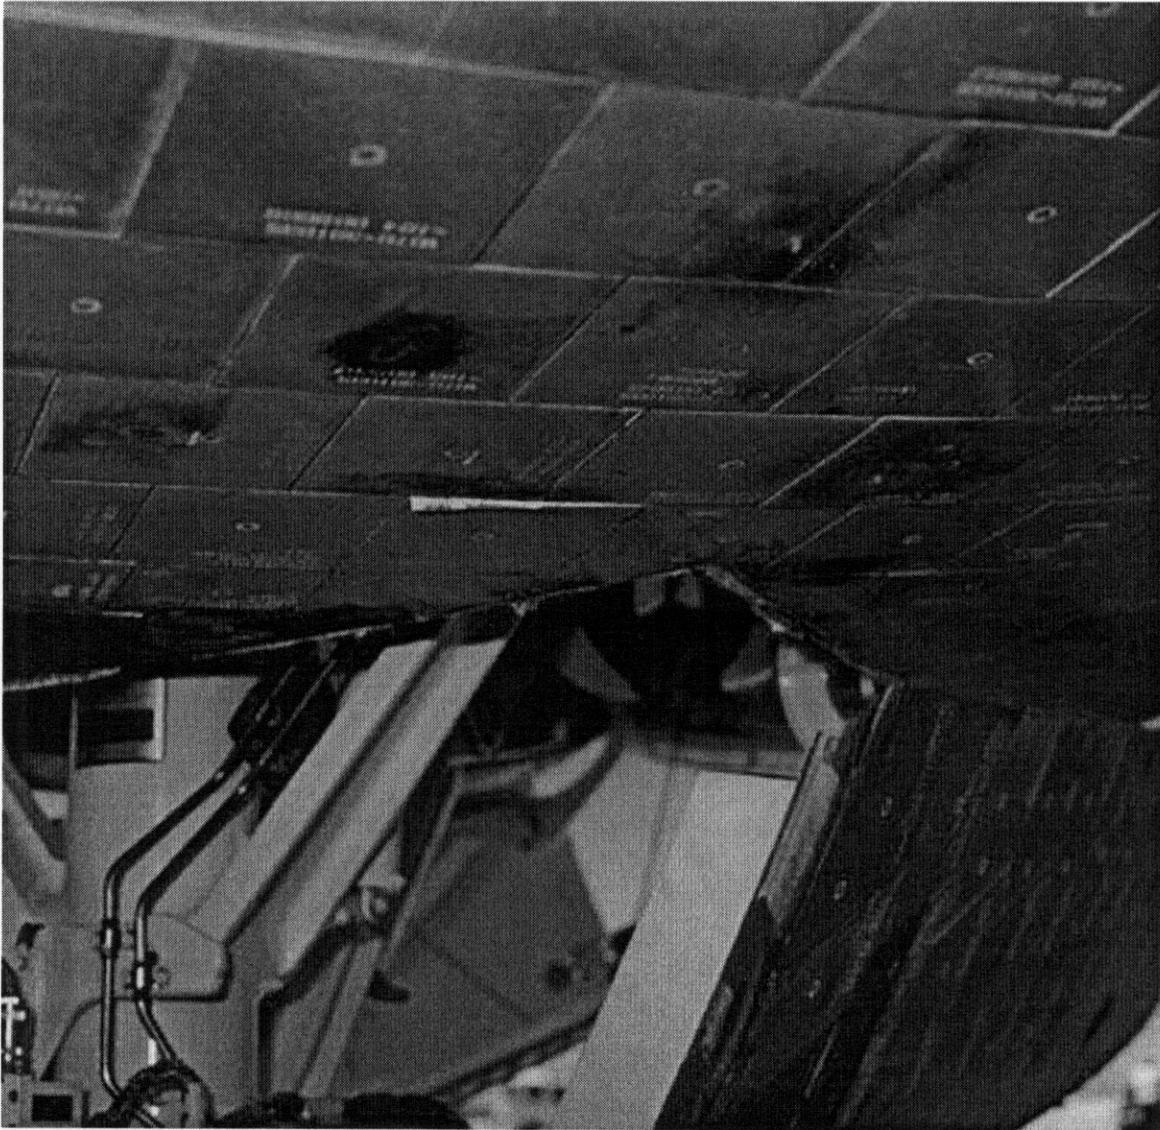
There were two protruding Ames gap filler on the lower surface. The first was located between tiles V070-391017-280 and V070-391017-014 (refer to [photo 5](#)). The gap filler protruded 0.300 inch and measured 4 inches in length. The second was located between the V070-394502-220 and V070-394502-222 tiles. The gap filler protruded 0.100 inch and was 4 inches in length.

*Photo 5. Protruding Ames Gap Filler*

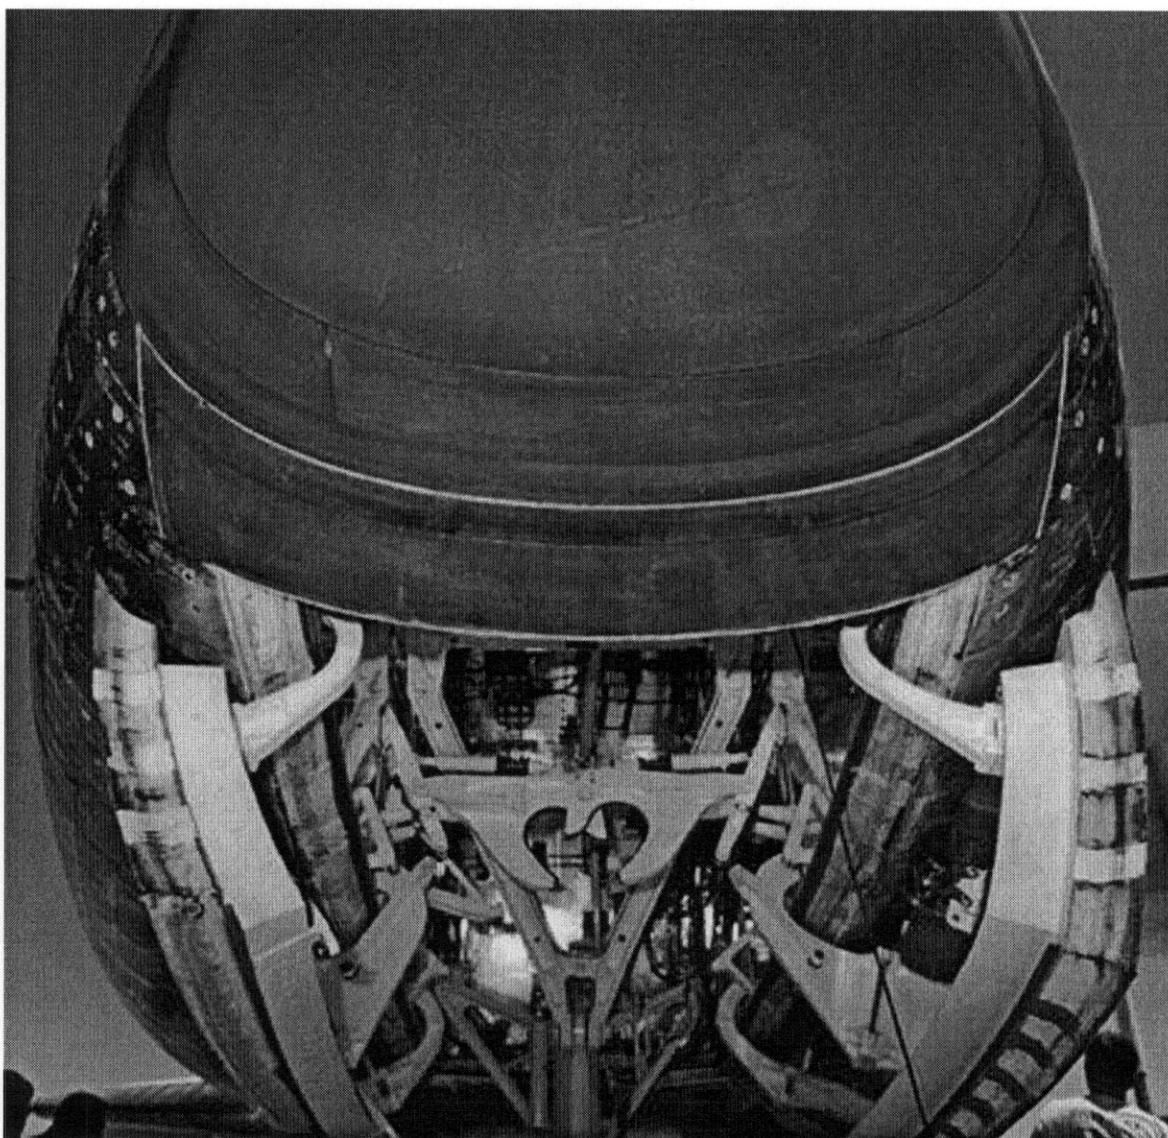
The performance of the forward LESS components was also nominal. Refer to [photo 9](#) for an overall view of the chin panel and nose cap area. The tadpole gap filler, which was a limited life repair to ramp out the step from the chin panel to the V070-399415-134 tile, experienced some shrinkage and was brittle post flight. Thermal evaluation determined that the tadpole gap filler is in nominal condition and still protects the lip of the V070-399415-134 tile. The compression-recession measurements at the outboard locations raised questions about internal flow to the structure. Engineering evaluation of the underlying structure showed no signs of overtemperature thus the chin panel installation will fly another flight with this step condition. Concern was raised over the black discoloration on the V070-399441 gap filler (refer to [photo 10](#)). This black discoloration was determined to be degraded RTV material and was previously MR accepted for unrestricted use based on thermal evaluation.

*Photo 9. RCC Nosecap-to-Chin Panel Interface, Overall View*

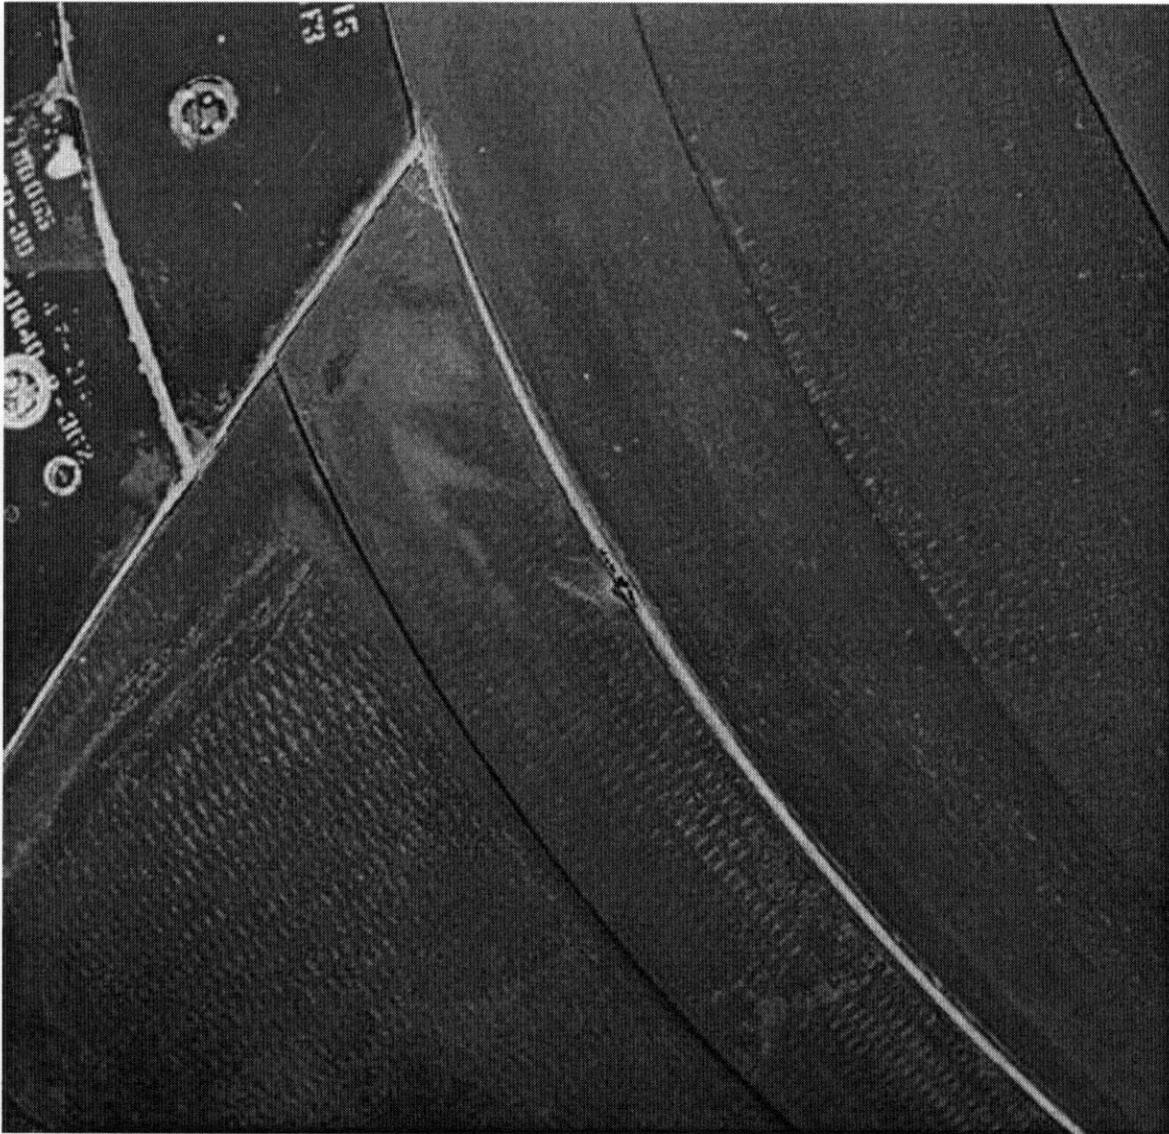
*Photo 10. Chin Panel V070-399441 Gap Filler Discoloration*

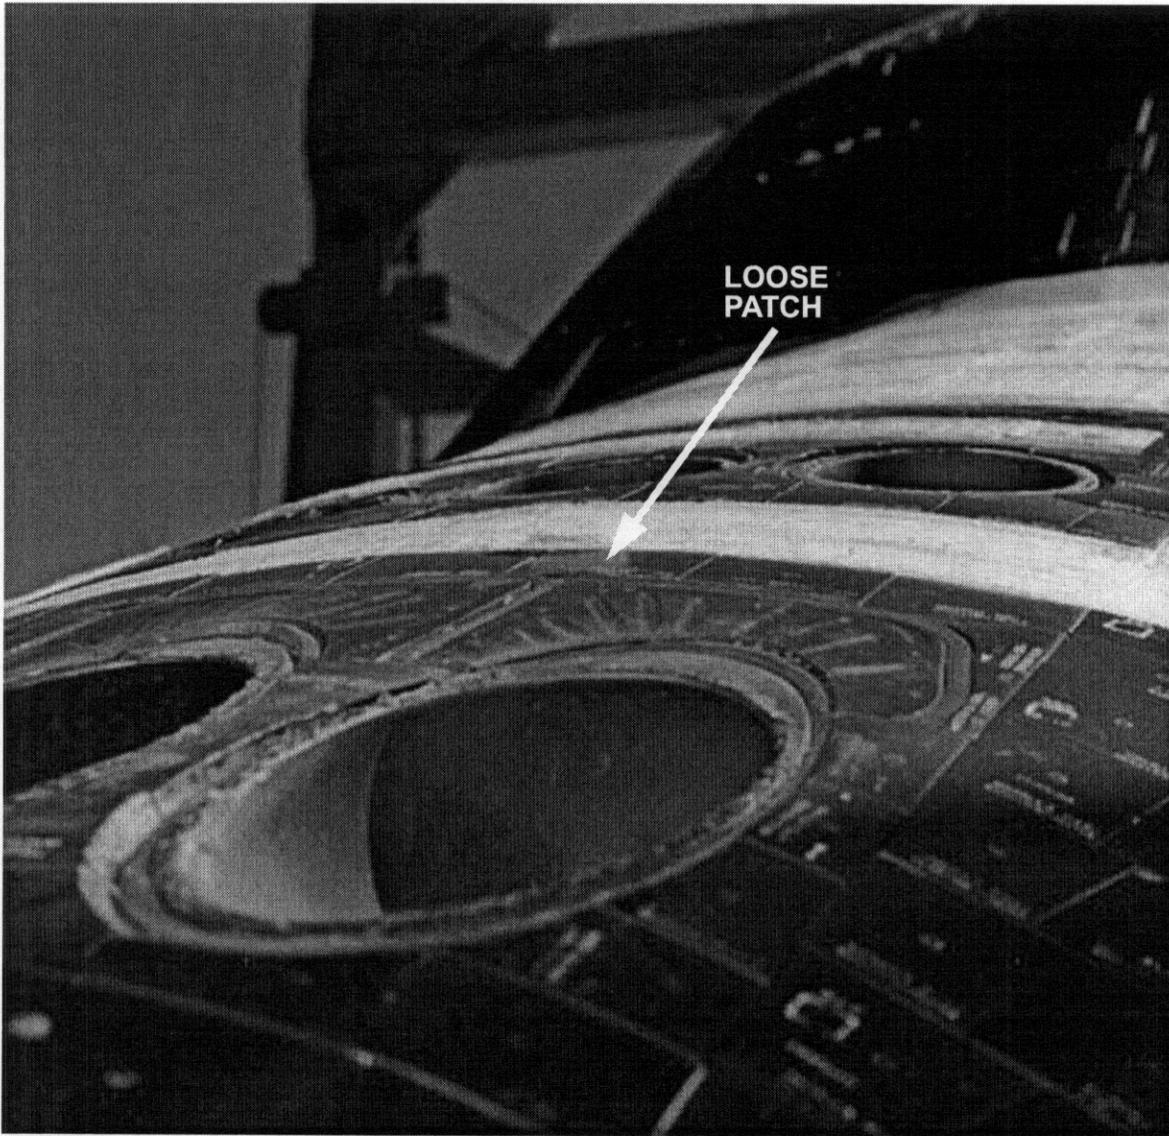
TPS on the FRCS experienced typical post-flight degradation and was in nominal post-flight condition. The V070-398300-002 thermal barrier (adjacent to thruster F2D) had a previous MR patch tear open approximately 2 inches in length. Removing and replacing the patch with a new MR patch repaired the thermal barrier. The MR patch was bonded to the outer fabric of the thermal barrier and then was stitched in line to adequately secure the patch. The V070-398308-001 thermal barrier (adjacent to thruster F5L) also had a patch with loose stitches that was replaced per detailed steps. Upon landing at Dryden the V070-391134-048 FI blanket had a previously installed patch blown loose (refer to [photo 16](#)). The patch was repaired per standard repair procedures. Thermal barriers around the periphery of the FRCS exhibited typical post-flight degradation of the black RTV coating. This coating was reworked per standard repair procedures.

Photo 16. Torn Blanket Patch On FRCS

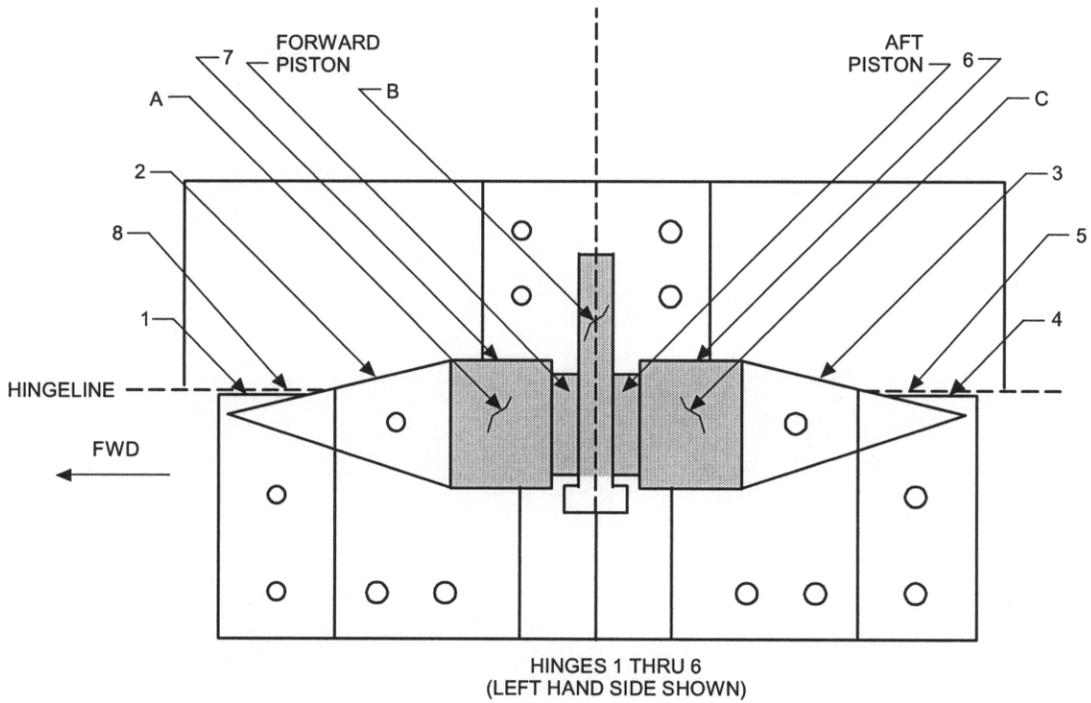
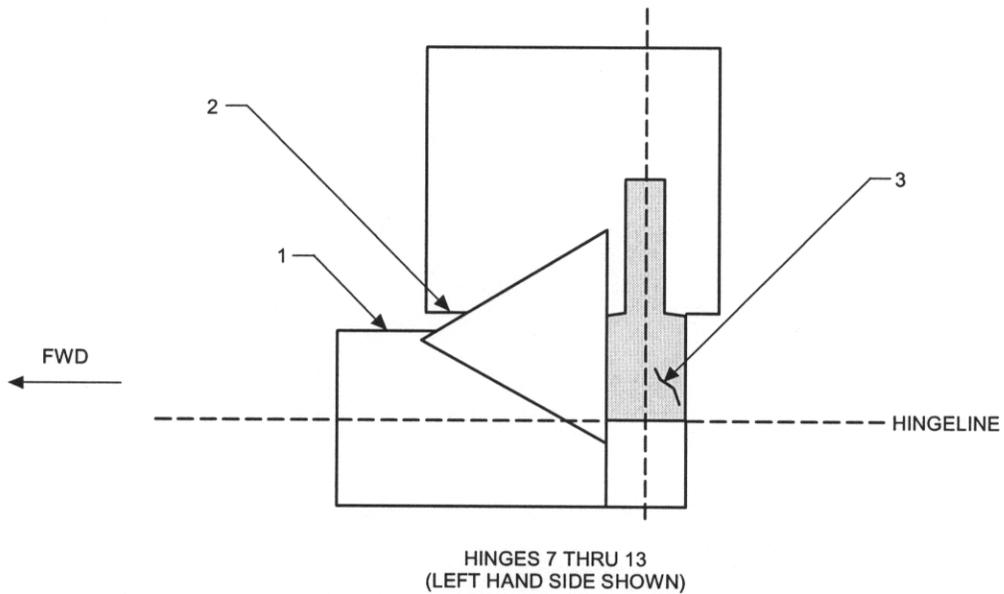
Figure 17. Payload Bay Door Hinge Cover

HINGE NUMBER	PISTON GAP (INCHES)	BOUND PISTON	ADDITIONAL DISCREPANCIES (REFER TO FIGURE 17 FOR DISCREPANCY LOCATIONS)
LEFT HAND #1 Xo 602.300	FORWARD: 0.000 CONST AFT: 0.020 TO 0.030	N N	* SCRAPING IN PYROMARK 1.2" x 0.5" (LOC B) * SCRAPING IN PYROMARK 1.8" x 2.0" (LOC C) * FILLER BAR EROSION 0.4" x 0.15" (LOC 1) * FILLER BAR EROSION 0.5" x 0.20" (LOC 8)
LEFT HAND #2 Xo 669.800	FORWARD: 0.000 TO 0.010 AFT: 0.000 CONST	N Y	* SCRAPING IN PYROMARK 2.0" x 1.5" (LOC A) * SCRAPING IN PYROMARK 2.0" x 0.5" (LOC C)
LEFT HAND #3 Xo 737.300	FORWARD: 0.000 CONST AFT: 0.000 CONST	N N	* SCRAPING IN PYROMARK 1.0" x 2.0" (LOC B) * SCRAPING IN PYROMARK 2.5" x 2.0" (LOC C)
LEFT HAND #4 Xo 783.550	FORWARD: 0.000 CONST AFT: 0.000 TO 0.005	N N	* SCRAPING IN PYROMARK 1.0" x 0.5" (LOC A) * SCRAPING IN PYROMARK 1.0" x 1.0" (LOC B) * SCRAPING IN PYROMARK 2.0" x 0.4" (LOC C)
LEFT HAND #5 Xo 850.600	FORWARD: 0.000 CONST AFT: 0.000 CONST	N N	* SCRAPING IN PYROMARK 1.3" x 0.4" (LOC A) * SCRAPING IN PYROMARK 1.0" x 0.3" (LOC B)

HINGE NUMBER	PISTON GAP (INCHES)	BOUND PISTON	ADDITIONAL DISCREPANCIES (REFER TO FIGURE 17 FOR DISCREPANCY LOCATIONS)
RIGHT HAND #1 Xo 602.300	FORWARD: 0.000 TO 0.010 AFT: 0.010 TO 0.020	N N	* SCRAPING IN PYROMARK 2.0" x 1.6" (LOC A) * SCRAPING IN PYROMARK 2.0" x 0.8" (LOC B) * SCRAPING IN PYROMARK 2.0" x 1.5" (LOC C)
RIGHT HAND #2 Xo 669.800	FORWARD: 0.000 CONST AFT: 0.000 CONST	N N	* SCRAPING IN PYROMARK 2.7" x 1.3" (LOC A) * SCRAPING IN PYROMARK 1.0" x 1.0" (LOC B) * SCRAPING IN PYROMARK 2.8" x 1.0" (LOC C)
RIGHT HAND #3 Xo 737.300	FORWARD: 0.000 CONST AFT: 0.000 CONST	N N	* NO DISCREPANCIES TO REPORT
RIGHT HAND #4 Xo 783.550	FORWARD: 0.000 CONST AFT: 0.000 CONST	N N	* NO DISCREPANCIES TO REPORT
RIGHT HAND #5 Xo 850.600	FORWARD: 0.000 CONST AFT: 0.000 TO 0.005	N N	* SCRAPING IN PYROMARK 1.0" x 1.0" (LOC B)
RIGHT HAND #6 Xo 917.650	FORWARD: 0.000 CONST AFT: 0.000 CONST	N N	* NO DISCREPANCIES TO REPORT
