STS-108 Run 3

# PROCESSING OPERATIONS CONTROL OMI PLANNING SHEET

Title: SSV ICE AND DEBRIS ASSESSMENT	Sub Element/Zone 30
-----------------------------------------	------------------------

**STS-108 ORBITER POST LANDING INSPECTION**  
DEBRIS ASSESSMENT  
18 December 2001

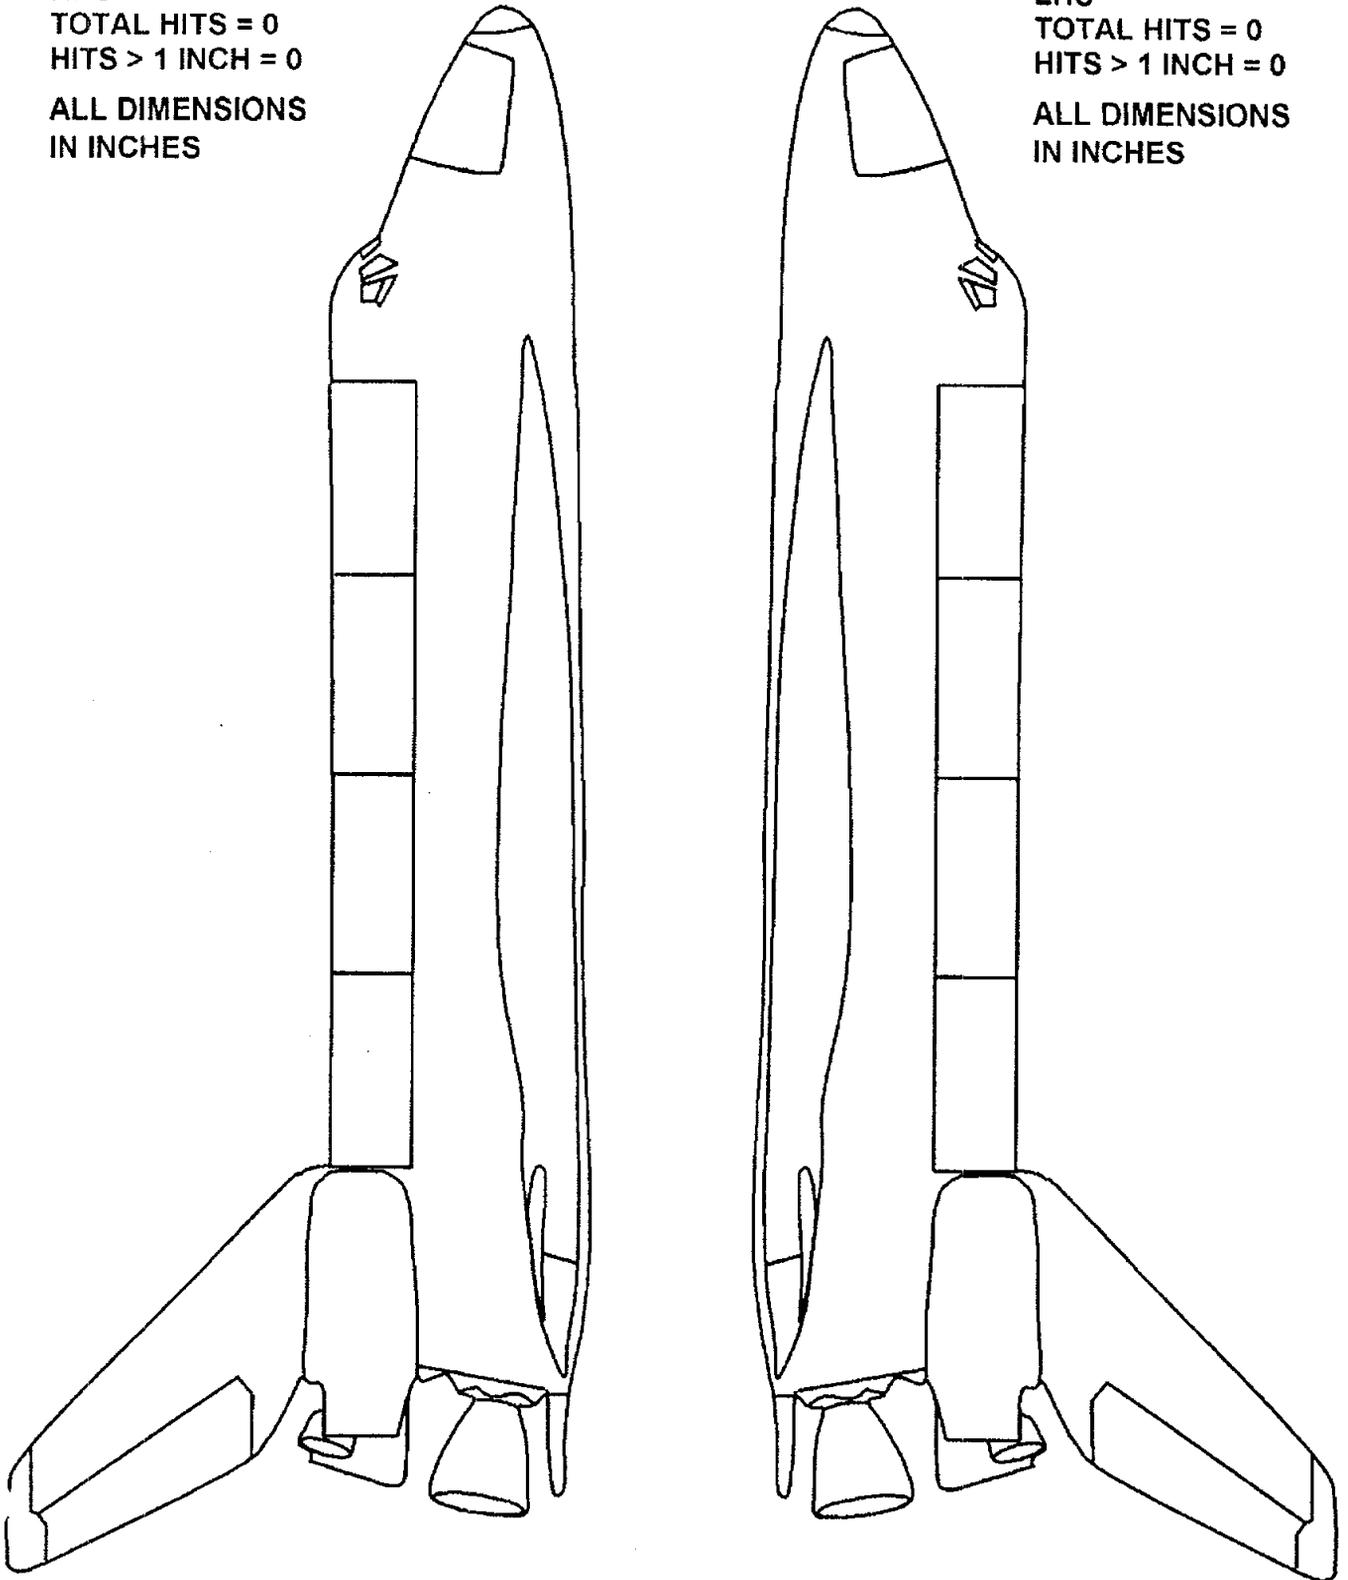
STEP 150-1

RHS  
TOTAL HITS = 0  
HITS > 1 INCH = 0  
ALL DIMENSIONS  
IN INCHES

LHS  
TOTAL HITS = 0  
HITS > 1 INCH = 0  
ALL DIMENSIONS  
IN INCHES
