Mission STS-109  
OV-102 Flight 27  
Thermal Protection System  
Post-Flight Assessment

Mission STS-109

OV-102 Flight 27

Thermal Protection System Post-Flight Assessment

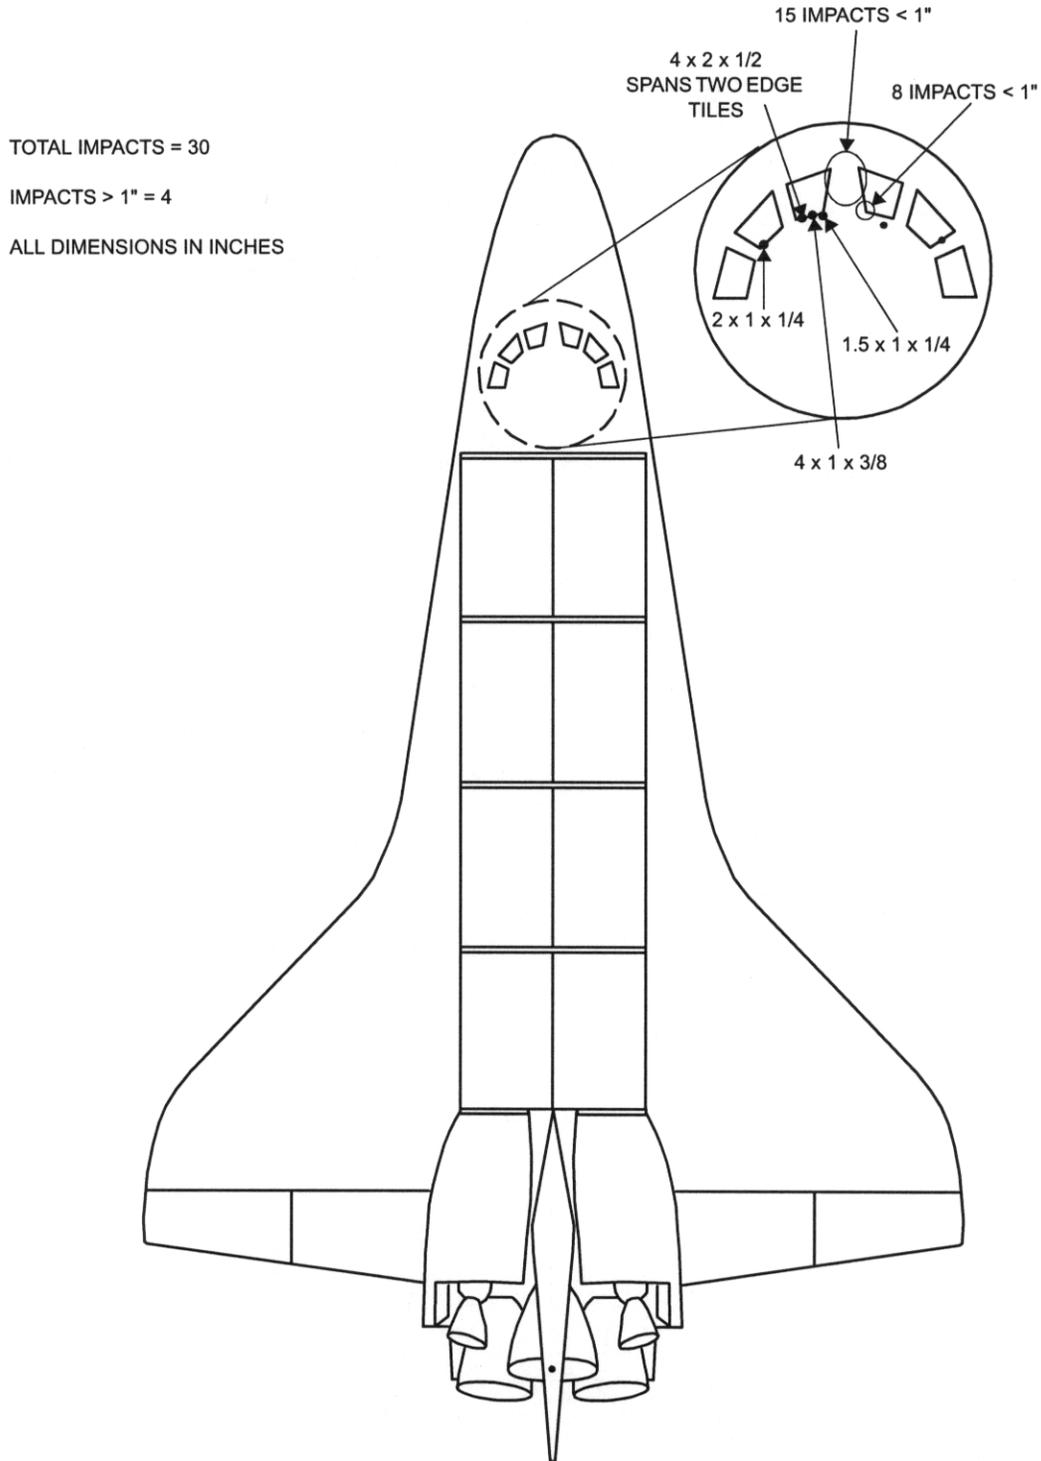
Figure 1. Lower Surface Debris Damage

Both the number of overall debris impacts (98) and impacts over 1 inch (18) were below average when compared to previous flights for both OV-102 and the vehicle fleet (refer to [tables 4](#) and [5](#), and [figures 1](#) through [3](#)).

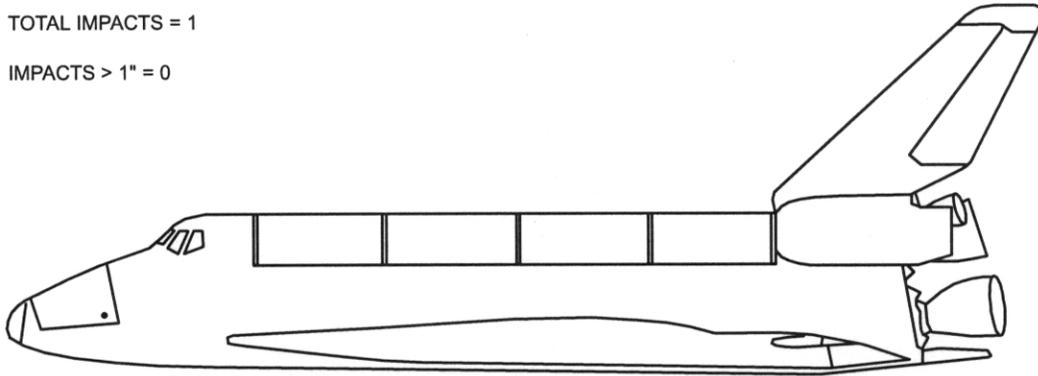
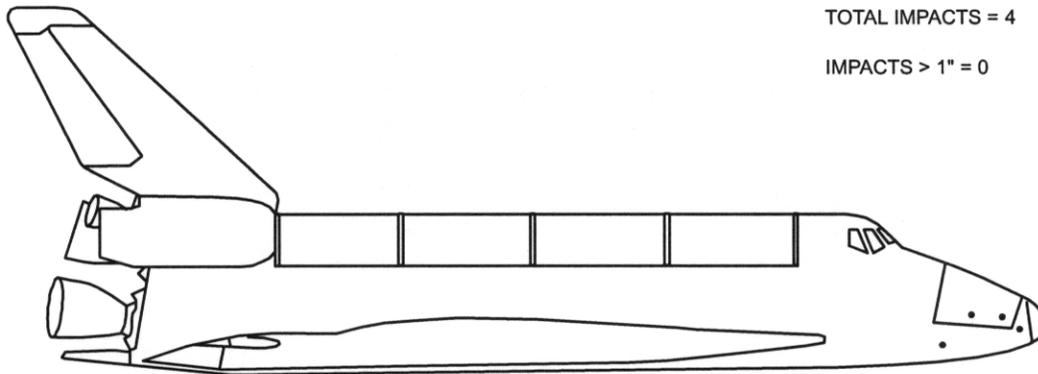
Figure 2. Upper Surface Debris Damage

TOTAL IMPACTS = 1  
IMPACTS > 1" = 0

TOTAL IMPACTS = 4  
IMPACTS > 1" = 0

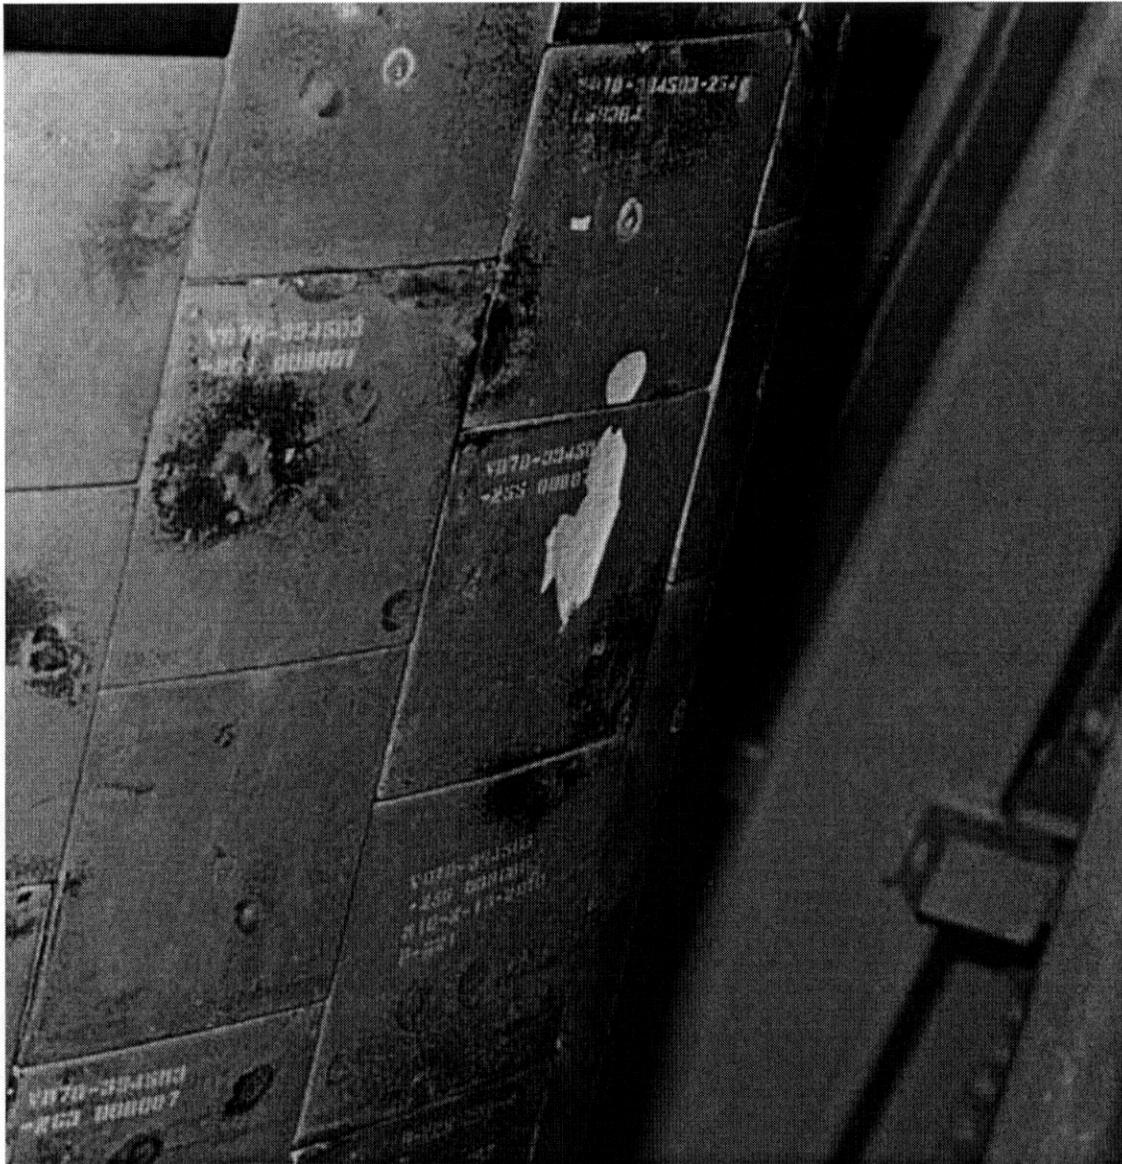
The post-flight inspection of the lower fuselage and lower surface wing areas found the TPS components to be in nominal condition. The number of debris impacts on the lower surface was below the vehicle and fleet average. Damages were concentrated primarily along the wing chine areas and in areas around the ET doors, which is typical for lower surface damages. The number of large damages (>1 inch in diameter) was also below the vehicle and fleet averages with depths generally 0.13 inch or less. The majority of impacts were within criteria suitable for repair utilizing standard procedures (refer to [photo 5](#) and [photo 6](#)).

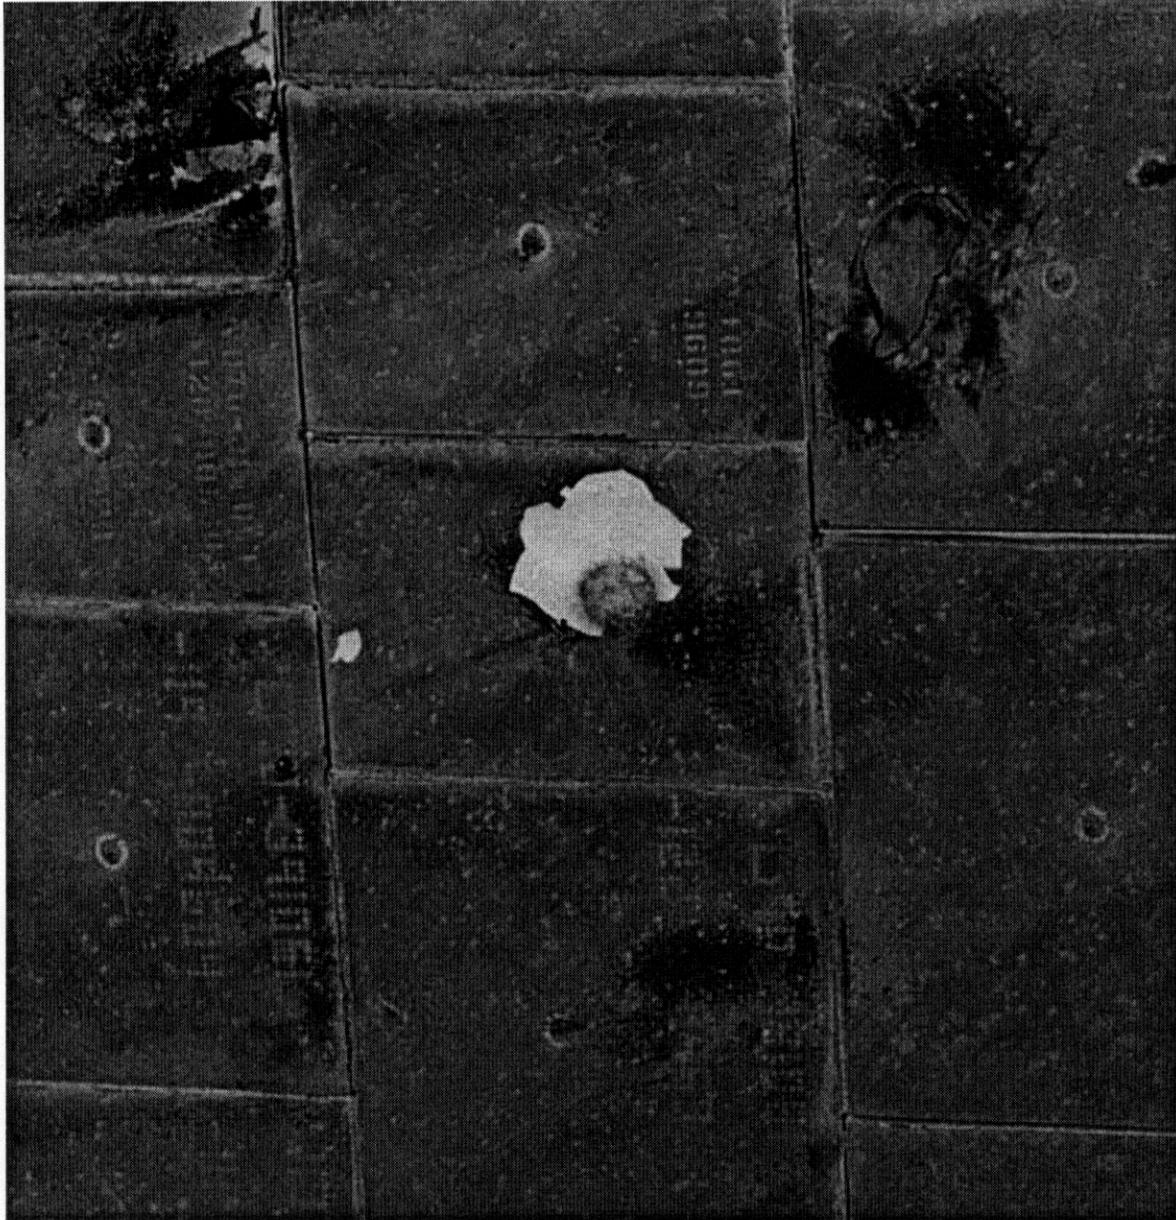
*Photo 6. Right-Hand and Lower Surface Debris Impacts*

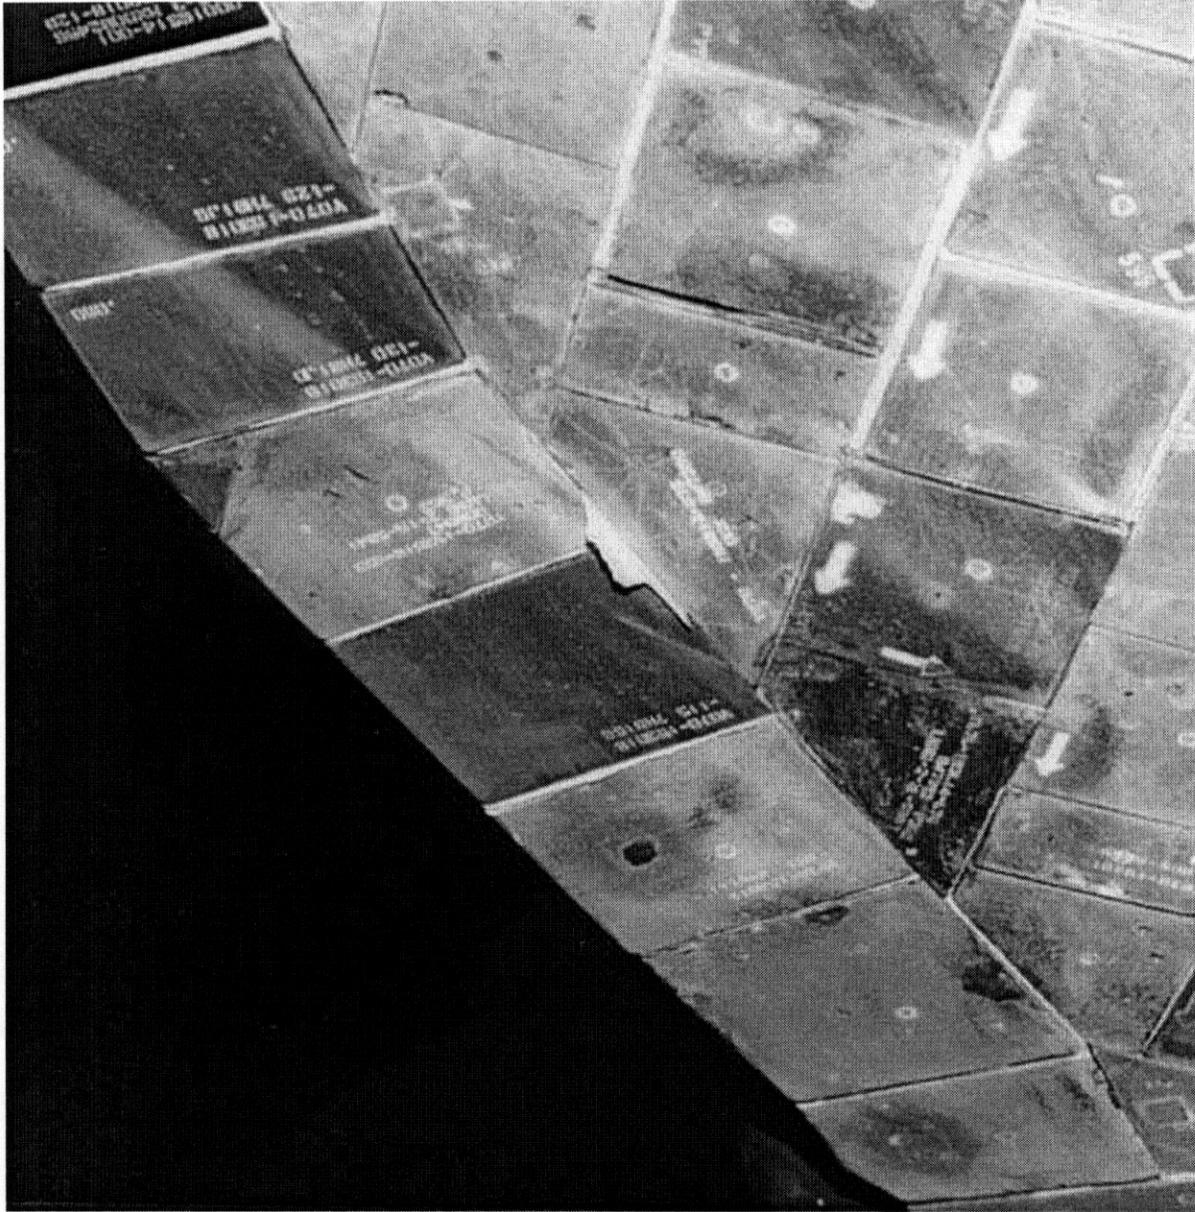
One protruding Ames was located on the left outboard elevon between tiles V070-193014-075 and V070-193018-115 with a protrusion of approximately 0.75 inch constant (refer to [photo 7](#)). The other protruding Ames was located on the right ET door between tiles V070-395055-097 and V070-395025-037 with a protrusion of approximately 0.4 inch constant (refer to [photo 8](#)). There was no notable degradation of adjacent RSI components due to the protruding Ames gap fillers.

*Photo 7. Protruding Ames Gap Filler on Left Outboard Elevon*

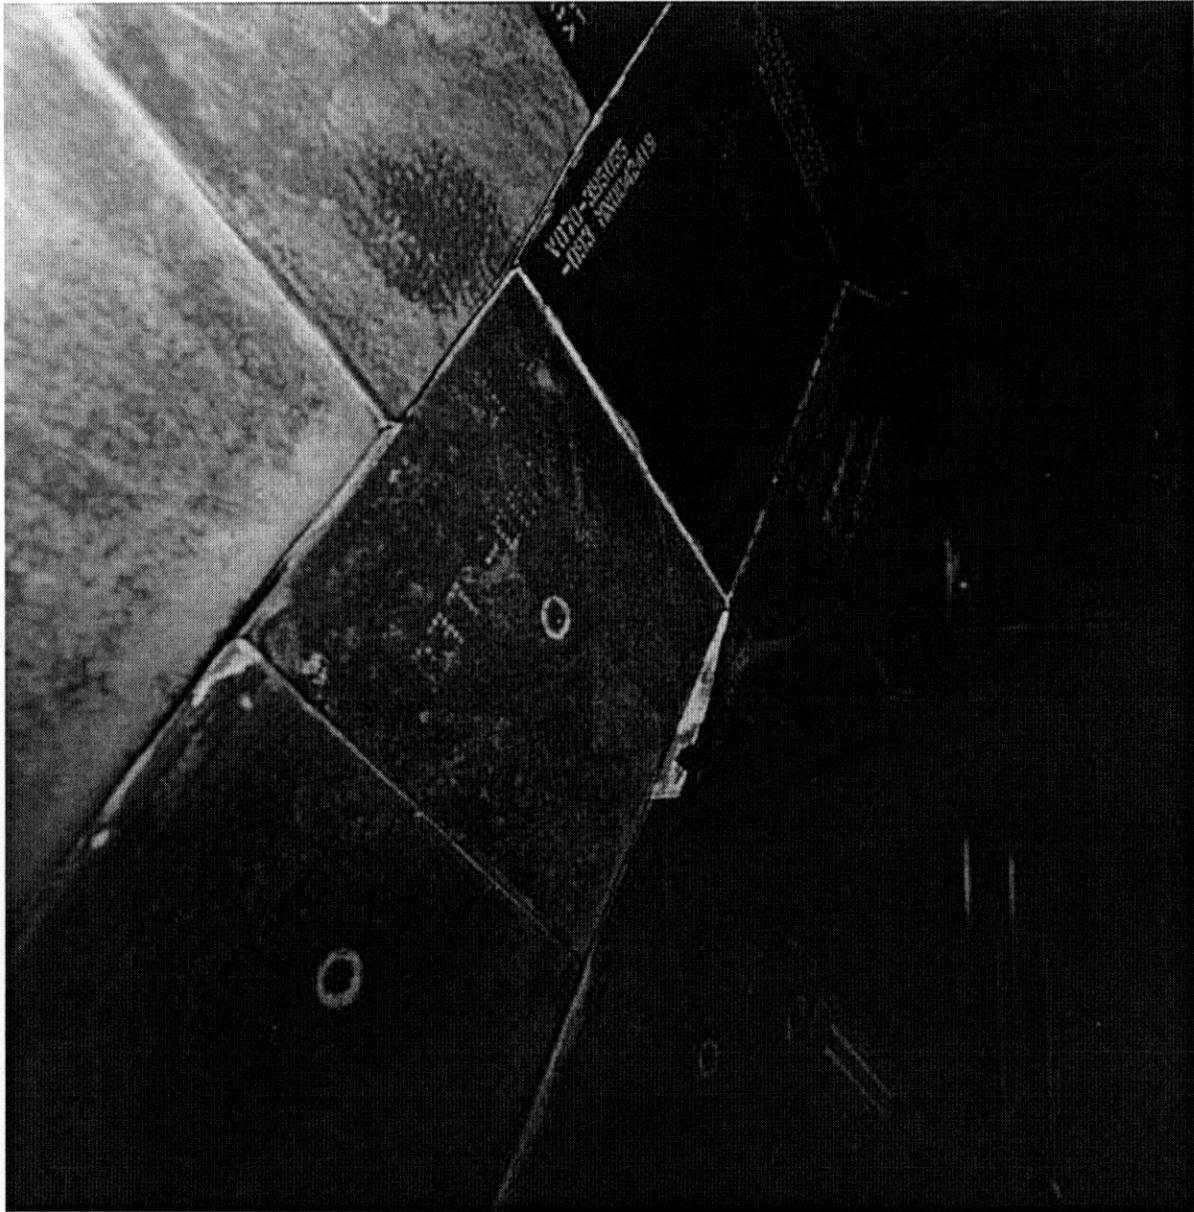
*Photo 8. Protruding Ames Gap Filler on Right ET Door*

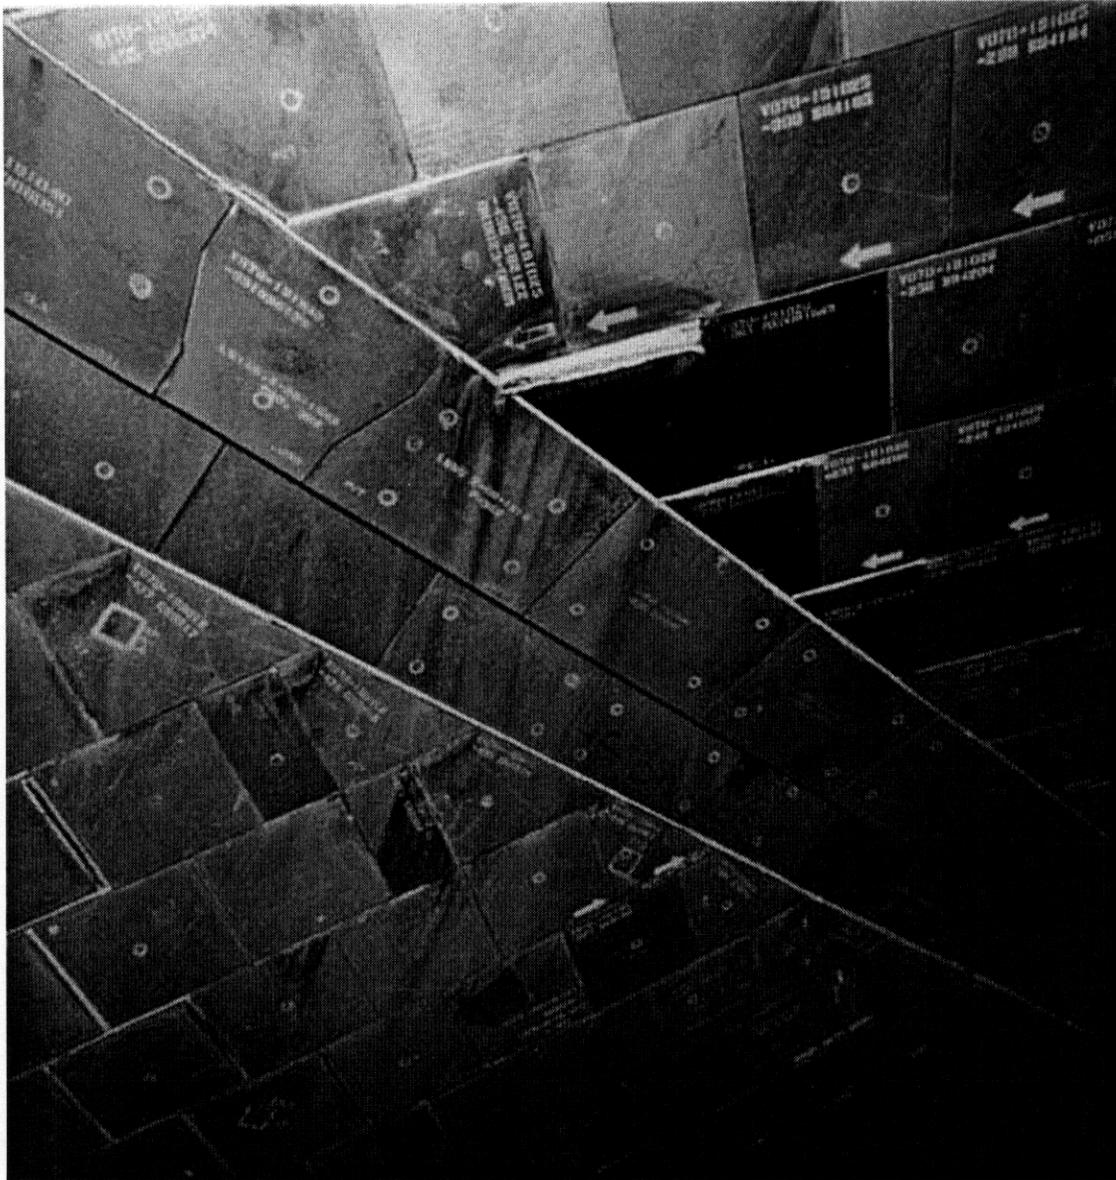
*Photo 9. V070-191135-085 Pillow Gap Filler Protruding On Lower Left Wing*

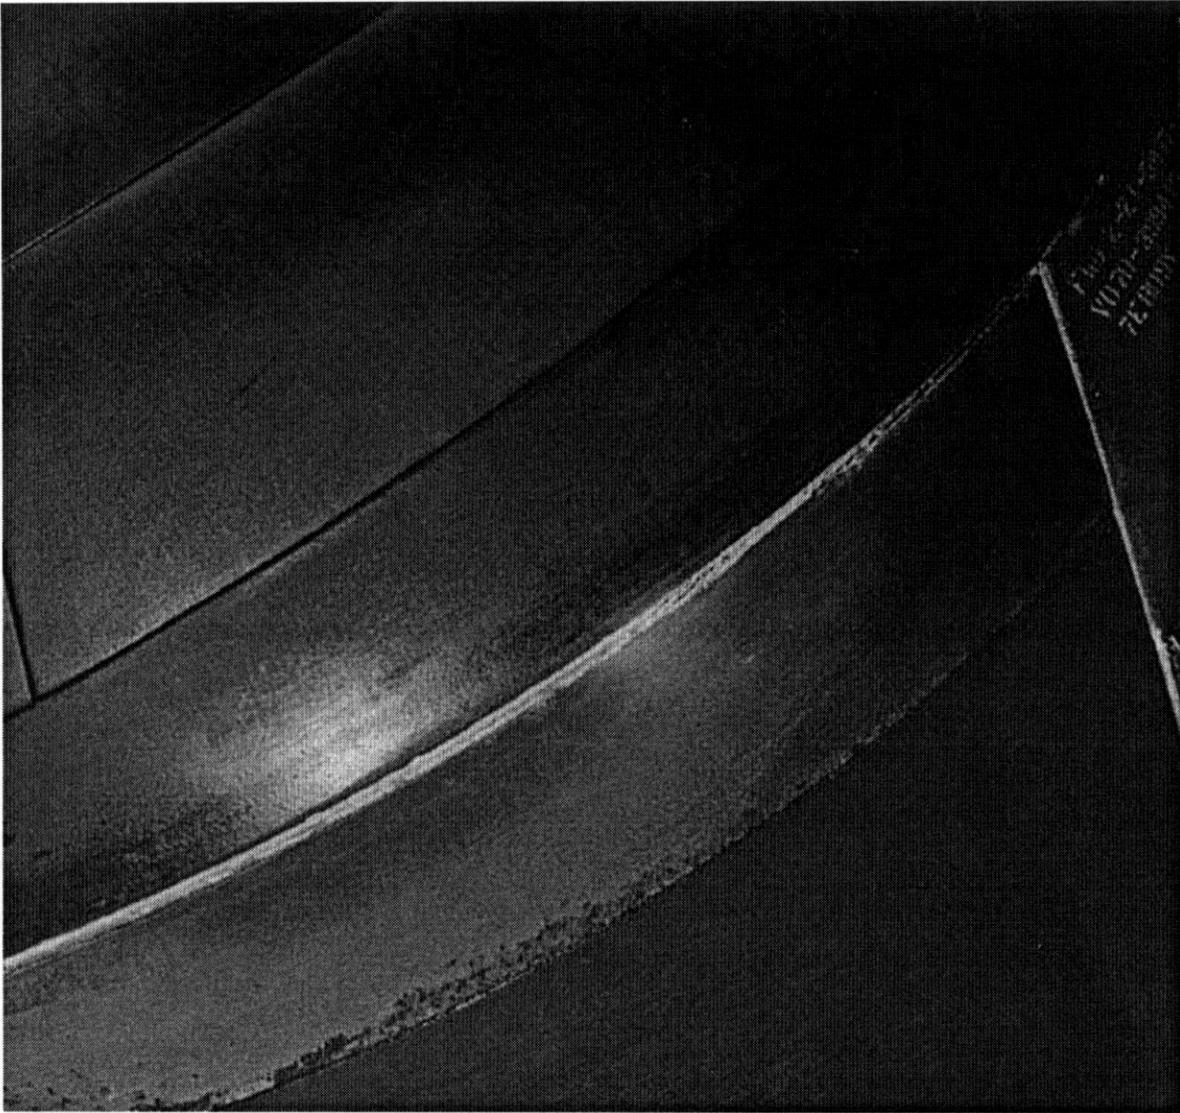
The overall condition of the chin panel installation appeared nominal with the exception of the V070-399441-044 gap filler (chin panel/nose cap expansion seal interface). The gap filler outer fabric was breached in two locations. This gap filler was newly installed during J3 OMM prior to flight 27. Possible contributing factors in the premature failure of the gap filler were type A sealant from the nose cap assembly and marginal step/gap conditions at the chin panel to nose cap expansion seal interface. The type A sealant on the nose cap assembly was refurbished during J3 OMM. The type A sealant may have caused the outer fabric of the gap filler to adhere to the nose cap expansion seal resulting in separation of the outer fabric during gap expansion. Several locations along the chin panel to nose cap interface were noted as having out-of-tolerance step/gap conditions prior to flight 27. These conditions may have caused localized heating in the noted gap resulting in degradation of the gap filler outer fabric (refer to [photo 10](#) and [photo 11](#)). Refer to [section 5.1.4](#) for additional details.

*Photo 10. V070-399441-044 Gap Filler Breached Location On Left-Hand Side*

The V070-399441 gap filler was breached in two locations. One location was approximately 2.5 inches in length and was located on left side 6 to 8 inches from the outboard edge of the chin panel and the other location was approximately 0.5 inch in length and was located just left of the centerline (refer to [photo 15](#)). The inner fabric was exposed on the larger damage toward the outboard left portion of the gap filler. Aside from the damages, the outer fabric of this gap filler appeared to be separated by adhering to both the nose cap expansion seal and the chin panel gap seal. In addition to the damages to the V070-399441 gap filler, there were significant damages to the V070-399412-053, V070-399412-082, V070-399442-009, and V070-399442-010 gap fillers that warranted replacement.

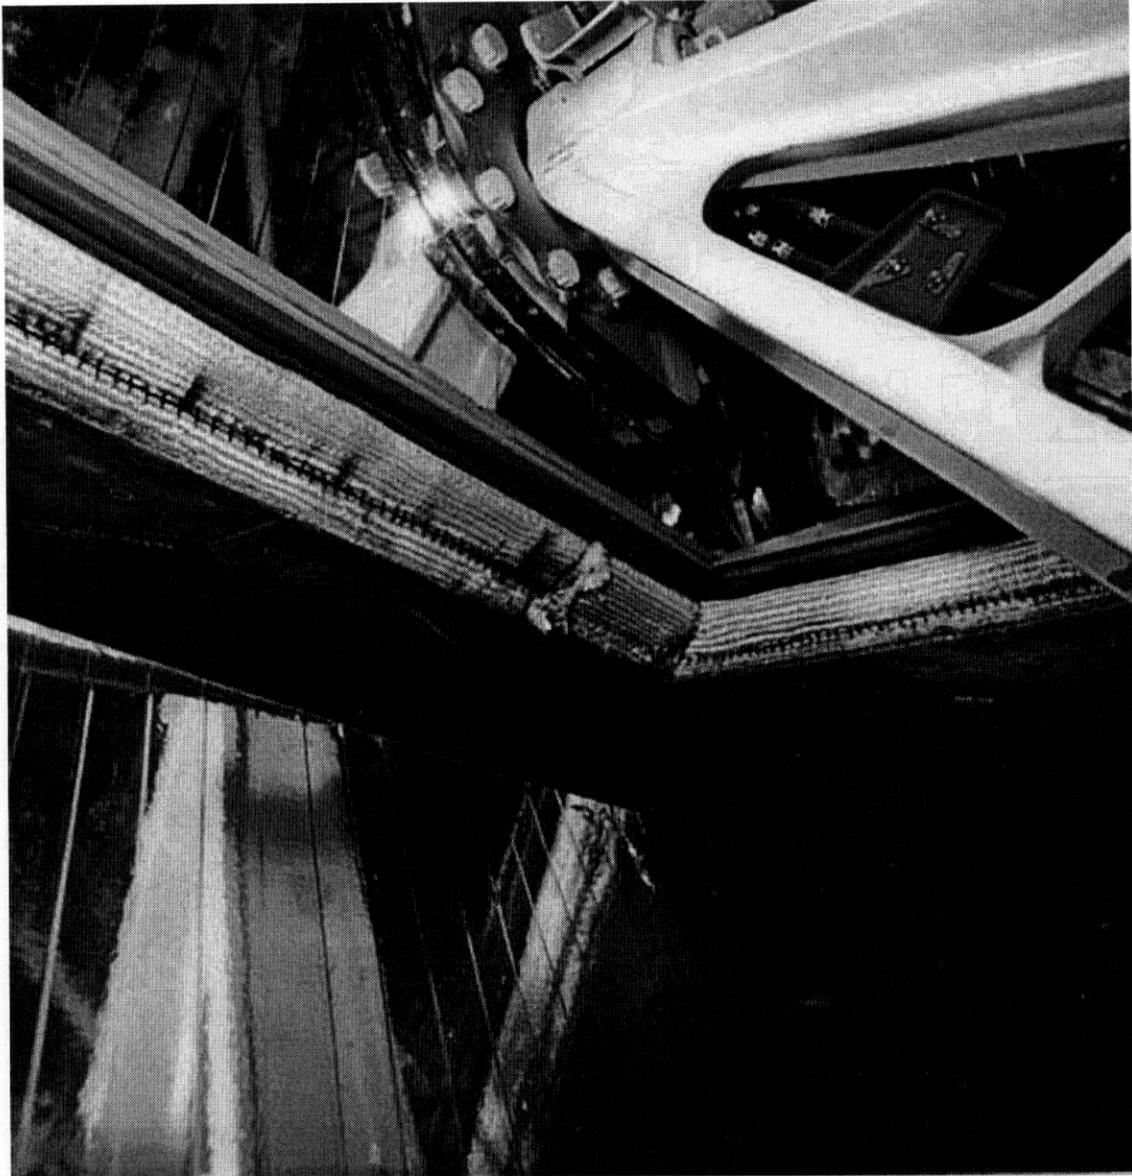
The NLGD thermal barriers were in good condition with the exception of seven previously flown thermal barriers, which were replaced due to flight damage. In addition, 15 thermal barriers were removed in support of the chin panel removal. New thermal barriers were installed at these locations. The three chin panel OML thermal barriers (V070-398379-009 (2) and V070-398379-010) were replaced with a single OML thermal barrier (V070-398379-017) in accordance with V070-398379 EO B03. This modification was implemented to reduce the number of OML thermal barrier junctions along the chin panel, which contributed to damage along the interfacing tile lips. Several patches installed to improve the compression of the NLGD thermal barrier seal-to-door periphery tiles were frayed/degraded (refer to [photo 12](#)). The removal and replacement of several primary thermal barriers consequently eliminated the degrading patches. Refer to [table 10](#) for NLGD thermal barrier replacement history and locations.

*Photo 12. OML And Primary Thermal Barrier Patches At Aft  
Right-Hand Hingeline Of NLGD Area*

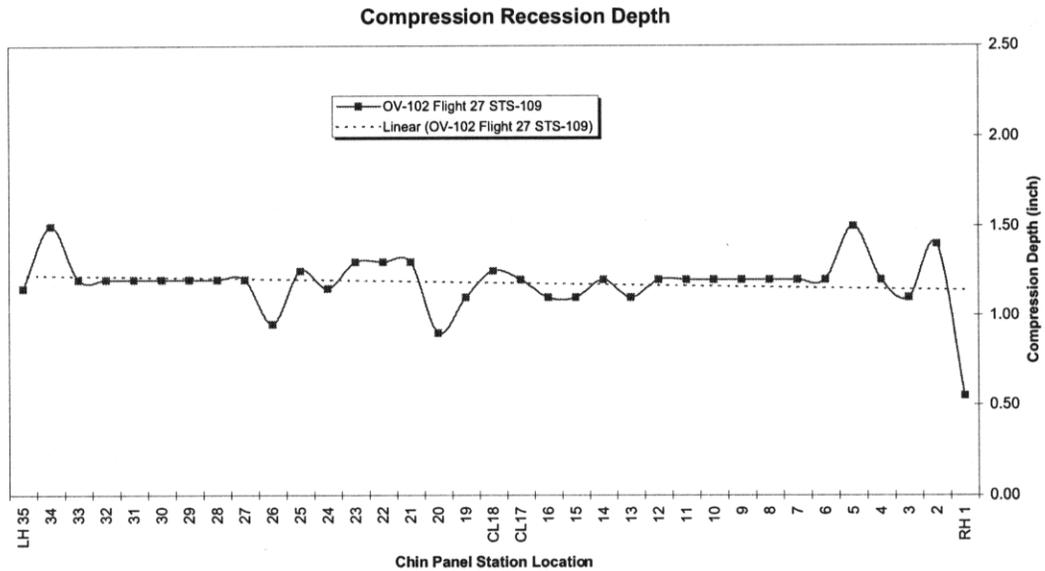
Figure 15. OV-104 Gap Filler Compression Recession Measurements

In general, the LESS was in nominal post-flight condition, however, there was a necessity to remove the chin panel assembly on account of severe damage to the V070-399441-041 gap filler. Also, there was a bizarre contamination discovery in the left wing RCC cavity. The gap filler data gathered during post-flight engineering inspection is shown in figure 15.

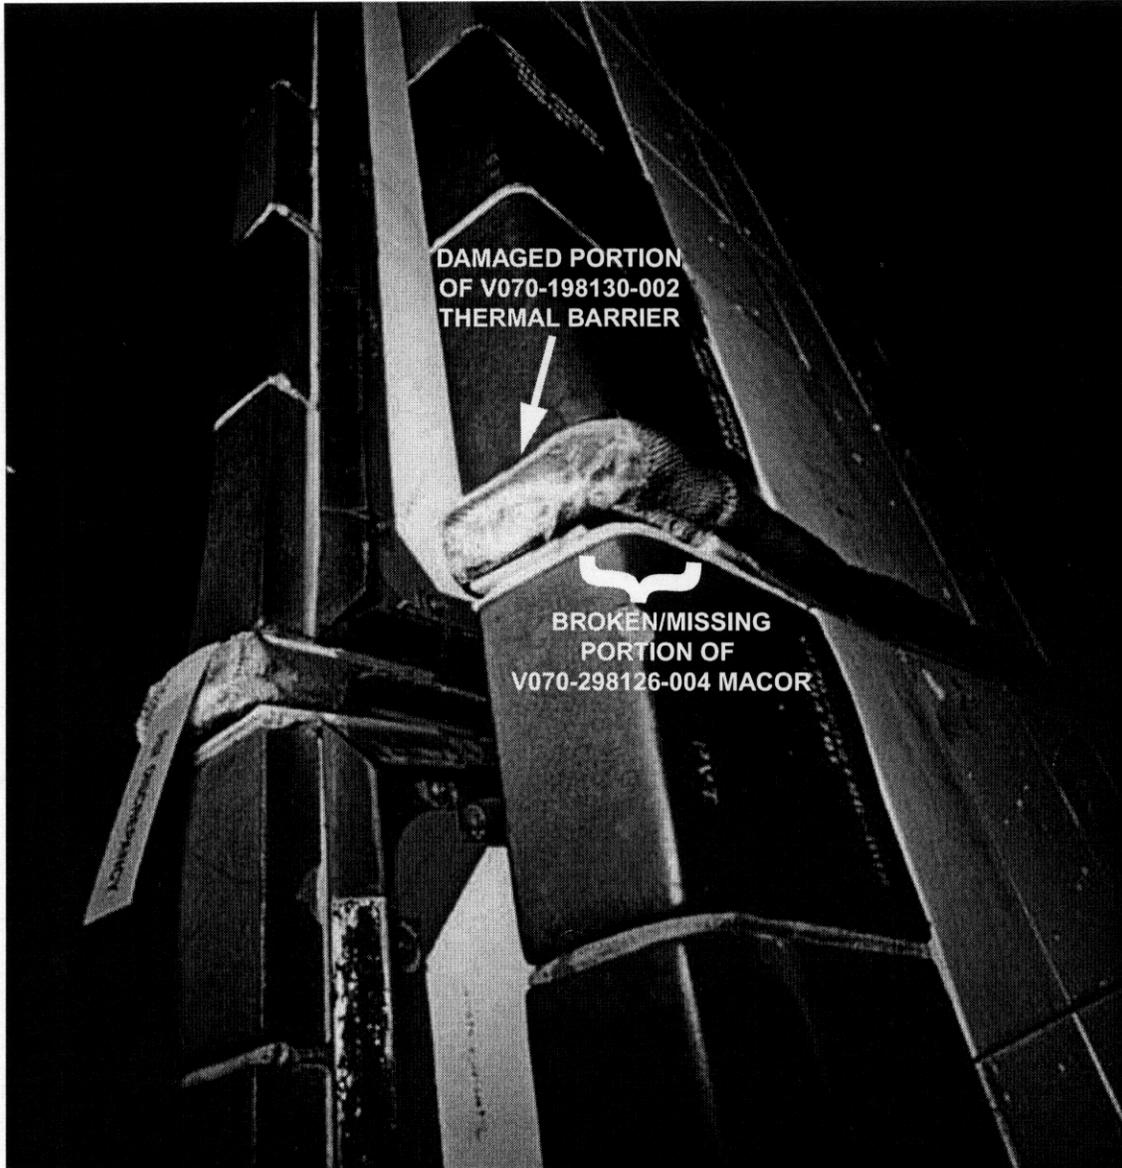
*Photo 25. Damaged Thermal Barrier and Macor at Aft Right-Hand Side of Vertical Speed Brake Splitline*

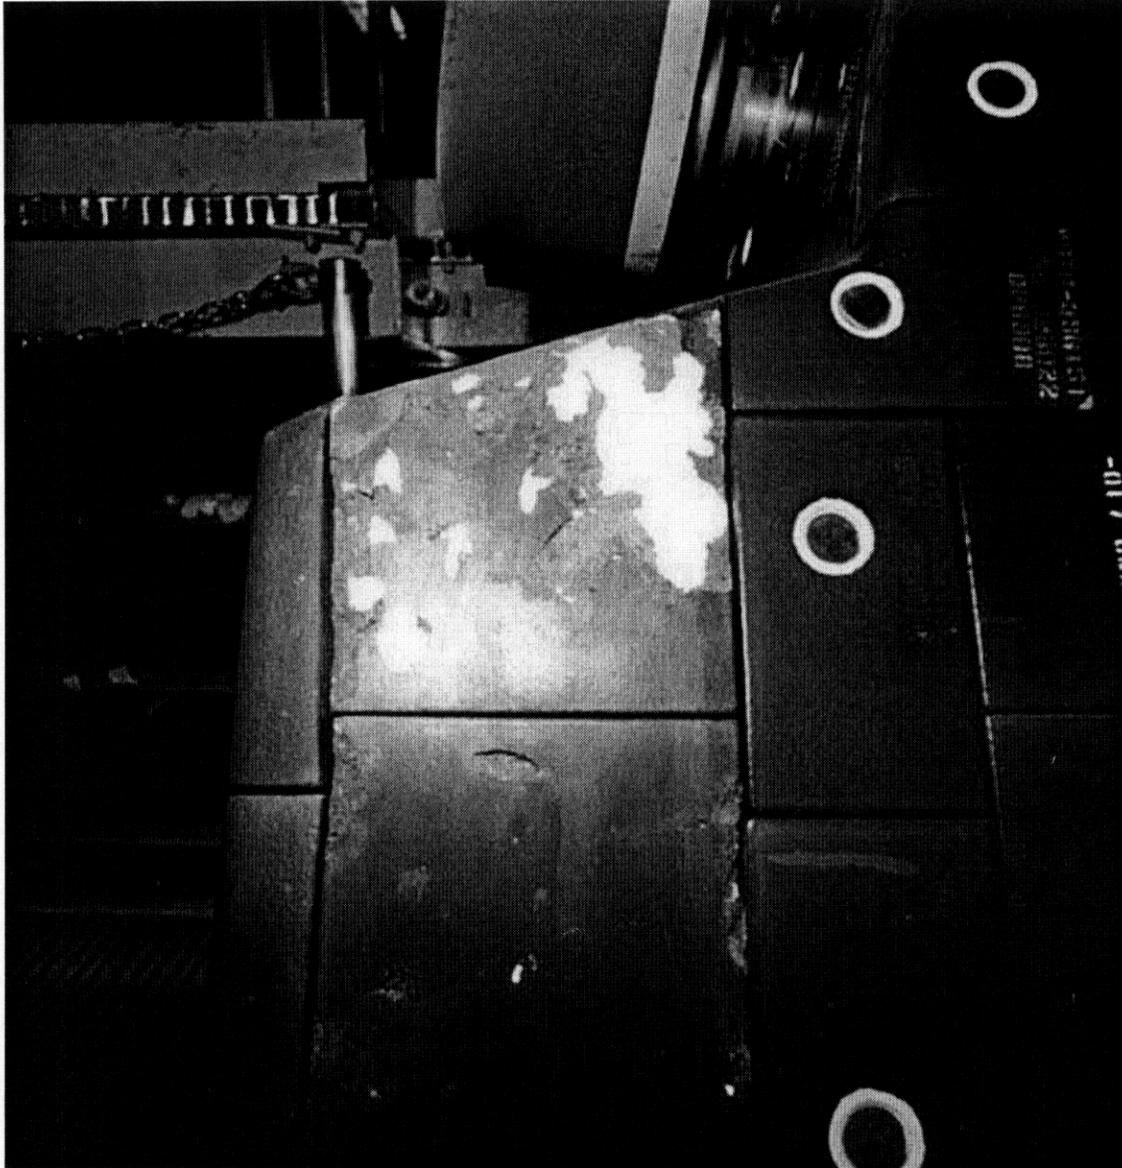
*Photo 26. V070-396151-189 Tile Damage on Left OMS Pod (LP05) Stinger*
