NASA-DoD Lead-Free Electronics Project

Automated X-Ray of Circuit Card Assemblies

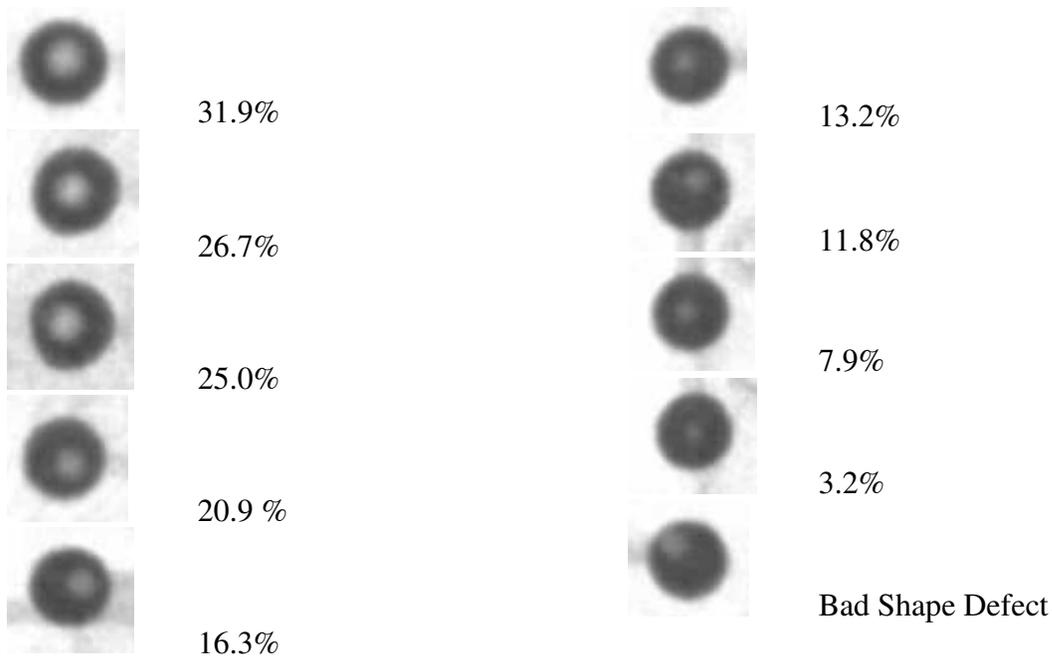
The first image above is the raw x-ray image of part of a BGA. Voids within the solder ball are clearly visible as lighter spots within the joints. The second image is the binary image used to determine the presence, size, and shape of the solder balls. A threshold value has been set (based on the contrast between solder and surrounding areas) for this image such that the resulting shapes in the binary image match the size of the solder balls in the raw x-ray image. The third image is the binary image used to evaluate the presence and size of voids. Because the contrast between the voids and the surrounding solder is different from the contrast between the solder ball and the surrounding area, the threshold level is different, and a different image is created. This threshold value is set such that the resulting voids in the binary image match the size of the voids in the raw x-ray image
