**Network Centric Systems  
Raytheon Company  
McKinney, TX 75071**

**EER-2006-34171-002  
Engineering Evaluation Report**

# **JCAA/JG-PP LEAD-FREE SOLDER PROJECT: FAILURE ANALYSIS OF TEST VEHICLES SUBJECTED TO COMBINED ENVIRONMENTS TEST**

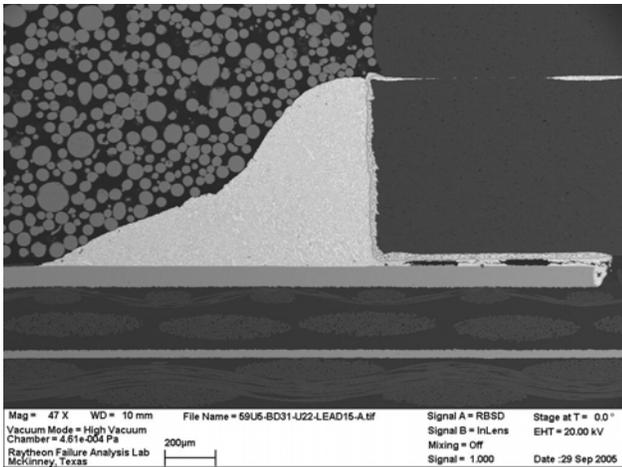
**Figure 8** SEM Micrograph of SnPb Soldered SnPb CLCC-20 on Manufactured Test Vehicle (SN 31, U22, Lead 16) Crack propagating from inside of solder joint below component. Some voiding present in this area as well. The joint is not cracked all the way through the solder.

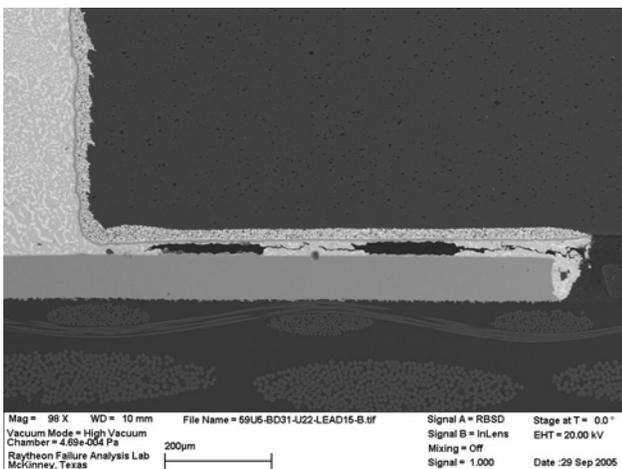
**Figure 9** SEM Micrograph of SnPb Soldered SnPb CLCC-20 on Manufactured Test Vehicle (SN 31, U22, Lead 16) Higher magnification view of solder joint seen in the previous image.

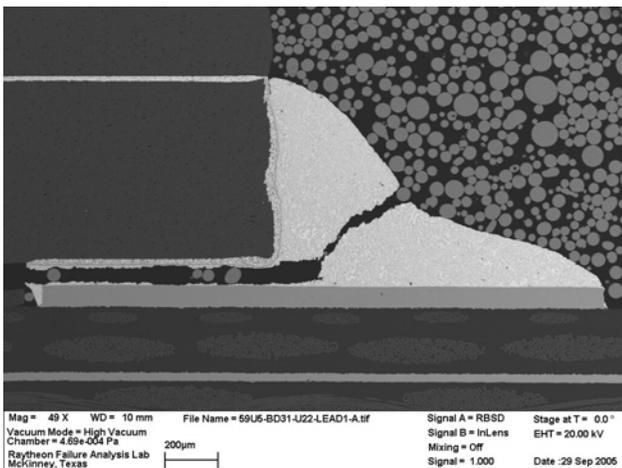
**Figure 10** SEM Micrograph of SnPb Soldered SnPb CLCC-20 on Manufactured Test Vehicle (SN 31, U22, Lead 1) Crack propagates all the way through the joint. See the EDS elemental data of the solder to board and component interfaces in Figure 11, Figure 12, Figure 13, and Figure 14.

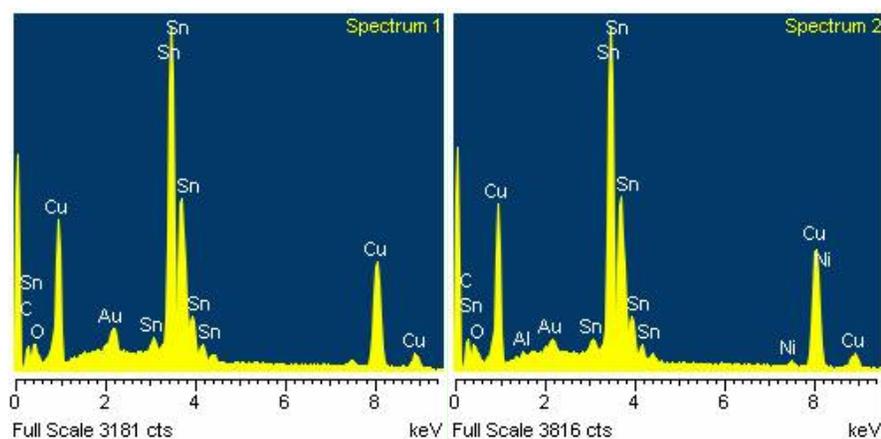
**Figure 12** EDS Spectra of SnPb Soldered SnPb CLCC-20 on Manufactured Test Vehicle (SN 31, U22, Lead 1) CuSn intermetallic zone at the board interface. Some phases of AuSn are also present.

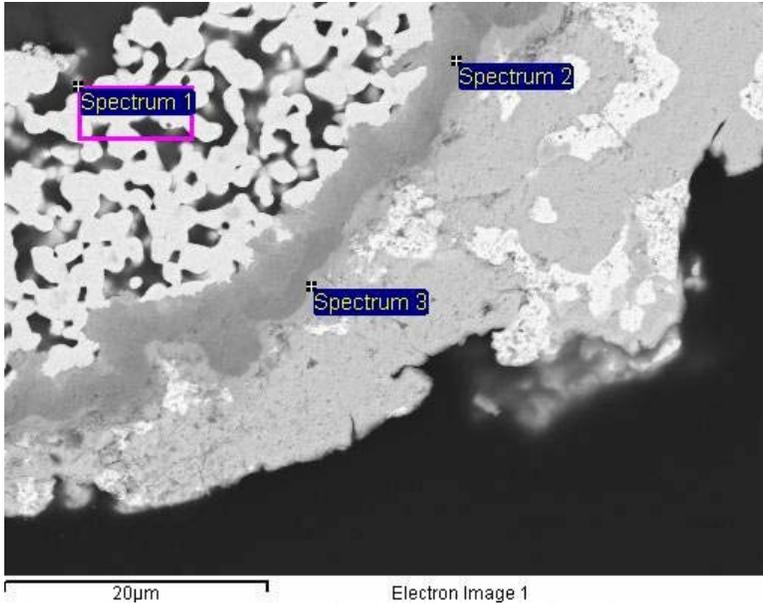
**Figure 13** SEM Micrograph of SnPb Soldered SnPb CLCC-20 on Manufactured Test Vehicle (SN 31, U22, Lead 1) Solder to component interface

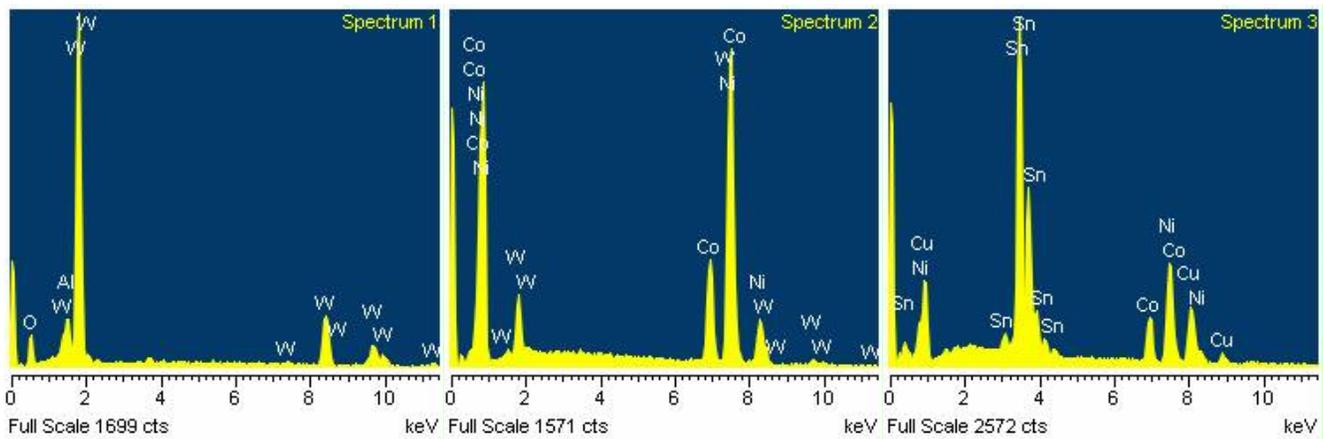
**Figure 14** EDS Spectra of SnPb Soldered SnPb CLCC-20 on Manufactured Test Vehicle (SN 31, U22, Lead 1) Solder to component interface, Spectrum 1 indicates a tungsten (W) thickfilm; Spectrum 2 is a nickel-cobalt (Ni/Co) layer; Spectrum 3 indicates a nickel-tin (Ni/Sn) intermetallic compound zone. The data also suggest some copper (Cu) has migrated from the board to the component interface.

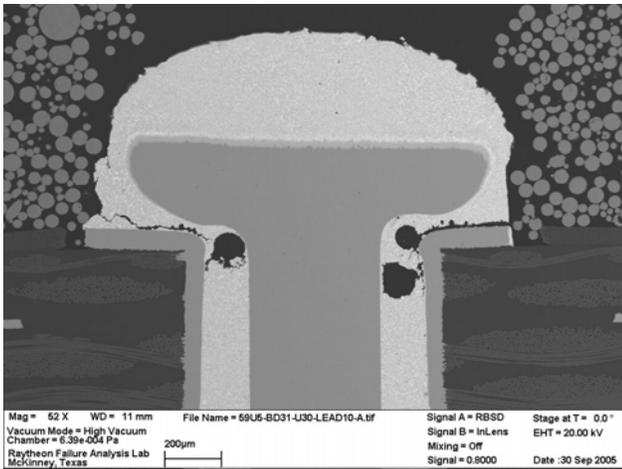
**Figure 17** SEM Micrograph of SnPb Soldered Sn PDIP-20 on Manufactured Test Vehicle (SN 31, U30, Lead 10) Crack in solder on both sides of lead and board. Crack extends a significant distance along lead. Voiding is present in the solder in the area of cracking. Other leads similar in appearance.

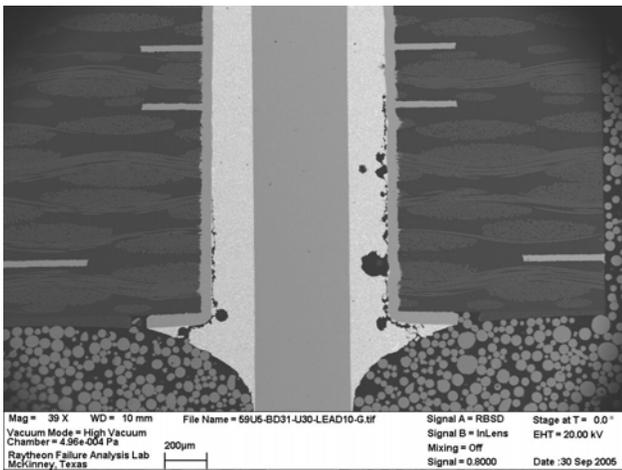
**Figure 18** SEM Micrograph of SnPb Soldered Sn PDIP-20 on Manufactured Test Vehicle (SN 31, U30, Lead 10) Opposite side of board also has cracking nearest the PWB interface. Voiding is also present.

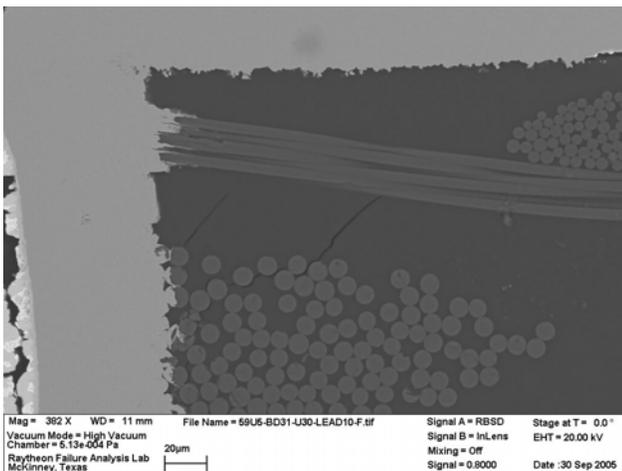
**Figure 19** SEM Micrograph of SnPb Soldered Sn PDIP-20 on Manufactured Test Vehicle (SN 31, U30, Lead 10) Minor cracks in PWB.

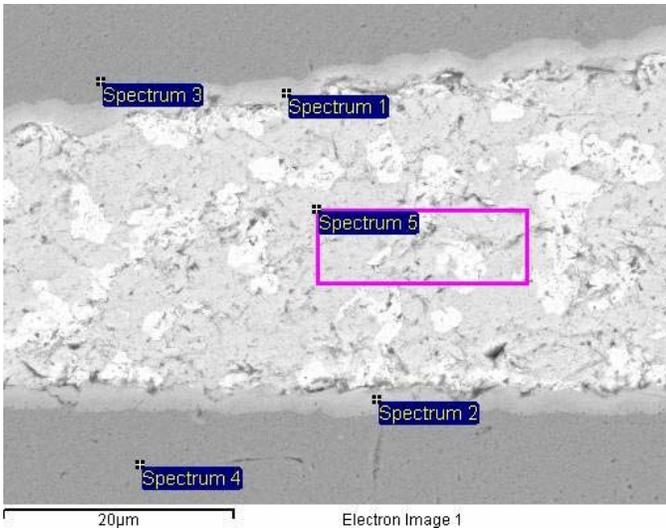
**Figure 28** SEM Micrograph of SnPb Soldered Sn TQFP-144 on Manufactured Test Vehicle (SN 30, U1, Lead 144) EDS elemental analysis indicates the lead and board pad are both copper (Cu). The intermetallic (IMC) layer at the component lead is CuSn; the board pad interface IMC is also CuSn. The solder was confirmed to be tin-lead (SnPb).

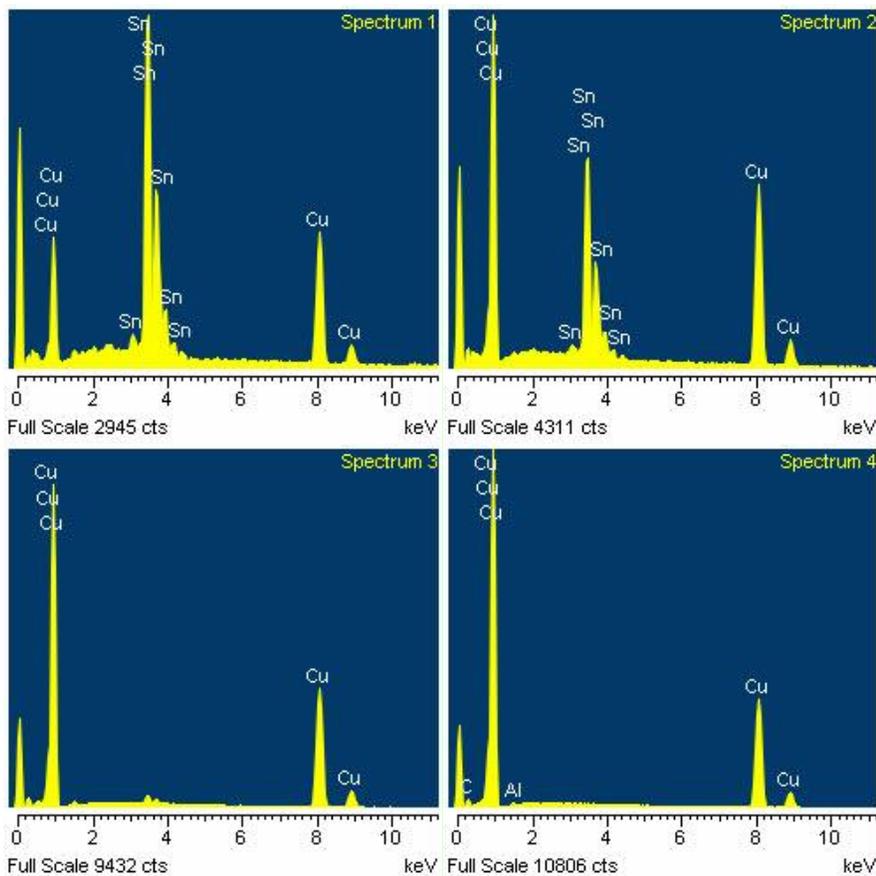
**Figure 29** EDS Spectra of SnPb Soldered Sn TQFP-144 on Manufactured Test Vehicle (SN 30, U1, Lead 144) EDS elemental analysis indicates the lead and board pad are both copper (Cu), however a thin Ni layer is present on the lead surface. The intermetallic layer at the component lead is nickel-tin (NiSn) and copper-tin (CuSn); the

board pad interface intermetallic layer is CuSn. The solder was confirmed to be tin-lead (SnPb). The presence of Cu at the lead interface is likely migrating from the board side.

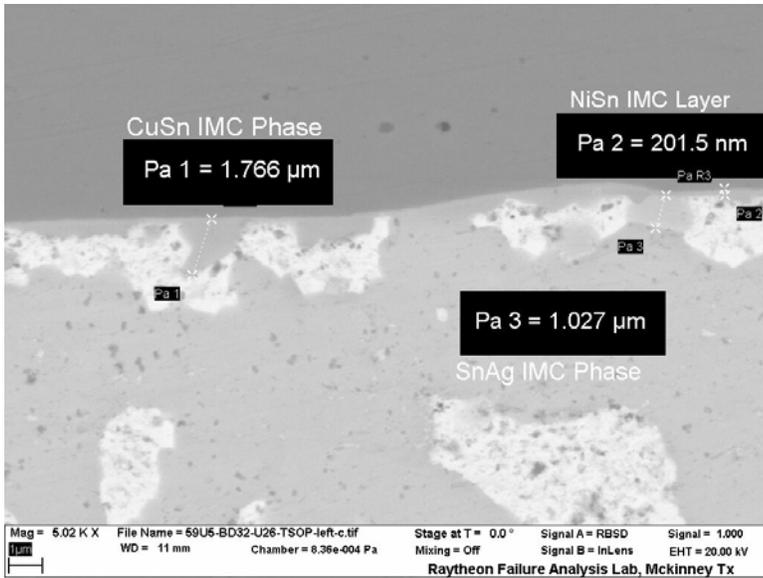
**Figure 34** SEM Micrograph of SnPb Soldered SnPb TSOP-50 on Manufactured Test Vehicle (SN 32 U26, left side) Lead side interface showing the intermetallic compounds present; NiSn, CuSn, and SnAg.

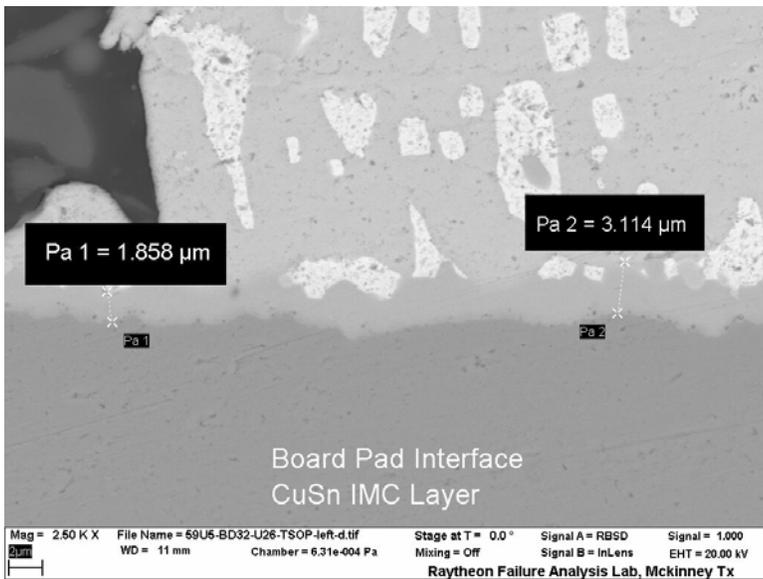
**Figure 35** SEM Micrograph of SnPb Soldered SnPb TSOP-50 on Manufactured Test Vehicle (SN 32 U26, left side) Board side interface showing the CuSn intermetallic layer.

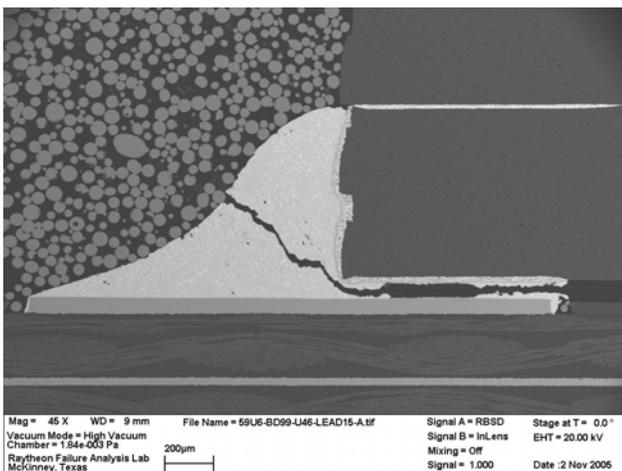
**Figure 40** SEM Micrograph of SnAgCu Soldered SnPb CLCC-20 on Manufactured Test Vehicle (SN 99, U46, Lead 25) Crack extends completely through joint. Some voiding is present below component.

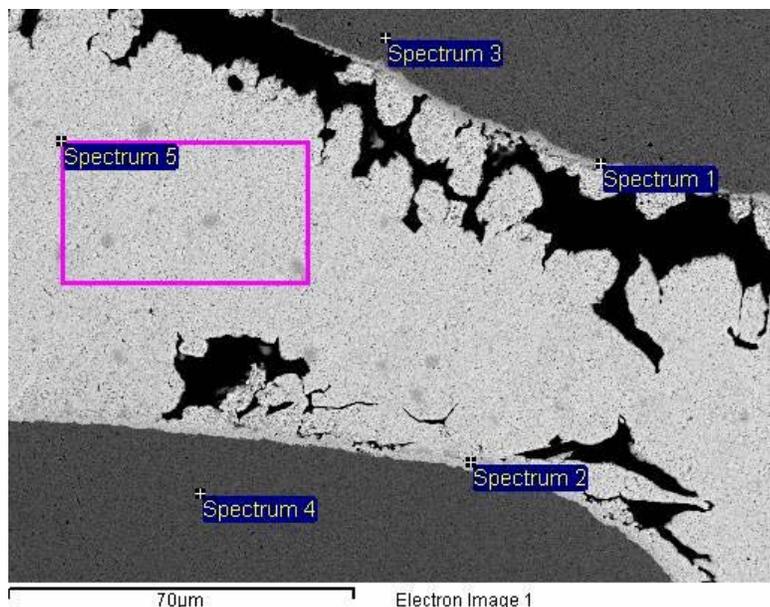
**Figure 46** SEM Micrograph of SnAgCu Soldered Sn PDIP-20 on Manufactured Test Vehicle (SN 99, U11, Lead 1) The board base metallization is Cu plated with immersion Ag. The intermetallic layer is mainly AgSn with low levels of Cu. The lead is Cu with a Ni plating on the surface. The intermetallic layer is NiSnCu.

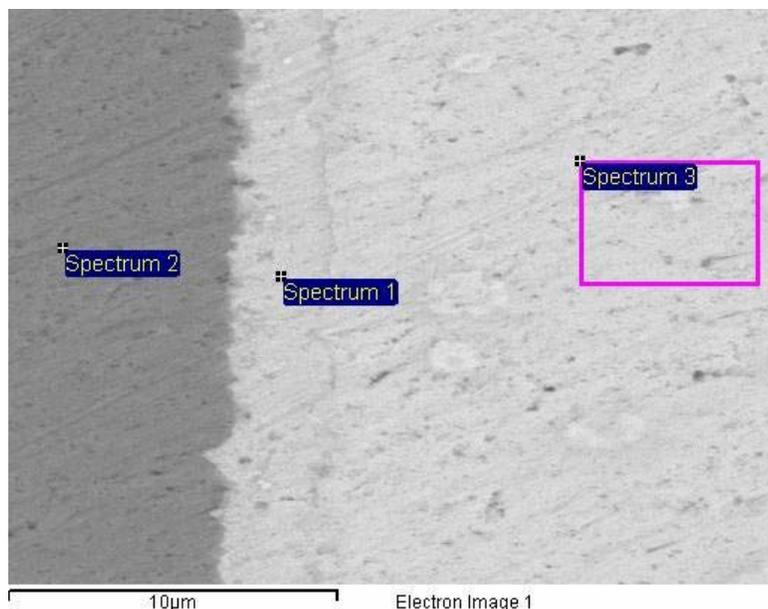
**Figure 48** SEM Micrograph of SnAgCu Soldered AuPdNi PDIP-20 on Manufactured Test Vehicle (SN 99, U23, Lead 1) Board side interface and IMC layer.

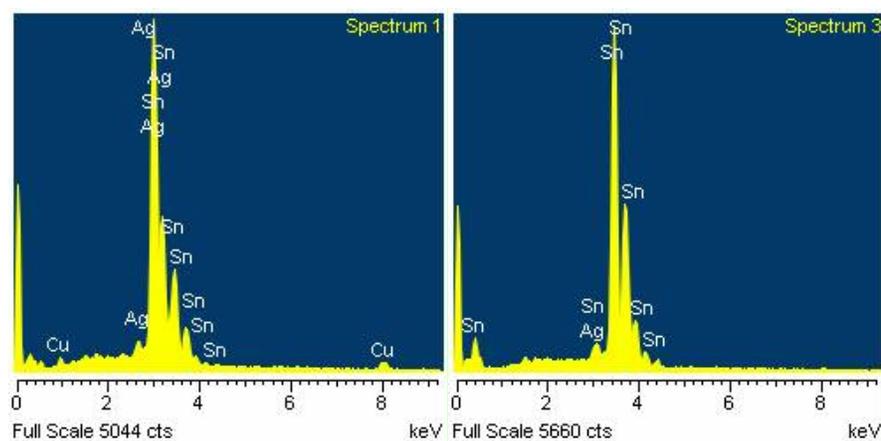
**Figure 49** EDS Spectra of SnAgCu Soldered AuPdNi PDIP-20 on Manufactured Test Vehicle (SN 99, U23, Lead 1) The board metallization is Cu (spectrum not shown) plated with immersion Ag, the intermetallic layer is mainly AgSn with low levels of Cu (Spectrum 1), solder is SnAgCu (Spectrum 3).

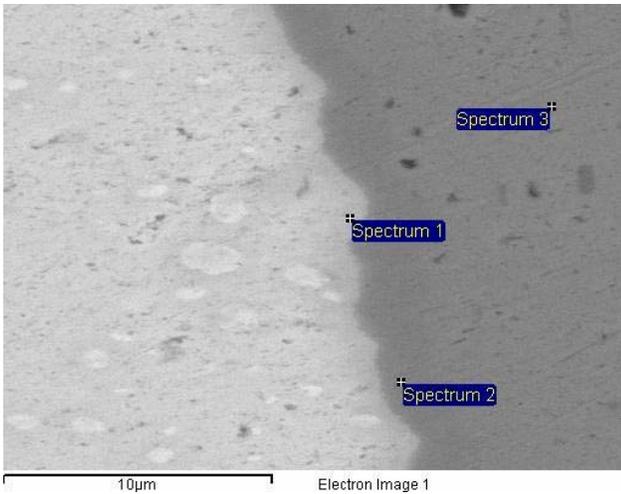
**Figure 50** SEM Micrograph of SnAgCu Soldered AuPdNi PDIP-20 on Manufactured Test Vehicle (SN 99, U23, Lead 1) Component lead side interface and IMC layer

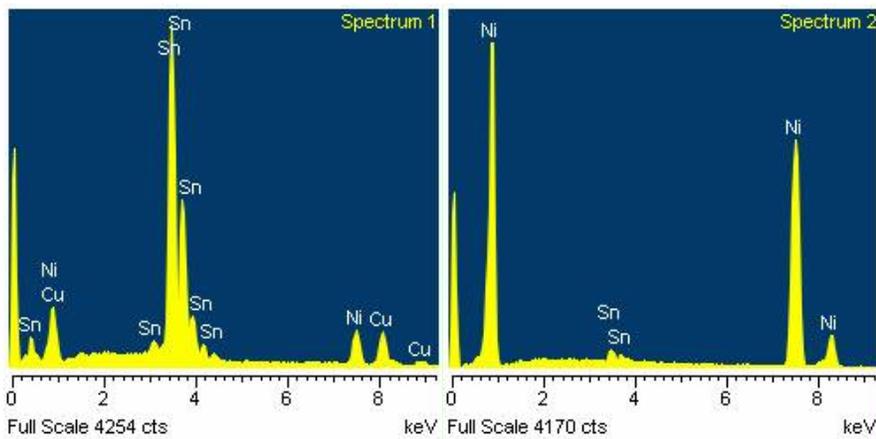
**Figure 51** EDS Spectra of SnAgCu Soldered AuPdNi PDIP-20 on Manufactured Test Vehicle (SN 99, U23, Lead 1) The lead is Cu with a Ni plating on the surface. The intermetallic layer is NiSnCu. Spectrum 1 = IMC, Spectrum 2 = Ni layer, Spectrum 3 = Cu base (spectrum not shown)

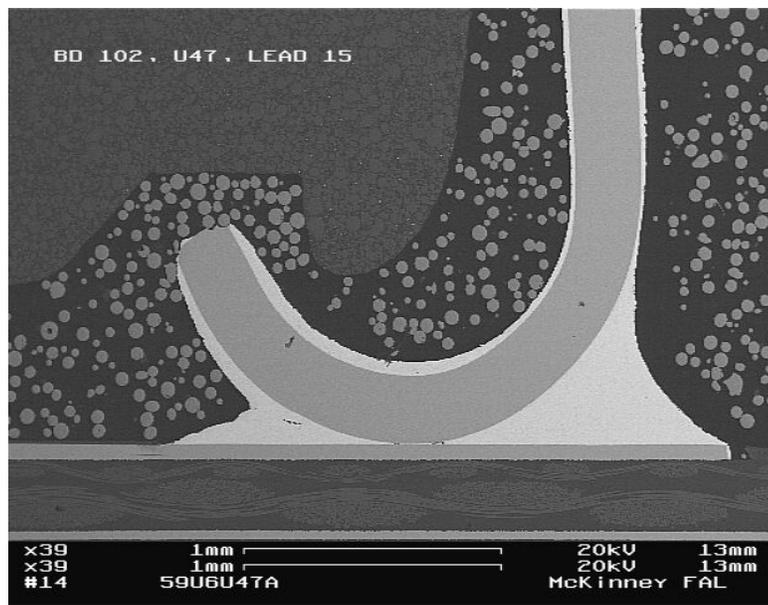
SN	REFDES	Lead Finish	Lead	IMC Thickness, IC (um)	IMC Thickness, PWB (um)	IMC at IC	IMC at PWB	Observations
102	U47	Sn	15	1.31 2.67	2.03 3.98	CuSn	CuSn	Minor voiding in joint.

**Figure 52** SEM Micrograph of SnAgCu Soldered Sn PLCC-20 on Manufactured Test Vehicle (SN 102, U47, Lead 15) Minor voiding in joint.

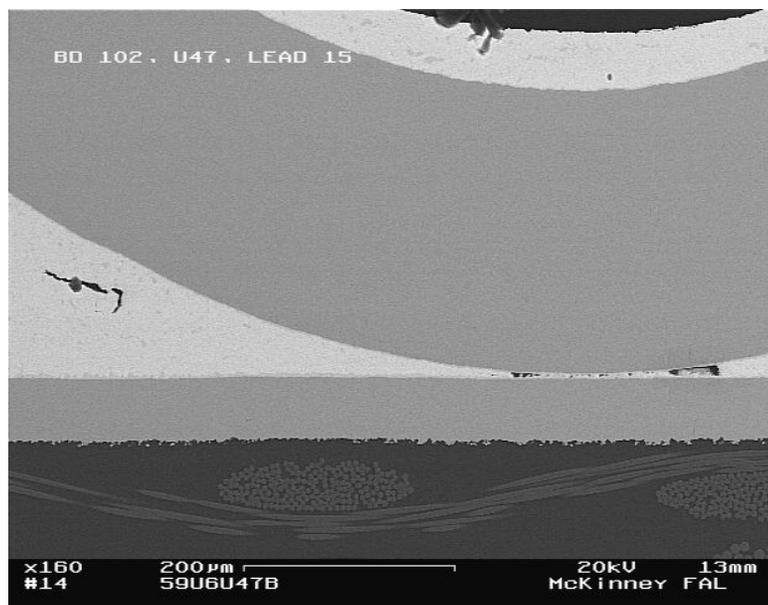
**Figure 53** SEM Micrograph of SnAgCu Soldered Sn PLCC-20 on Manufactured Test Vehicle (SN 102, U47, Lead 15) High magnification view of joint seen above.

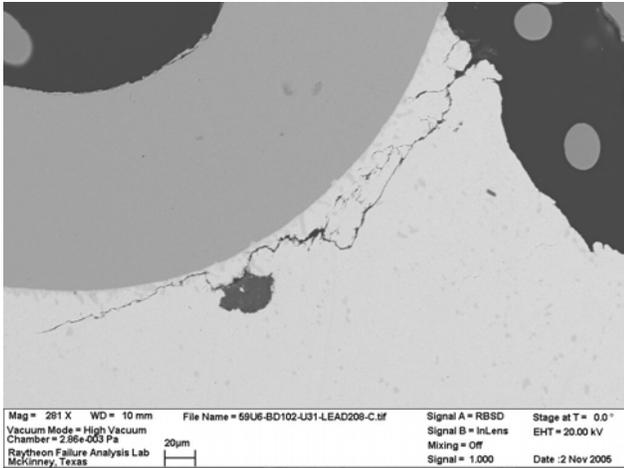
**Figure 56** SEM Micrograph of SnAgCu Soldered AuPdNi TQFP-208 on Manufactured Test Vehicle (SN 103, U31, Lead 208) Crack extends approximately 1/2 of the way into the joint.

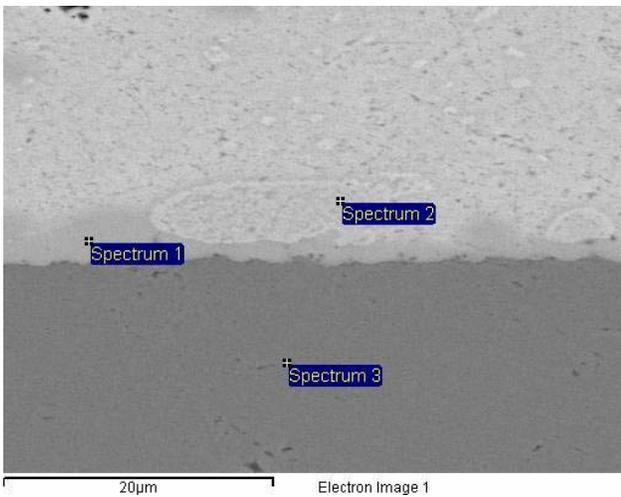
**Figure 57** SEM Micrograph of SnAgCu Soldered AuPdNi TQFP-208 on Manufactured Test Vehicle (SN 101, U3, Lead 105) Board side solder interface.

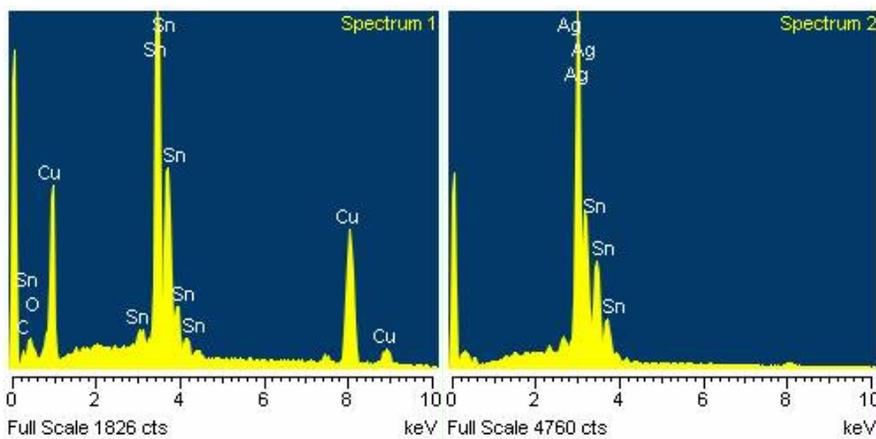
**Figure 58** EDS Spectra of SnAgCu Soldered AuPdNi TQFP-208 on Manufactured Test Vehicle (SN 101, U3, Lead 105) The base material is Cu (Spectrum 3), the IMC layer is CuSn (Spectrum 1), Spectrum 2 indicates a AgSn IMC phases near the board interface.

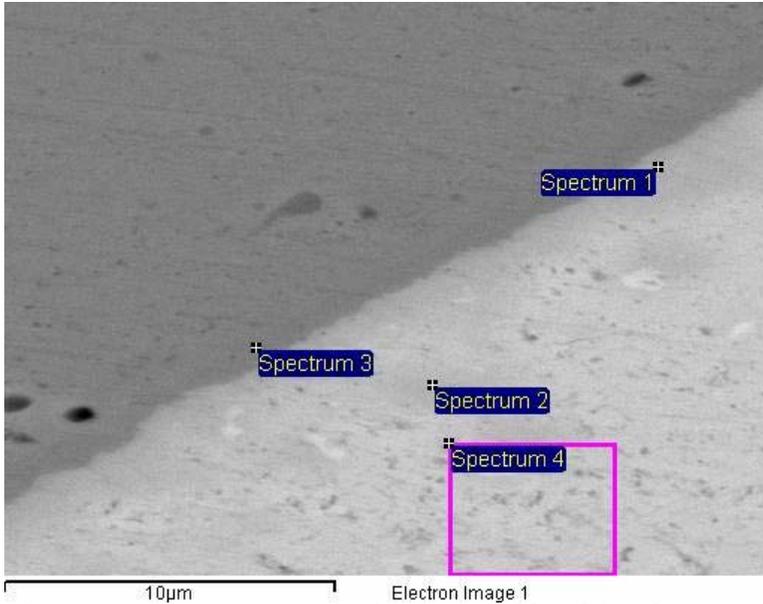
**Figure 59** SEM Micrograph of SnAgCu Soldered AuPdNi TQFP-208 on Manufactured Test Vehicle (SN 101, U3, Lead 105) Component side solder interface.

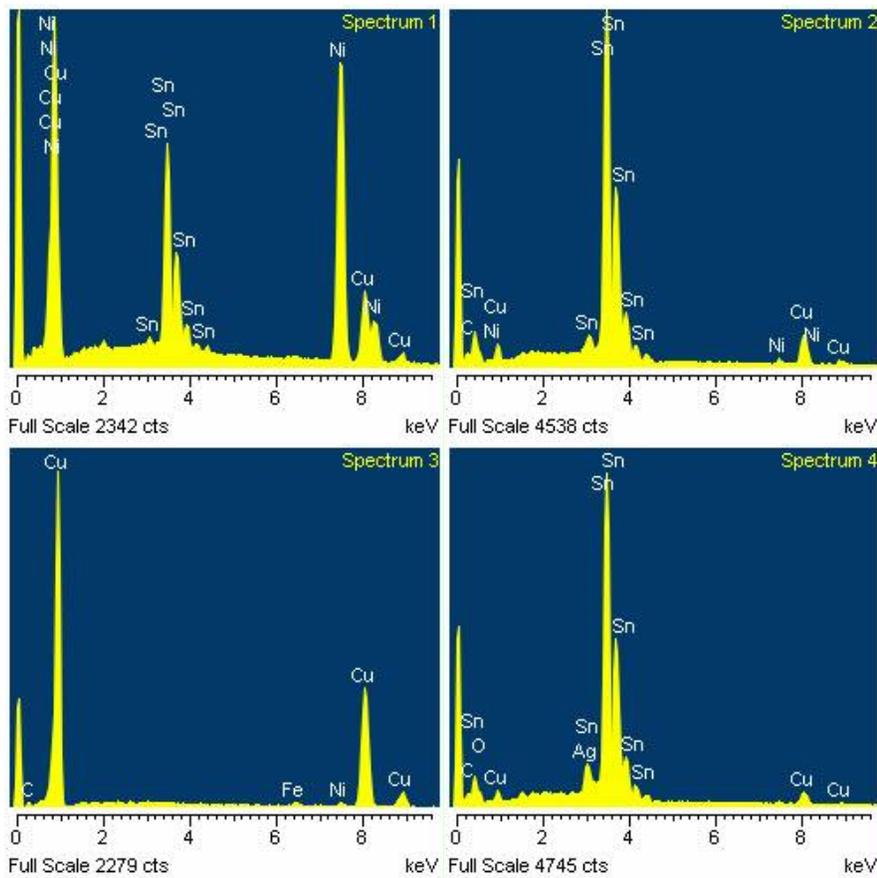
**Figure 60** SEM Micrograph of SnAgCu Soldered AuPdNi TQFP-208 on Manufactured Test Vehicle (SN 101, U3, Lead 105) Intermetallic layer is NiSnCu (Spectrum 1), CuSn intermetallic likely migrating from the board side interface (Spectrum 2), lead is Cu with a Ni plating (Spectrum 3), solder is SnAgCu (Spectrum 4).

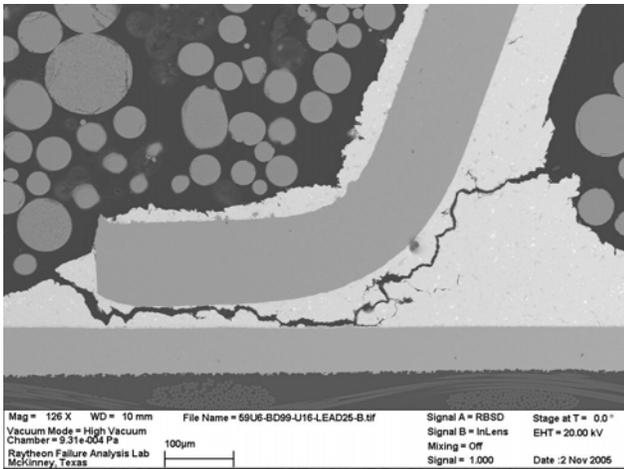
**Figure 61** SEM Micrograph of SnAgCu Soldered SnPb TSOP-50 on Manufactured Test Vehicle (SN 99, U16, Lead 25) Crack extends completely through joint.

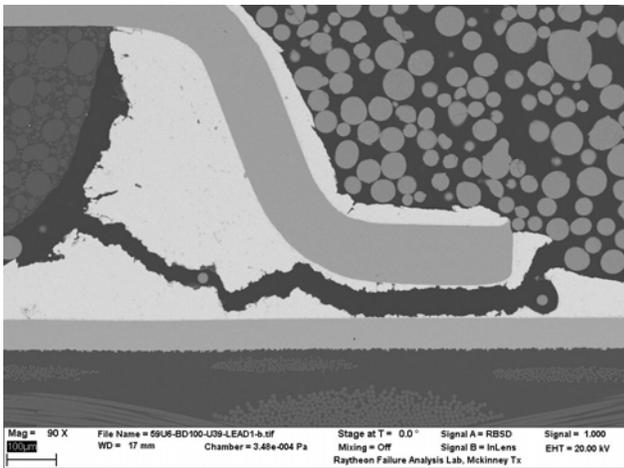
**Figure 62** SEM Micrograph of SnAgCu Soldered SnCu TSOP-50 on Manufactured Test Vehicle (SN 100, U39, Lead 1) Crack extends all the way through the joint.

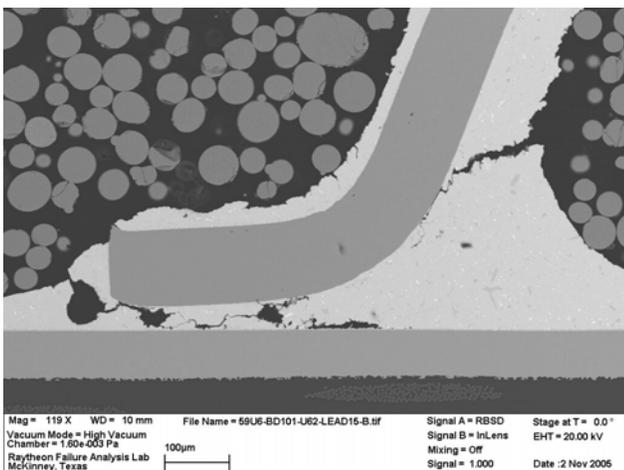
**Figure 63** SEM Micrograph of SnAgCu Soldered SnPb TSOP-50 on Manufactured Test Vehicle (SN 101, U62, Lead 15) Crack extends from outside of the joint inward on both sides of joint. Crack is almost completely through joint. Some voids are present.

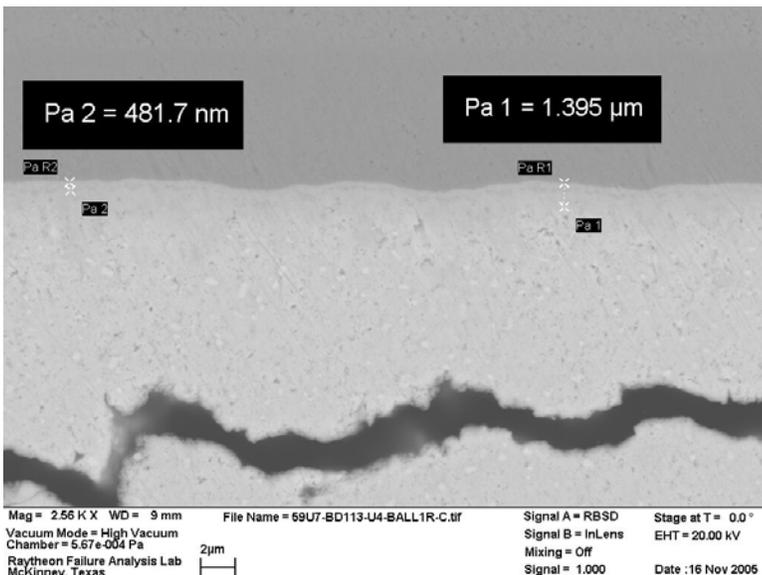
**Figure 65** SEM Micrograph of SnAgCuBi Soldered SnAgCu BGA-225 on Manufactured Test Vehicle (SN 113, U4, Bump 1R) Component side interface, intermetallic layer measurements are shown.

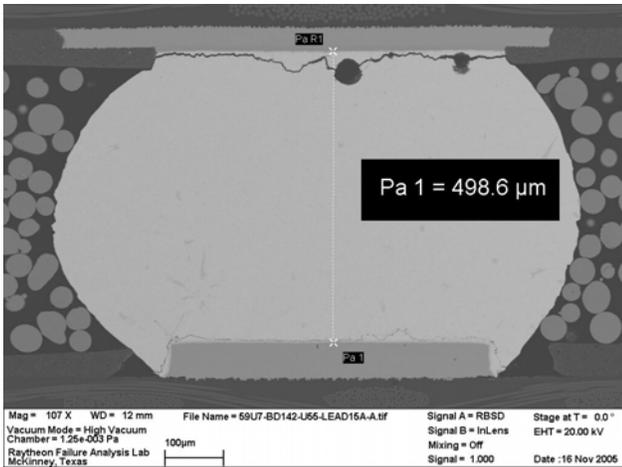
**Figure 66** SEM Micrograph of SnAgCuBi Soldered SnAgCu BGA-225 on Manufactured Test Vehicle (SN 142, U55, Bump 15A) Solder completely cracked through the joint at both interfaces.

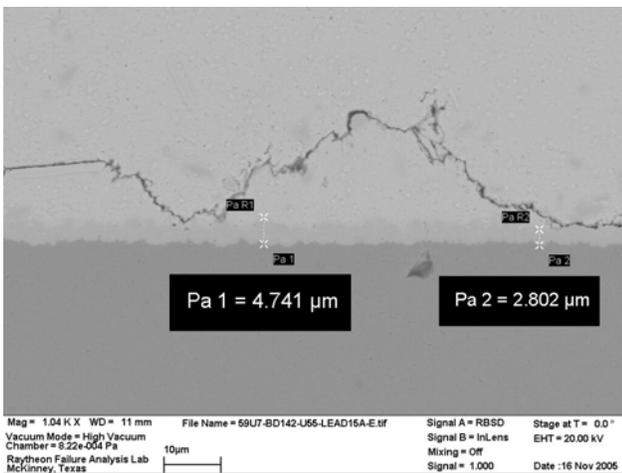
**Figure 67** SEM Micrograph of SnAgCuBi Soldered SnAgCu BGA-225 on Manufactured Test Vehicle (SN 142, U55, Bump 15A) Solder completely cracked through the joint at both interfaces. Closer view of board side interface shows the CuSn intermetallic layer and that the crack is through the solder.

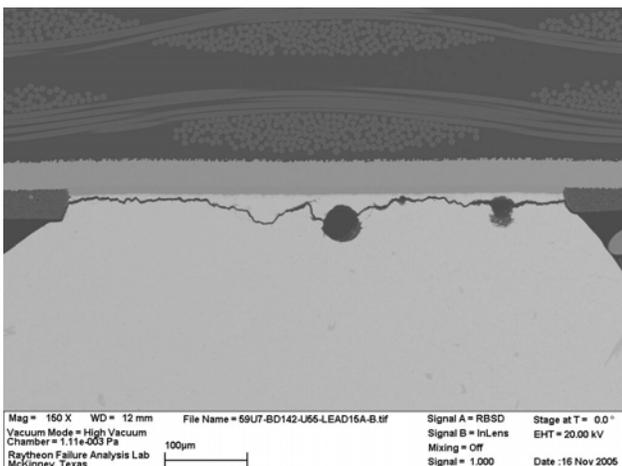
**Figure 68** SEM Micrograph of SnAgCuBi Soldered SnAgCu BGA-225 on Manufactured Test Vehicle (SN 142, U55, Bump 15A) Closer view of component side interface.

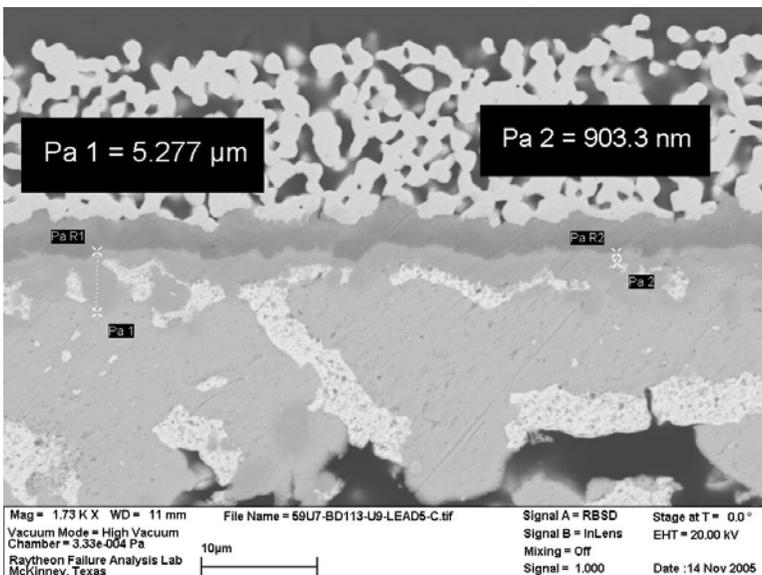
**Figure 72** SEM Micrograph of SnAgCuBi Soldered SnPb CLCC-20 on Manufactured Test Vehicle (SN 113, U9, Lead 5) Solder to component interface showing measurements of the NiSn IMC layer. The metallurgy on the component is a W thick-film followed by a Ni layer. The solder bonds to the Ni and forms a NiSn IMC. Some CuSn is also present near the component interface due to Cu migrating from the board side interface.

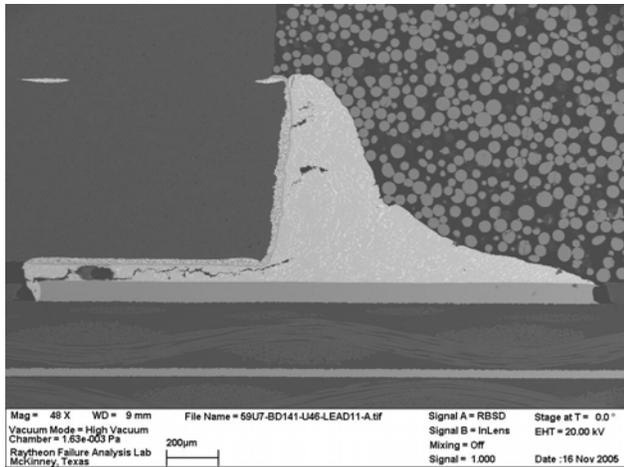
**Figure 73** SEM Micrograph of SnAgCuBi Soldered SnPb CLCC-20 on Manufactured Test Vehicle (SN 141, U46, Lead 11) Crack below the component, crack does not extend all the way through the solder fillet.

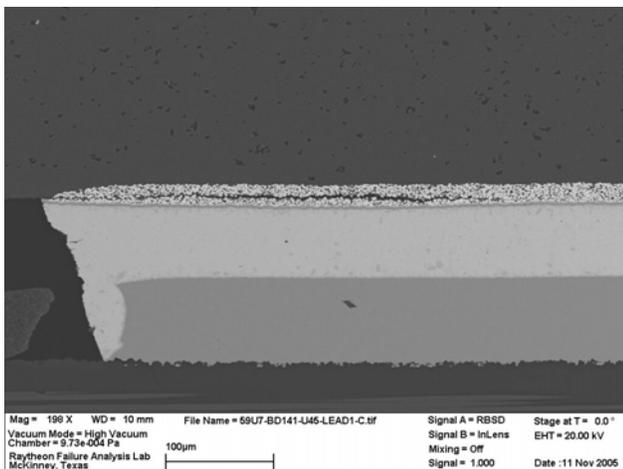
**Figure 74** SEM Micrograph of SnAgCuBi Soldered SnAgCuBi CLCC-20 on Manufactured Test Vehicle (SN 141, U45, Lead 1) Crack in the W thick-film at the component.

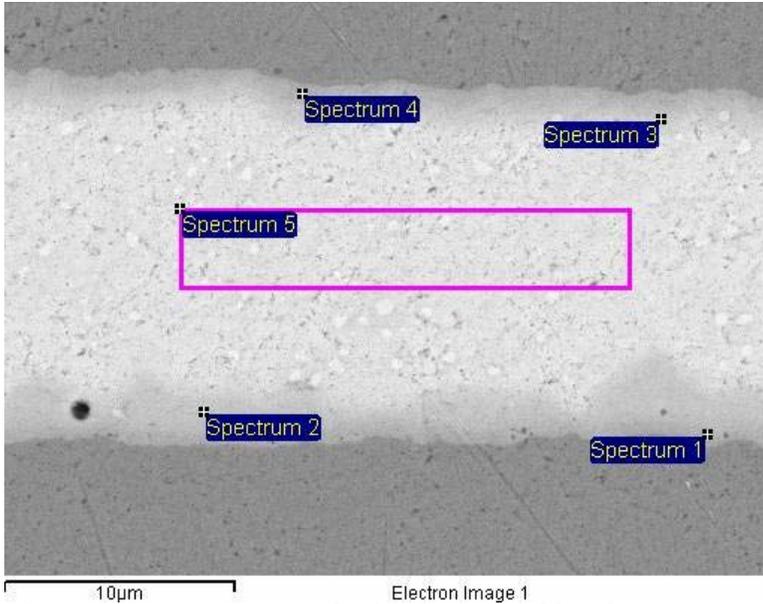
**Figure 77** SEM Micrograph of SnAgCuBi Soldered Sn PLCC-20 on Manufactured Test Vehicle (SN 140, U54, Lead 10) Image shows intermetallic layer at lead (top) and board (bottom) interfaces.

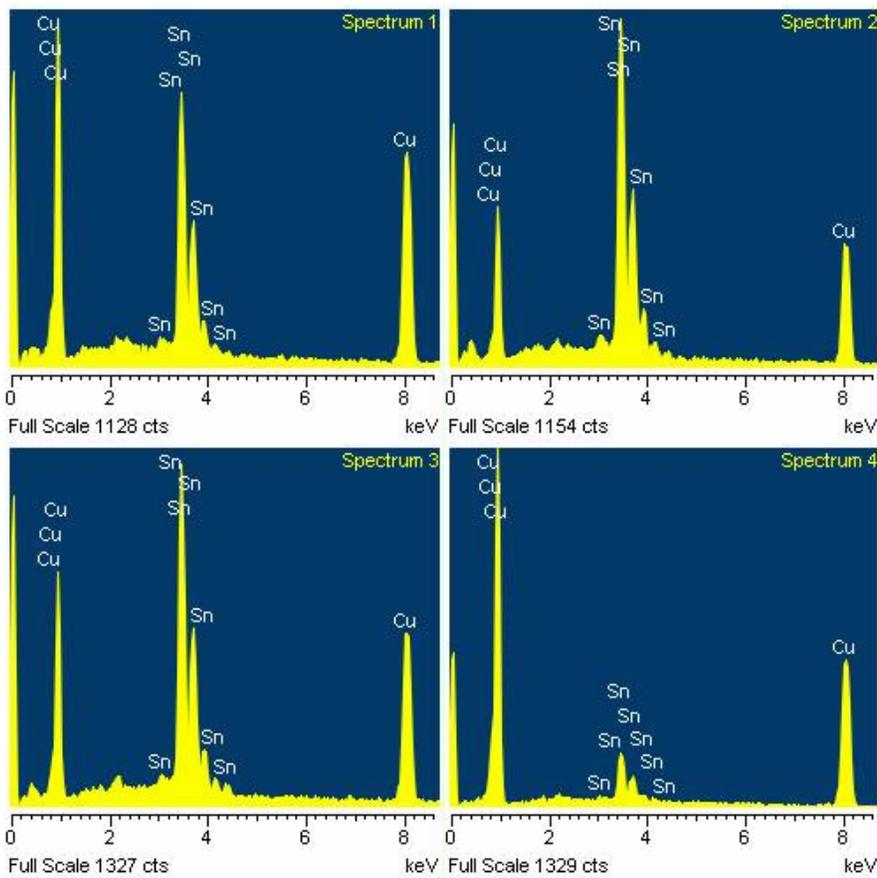
**Figure 78** EDS Spectra of SnAgCuBi Soldered Sn PLCC-20 on Manufactured Test Vehicle (SN 140, U54, Lead 10) Intermetallic layer at both interfaces is CuSn.

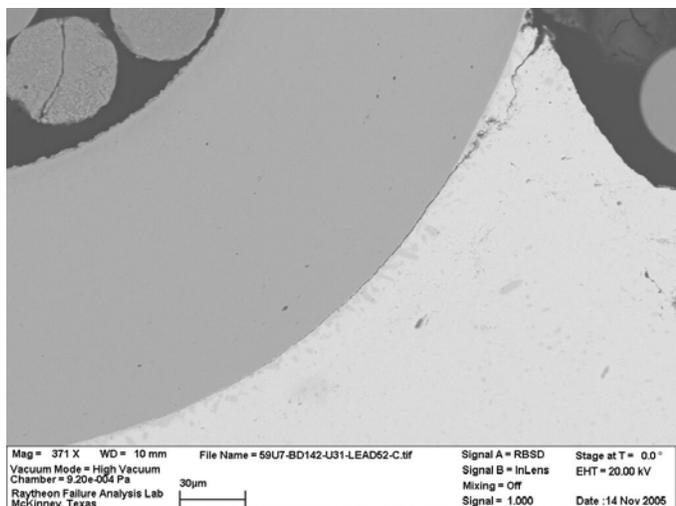
**Figure 83** SEM Micrograph of SnAgCuBi Soldered AuPdNi TQFP-208 on Manufactured Test Vehicle (SN 142, U31, Lead 52)

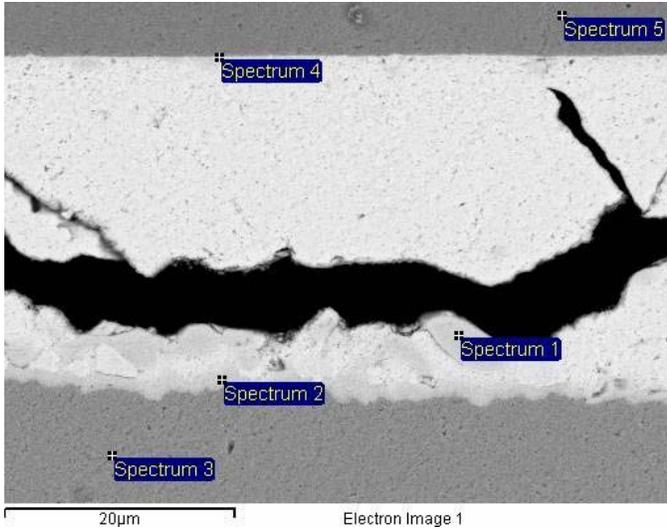
**Figure 86** SEM Micrograph of SnAgCuBi Soldered SnCu TSOP-50 on Manufactured Test Vehicle (SN 142, U25, Lead 25) Lead to solder to board metallurgy.

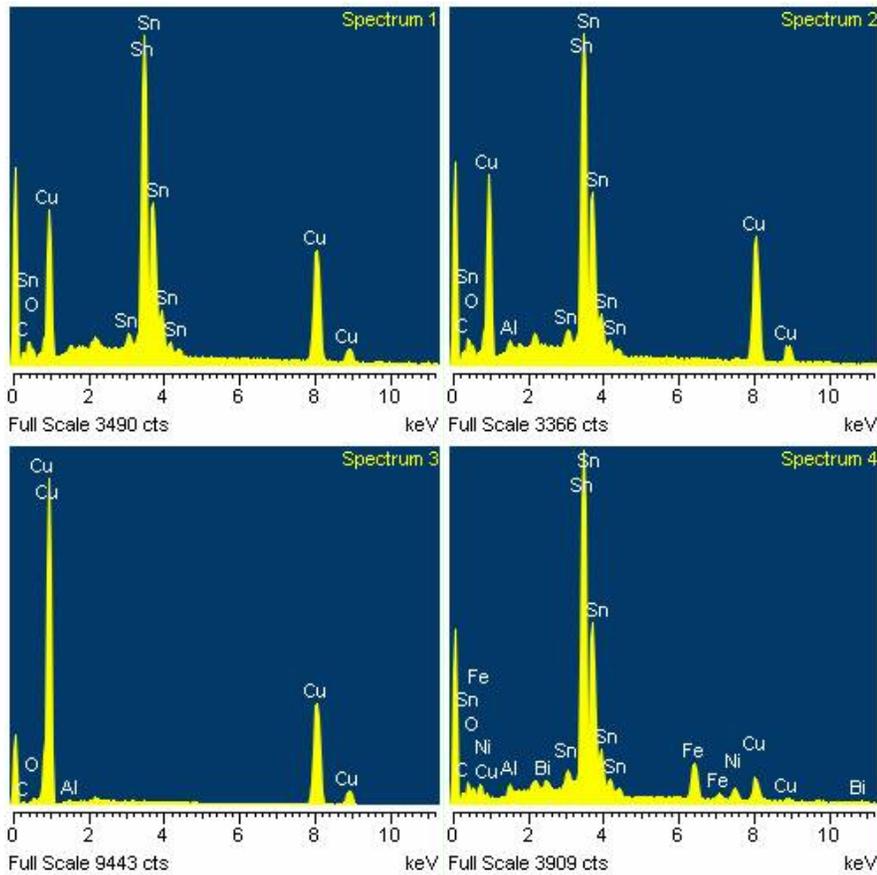
**Figure 87** EDS Spectra of SnAgCuBi Soldered SnCu TSOP-50 on Manufactured Test Vehicle (SN 142, U25, Lead 25) IMC at board CuSn (Spectra 1 and 2), board pad is Cu (Spectrum 3), IMC at component lead is NiSn and CuSn, solder bonds to alloy 42 (Ni-Fe) lead, presence of Cu at this interface is the result of Cu migration from the board or Cu from the SnAgCuBi solder.

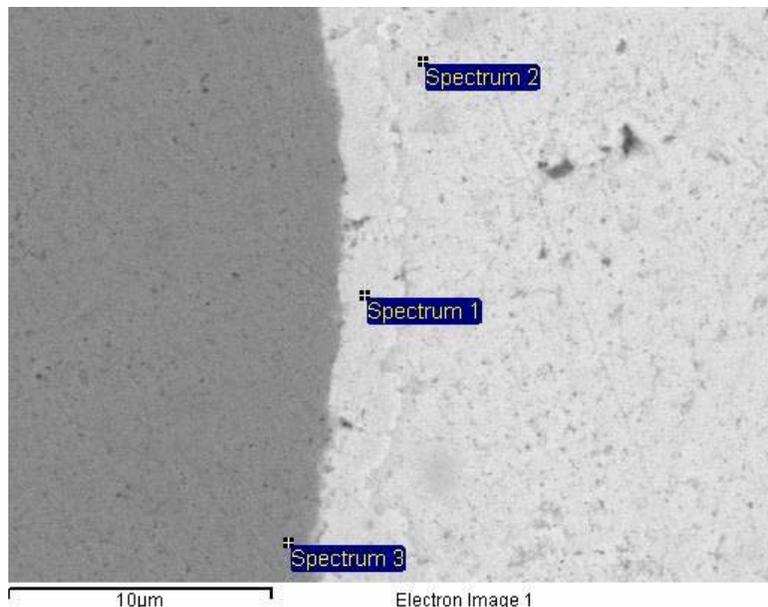
**Figure 91** SEM Micrograph of SnCu Soldered Sn PDIP-20 on Manufactured Test Vehicle (SN 140, U51) Board Interface.

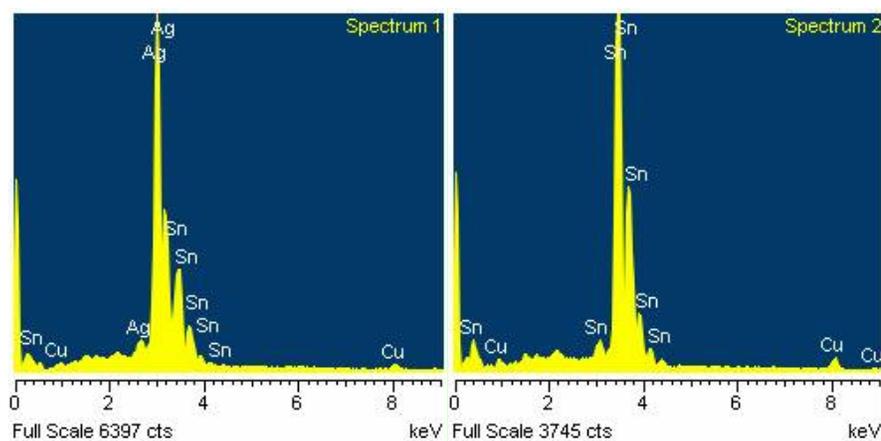
**Figure 92** EDS Spectra of SnCu Soldered Sn PDIP-20 on Manufactured Test Vehicle (SN 140, U51) The IMC layer is AgSnCu (Spectrum 1); the solder is SnAgCuBi (Spectrum 2). The board metal is Cu, spectrum not shown. The Ag is from the immersion Ag finish on the board.

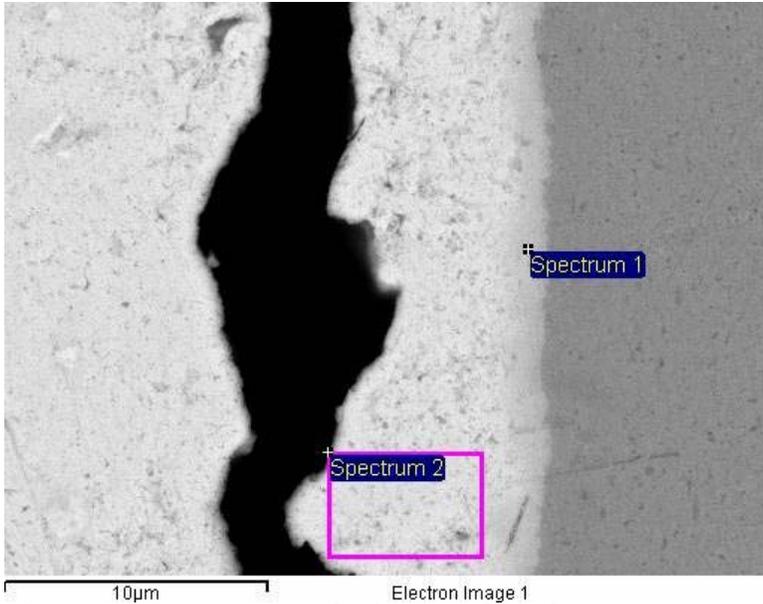
Figure 93 SEM Micrograph of SnCu Soldered Sn PDIP-20 on Manufactured Test Vehicle (SN 140, U51) Lead Interface.

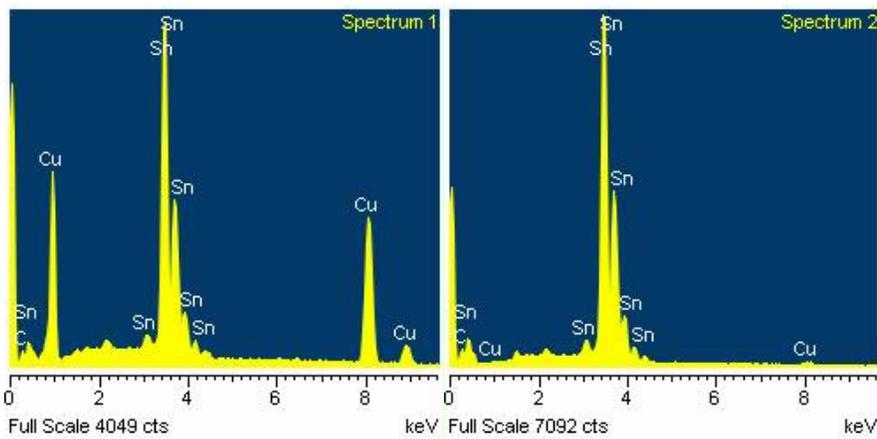
Figure 94 EDS Spectra of SnCu Soldered Sn PDIP-20 on Manufactured Test Vehicle (SN 140, U51) IMC layer at board interface is CuSn.

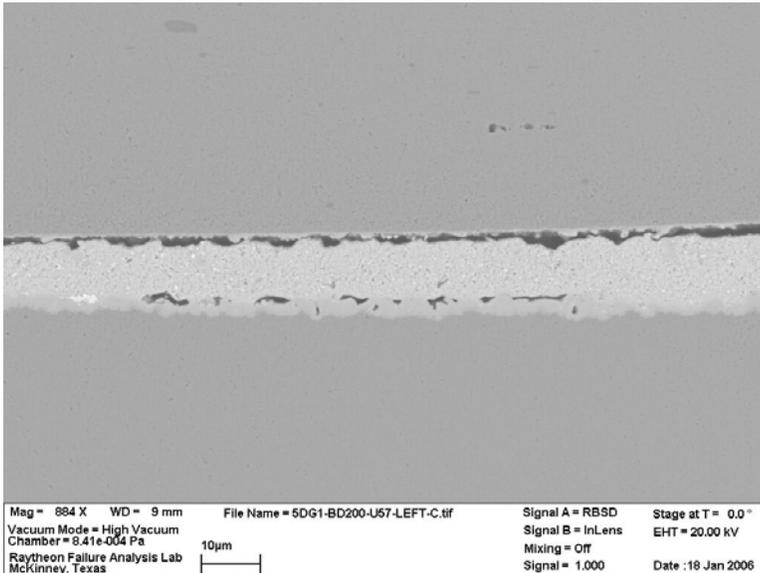
**Figure 96** SEM Micrograph of Reworked AuPdNi TQFP-208 Soldered with Tin-Silver-Copper-Bismuth Solder Alloy on Rework Test Vehicles (SN 200, U57, Lead Left) Some voiding present between the solder and intermetallic layer on the board side.

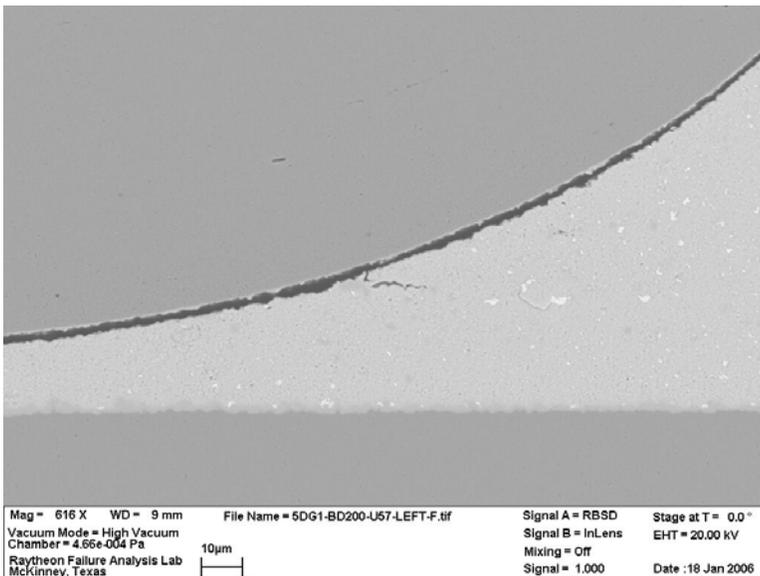
**Figure 97** SEM Micrograph of Reworked AuPdNi TQFP-208 Soldered with Tin-Silver-Copper-Bismuth Solder Alloy on Rework Test Vehicles (SN 200, U57, Lead Left) Microcracks in solder below lead.

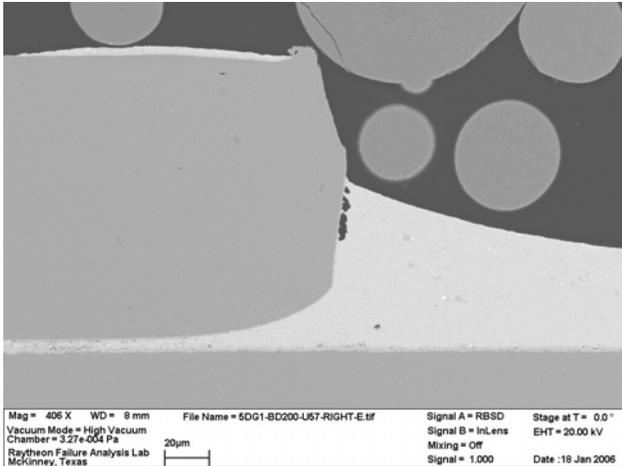
**Figure 100** SEM Micrograph of Reworked AuPdNi TQFP-208 Soldered with Tin-Silver-Copper-Bismuth Solder Alloy on Rework Test Vehicles (SN 200, U57, Lead Right) Some voiding is present at interface at the lead toe.

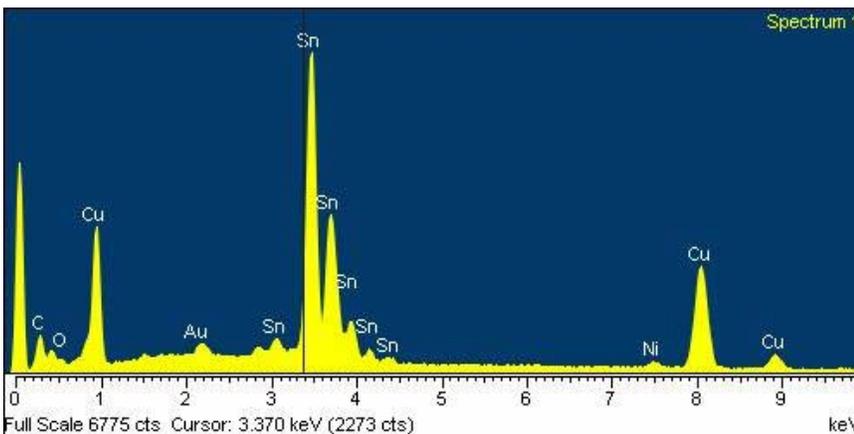
**Figure 102** EDS Spectra of Reworked AuPdNi TQFP-208 Soldered with Tin-Silver-Copper-Bismuth Solder Alloy on Rework Test Vehicles (SN 200, U57, left side lead, board interface) The intermetallic layer is CuSn however, low levels of Ni and Au are also present.
