**Network Centric Systems  
Raytheon Company  
McKinney, TX 75071**

**EER-2006-34171-002  
Engineering Evaluation Report**

# **JCAA/JG-PP LEAD-FREE SOLDER PROJECT: FAILURE ANALYSIS OF TEST VEHICLES SUBJECTED TO COMBINED ENVIRONMENTS TEST**

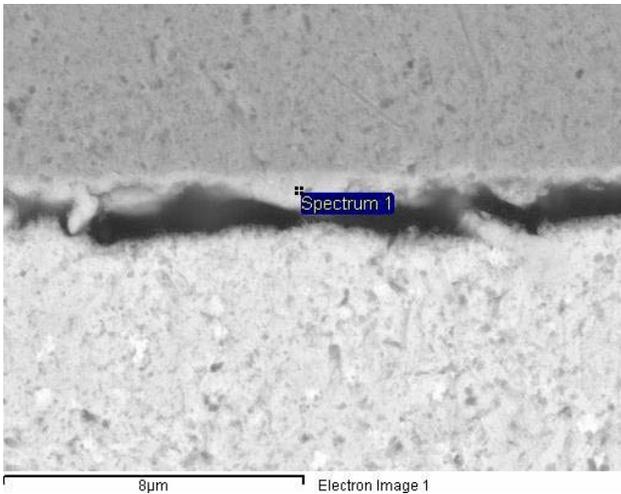
**Figure 103** SEM Micrograph of Reworked AuPdNi TQFP-208 Soldered with Tin-Silver-Copper-Bismuth Solder Alloy on Rework Test Vehicles (SN 200, U57, left side lead, component interface) The fracture is at the lead IMC to solder interface.

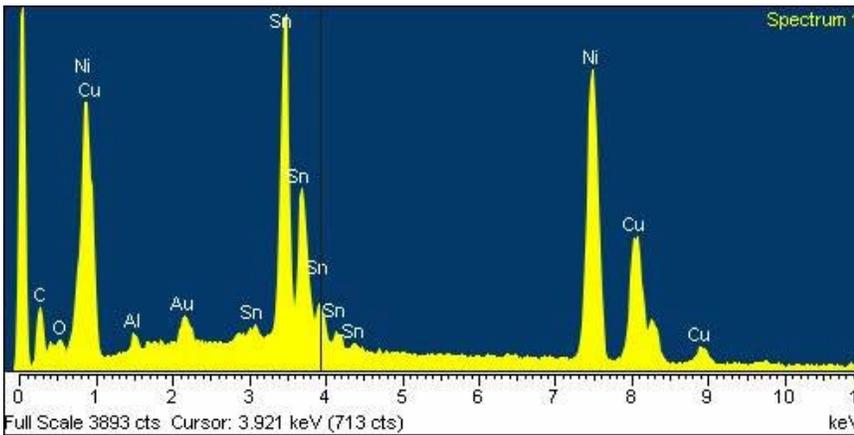
**Figure 104** EDS Spectra of Reworked AuPdNi TQFP-208 Soldered with Tin-Silver-Copper-Bismuth Solder Alloy on Rework Test Vehicles (SN 200, U57, left side lead, component interface) IMC is NiSnCu.

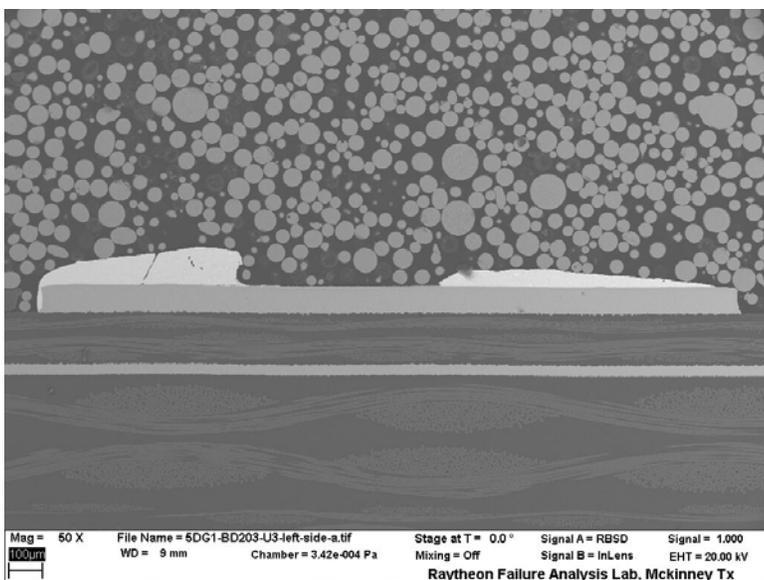
**Figure 107** SEM Micrograph of Reworked AuPdNi TQFP-208 Soldered with Tin-Silver-Copper-Bismuth Solder Alloy on Rework Test Vehicles (SN 203, U3, Lead Left) Component missing, the separation appears to have occurred at the component lead to solder interface likely due to poor wetting of the solder to the lead.

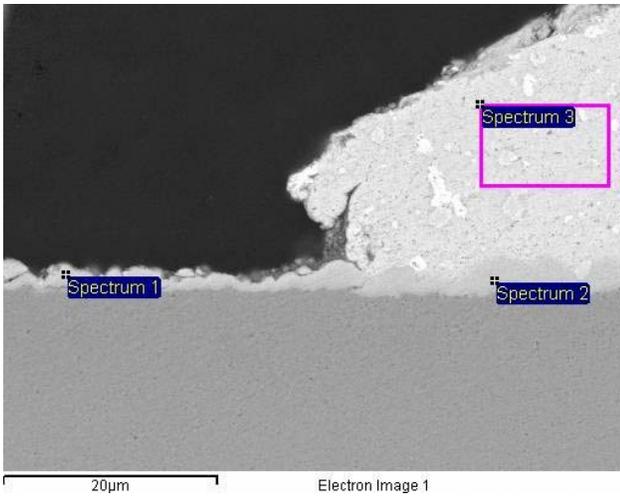
**Figure 108** SEM Micrograph of Reworked AuPdNi TQFP-208 Soldered with Tin-Silver-Copper-Bismuth Solder Alloy on Rework Test Vehicles (SN 203, U3, board interface)

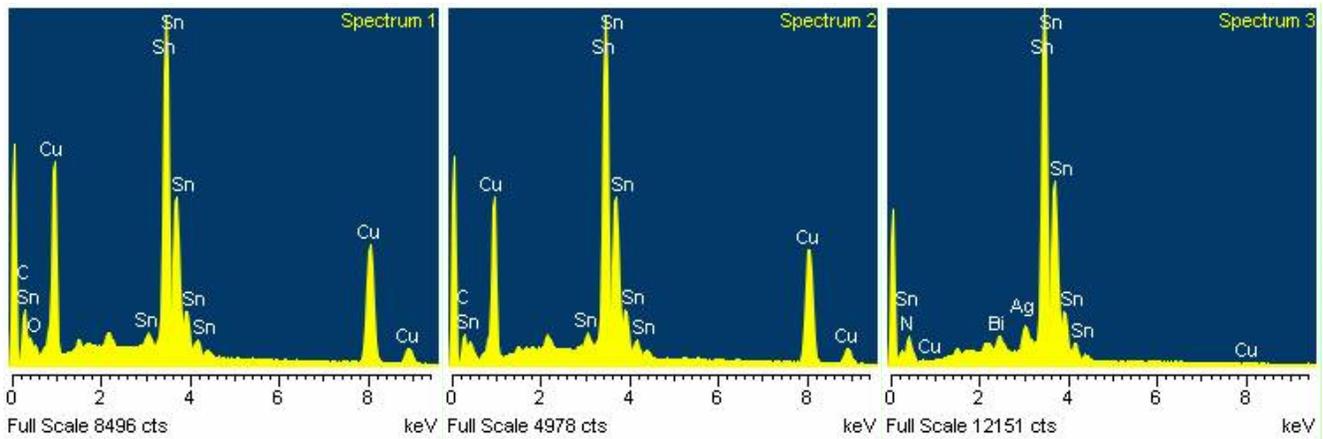
**Figure 109** EDS Spectra of Reworked AuPdNi TQFP-208 Soldered with Tin-Silver-Copper-Bismuth Solder Alloy on Rework Test Vehicles (SN 203, U3, board interface) IMC is CuSn.

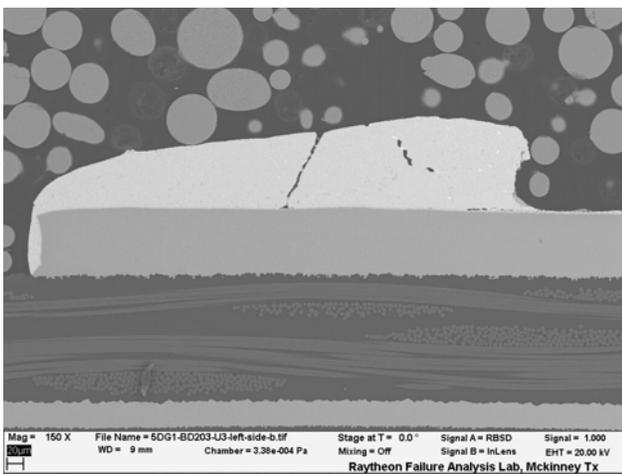
**Figure 110** SEM Micrograph of Reworked AuPdNi TQFP-208 Soldered with Tin-Silver-Copper-Bismuth Solder Alloy on Rework Test Vehicles (SN 203, U3, Lead Left) Microcracks present in the solder.

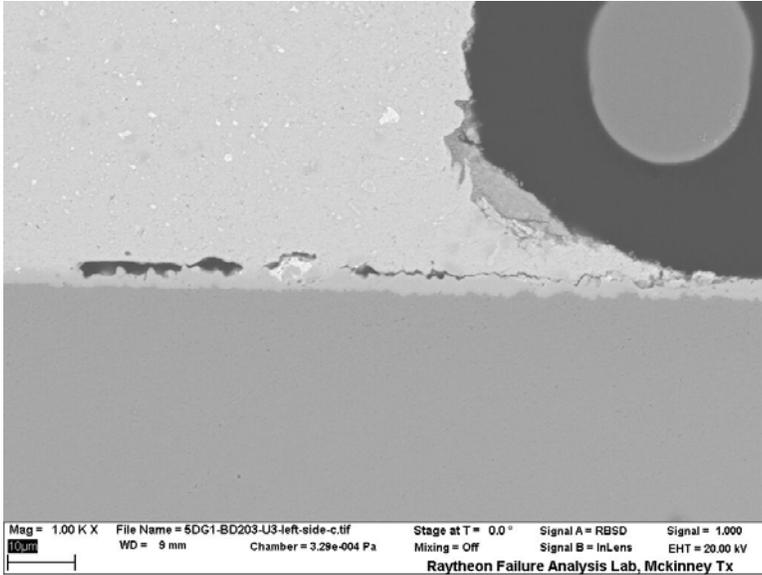
**Figure 111** SEM Micrograph of Reworked AuPdNi TQFP-208 Soldered with Tin-Silver-Copper-Bismuth Solder Alloy on Rework Test Vehicles (SN 203, U3, Lead Left) Separation at solder to IMC interface result of poor wetting of the solder.

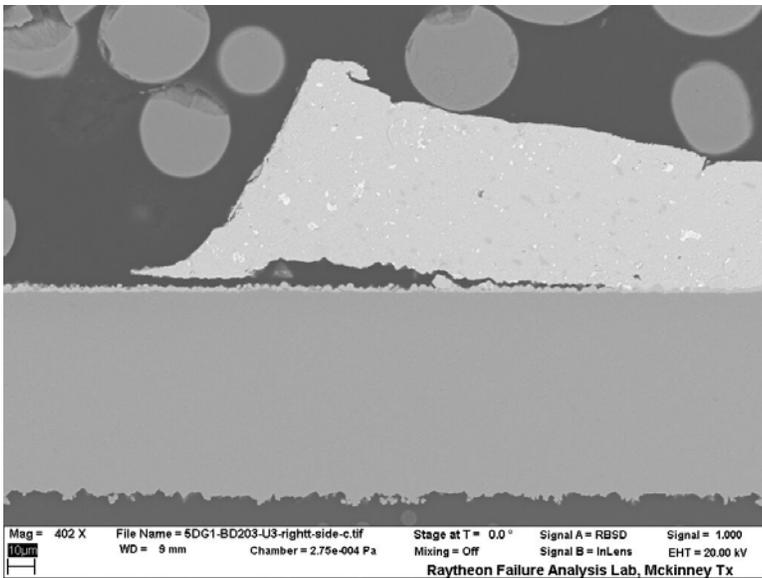
**Figure 112** SEM Micrograph of Reworked AuPdNi TQFP-208 Soldered with Tin-Silver-Copper-Bismuth Solder Alloy on Rework Test Vehicles (SN 203, U3, Lead Right) Component missing. Separation is the result of poor wetting of the solder.

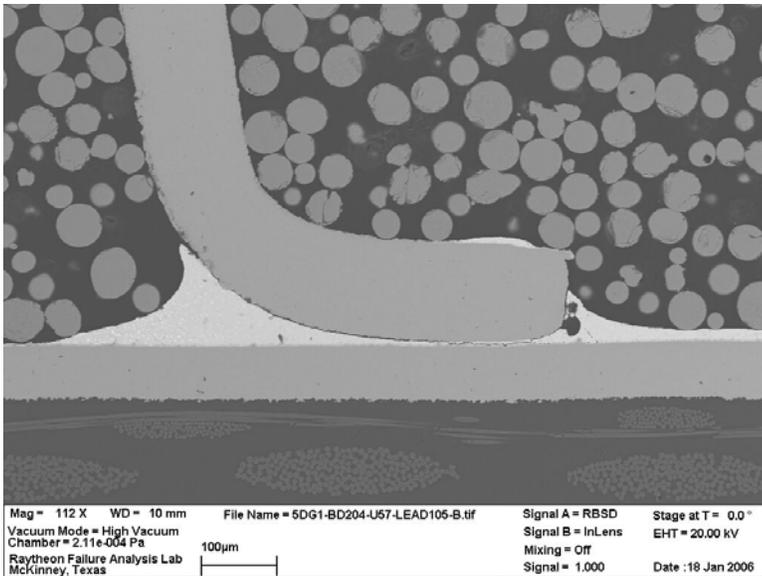
**Figure 113** SEM Micrograph of Reworked AuPdNi TQFP-208 Soldered with Tin-Silver-Copper-Bismuth Solder Alloy on Rework Test Vehicles (SN 204, U57, Lead 105) Crack extends completely through joint at lead to solder interface. Some voiding present near toe of lead.

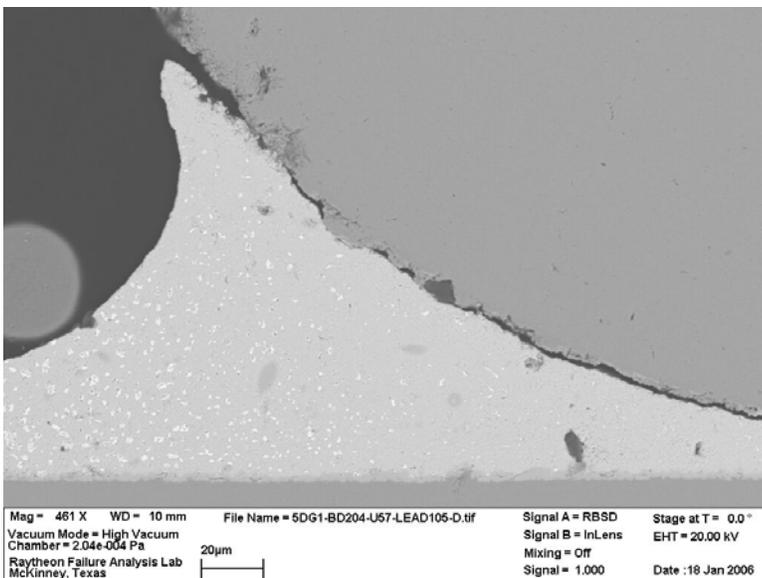
**Figure 114** SEM Micrograph of Reworked AuPdNi TQFP-208 Soldered with Tin-Silver-Copper-Bismuth Solder Alloy on Rework Test Vehicles (SN 204, U57, Lead 105) There is not an even dispersion of lead-bismuth (PbBi) phases. These phases have a heavier concentration in the solder fillet as opposed to below the lead.

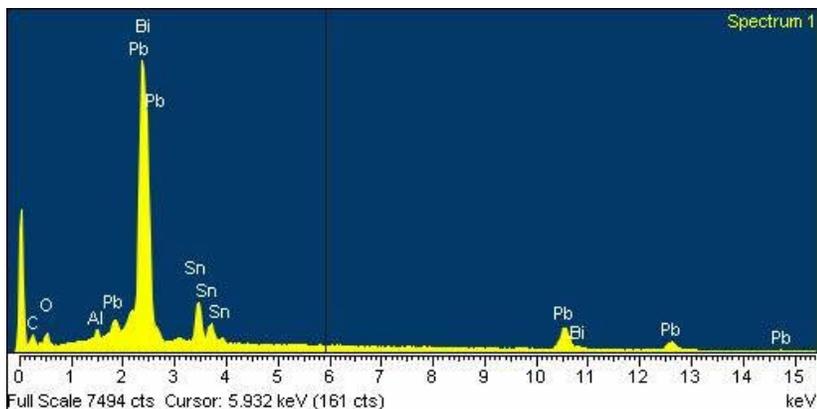
**Figure 115** SEM Micrograph of Reworked AuPdNi TQFP-208 Soldered with Tin-Silver-Copper-Bismuth Solder Alloy on Rework Test Vehicles (SN 204, U57, Lead 105) The bright phases are a PbBi alloy.

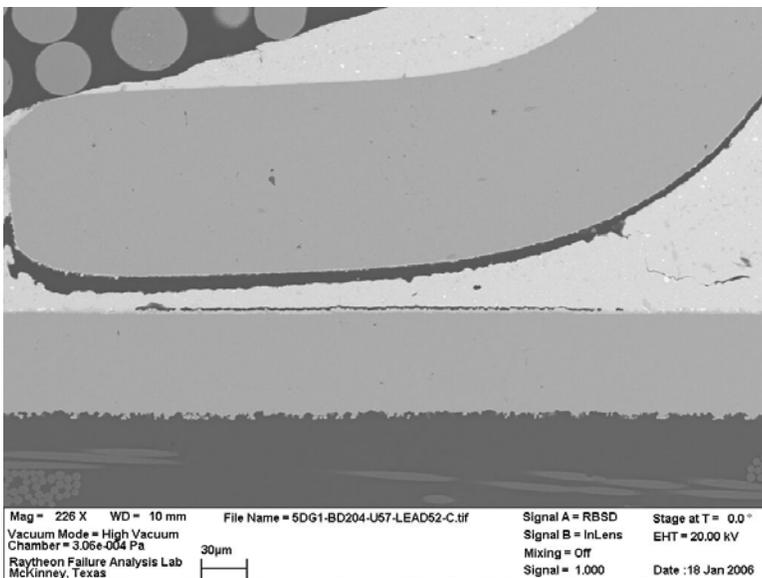
**Figure 117** SEM Micrograph of Reworked AuPdNi TQFP-208 Soldered with Tin-Silver-Copper-Bismuth Solder Alloy on Rework Test Vehicles (SN 204, U57, Lead 105) Crack extends completely through joint at lead to solder interface.

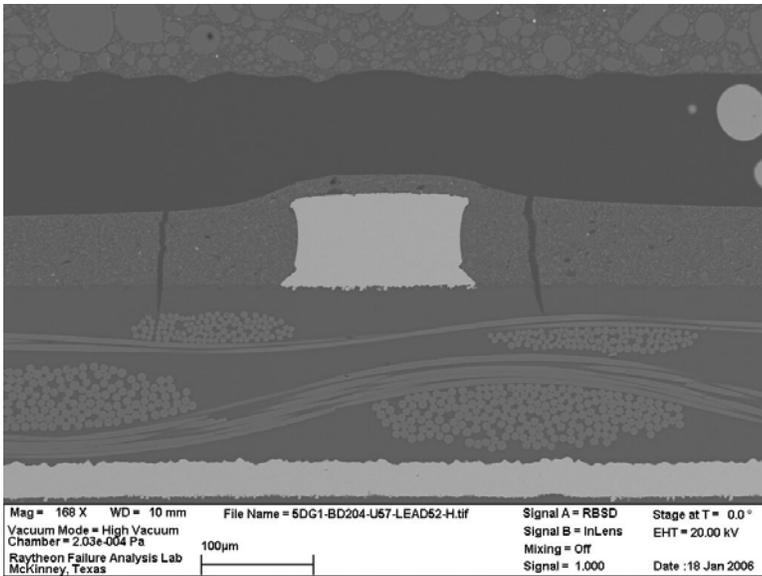
**Figure 118** SEM Micrograph of Reworked AuPdNi TQFP-208 Soldered with Tin-Silver-Copper-Bismuth Solder Alloy on Rework Test Vehicles (SN 204, U57, Lead 105) Separation at solder to board interface. This could be the result of poor wetting of the solder.

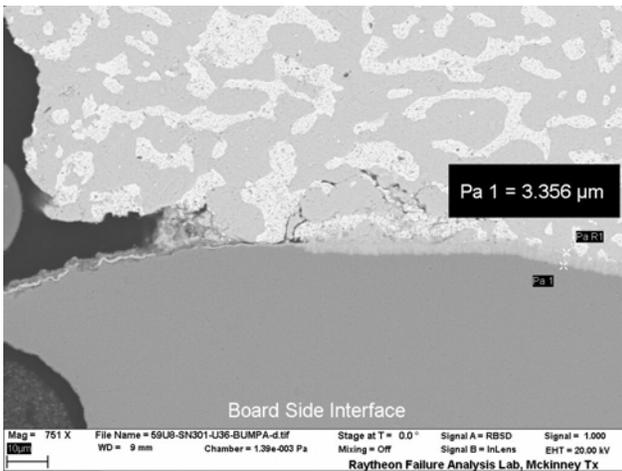
**Figure 120** SEM Micrograph of SnPb Soldered SnPb CSP-100 Components on Hybrid Test Vehicles (SN 301, U36, Bump A) The notch at the lower left corner of the bump is the result of the solder mask. Minor cracks in solder near component interface and board interface. Other bumps similar in appearance.

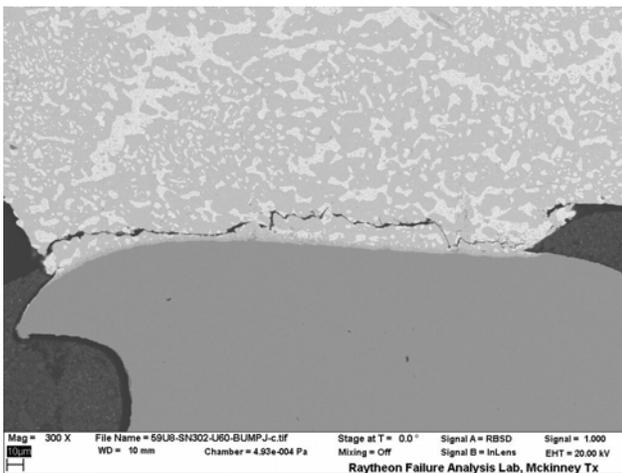
302	U60	SnPb	J	746 nm 6.69	3.52	*NiSnCu	CuAuSn	Crack through solder on board side. Minor cracking in solder on component side.

**Figure 124** SEM Micrograph of SnPb Soldered SnPb CSP-100 Components on Hybrid Test Vehicles (SN 302, U60, Bump J) Fracture extends completely through solder joint on board side. Minor cracks at corner of bump on component side.

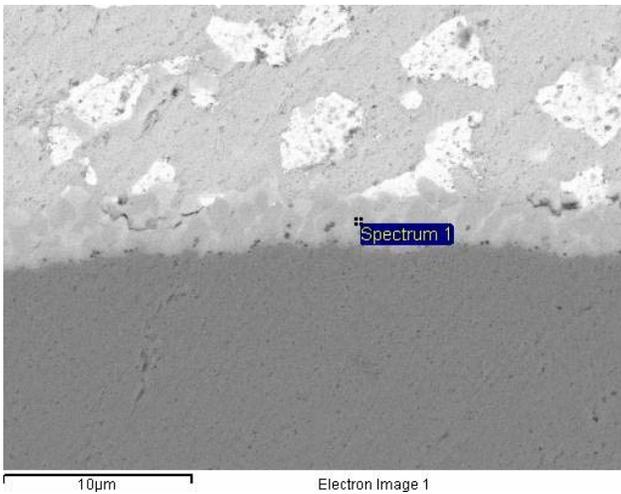
**Figure 126** SEM Micrograph of SnPb Soldered SnPb CSP-100 Components on Hybrid Test Vehicles (SN 301, U36, Bump A) Board side solder to pad interface showing the IMC layer.

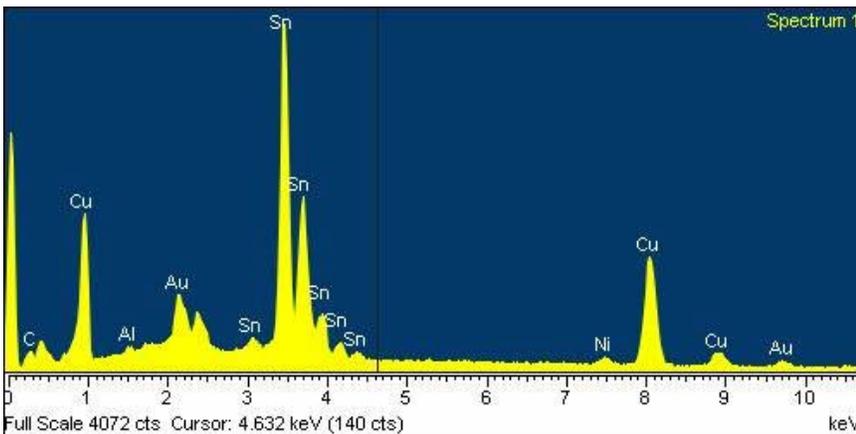
**Figure 127** SEM Micrograph of SnPb Soldered SnPb CSP-100 Components on Hybrid Test Vehicles (SN 301, U37, Bump E) The IMC layer at the board interface is CuAuSn.

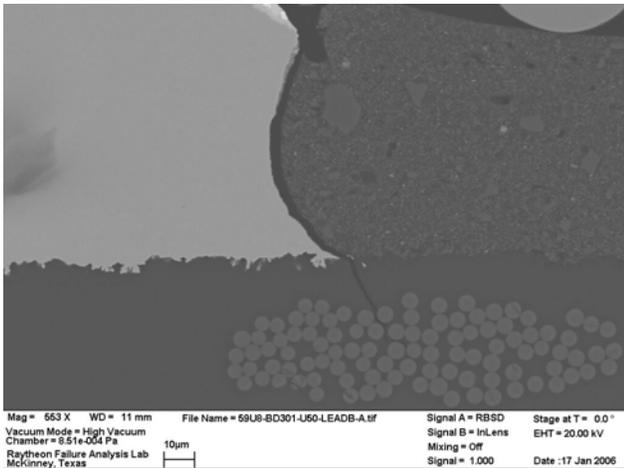
**Figure 130** SEM Micrograph of SnPb Soldered SnPb Hybrid-30 Components on Hybrid Test Vehicles (SN 301, U50, Lead A) Crack in PWB.

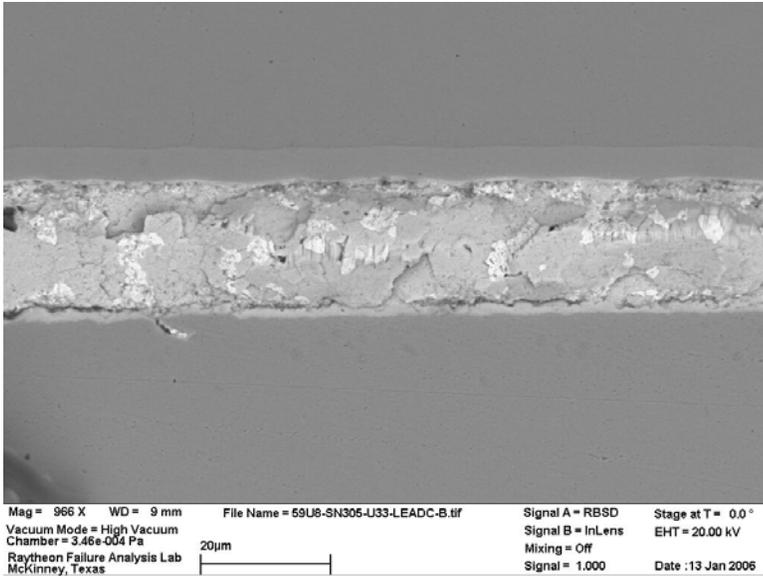
**Figure 132** SEM Micrograph of SnPb Soldered SnPb Hybrid-30 Components on Hybrid Test Vehicles (SN 306, U50, Lead E) Solder joint taller than some of the surrounding joints.

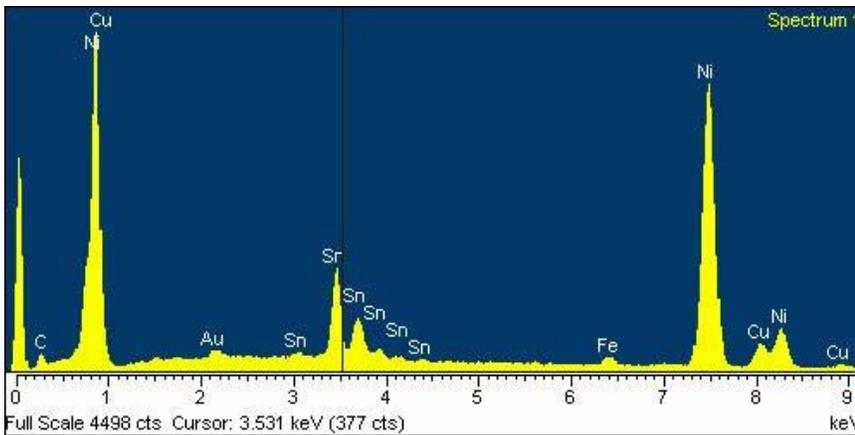
**Figure 139** SEM Micrograph of SnAgCu Soldered SnAgCu Hybrid-30 Components on Hybrid Test Vehicles (SN 326, U33, LEAD A) Component side interface, the IMC layer is NiSn however low levels of Cu are also present.

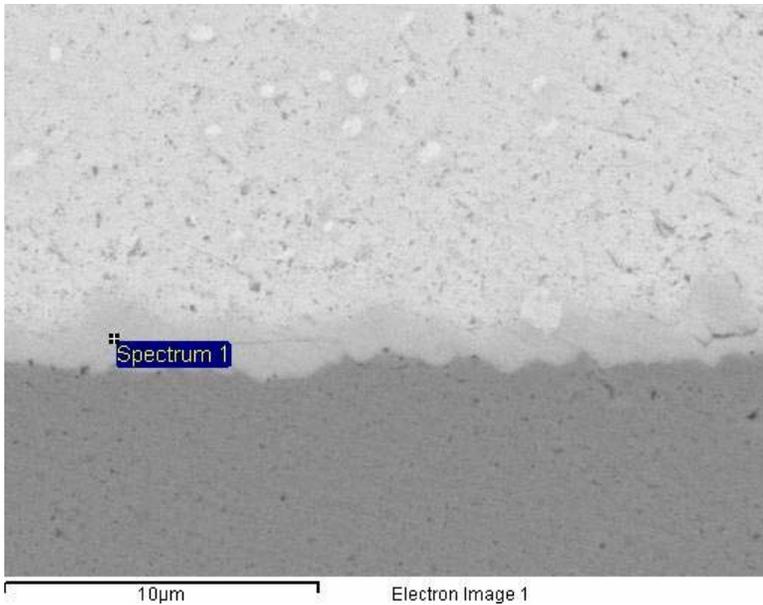
**Figure 140** EDS Spectra of SnAgCu Soldered SnAgCu Hybrid-30 Components on Hybrid Test Vehicles (SN 326, U33, LEAD A) The IMC layer is NiSn however low levels of Cu are also present.

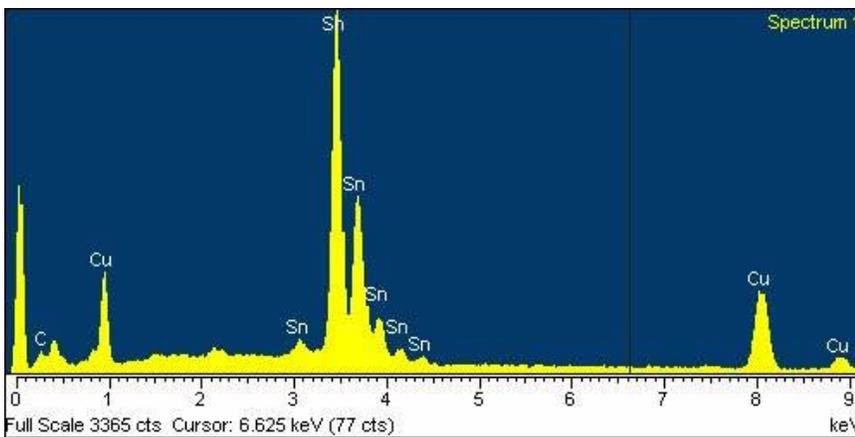
**Figure 141** SEM Micrograph of SnAgCu Soldered SnAgCu Hybrid-30 Components on Hybrid Test Vehicles (SN 326, U32, LEAD A) Board side interface, IMC layer is CuSn.

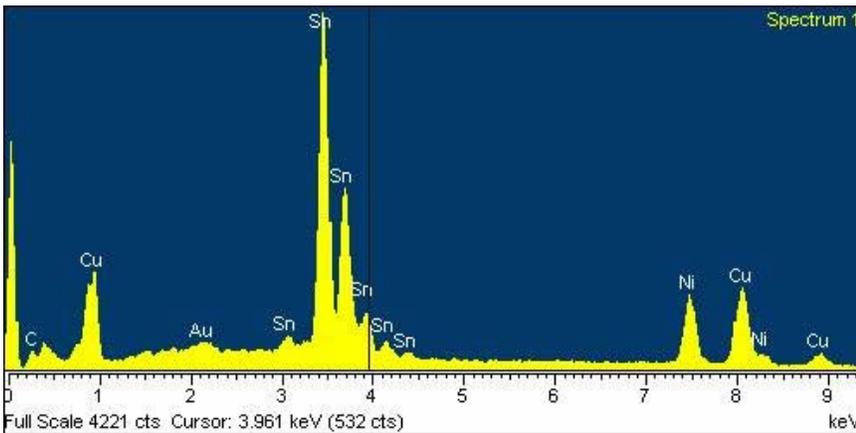
**Figure 144** SEM Micrograph of SnAgCuBi Soldered SnAgCu CSP-100 Components on Hybrid Test Vehicles (SN 333, U37, BUMP A) Component side interface

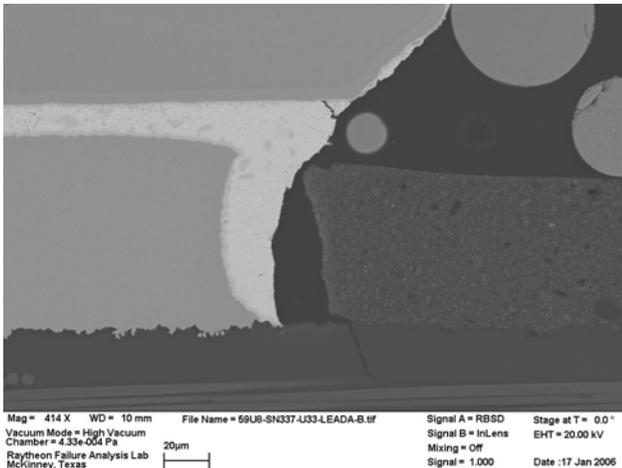
**Figure 151** SEM Micrograph of SnAgCuBi Soldered SnAgCuBi Hybrid-30 Components on Hybrid Test Vehicles (SN 337, U33, Lead A) Minor cracking in the corner of the solder near component.

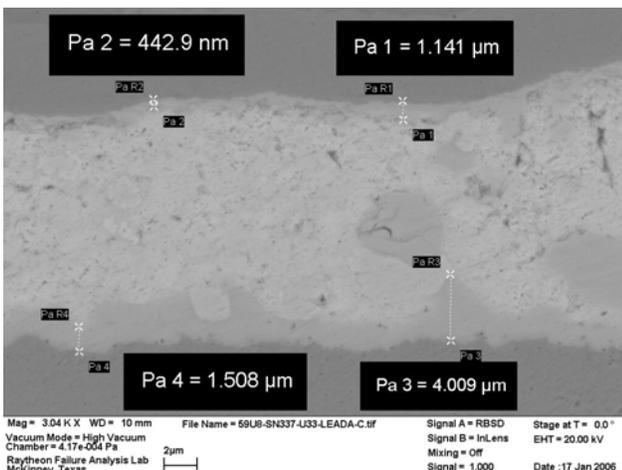
**Figure 152** SEM Micrograph of SnAgCuBi Soldered SnAgCuBi Hybrid-30 Components on Hybrid Test Vehicles (SN 337, U 33, Lead A) Minor cracking on solder and PWB.
