Debris/Ice/TPS Assessment and Integrated Photographic Analysis of Shuttle Mission STS-87

Technical Memorandum-1998 - 206642

February 1998

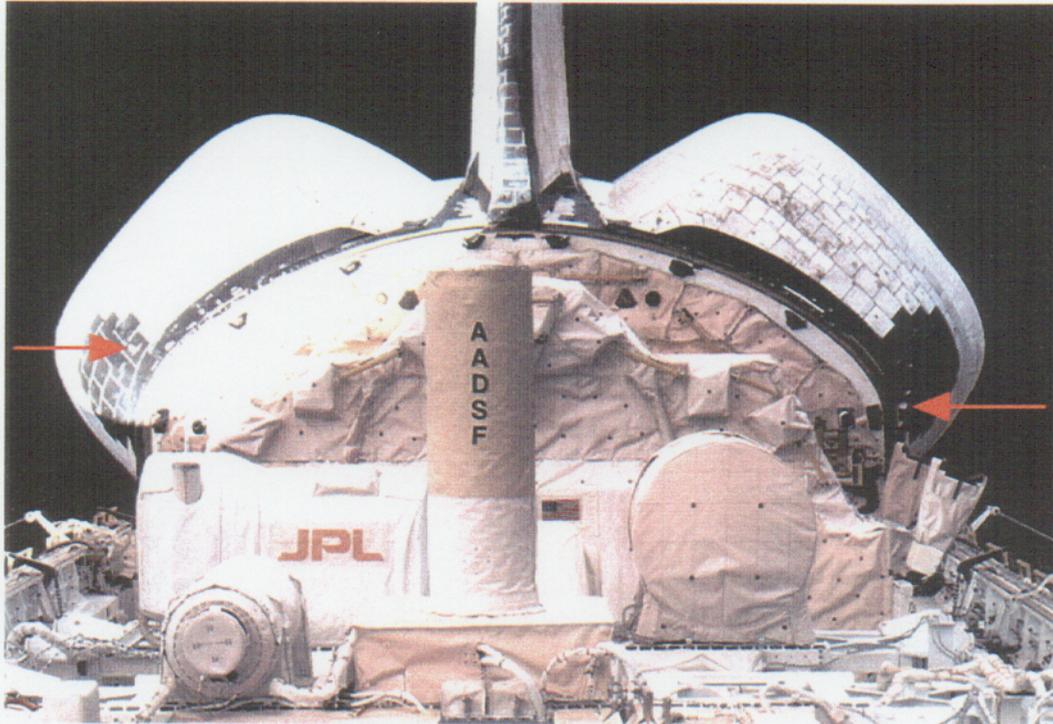
Figure 2.6.2 On-Orbit View of OMS Pod Damage

The OMS pod damage seen post-landing is clearly visible on STS-87 Hasselblad Roll 752, frame 19. This photograph was taken two days prior to landing (December 3, 1997) and confirms that the OMS pod damage did not occur during late on-orbit flight, re-entry, or landing. The on-orbit video taken after launch did not provide an adequate view of the OMS pod for tile damage assessment.

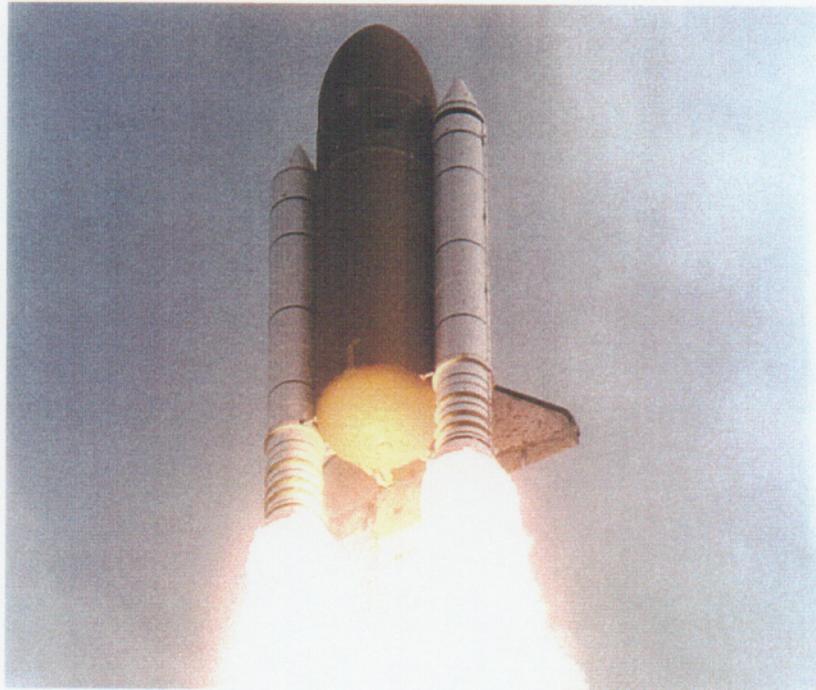
Figure 2.6.3.1 View of ET Intertank after Liftoff

Excellent quality views of the left and right ET intertank thrust panel regions were acquired on the perimeter cameras E54 and E57 at approximately 12 seconds MET. The left and right ET intertank thruster panels were confirmed to be undamaged at approximately 12 seconds MET from these views.

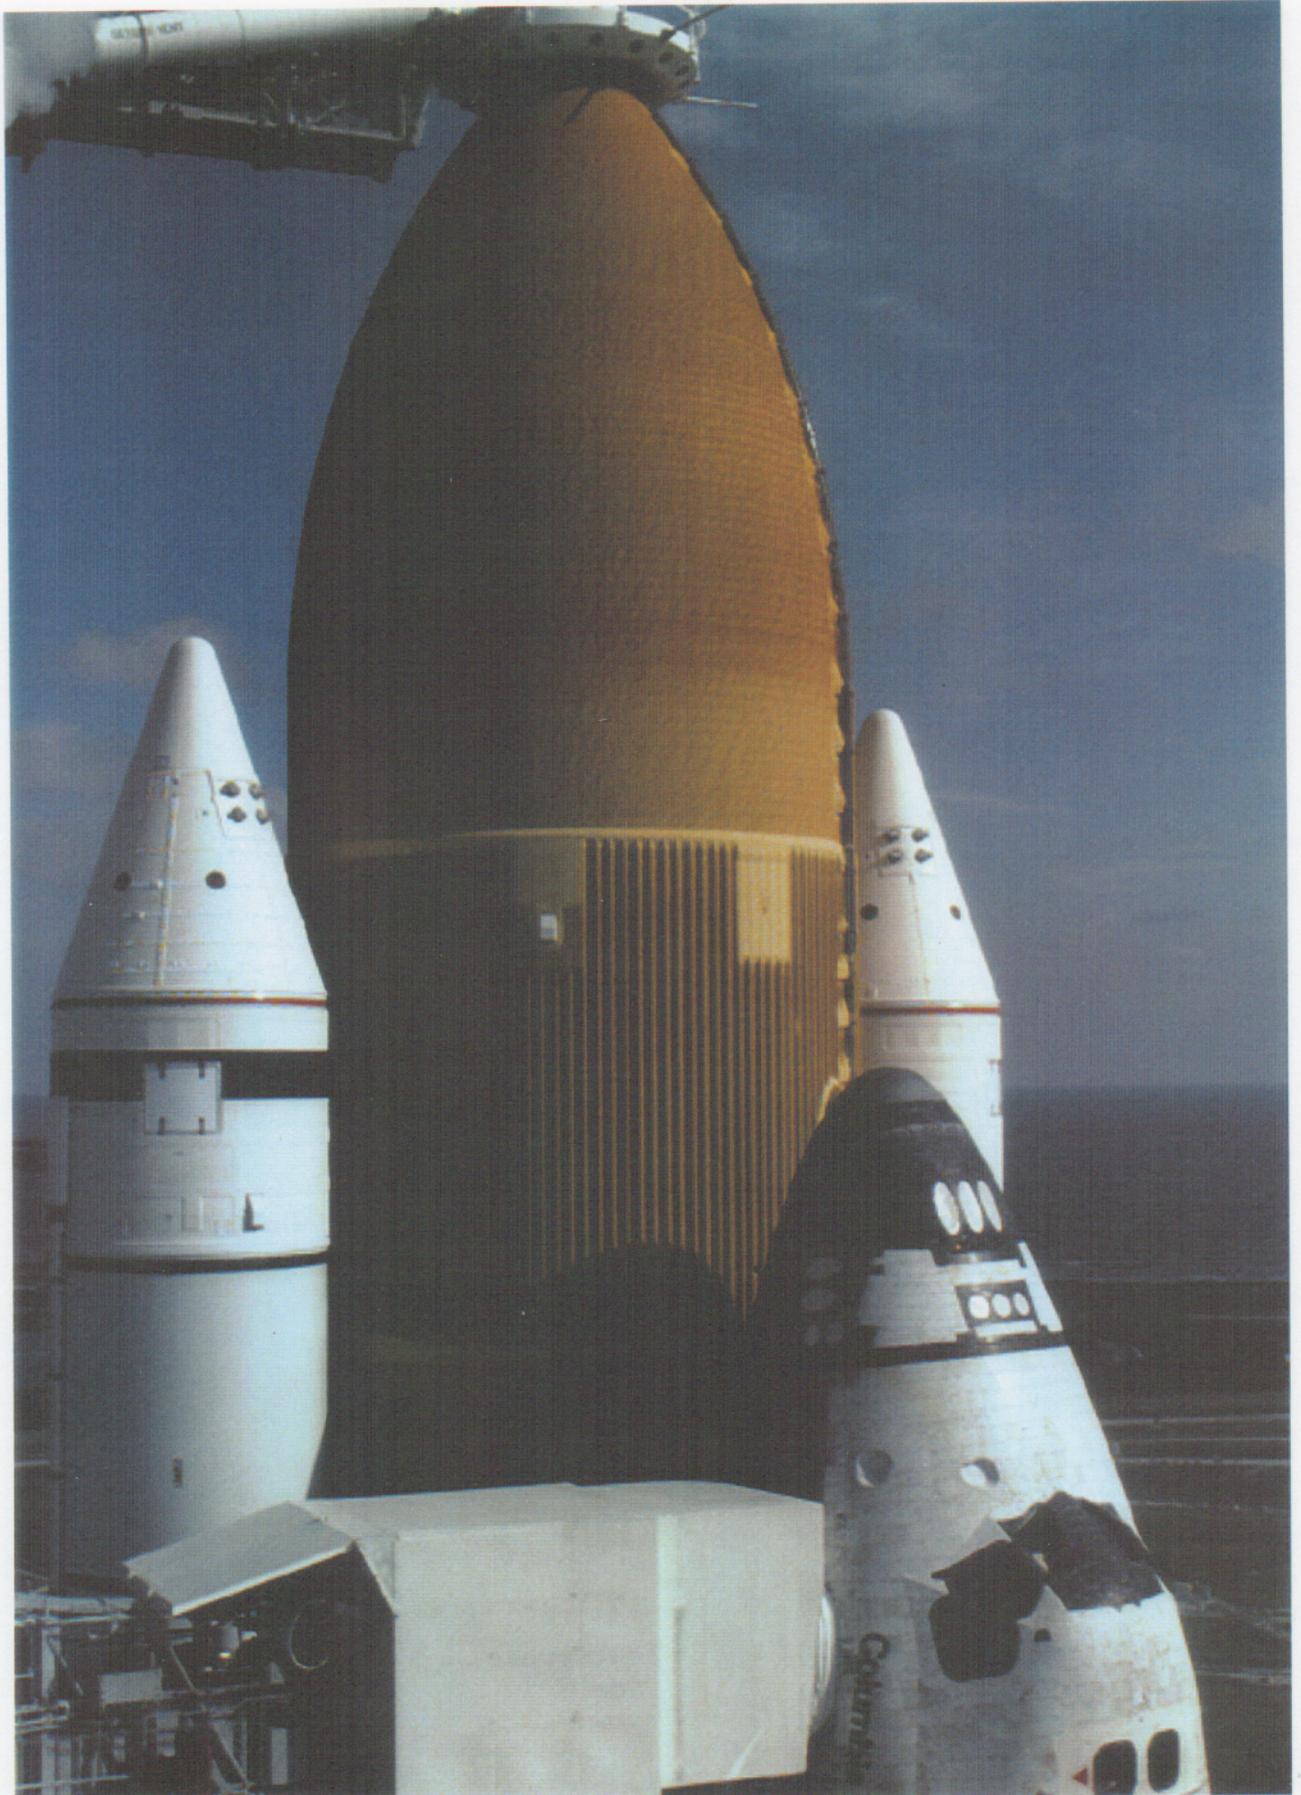
Photo 3: LO2 Tank After Cryoload

The Final Inspection Team observed light condensate, but no ice or frost accumulations, on the LO2 tank acreage. TPS surface temperatures ranged from 53 to 57 degrees F. No damage to either -Y or +Y ET intertank thrust panel TPS was observed prior to launch.

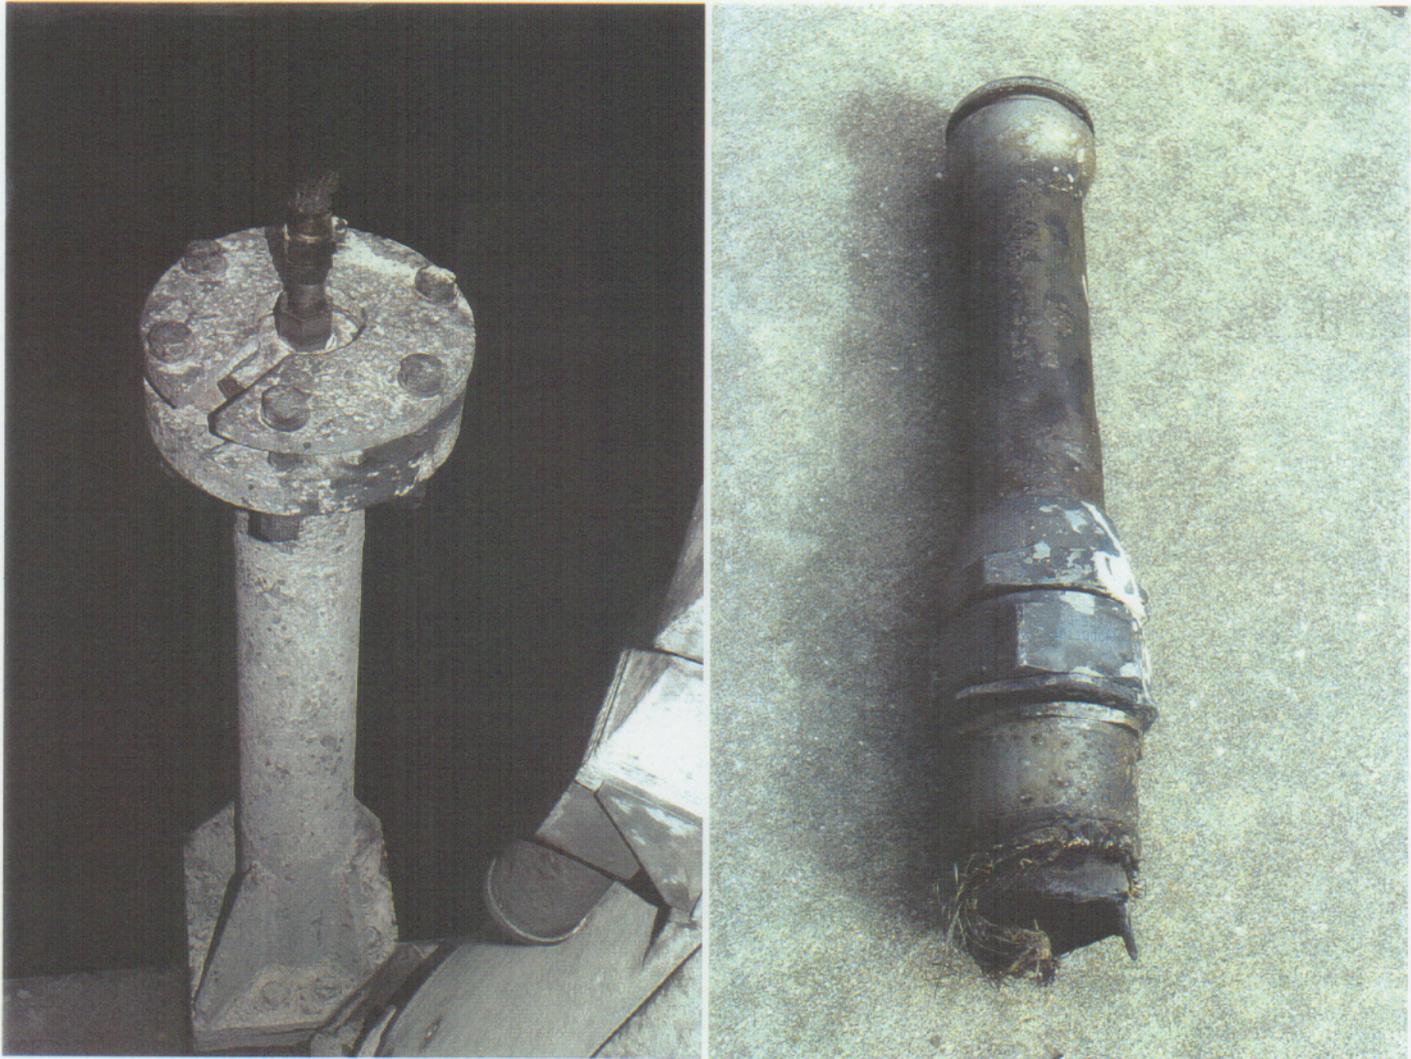
Photo 5: SRB Aft Skirt GN2 Purge Lines

Both left and right SRB aft skirt GN2 purge lines were missing approximately 12 inches of tube and flex-line. Typically, the purge lines are bent or deformed by SRB exhaust plume impingement. This was the first occurrence of missing hardware and was considered to be an “out-of-family” condition. The remaining, or lower, part of the line was still attached to the MLP GN2 standpipe supporting structure adjacent to holddown posts #2 and #6 (left photo). The right flex-line was recovered in an area just north of the SRB flame trench. This flex-line measured 10.5-inches long by 2.25-inches maximum width (right photo). The left flex-line was subsequently discovered on or near a holddown post haunch during MLP refurbishment operations.

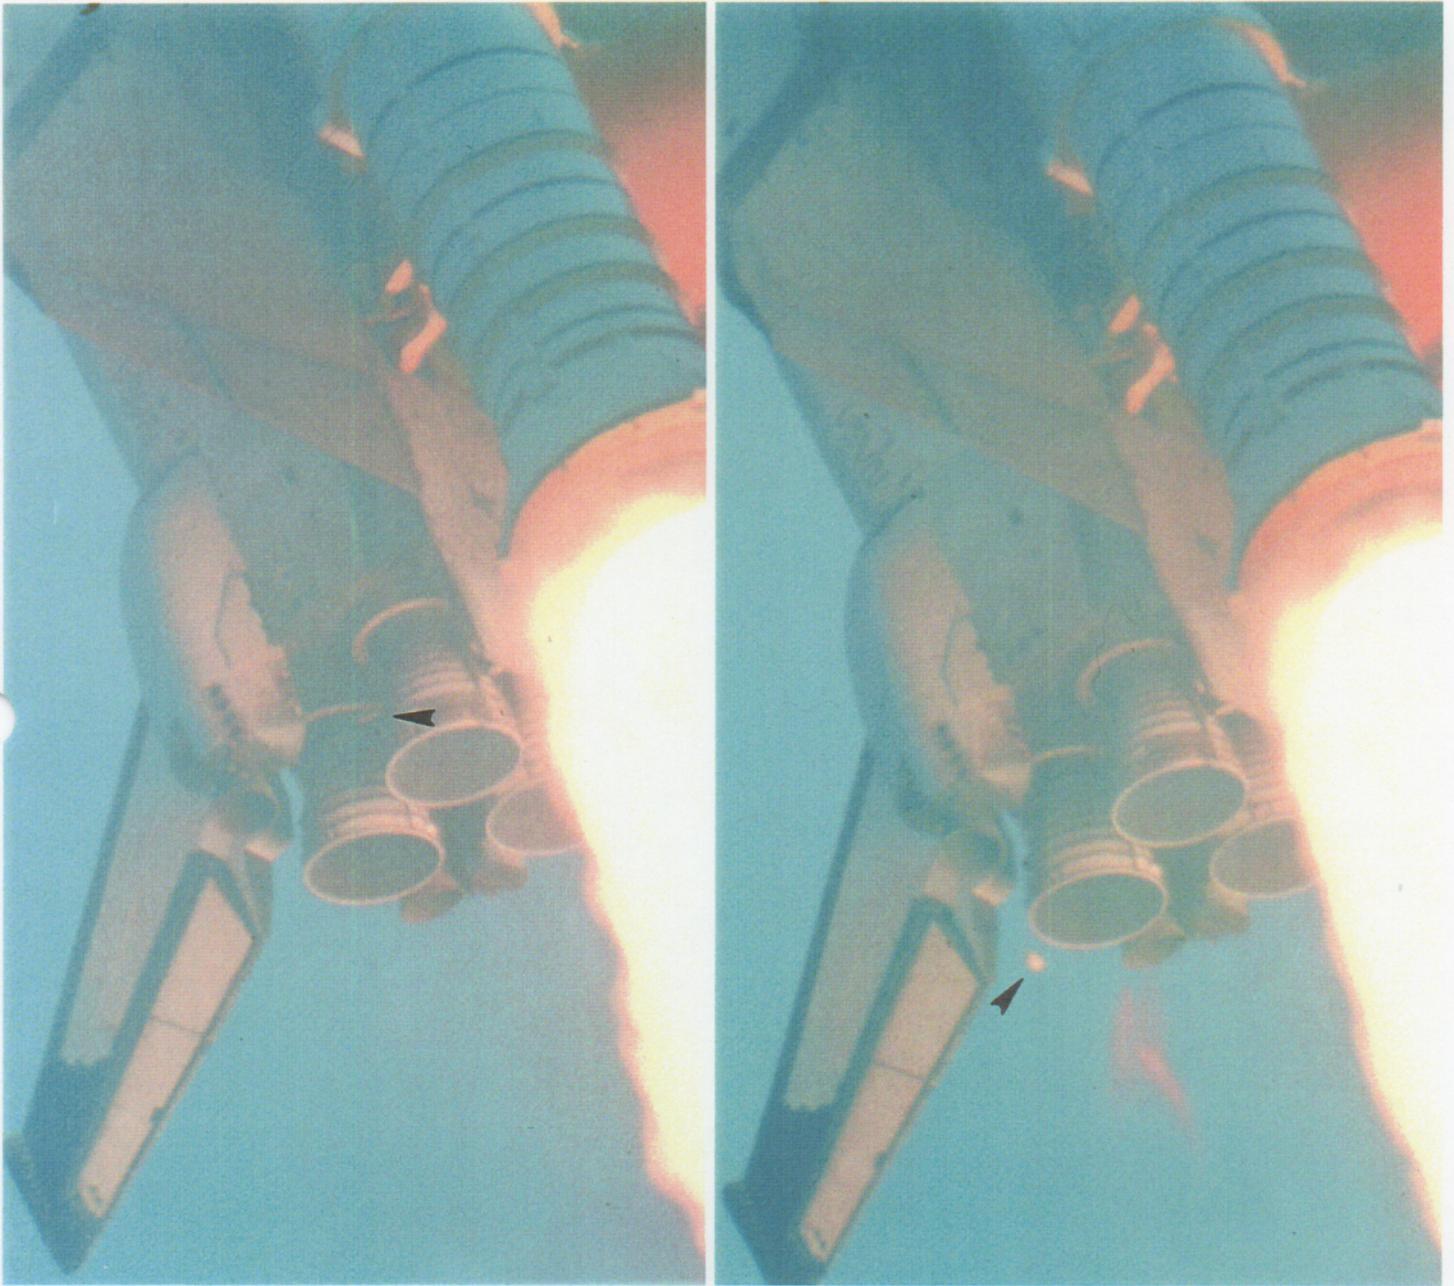
Photo 6: SSME Heat Shield Blanket

Film item E-207 and video item ET-207 provided the best views of a Dome Mounted Heat Shield (DMHS) closeout blanket at the 5:00 o'clock position of SSME #1 starting to tear and unstitch at T + 20.5 seconds MET (left photo). Air flow and plume recirculation eventually caused the blanket to come loose at T + 38.5 seconds MET. The blanket appeared to be lifted in the +Z direction and passed between the SSME #1 nozzle and the drag chute door before falling aft (right photo).

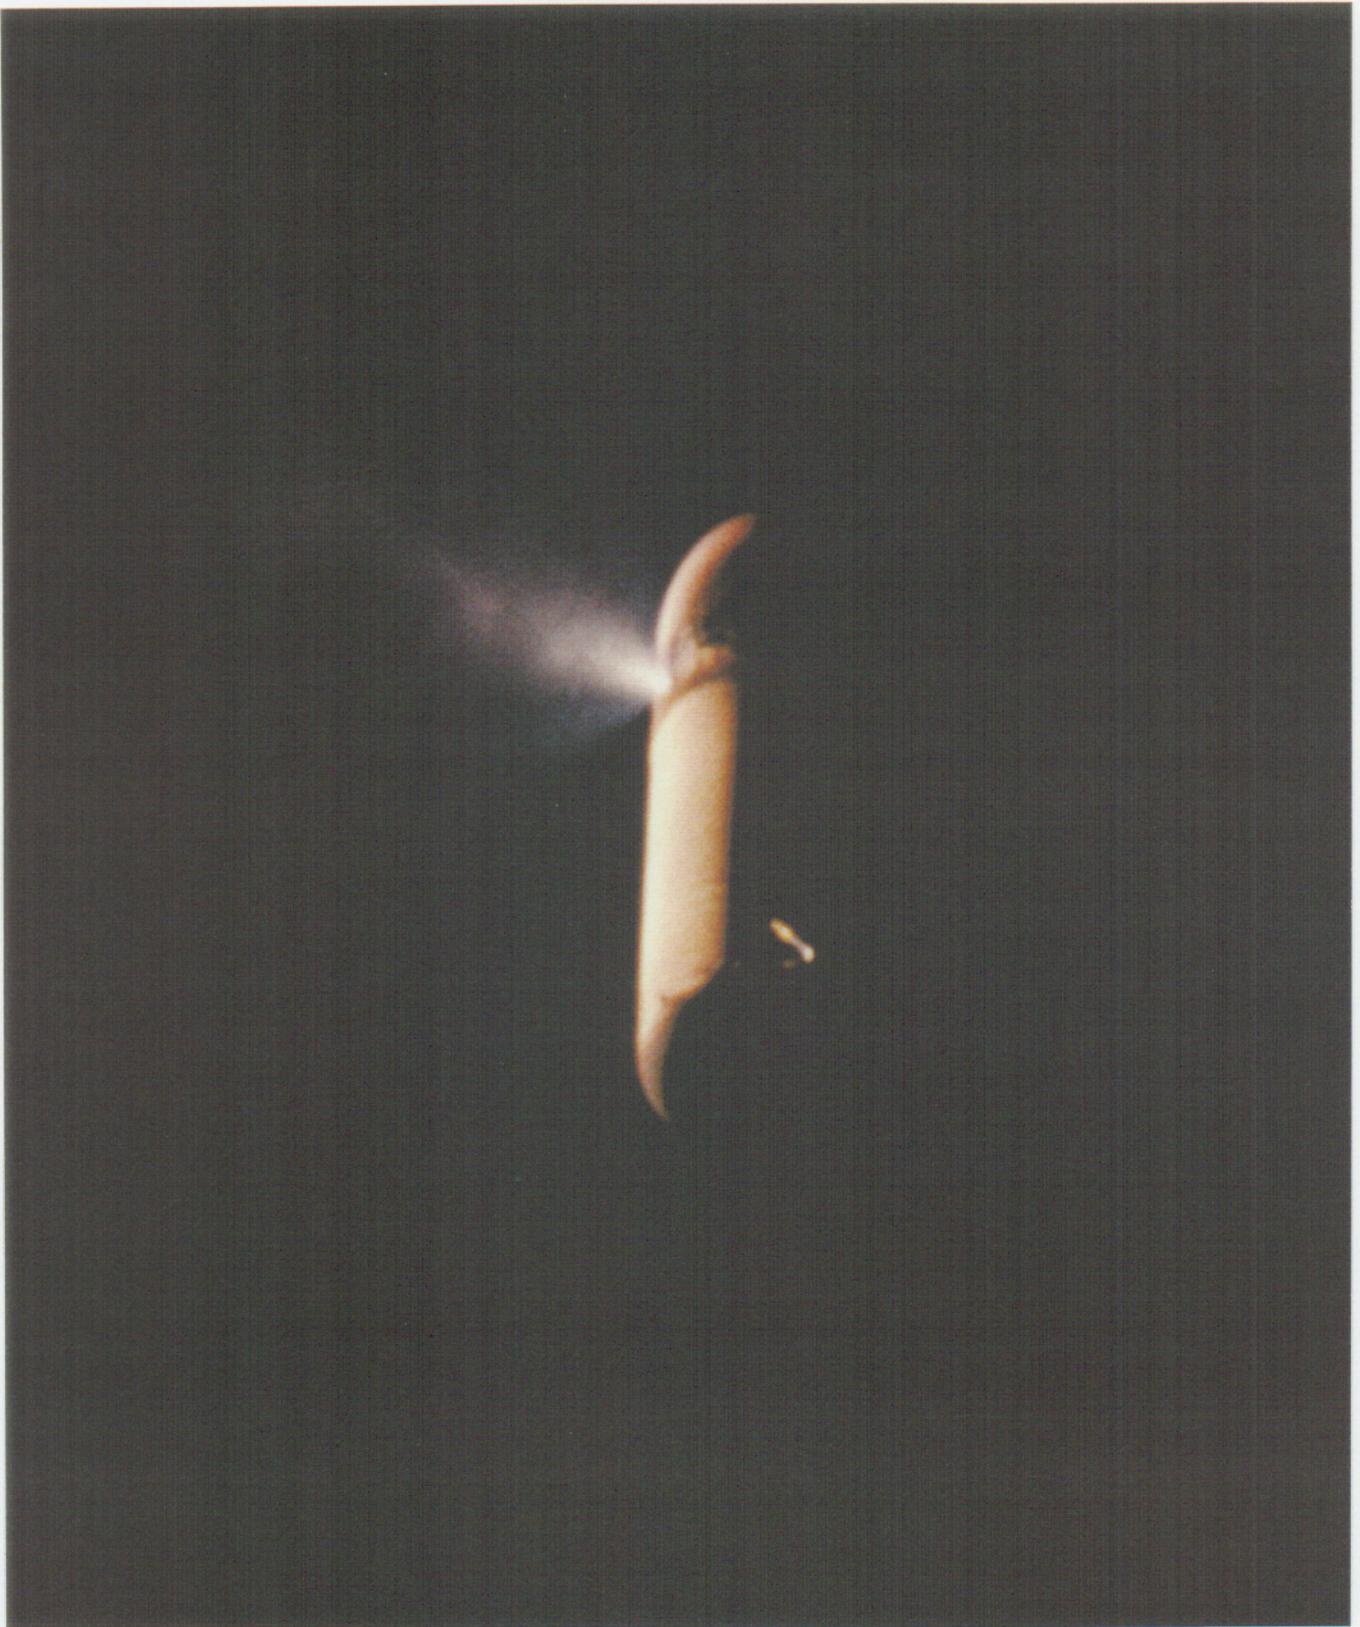
Photo 12: Gaseous Hydrogen Venting

A rarely seen view of gaseous hydrogen venting from the 7-inch QD in the intertank. Venting from this location had been observed only once before on STS-45. Since the venting was not visible in the 16mm ET/ORB umbilical films (distance of 200+ feet and time of 49 seconds after separation), this event and any associated debris were judged to have no affect on the Orbiter or be associated with any tile damage. The venting itself is not considered anomalous. Note damage to TPS on nearby intertank thrust panel.

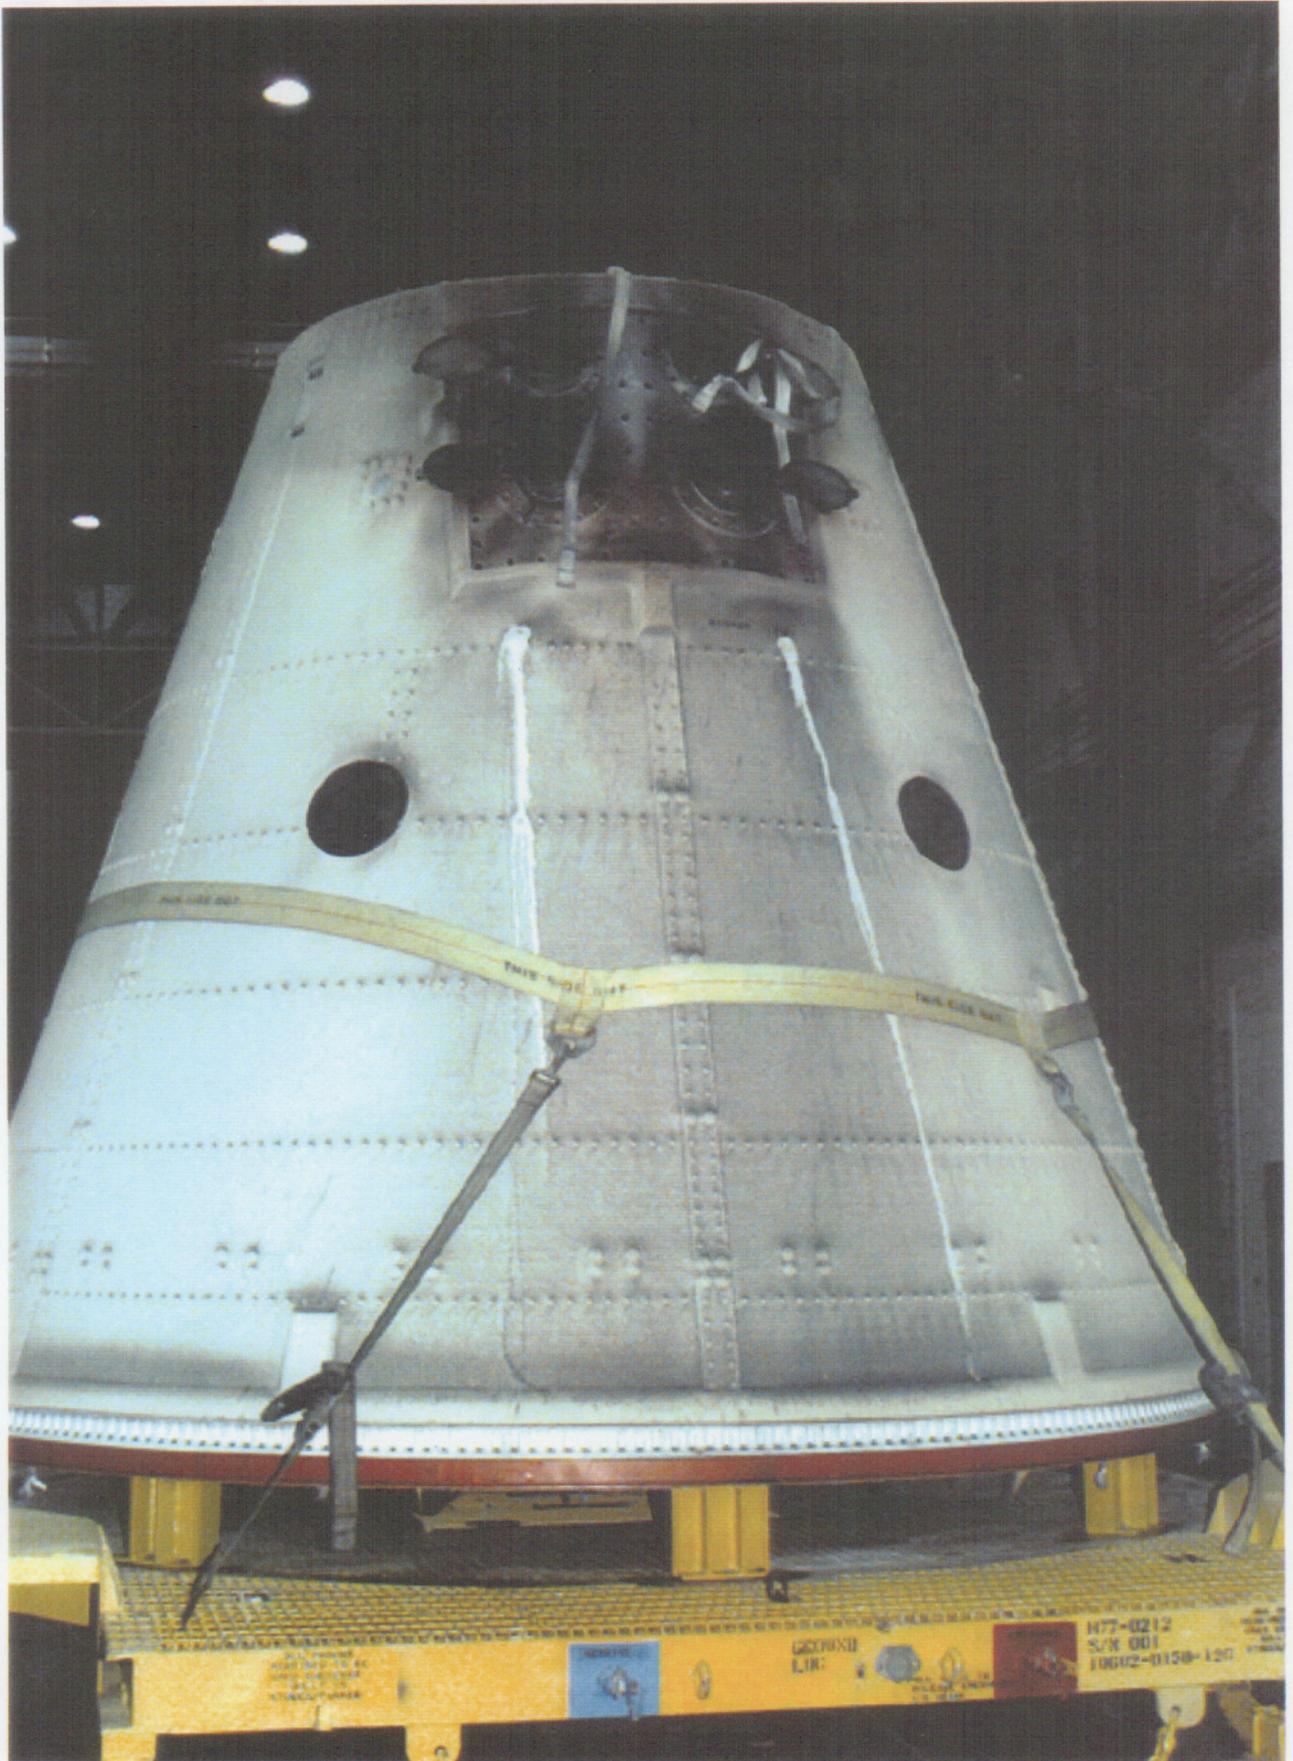
Photo 14: Frustum Configuration Change

A configuration change had been made to the right frustum. The PR-1422 sealant/cap closeouts had been eliminated from the majority of the fastener heads prior to the application of ablator. There were no debonds, unbonds, or missing TPS associated with this change.

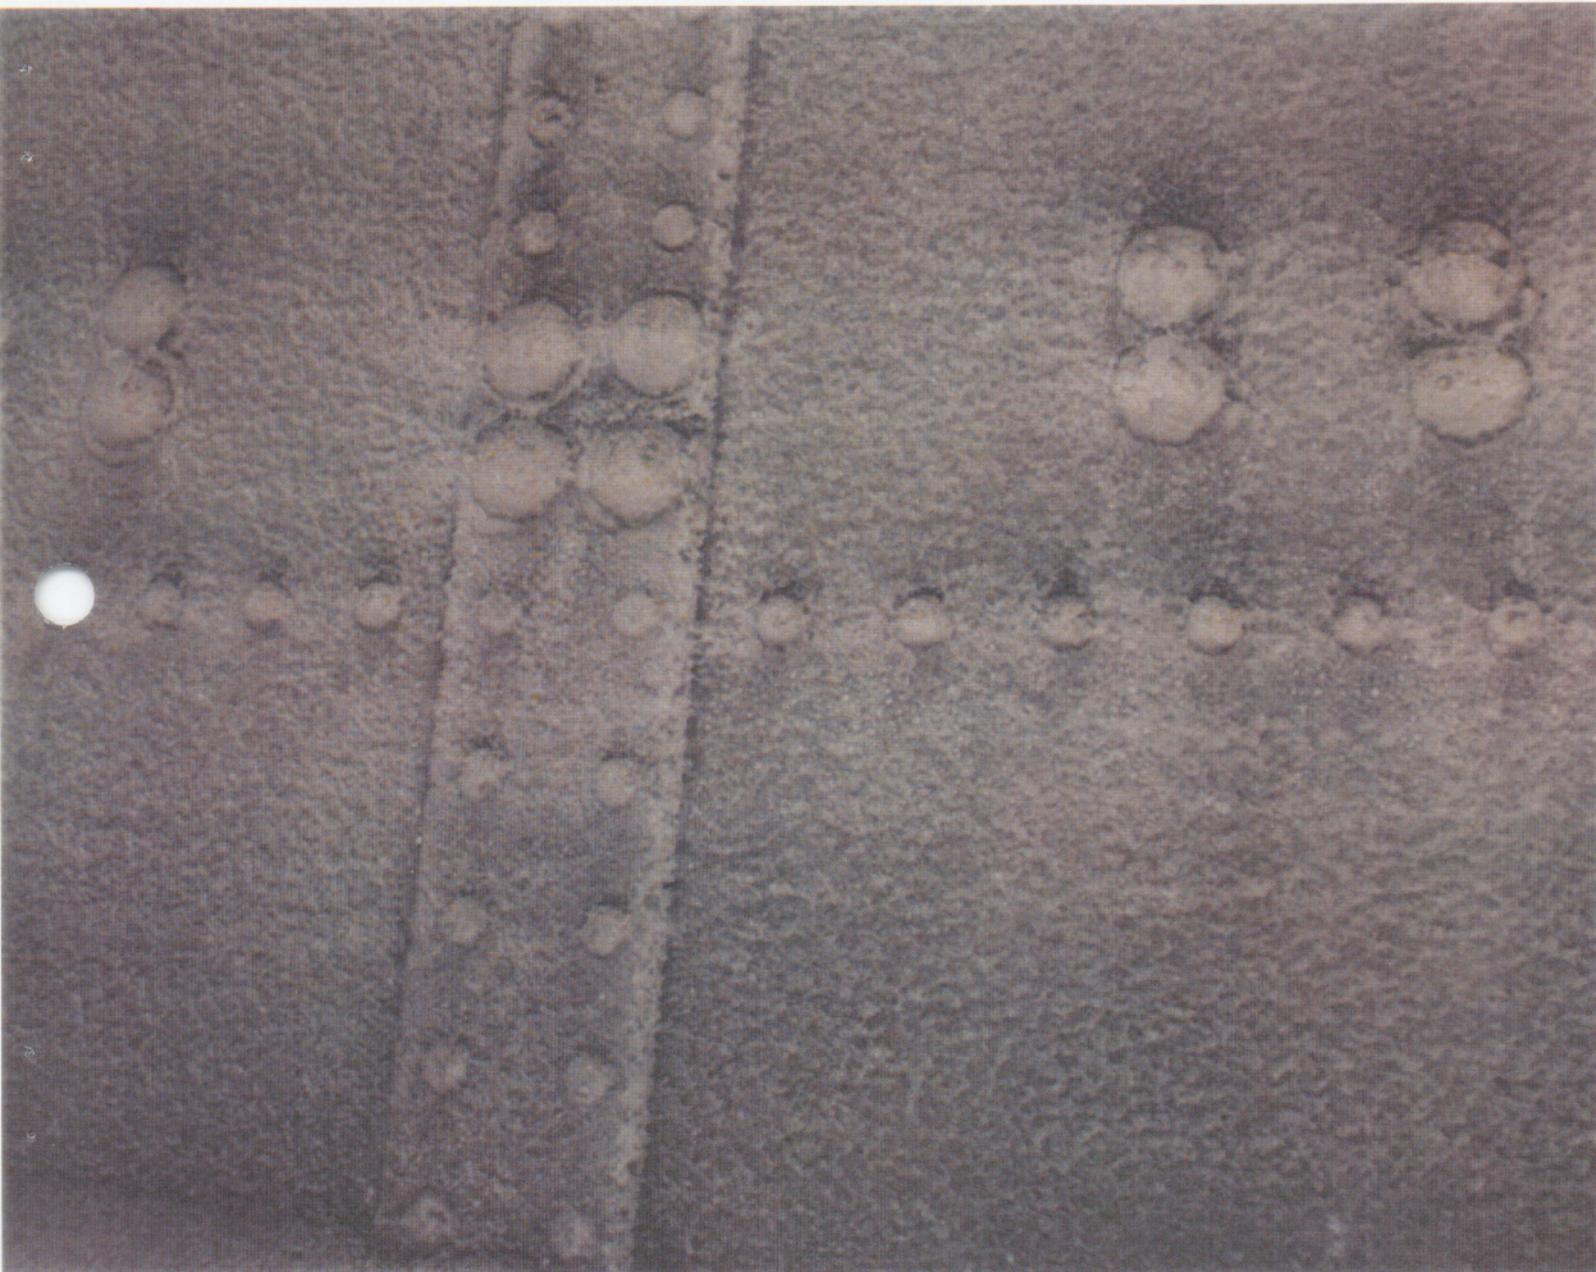
Photo 15: Elimination of Sealant/Cap Closeout

Close-up view of fastener heads covered by TPS.
Note ten PR-1422 sealant/cap closeouts for comparison.

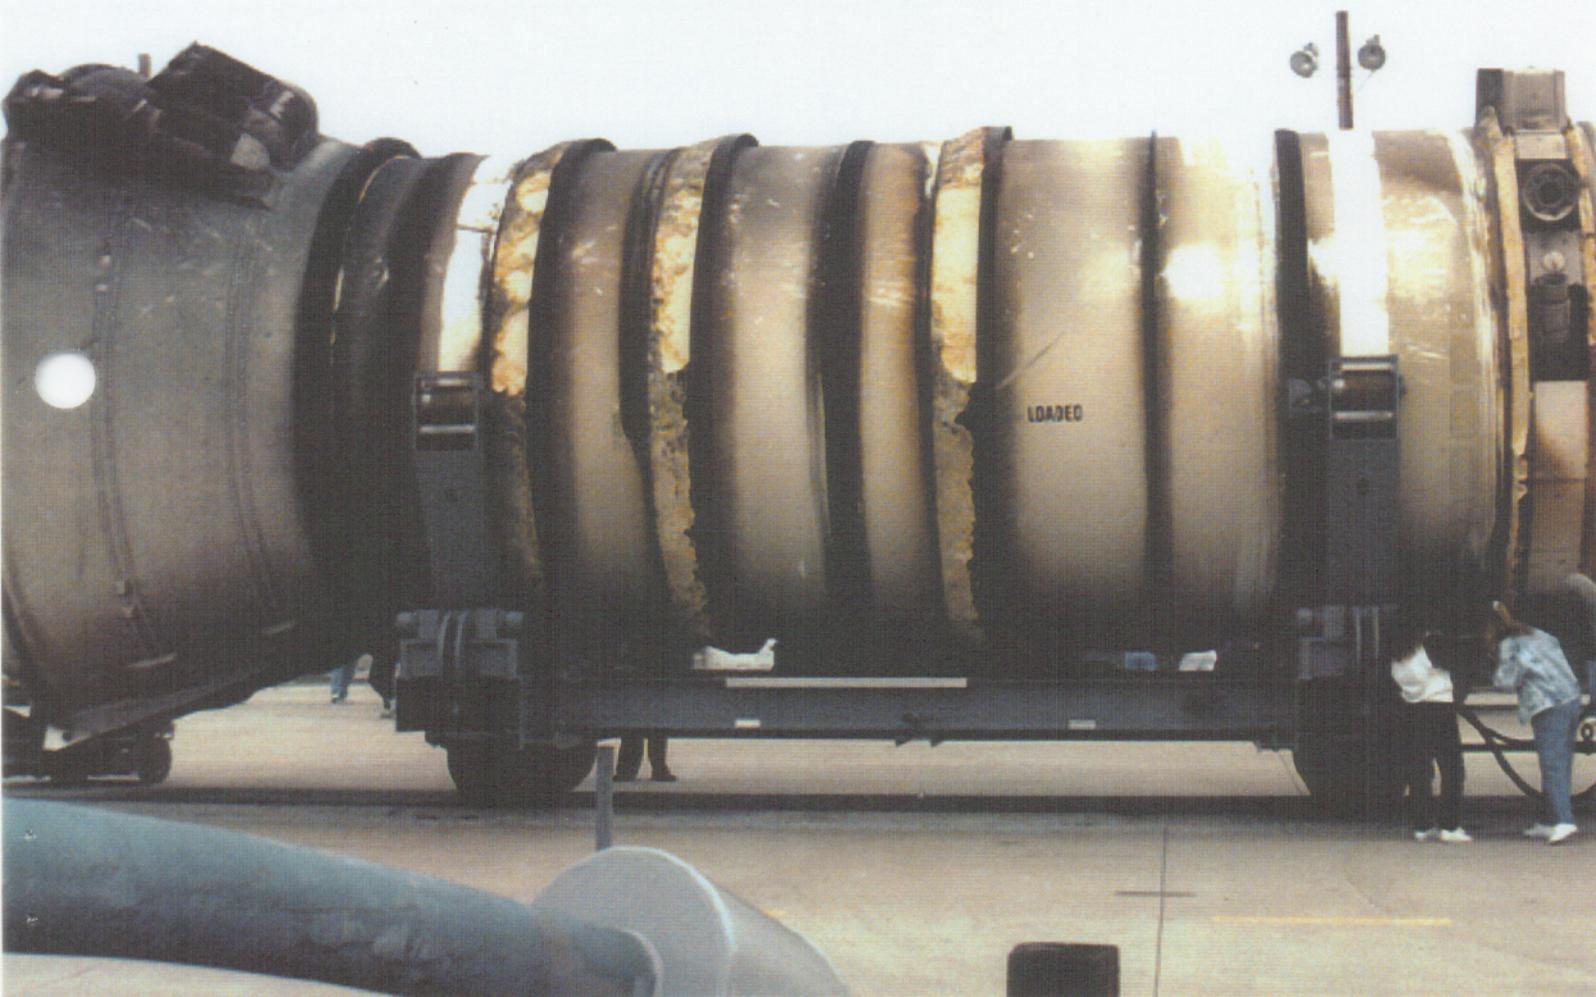
Photo 17: Aft Booster/Aft Skirt Post Flight Condition

Separation of the aft ET/SRB struts appeared normal. The stiffener rings, ETA rings, and IEA's appeared undamaged by water impact. TPS on the external surface of both aft skirts was intact and in good condition.

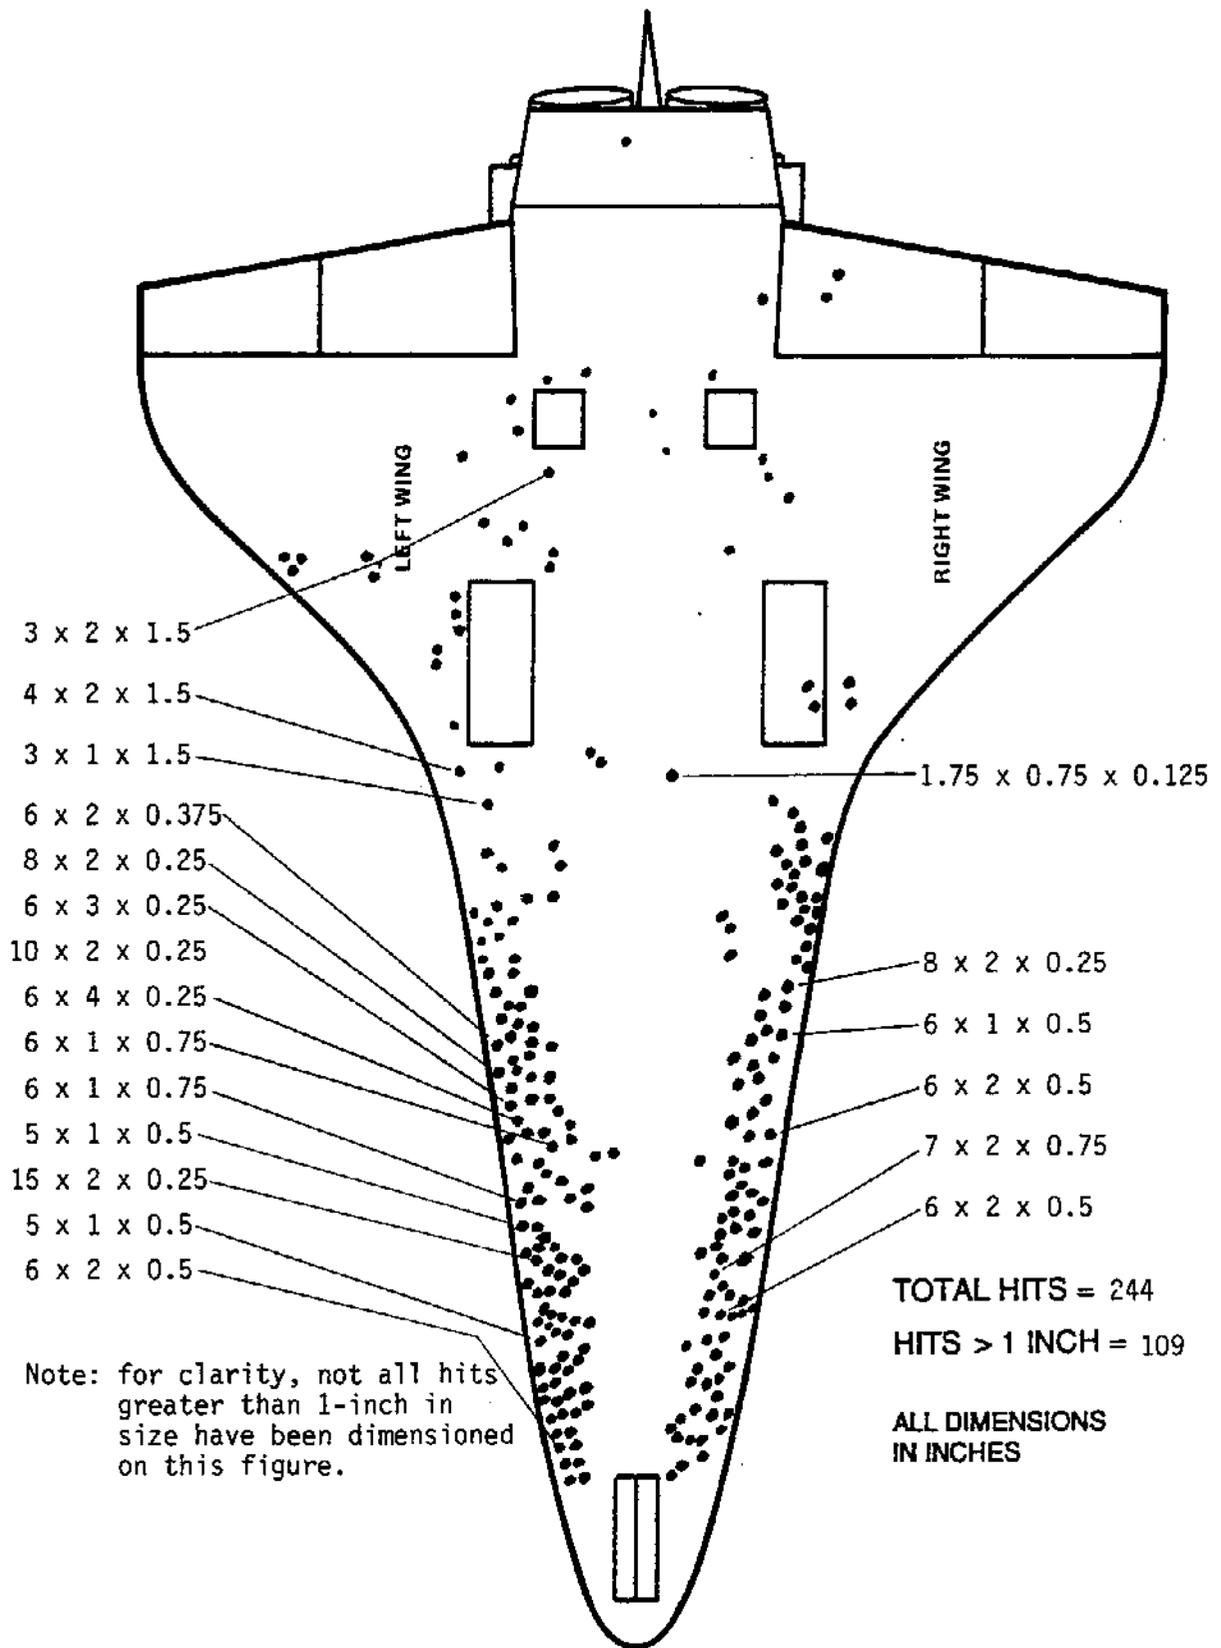
Figure 1: Orbiter Lower Surface Debris Damage Map

In summary, both the total number of Orbiter TPS debris hits and the number of hits 1-inch or larger was "out of family" when compared to previous missions (reference Figures 5 and 6). Since the same damage pattern occurred on STS-86, a trend was established that may involve the change to NCFI 24-124 used on the thrust panels. An investigation team is also examining TPS density and strength, structural loads and flexing of the thrust panels, aerodynamic loading, and the flight environment.

As a result of this investigation, plug pull tests to verify material strength were performed on the ET-90 (STS-89) thrust panels. All of the test results were within specification. Nevertheless, the panels were then modified. The foam was machined/sanded to minimum drawing requirements above the rib tops and the rind was removed in the rib valleys to improve the stress/strain capability, eliminate a denser material layer, reduce the amount of potential debris material, and reduce the foam height above the panel ribs to decrease the cross-flow air loading on the foam. All of these measures were designed to eliminate or reduce the amount of TPS loss from the thrust panels, and in turn reduce the amount of damage to Orbiter tiles.

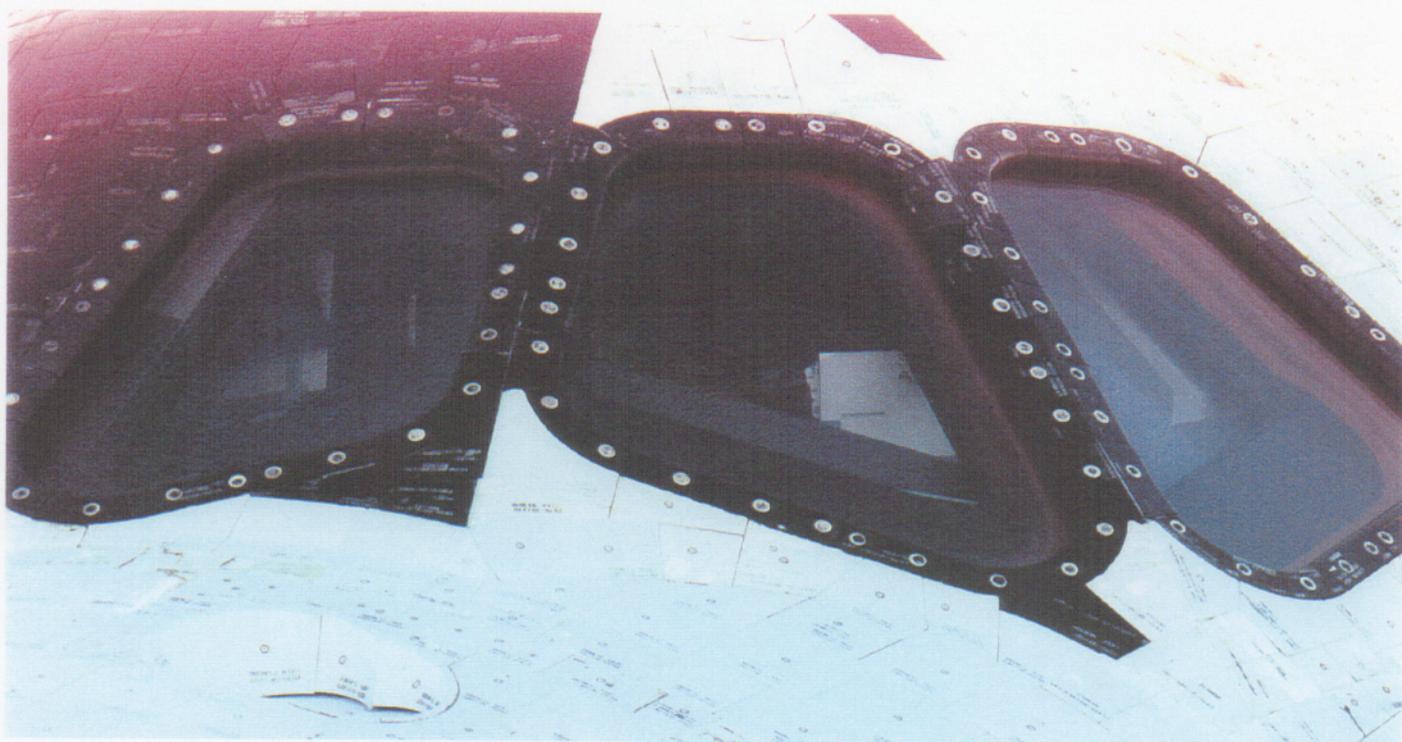
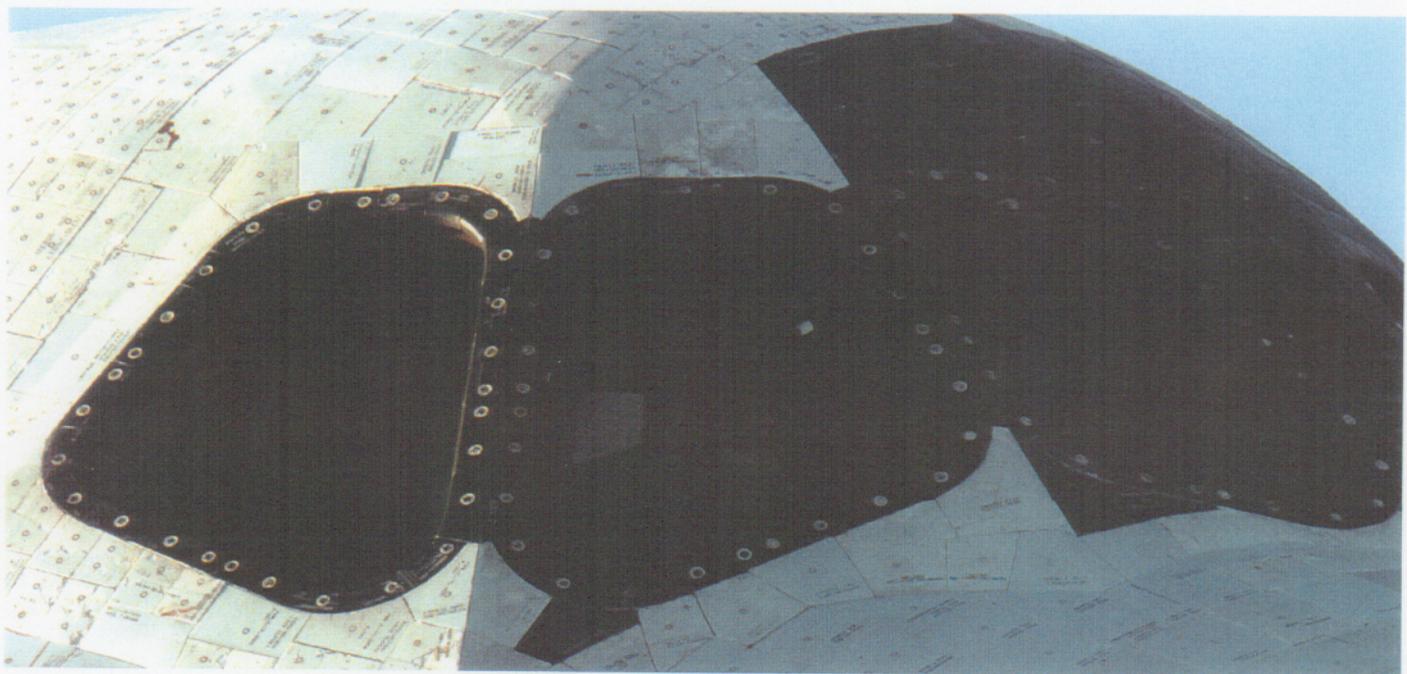
Photo 24: Windows and Perimeter Tiles

Hazing and streaking of forward-facing Orbiter windows was less than usual. Damage sites on the window perimeter tiles was noticeably less than usual in quantity and size.
