STS-107
FLIGHT READINESS REVIEW

January 9, 2003

Ground Operations

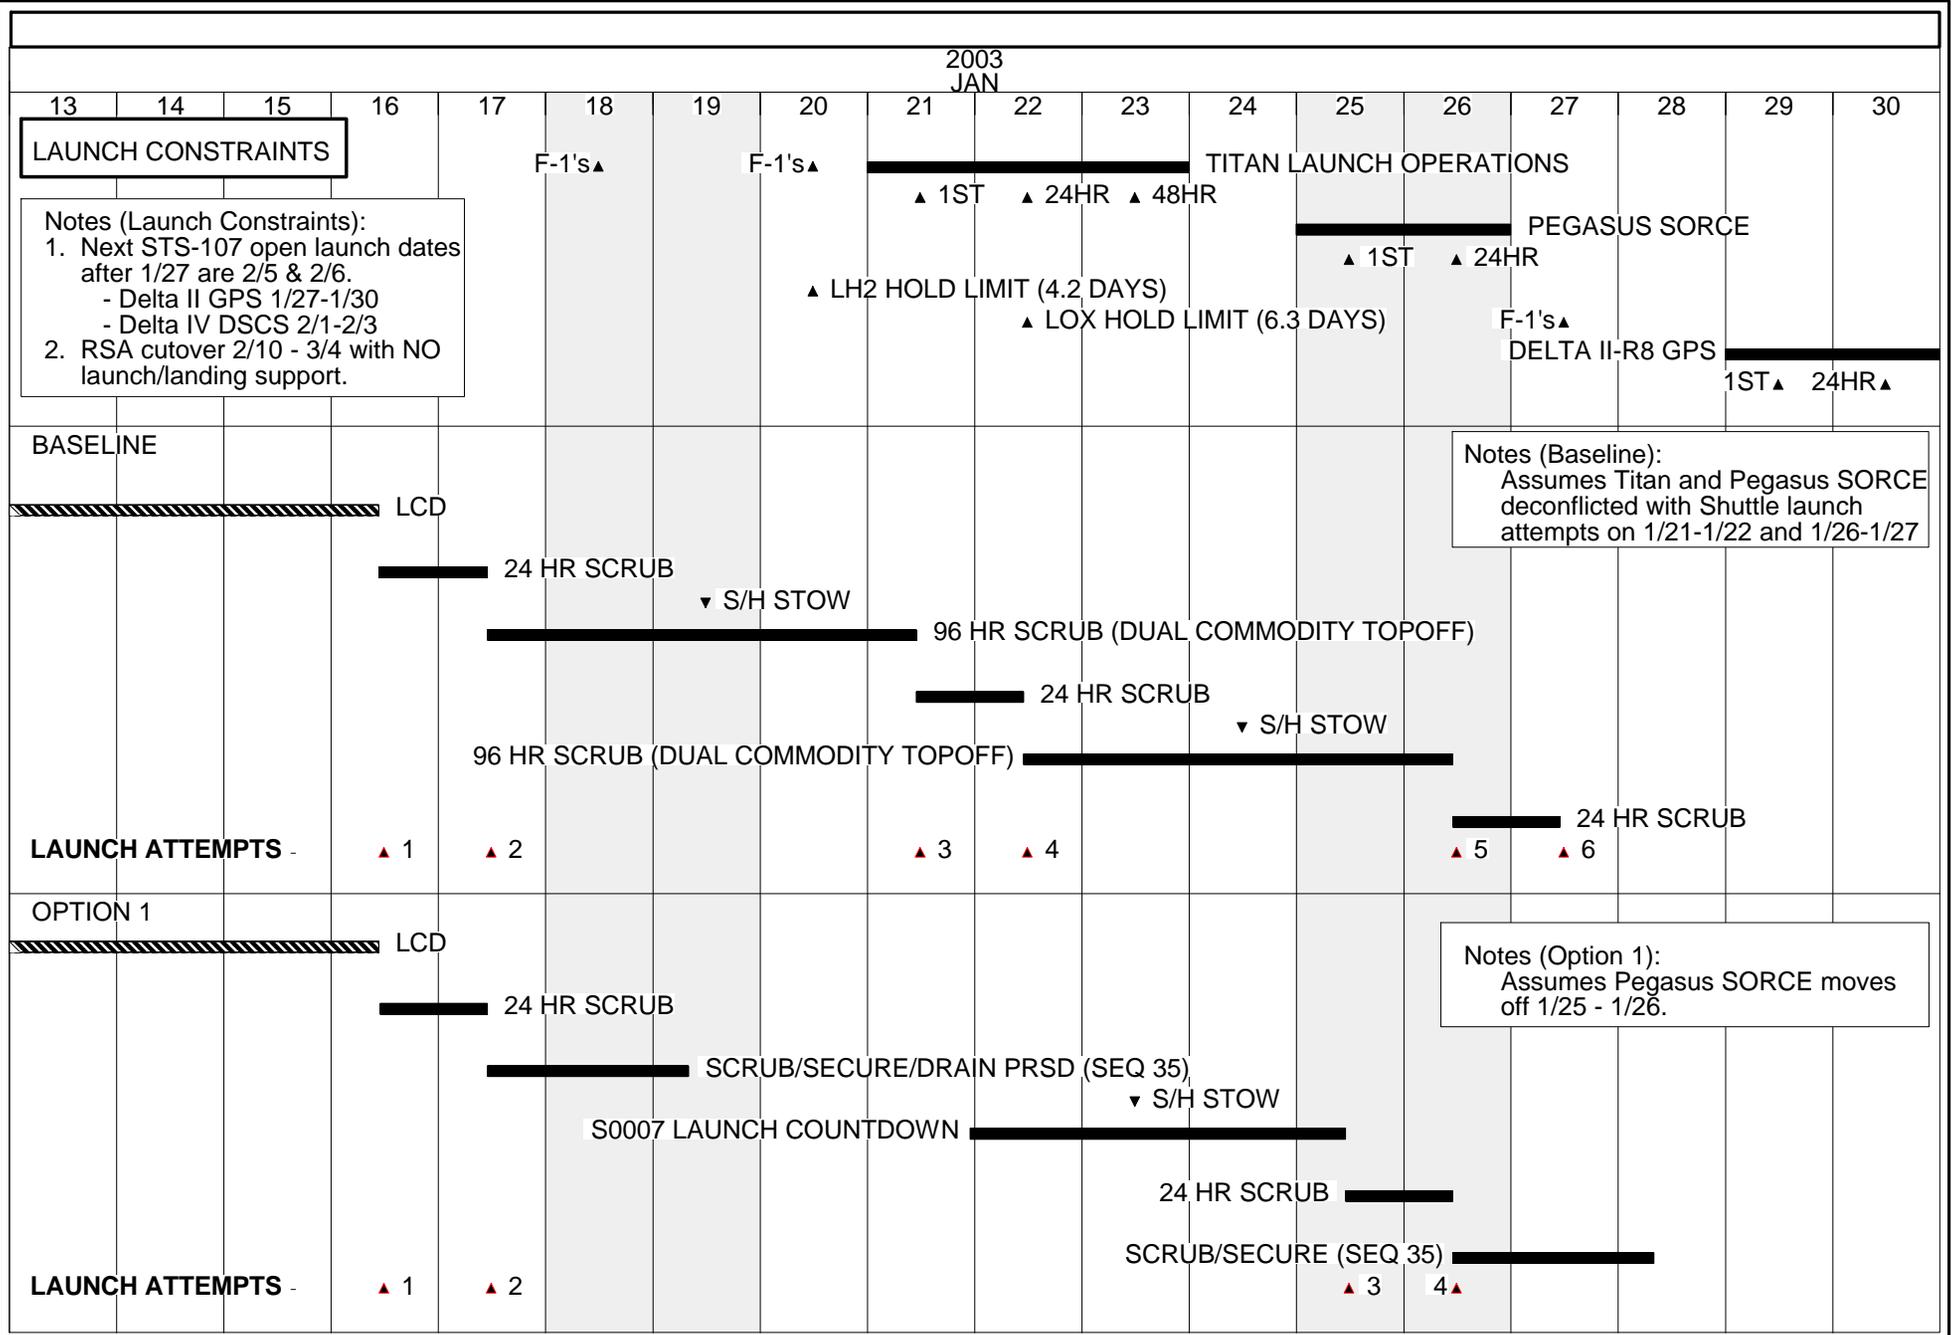
LAUNCH COUNTDOWN TURNAROUND OPTIONS

NOTE: Actual Scrub turnaround timelines will be determined realtime based on specific conditions encountered.

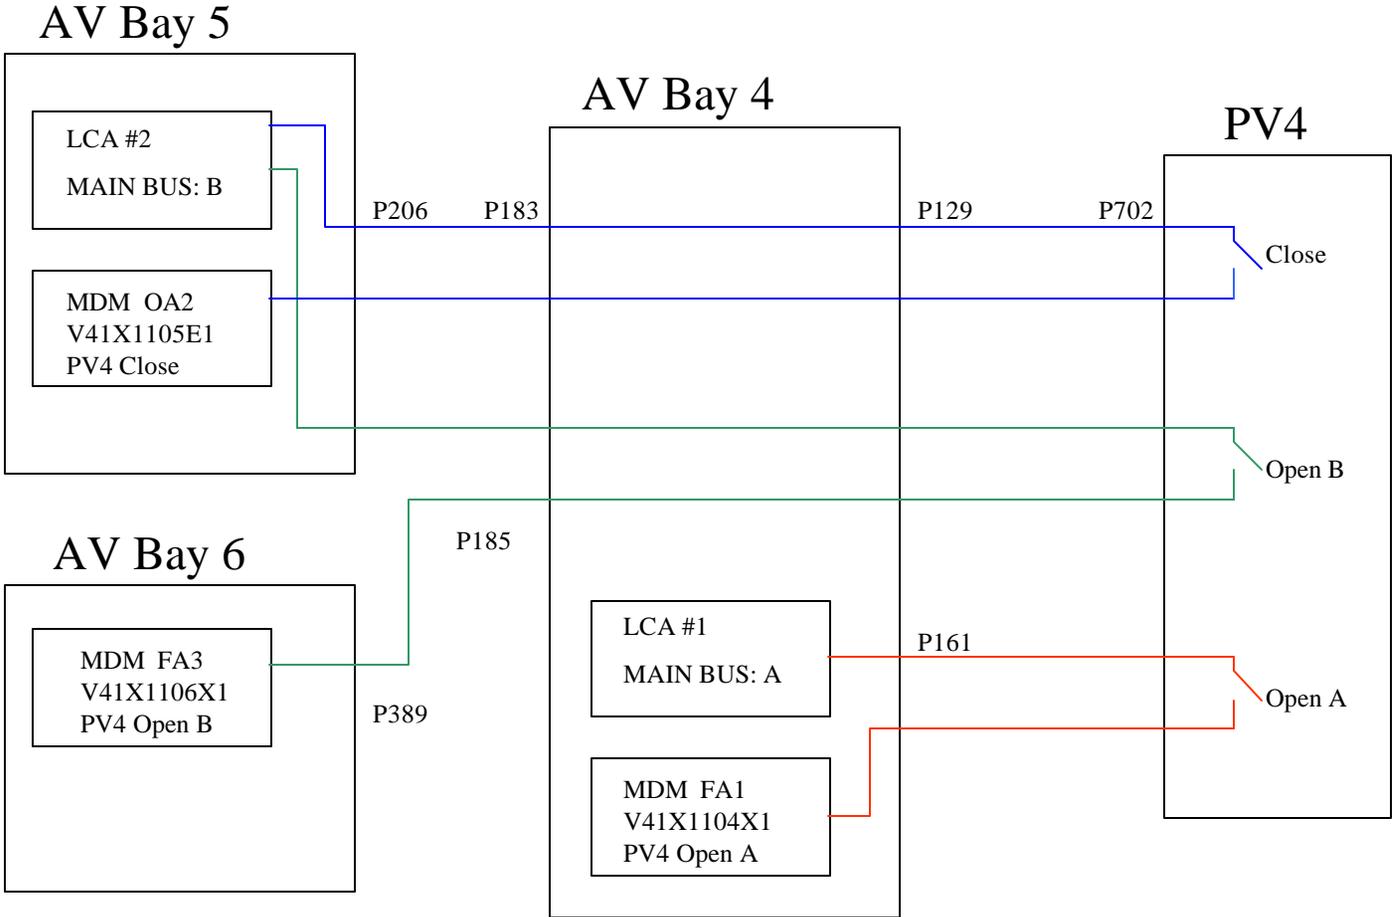
UNEXPLAINED ANOMALIES ENGINE #1 PREVALVE INDICATION DROP OUT (CONT'D)

- Discussion
 - 5 prior Unexplained Anomaly (UA) occurrences of Prevalve open indication signal drop outs
 - 2 on OV-102 Engine #3 LH2 (during STS-035 processing)
 - 3 on OV-104 Engine #1 LH2 (2 during STS-044/079 processing and 1 on STS-104 ascent)
 - No occurrences during cryogenic loading or launch count
 - Most probable cause for all 5 UA's was an intermittent short or open in the indicator electrical circuit
 - All occurred during times of heavy work traffic, or on ascent
 - Launch Commit Criteria requirement is for 1 of 2 open indications at T-7 s - valve opening
 - Indications not used for remainder of mission

- Actions Taken
 - A tap check was performed on the Prevalve actuator
 - No drop outs
 - Valve electrical connector was de-mated and inspected
 - No anomalies noted
 - Isolated valve from vehicle wiring
 - Micro switch was tested – no anomalies
 - Vehicle wiring wiggled while monitoring voltage – no signal noise
 - Convoluted tubing removed and wire harness inspected near valve connector
 - No damage
 - Open 'A' indication monitored during daily power-up
 - No drop outs

- Possible Causes
 - Mechanical failure of the micro switch
 - Intermittent mechanical failure is highly unlikely
 - Improper switch adjustment would result in multiple occurrences
 - No previous switch failures
 - An intermittent short or open in the indicator electrical circuit
 - All occurrences have been during high traffic periods in aft fuselage or during ascent
- Most Probable Cause
 - An intermittent short or open in the indicator electrical circuit

- Observation
 - During STS-109 ascent the Engine #1 LH2 Prevalve open 'A' indication experienced a drop out after SSME shut down
 - Drop out occurred 14 minutes after valve was opened for LH2 dump
 - The open 'B' indication operated nominally (remained ON)
 - No data dropout occurrences during troubleshooting
- Concerns
 - A repeat of the anomaly coupled with a failure of the redundant open 'B' indication at T-7 seconds (s) would cause a countdown hold
 - No concerns after engine start through remainder of mission

- Flight Rationale
 - The open indication is only required at T-7 prior to engine start
 - Only 1 of 2 indications required
 - Failure of both (redundant) open indications is highly unlikely
 - Prevalve open indication is not monitored for on-orbit propellant dump or re-entry inerting
 - No history of failures during cryogenic load or terminal count
 - Proper valve operation will be verified after Aft close out
- Risk Assessment
 - No risk to Flight and Crew's safety or Mission success

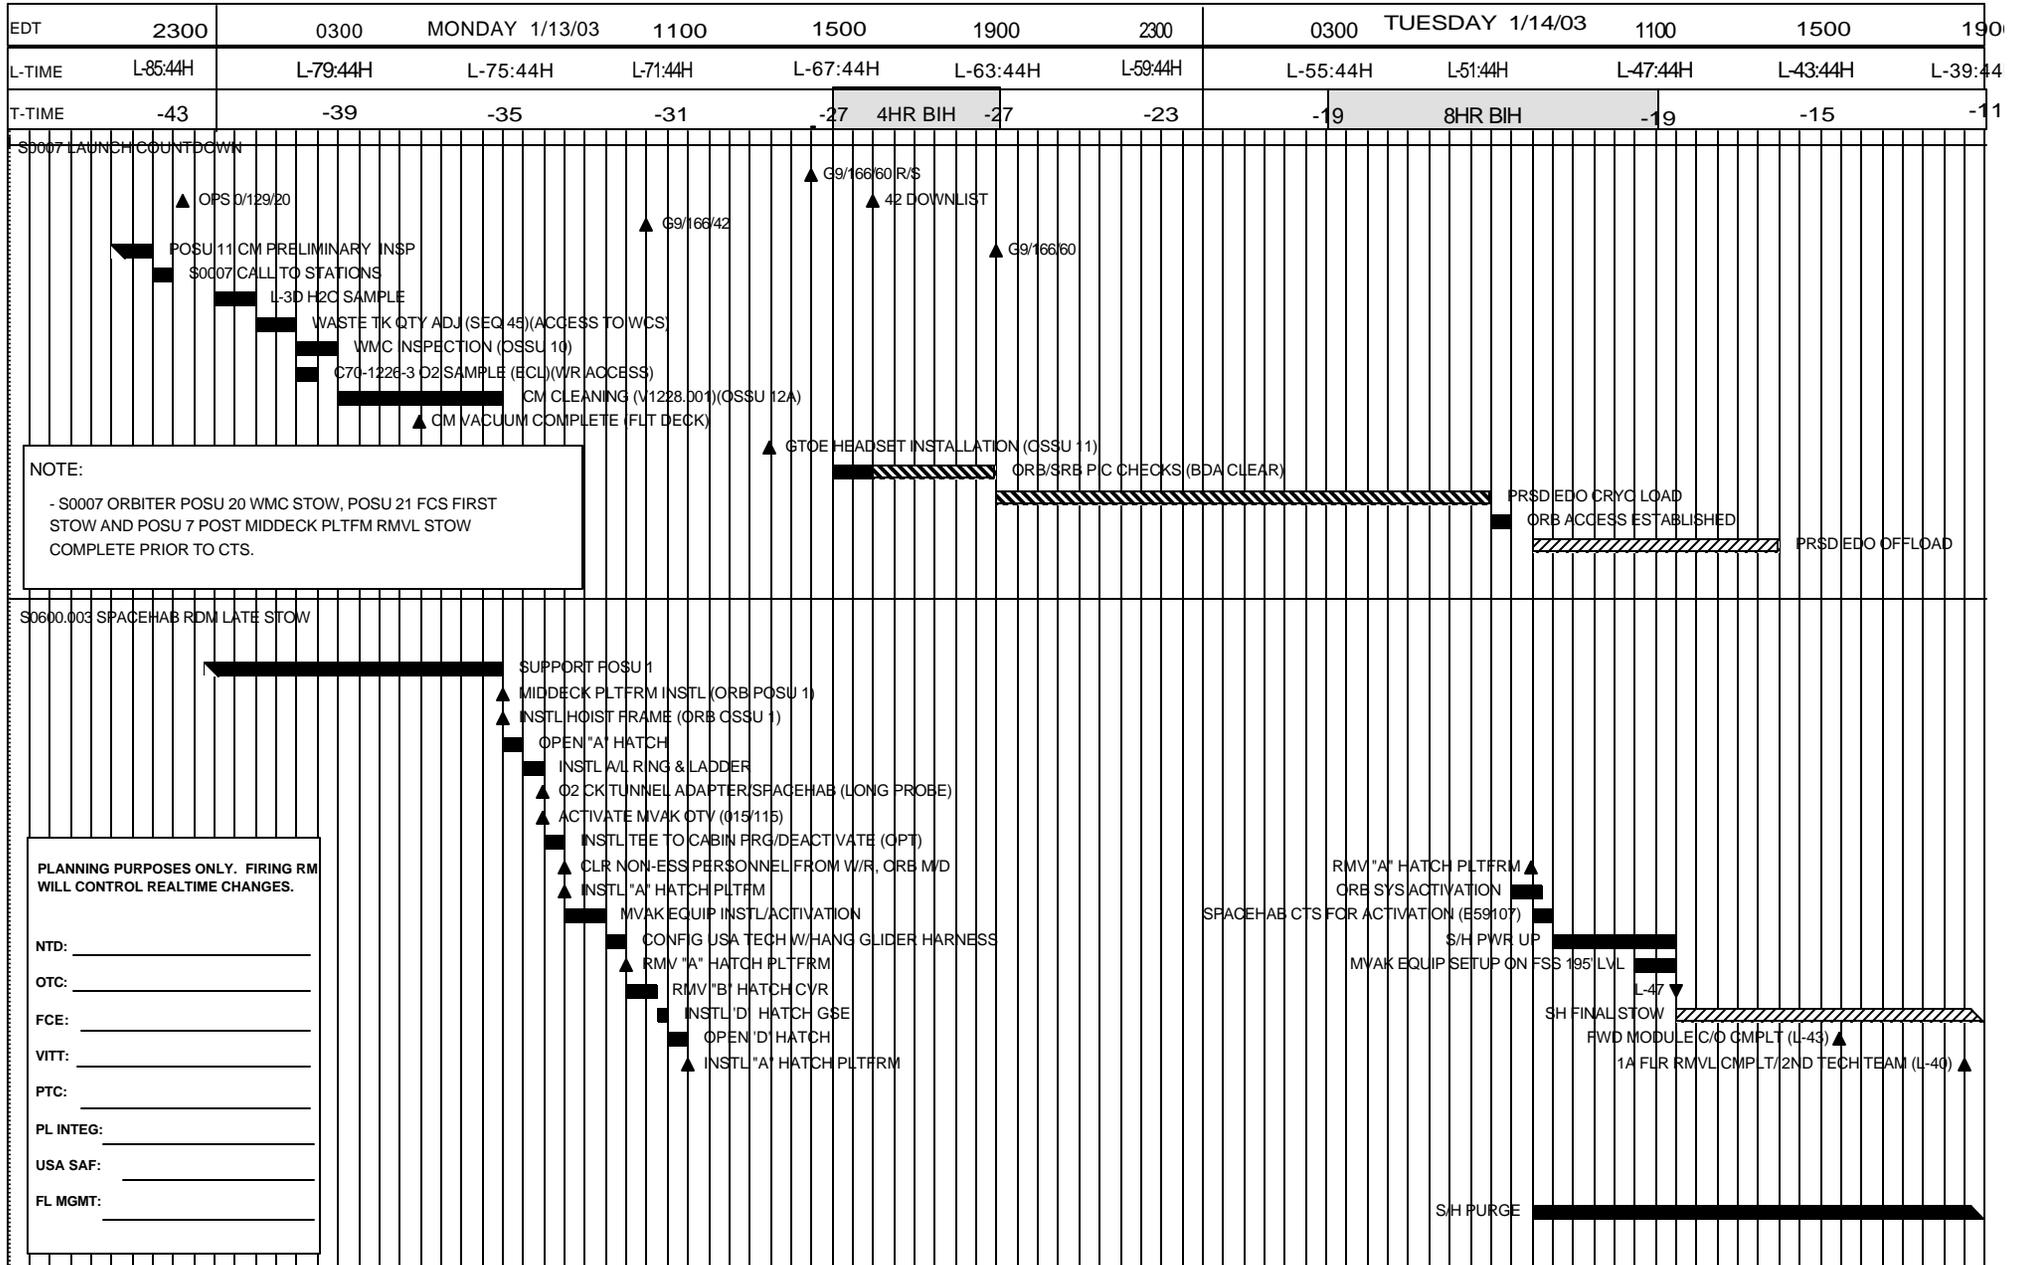
Crew Module Interface Chart

30 MINUTE INCREMENTS

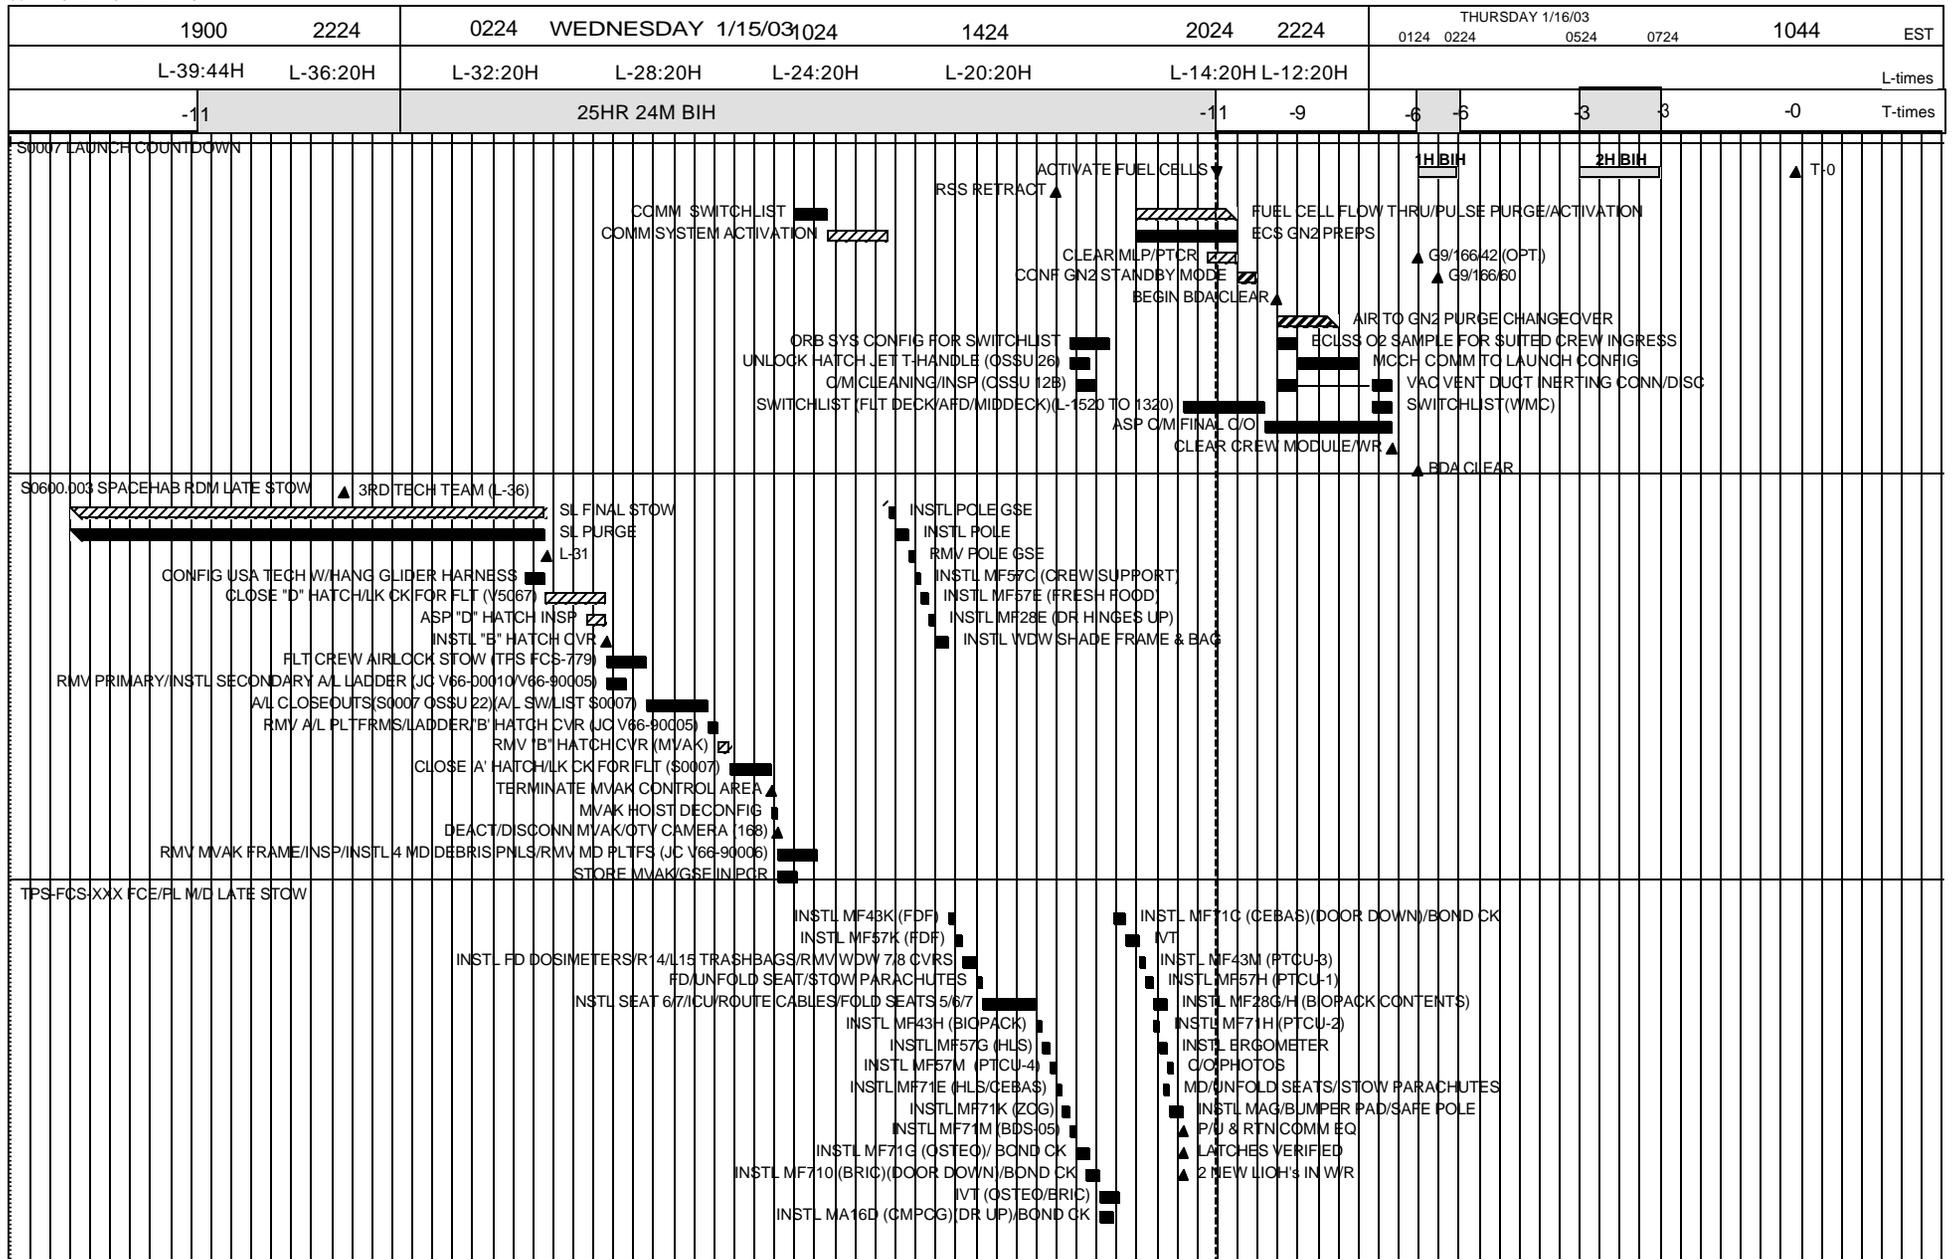
STS-107 S0007/S0600.003/TPS-FCS-XXX Crew Module Interface Chart

30 MINUTE INCREMENTS
