PROCESSING OPERATIONS CONTROL OMI PLANNING SHEET

Wad Number S6016-J09-R01	SITE VAB HB1	Elem CD B	End Item BI-116	DATE: 09/24/2002 TIME: 08:41:18
-----------------------------	-----------------	--------------	--------------------	------------------------------------

Title: ET/SRB PRE-ROLLOUT INSPECTIONS	Sub Element/Zone
--	------------------

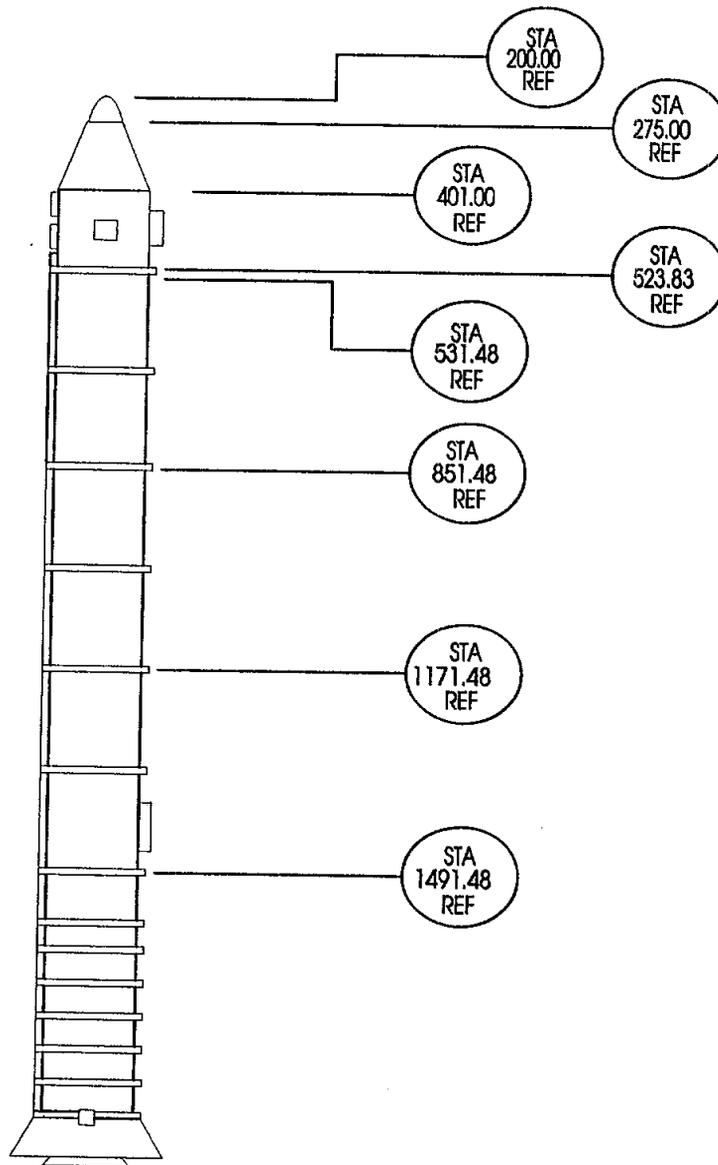
**Figure 40-1: SRB XB STA Locations
(For Reference Only)**

- 40-2 Inspect the three frustum vent holes at STA 299 and verify they are clear of any obstructions or foreign material. Refer to Figure 40-1: SRB XB STA Locations.

- 40-3 Inspect the two forward BSM cavity drain holes located at STA 317, and verify they are clear of any obstructions or foreign material. Refer to Figure 40-1: SRB XB STA Locations.

- 40-4 Inspect the six barometric switch ports at STA 334.5 and verify they are clear of any obstructions or foreign material. Refer to Figure 40-1: SRB XB STA Locations.

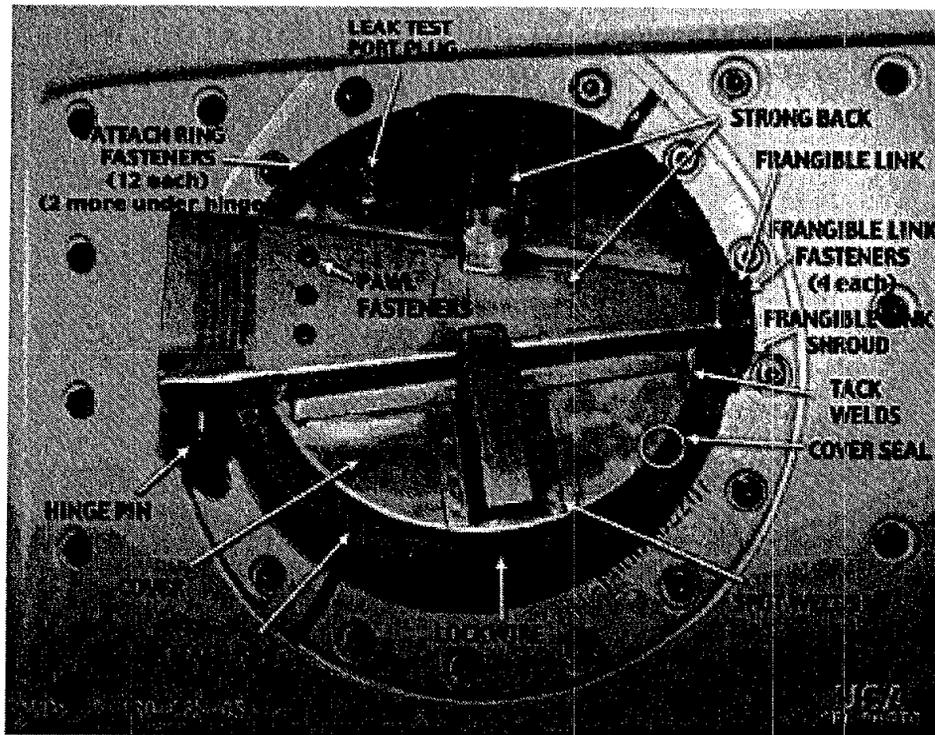
S6016-F-003

Figure 40-2: SRB BSM View (Typical)
(For Reference Only)

Inspect the four each forward Booster Separation Motors for the following; **Reference Figures 40-2 and 40-3 for nomenclature.**

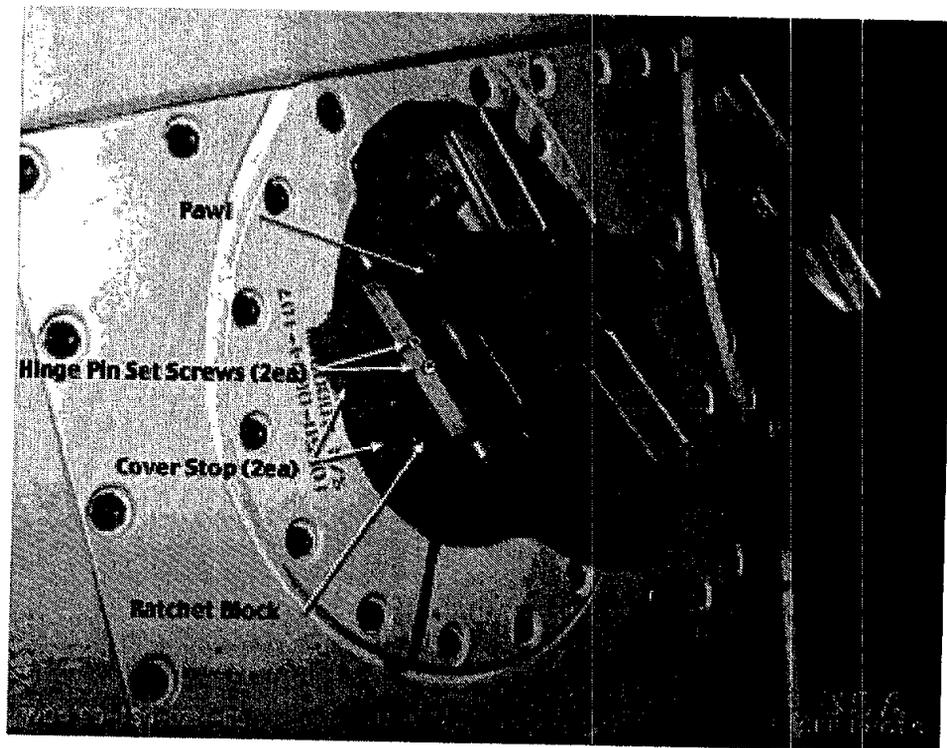
S6016-F-004

**Figure 40-3: SRB BSM View 2 (Typical)
(For Reference Only)**

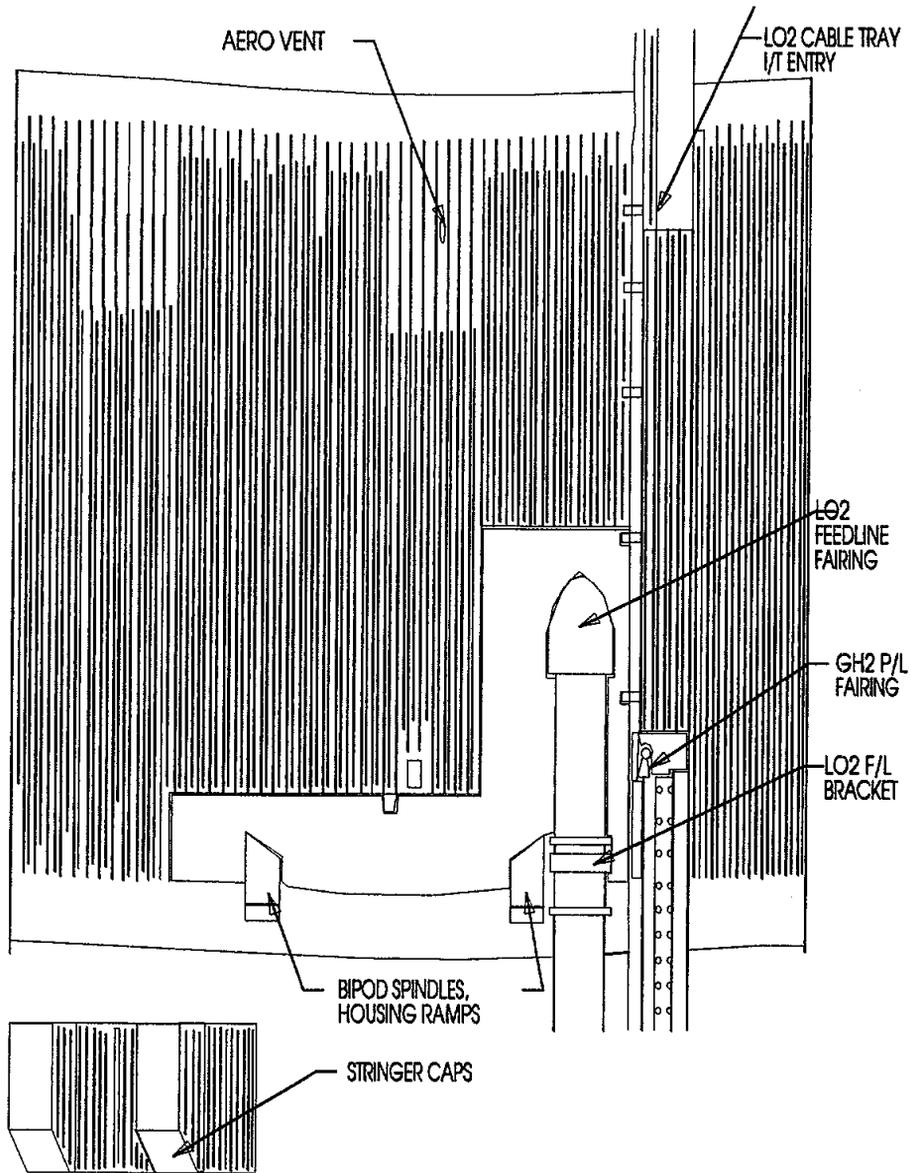
**Figure 50-1: Intertank External
(For Reference Only)**

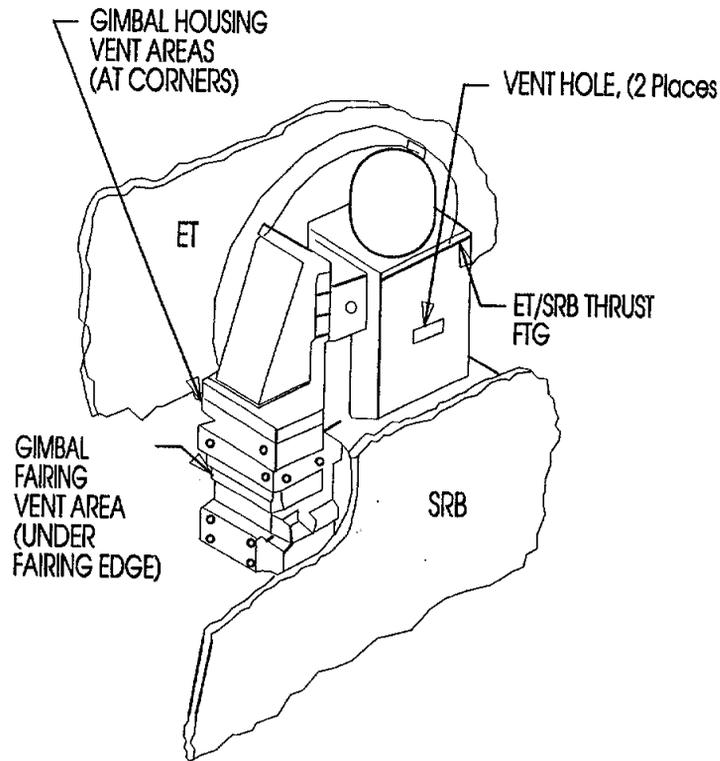
**Figure 50-2: ET/SRB Thrust Fitting Area
(For Reference Only)**

50-2 **Inspect** ET/SRB forward attach points on ET tank structure for visible damage.

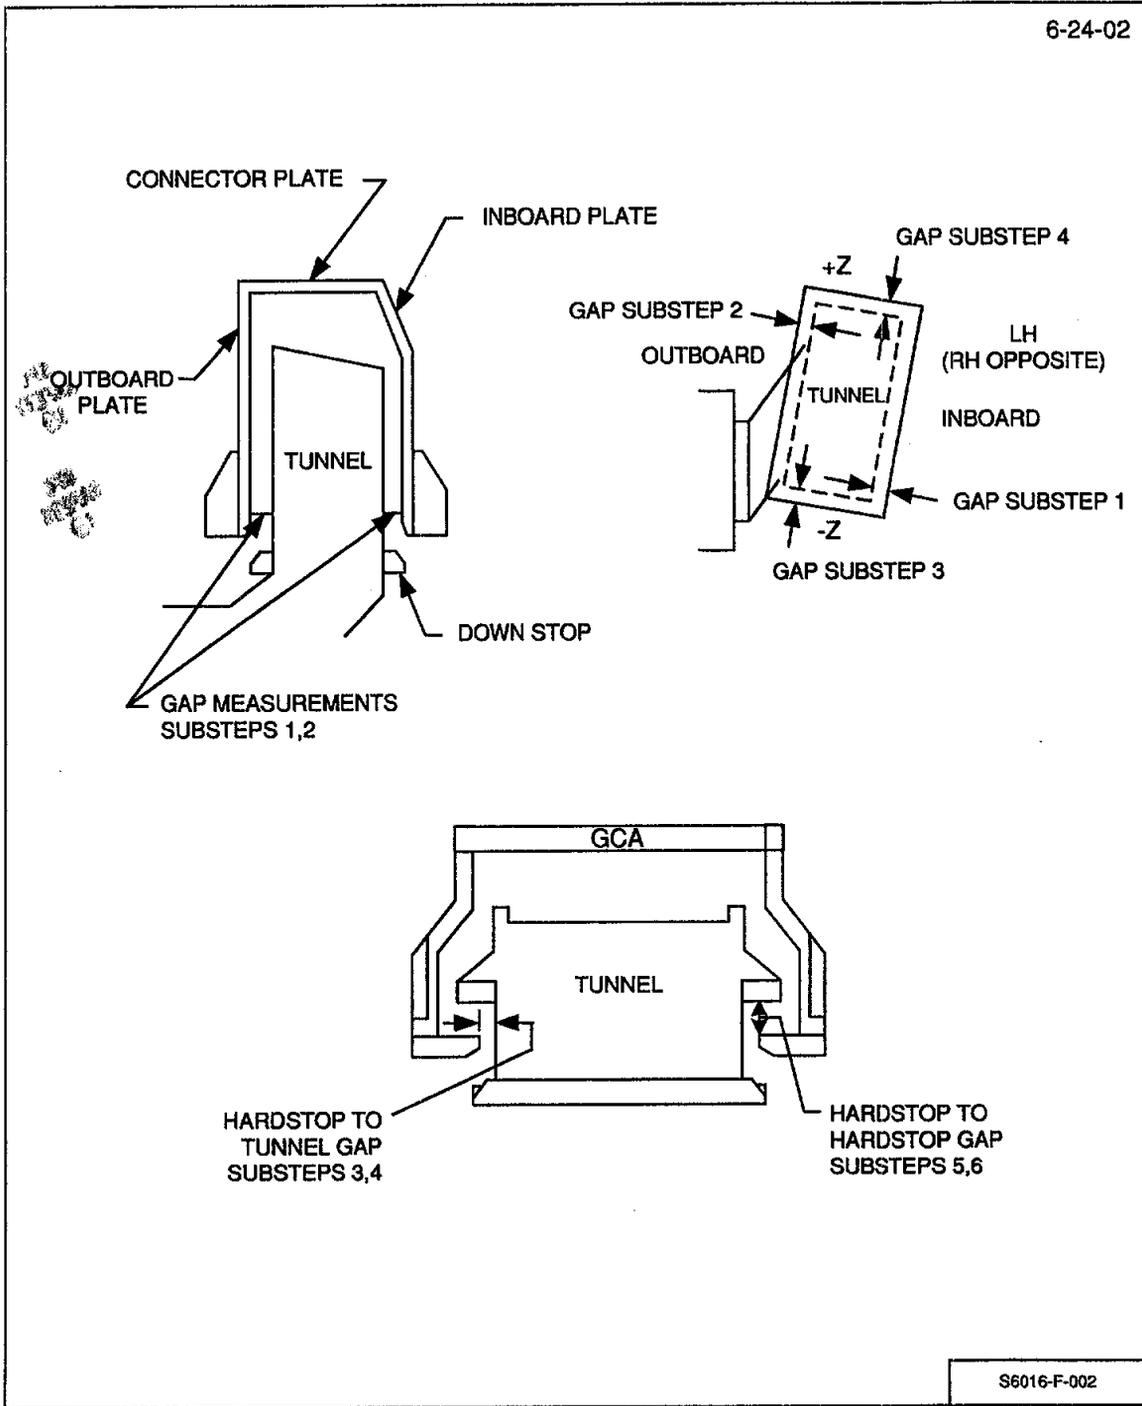
**Figure 140-1: Ground Carrier to Tunnel Clearances
(For Reference Only)**

140-15 **Verify following Ground Carrier assembly to tunnel clearances. Reference Figure 140-1.**

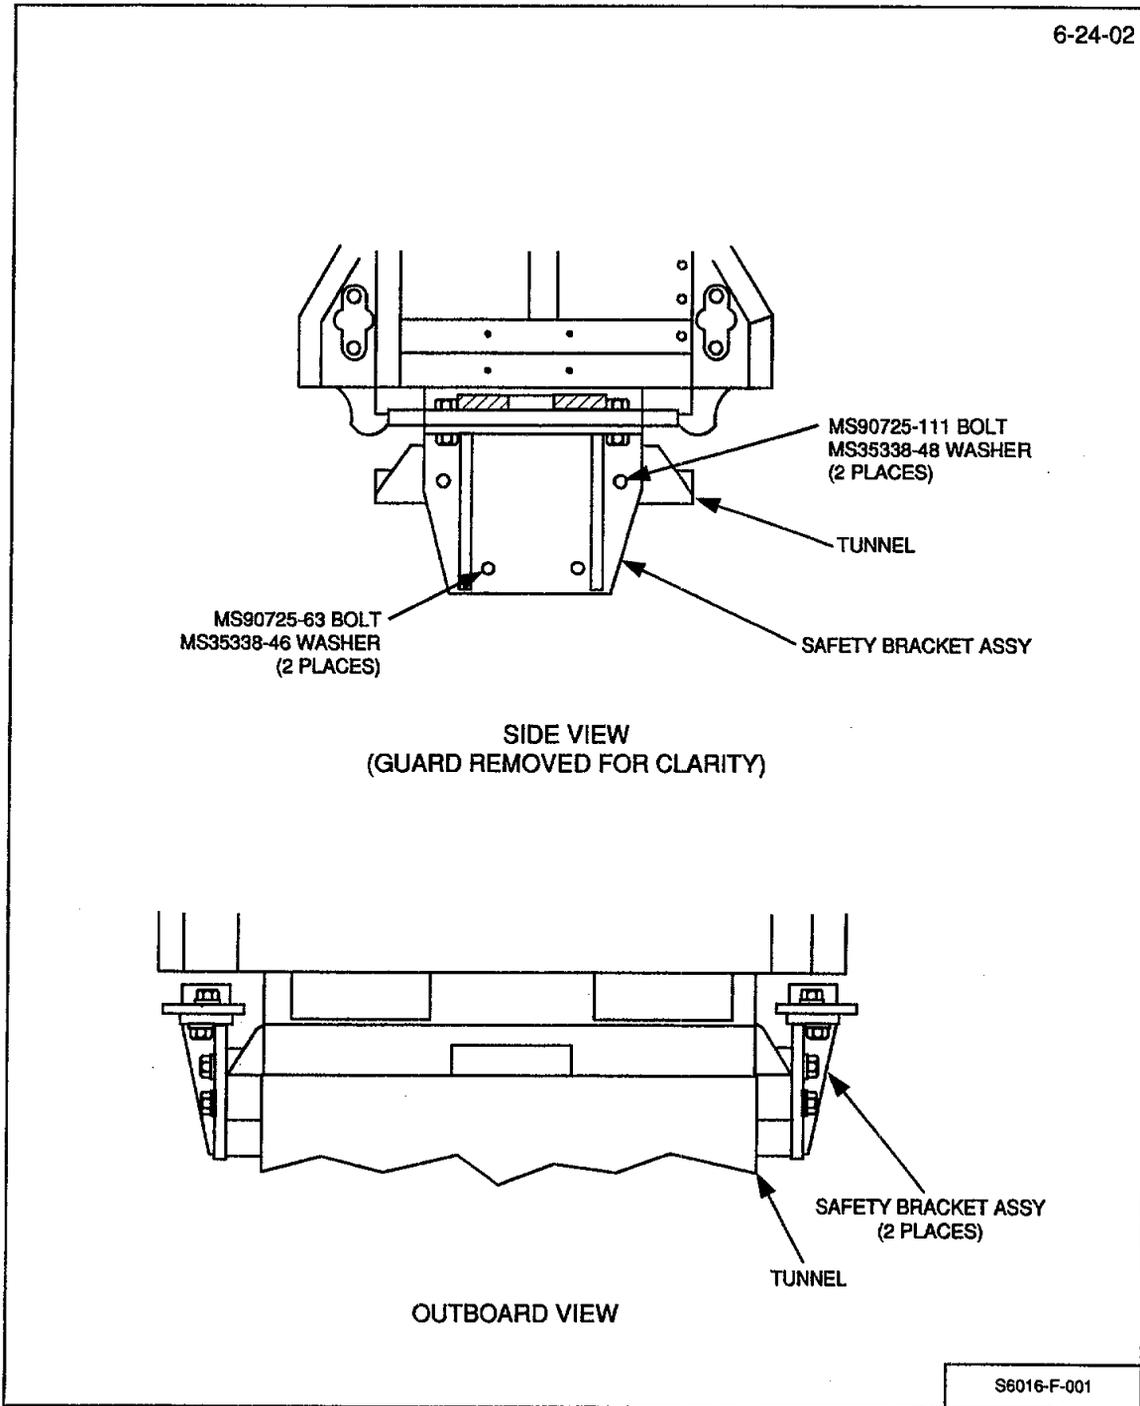
**Figure 140-2: Isolator/Safety Bracket
(For Reference Only)**

- 7. Top of isolator of safety bracket (+Z end) to bottom of GCA is greater than 0.18 inch. Measure at both Inboard and Outboard locations. Reference Figure 140-2.**

- 8. Top of isolator of safety bracket (-Z end) to bottom of GCA is greater than 0.18 inch. Measure at both Inboard and Outboard locations. Reference Figure 140-2.**
