National Aeronautics and Space Administration

**Technology Evaluation for Environmental Risk
Mitigation Principal Center (TEERM)**

**Hexavalent Chrome Free Coatings for Electronics
Applications**

DRAFT Joint Test Report

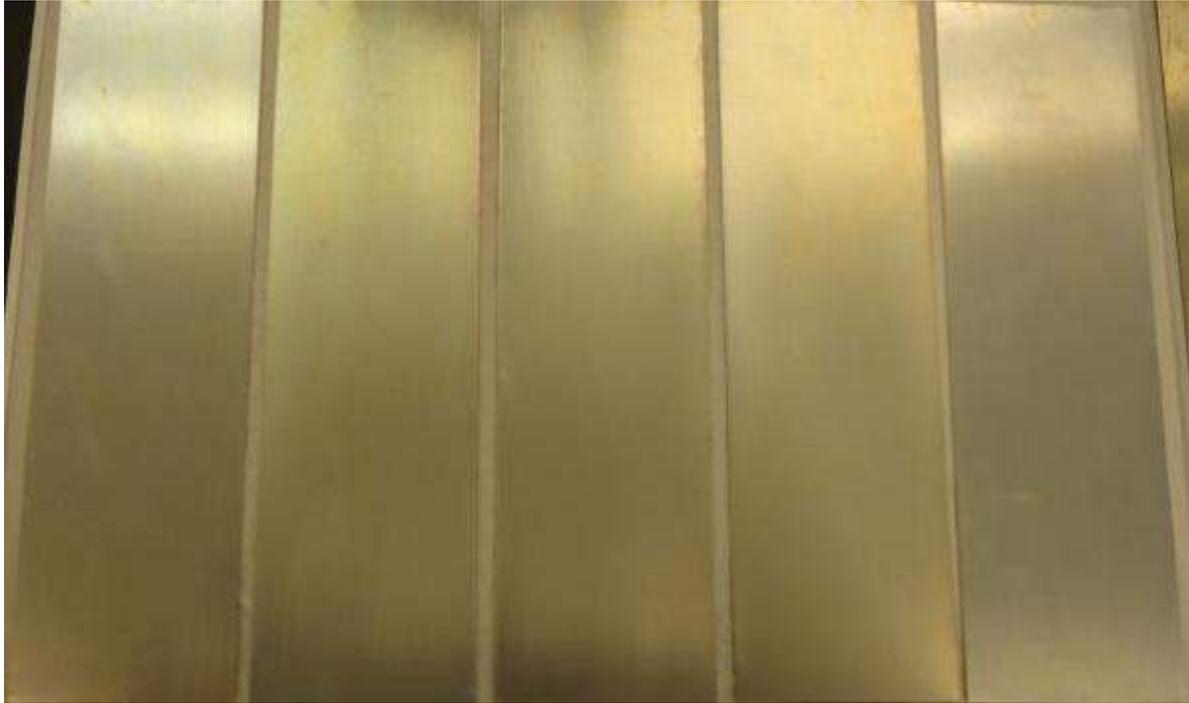
Figure 43 – Alodine 1600, 1011 - 1015

Alodine 1600 did not perform as expected on 7075-T73, 2024-T3 and 5052-H32 test panels. Curiously, Alodine 1600 did perform well on 6061-T6 test panels, a polar result to the ASTM B 117 salt spray results reported in section 3.1.3. Following 168 hours of salt spray exposure, all of the 7075-T73, 2024-T3 test panels with Alodine 1600 were considered failed. For 5052-H32 test panels, nearly all of the test panels failed, 4 of 5, the one exception was the test panel that was used for surface resistance measurements. These results bring into question the compatibility of Alodine 1600 and the panel preparation procedure selected for this project.

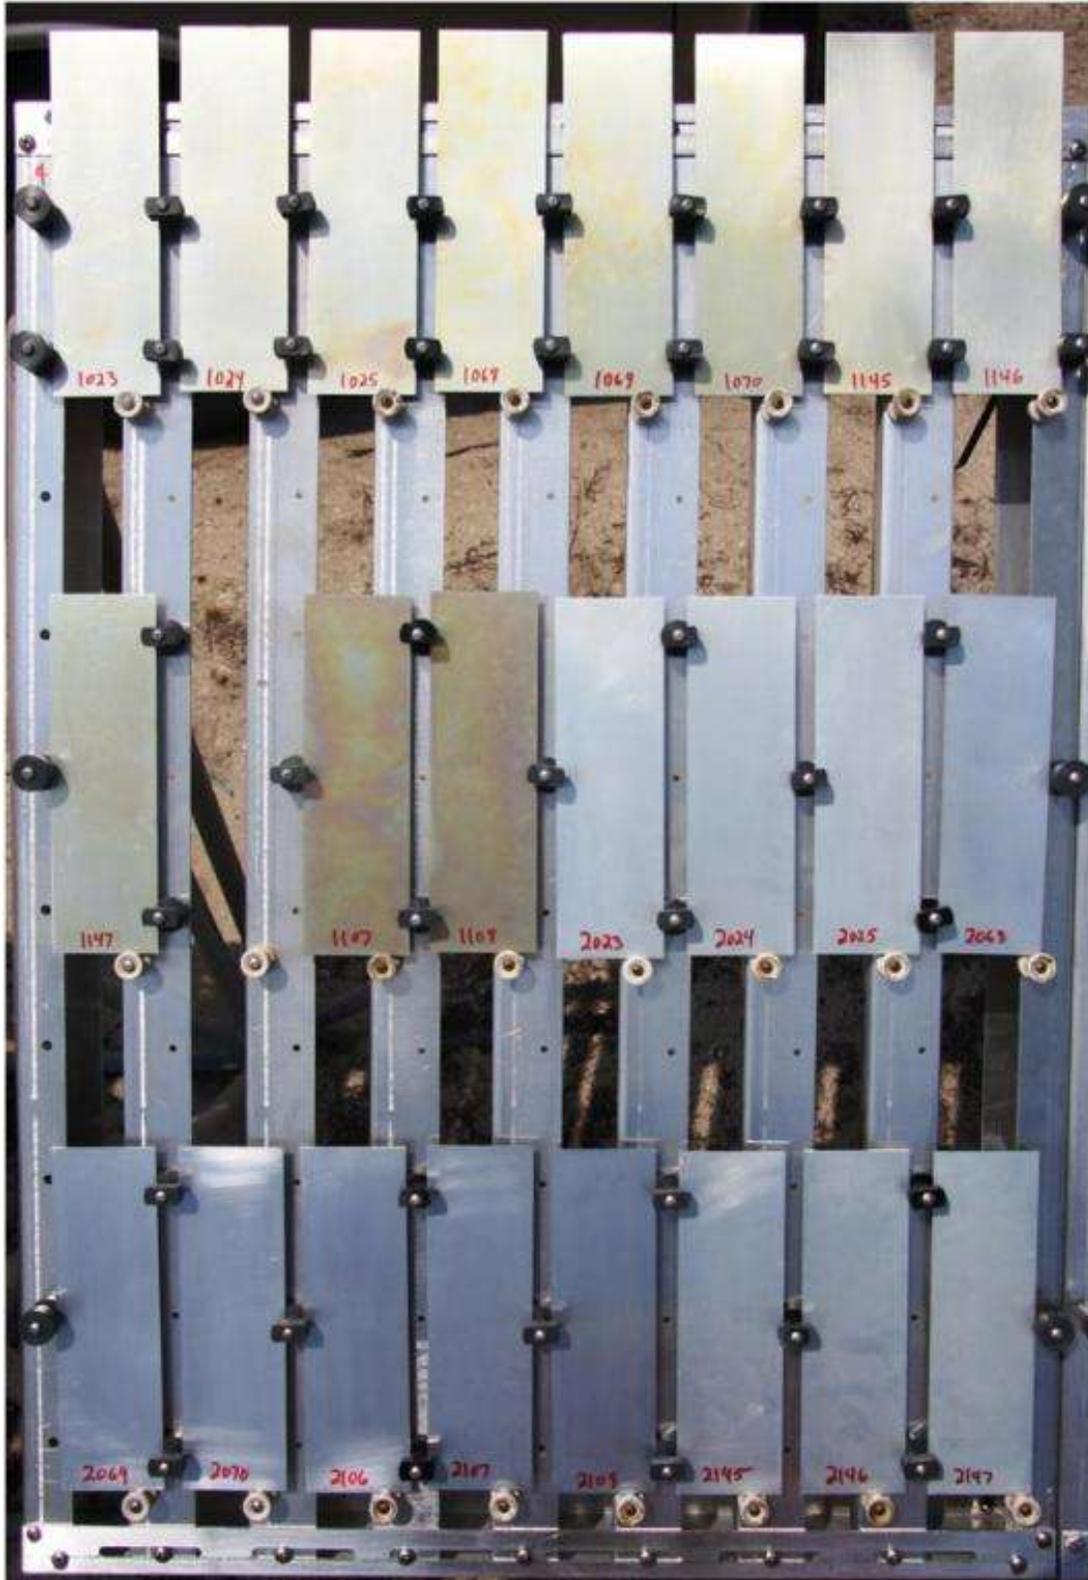
Figure 106 - Beachside Corrosion; Rack 1

Following 5 weeks of atmospheric exposure, all test panels showed signs of pitting through the entire test panel regardless of pretreatment or alloy. Overall the pitting was fairly consistent across all test panels with numerous small pits throughout the test panels.

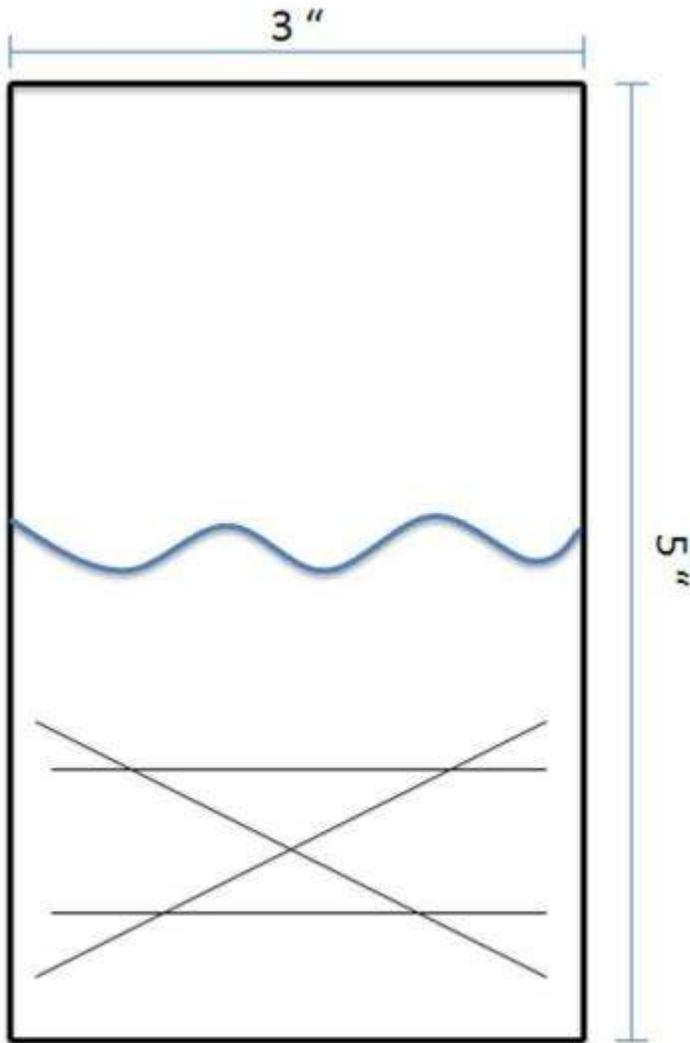
Figure 168 – Wet Tape Adhesion Test Panel

Once the test panels were removed from the water and dried, the test panels were scribed with two parallel scratches one inch apart with an x-cut through the middle of the parallel lines (see Figure 168). Immediately after scribing, a 1-inch wide strip of tape (the same Elcometer adhesive tape used for cross-cut tape test) is applied with the adhesive side down across the scratches. The tape was firmly pressed against the surface of the coating; a roller was used to ensure good adhesion. The tape was removed with one quick motion.
