## 2010 INTERNATIONAL WORKSHOP ON ENVIRONMENT AND ENERGY

### Environmental Projects for Aerospace Applications

# ***Chemical Depainting for Missile and Aviation Systems***

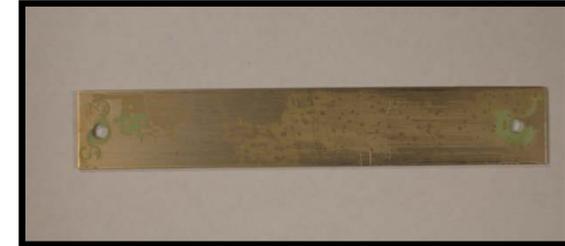
2024-T3  
 MIL-C-5541 Type I, Class 1a  
 Stripping Efficiency Panel

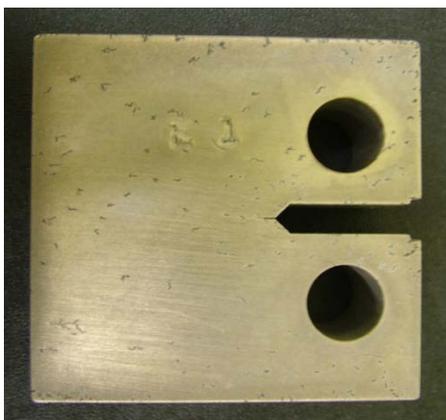
**Induced Crack, Magnesium Coupon**

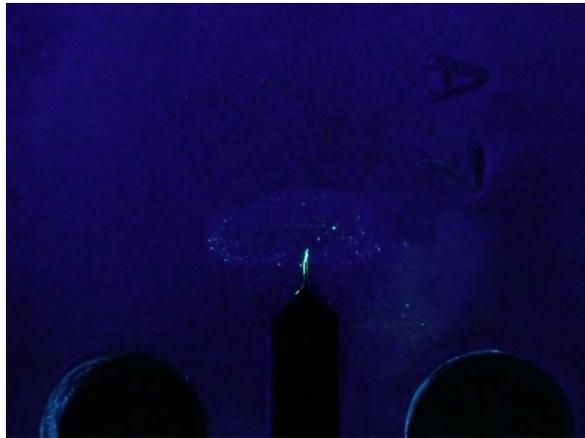
- Surface pitting occurred during the FPI post inspection cleaning process.
- Penetrant bleed out is adequate with some bleed out from pre crack-notch at 0X,10X.
- Pre-crack notch is distinguishable from crack at 60X magnification.
- Background fluorescence is acceptable.
- Residual penetrant remains on the bare surface after post inspection cleaning which could have detrimental effects.

Residual Penetrant, 0X

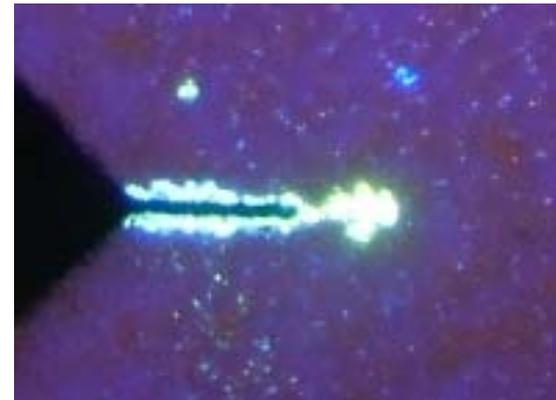
- **Tagnite 8200, Type I Anodize/High Temp Rockhard**
  - Rockhard coating over Tagnite eliminates the surface porosity and absorption of developer chemicals.
  - Penetrant bleed out is adequate with some bleed out from pre-crack notch at 0X,10X.
  - Indication appears blotchy and could be misinterpreted as excess bleed out from pre-crack notch.
  - Pre-crack notch distinguishable from crack at 60X.
  - Background fluorescence is almost nonexistent providing very good contrast.

Notch and Crack at 60X

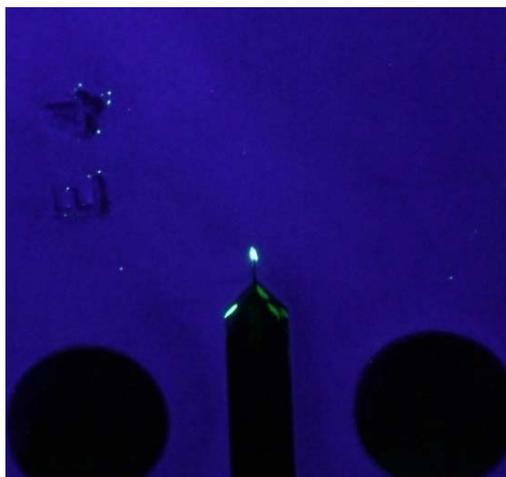
10X

- **Acid Bi-fluoride Pickle/Alodine 5700**
  - Penetrant bleed out is adequate with some bleed out from pre-crack notch at 0X, 10X.
  - Indication is blotchy and cannot distinguish notch from the crack.
  - At 30X using bleed back techniques, the crack is more distinctive.
  - Background fluorescence is minimal.

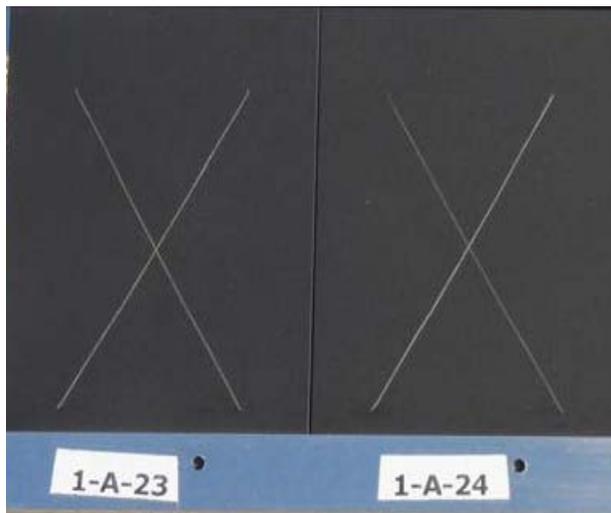
- First mounted on the exposure racks on April 16, 2010 and last evaluated August 17, 2010 at Wittman, AZ.
- The specimens will be assessed per ASTM D1654.
- All magnesium specimens are generally in good condition as of August 2010.

1A=Dow 7/HT Rockhard/23377C/53039  
4 months exposure

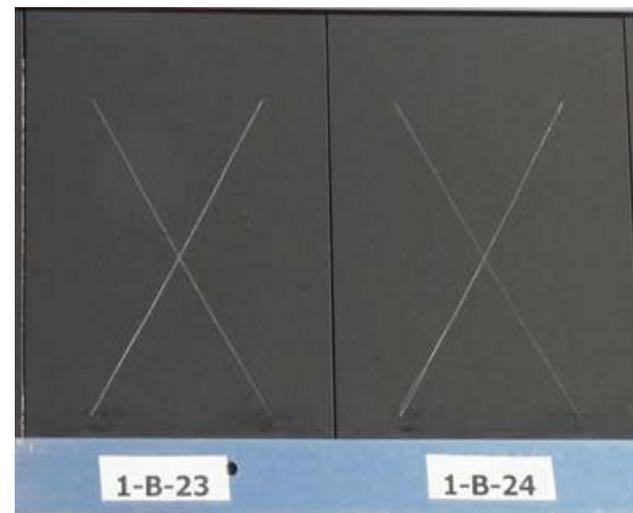
1B=Dow 7/HT Rockhard/23377N/53039  
4 months exposure

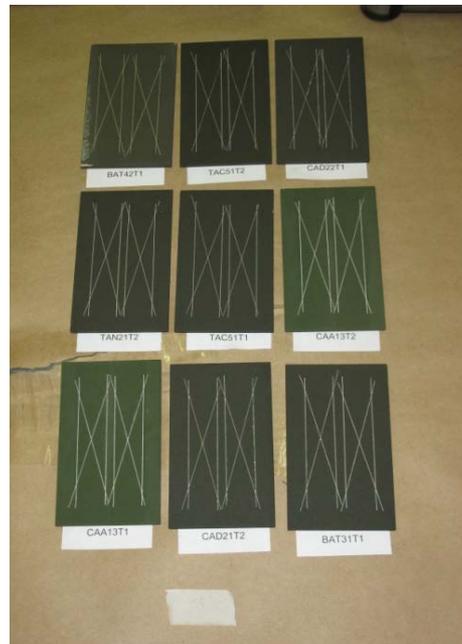
- Performed and evaluated per ASTM D 3359, Standard Test Methods for Measuring Adhesion by Tape Test, Method A.
- Immersed panels in deionized water for 24 hours.
- Testing completed for all steel and aluminum panels.

Aluminum, 4A  
 One Spectrum

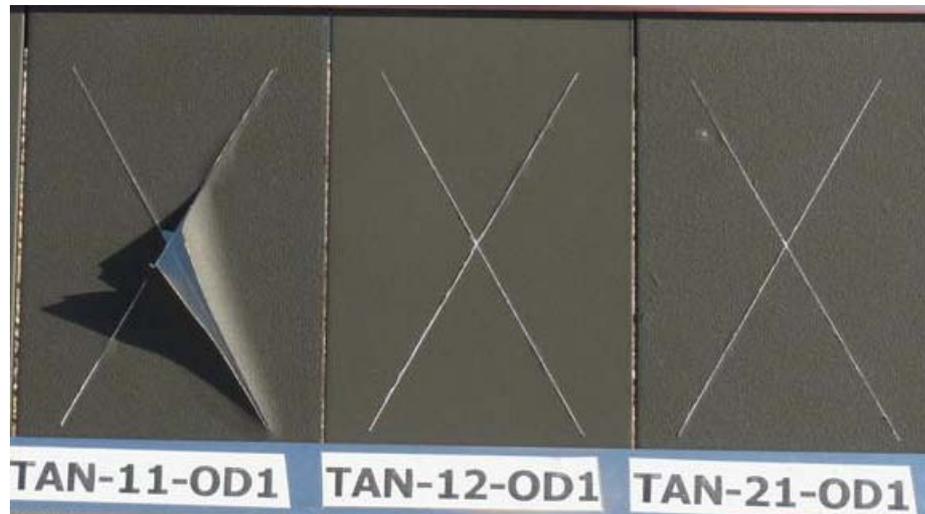
- First mounted on the exposure racks on April 16<sup>th</sup>, 2010 and last evaluated August 17<sup>th</sup>, 2010 in Wittmann, AZ.
- The specimens will be assessed periodically per ASTM D1654.
- Most specimens are generally in good condition as of August 2010.
- One case of coating delamination with the Spectrum EXGWP-508 is noted on the aluminum specimen below. The same coating system has not delaminated during beach exposure to date.

**Aluminum panels pretreated with Spectrum EXGWP-508  
4 Months Desert Exposure**

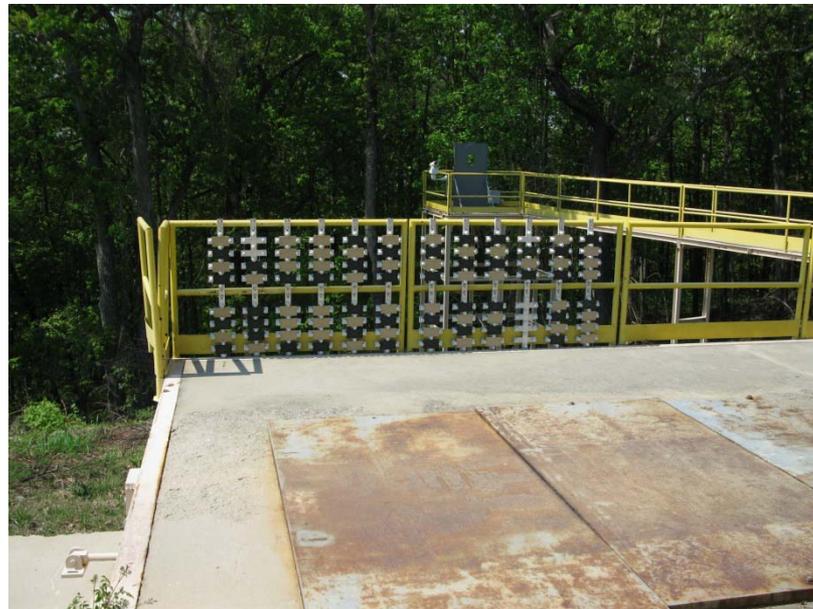
- Exposure at Redstone Arsenal, AL; Static Test Area 5, Stand E.
- Three month evaluations were completed the first week of August 2010.
- Aluminum and steel specimens are generally in good condition as of August 2010 with no major differences.
- The specimens will be photographed approximately every 3 month and fully assessed per ASTM D1654 at the end of the 12 month exposure period.
